Our Ref: 210607/PAH/PMR

**BARN AT WEAVERS FARM, WEAVERS LANE, CABUS, PR3 1AJ.**

**INTRODUCTION**

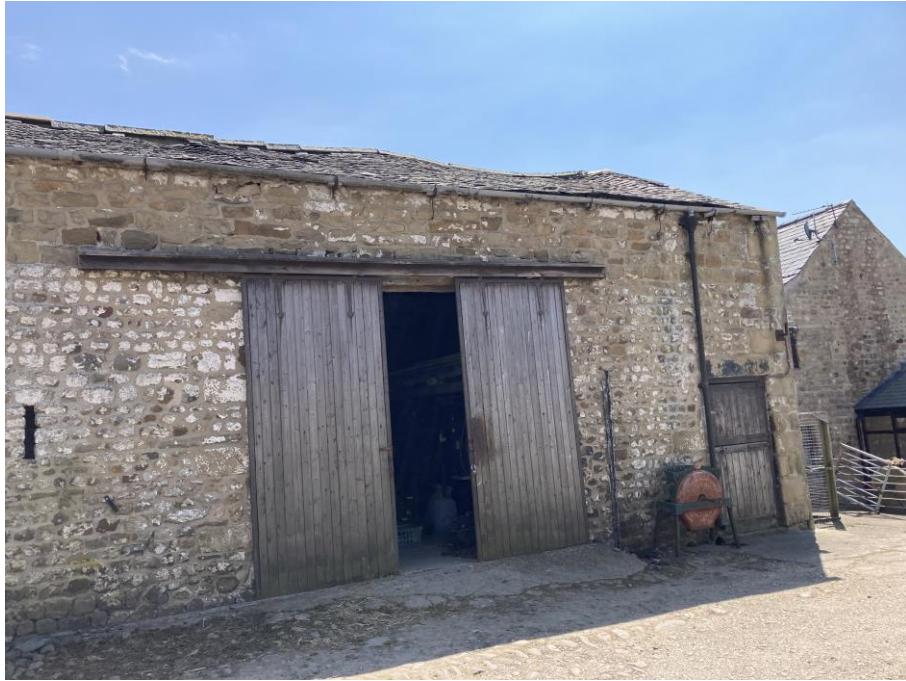
Externally we could see no evidence of structural cracking on any of the elevations and, despite some undulations, most of these appear relatively plumb and level. It is apparent however that the roof has sagged between the internal supporting trusses, see photo at rear of this report.

- 3.02 Whilst the roof structure appears sound, leak-free and in reasonable condition, any timbers which are to be re-used would have to be checked for any evidence of rot and as part of Building Regulations Approval, all suspect sections would have to be replaced. However, although the purlins are sagging between the supporting timber trusses, we feel this can easily be rectified by removing the slates and either repositioning or replacing some of the rafters and then refixing the slates. The condition of the existing roof timbers can be checked when access to the roof structure is more readily available.
