Land Adjacent to The Mill, Gurney Slade, Radstock

Desk Study and Preliminary Risk Assessment

Project No: 736000

Client: LKAB Minerals Limited

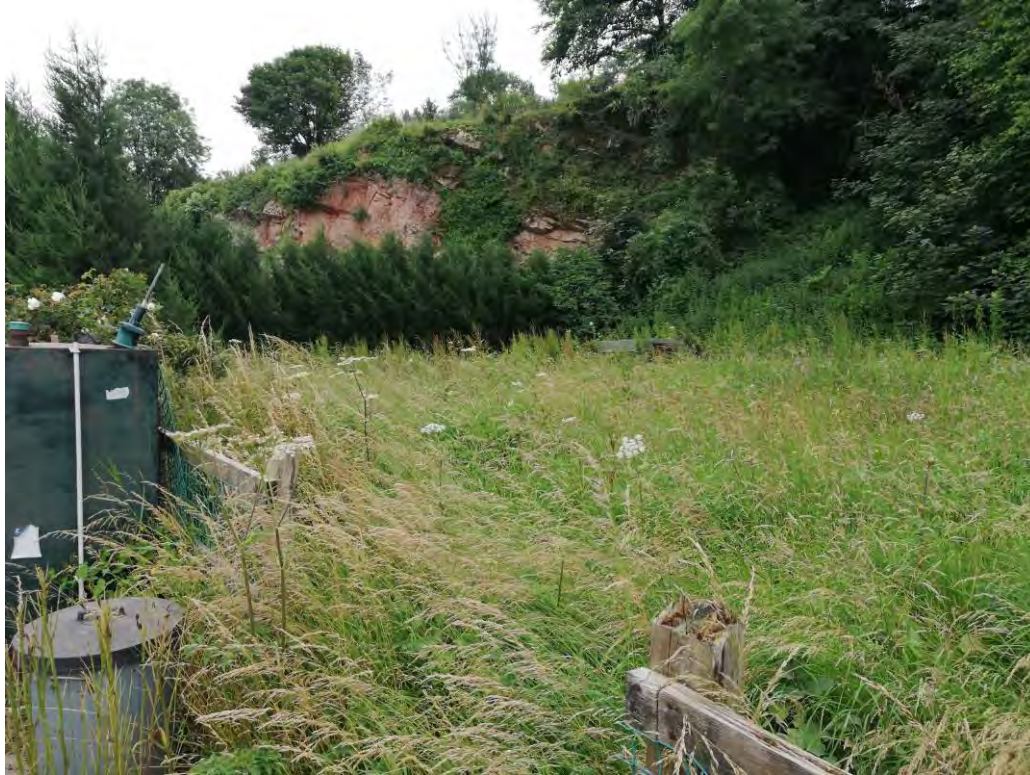
1. Grassed area in SW to rear of bungalows, looking SW. Cut face of quarry visible.

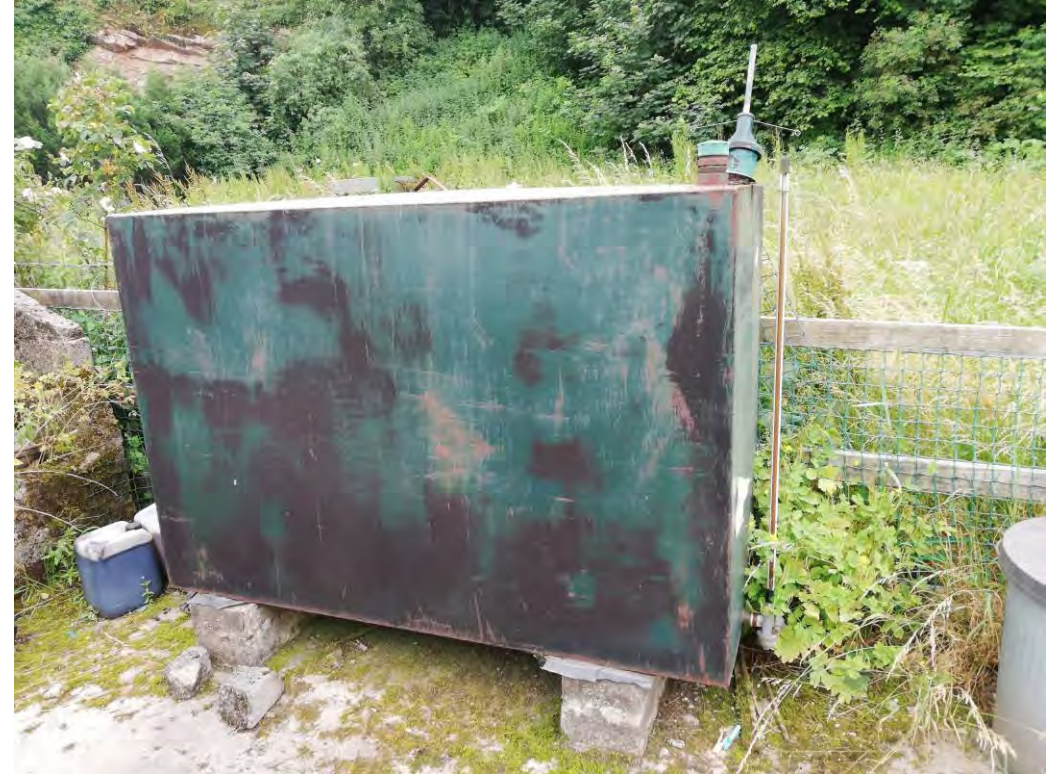
Each property has a heating oil tank to the rear (south). Alwyn has a metal tank (presumed single skin), estimated at 750-1000 litres in capacity, sat on raised bricks piers and located on the upper level of the site. Myrtledene has a modern plastic integrally banded 1000 litre tank which looks to be only recently installed, on a slightly raised concrete slab sat at the same level as the bungalows. Both tanks were full, with no evidence of surface staining or leaks and no obvious hydrocarbon odour. Discussions with LKAB Minerals Ltd indicate that the tanks will be appropriately decommissioned and removed as part of the bungalow demolition works. A heating oil tank was also visible on the adjoining property to the east of the site.

6. Heating oil tank.

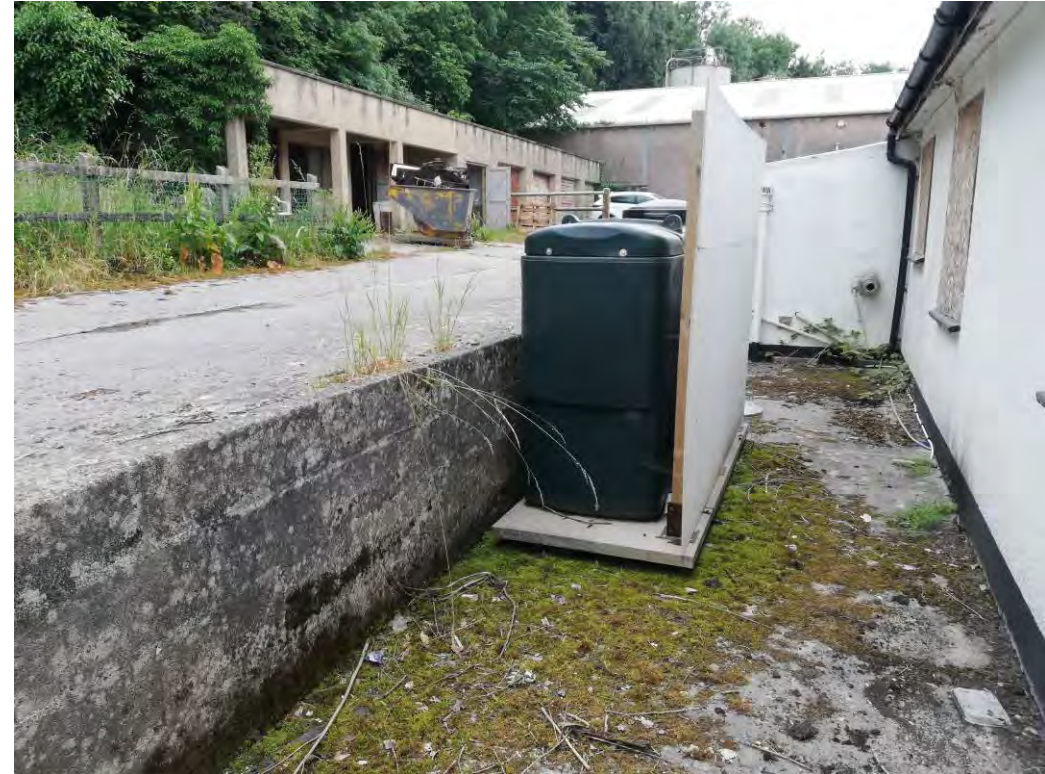
8. Retaining wall to rear of bungalows and Myrtledene heating oil tank. Looking W.

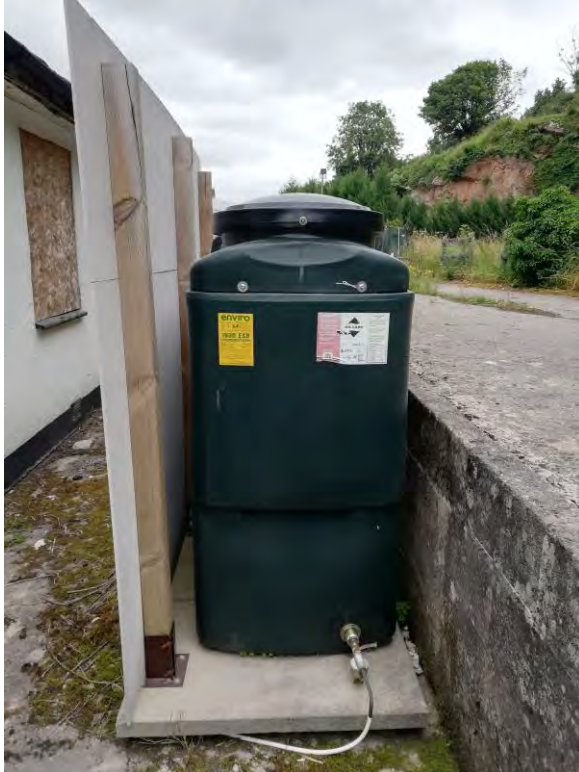
9. Myrtledene heating oil tank.

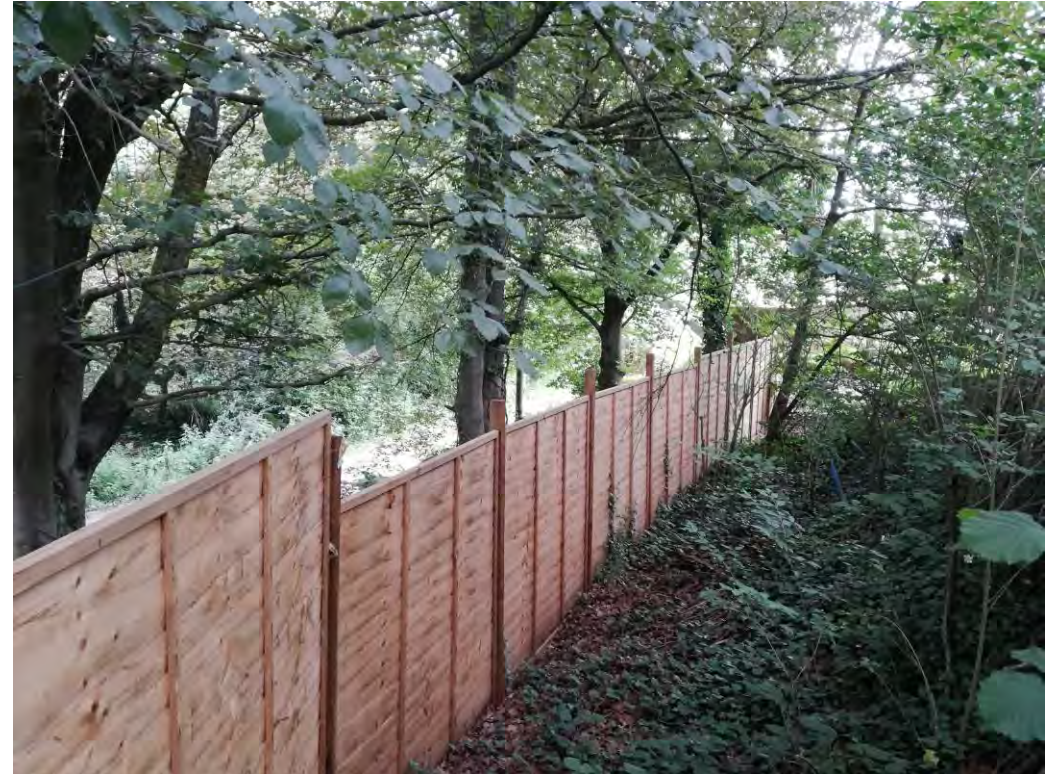
16. Fence towards NE site boundary, preventing access to the bungalows from Tape Lane.

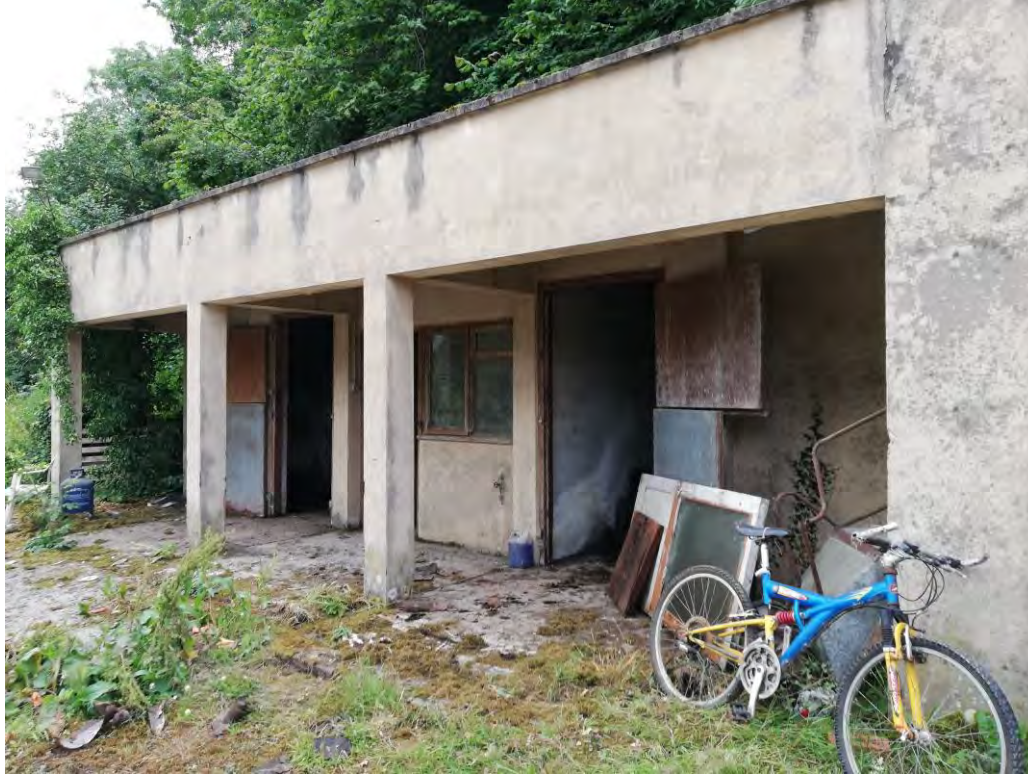
23. Workshops on S boundary, looking SE. Cut face of quarry to rear.

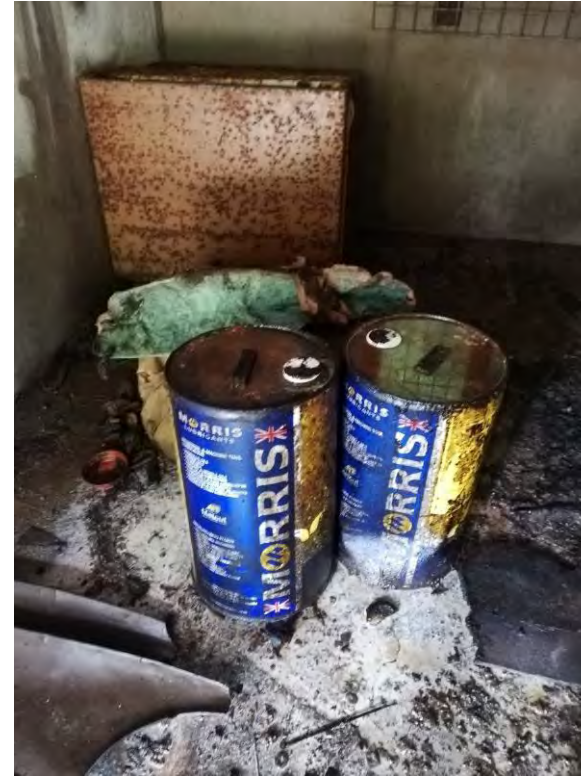
26. Lubricating oil drums inside workshop. Minimal staining and hydrocarbon odour inside workshop, concrete slab floor appears intact.

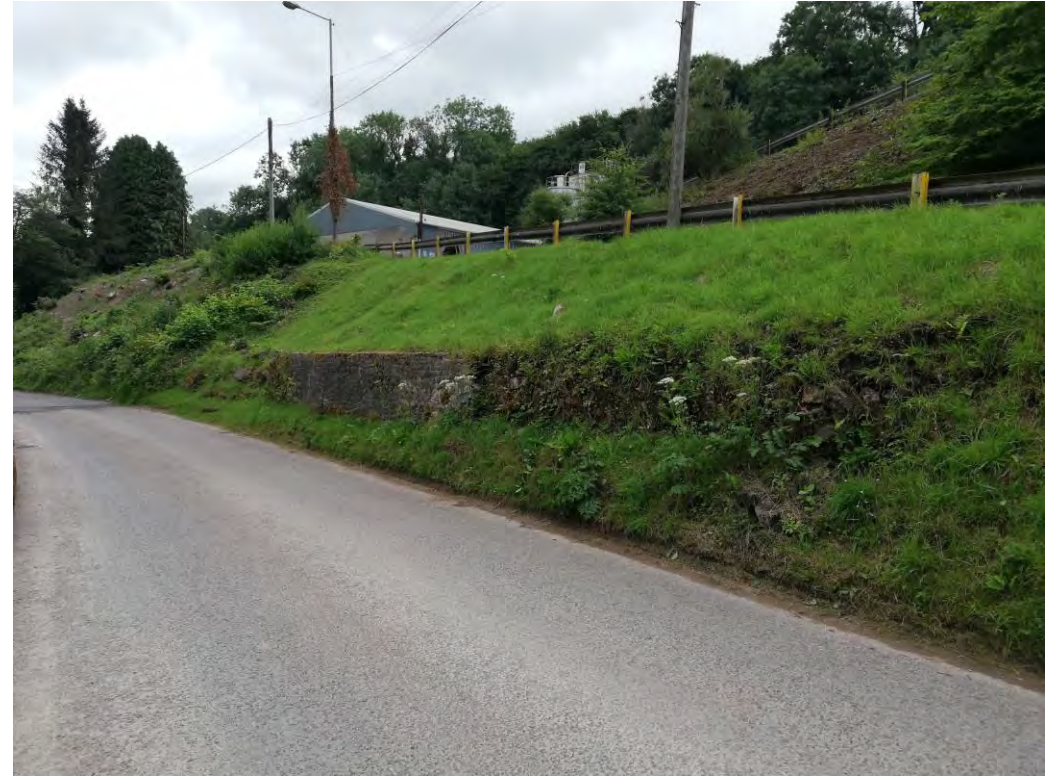
36. Site access road and short section of retaining wall, looking SE.

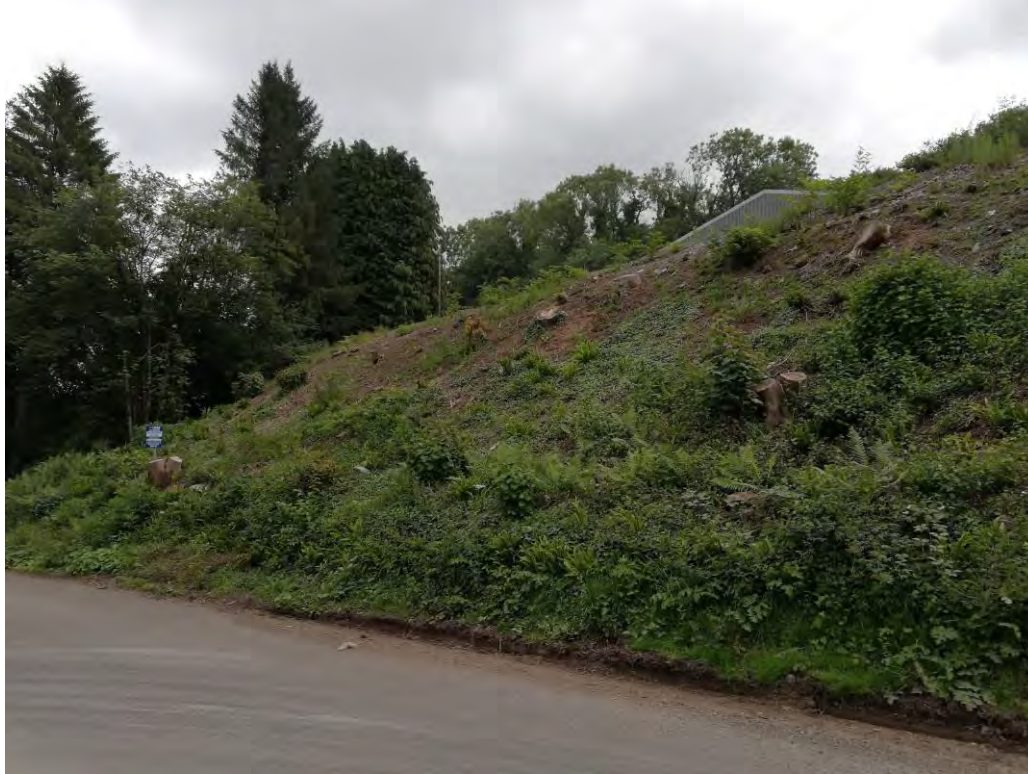
37. Slope below access road and bagging plant (visible in distance), felling works evident. Looking S.

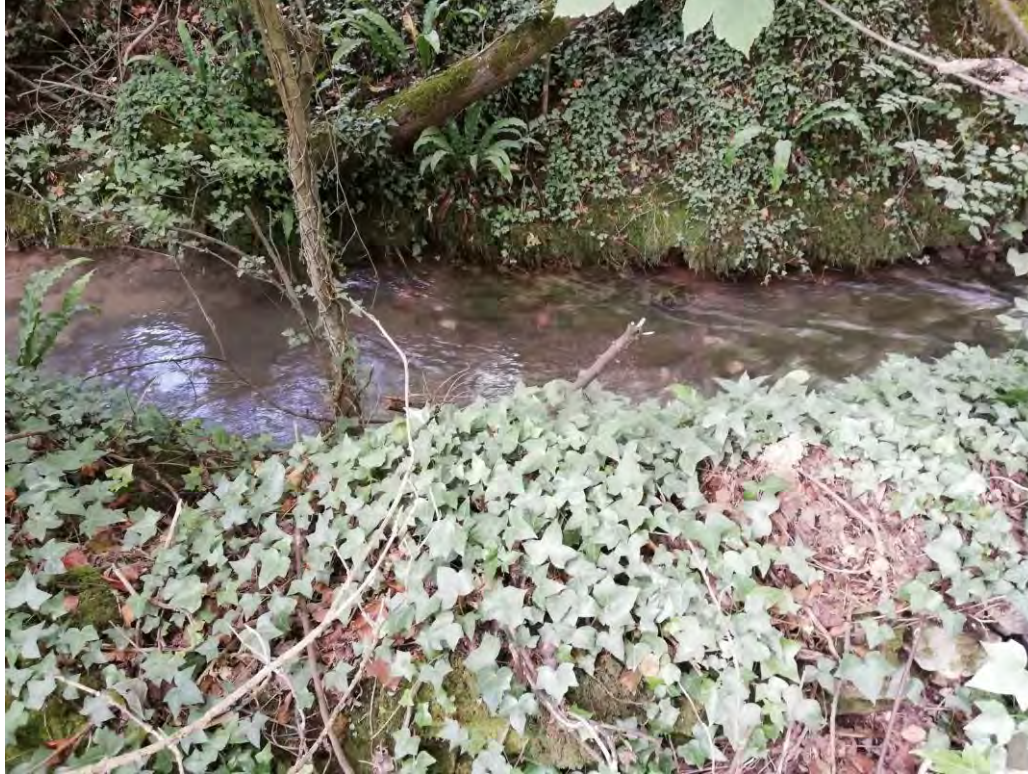
41. Stream near N site boundary, just beyond point where emerges from culvert, flowing E. Looking N.

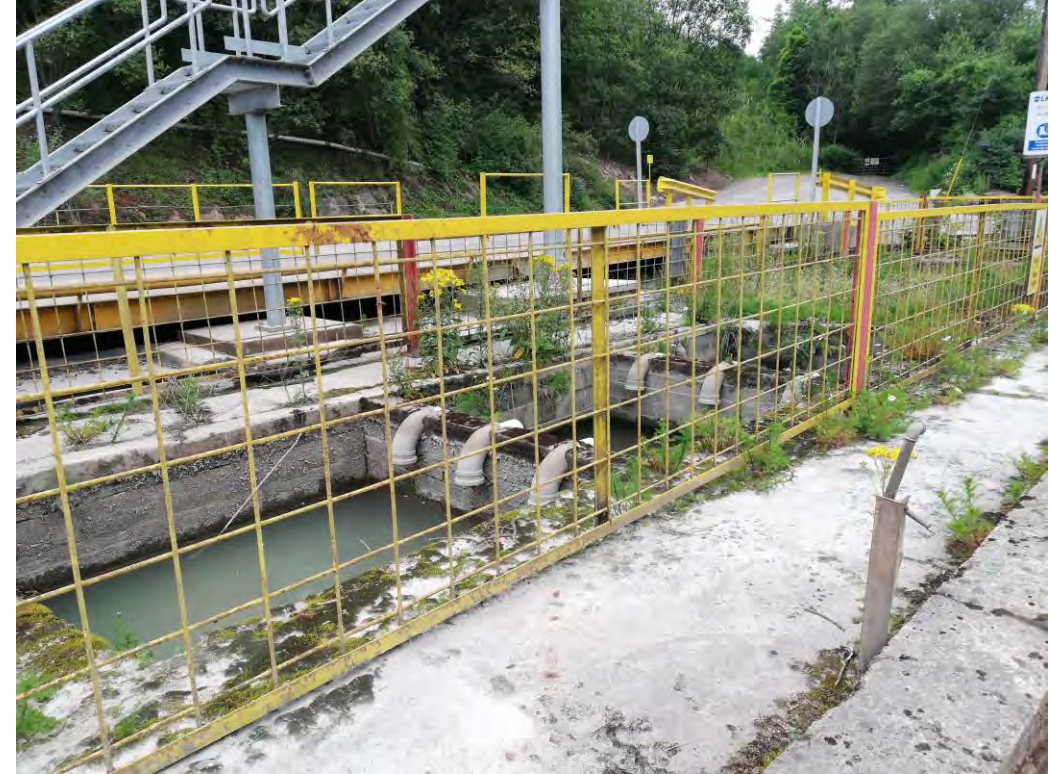
42. Settlement pit beyond N site boundary to W of culvert outlet. Looking NE.

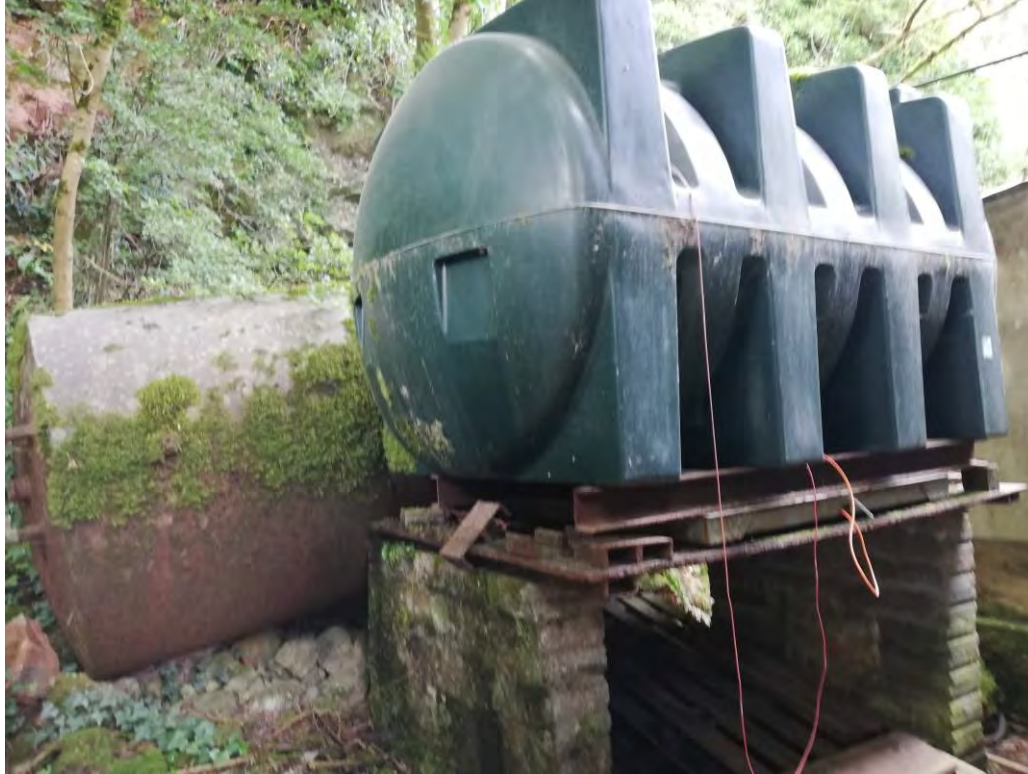
49. Fuel tank to rear (SE corner) of bagging plant. Abandoned metal tank visible beyond, before cut face of quarry.
