Project Number A-00738 (4949)

**Refurbishment and Demolition
Asbestos Survey Report**

**The Mill
Gurney Slade
Radstock
BA3 4TE**

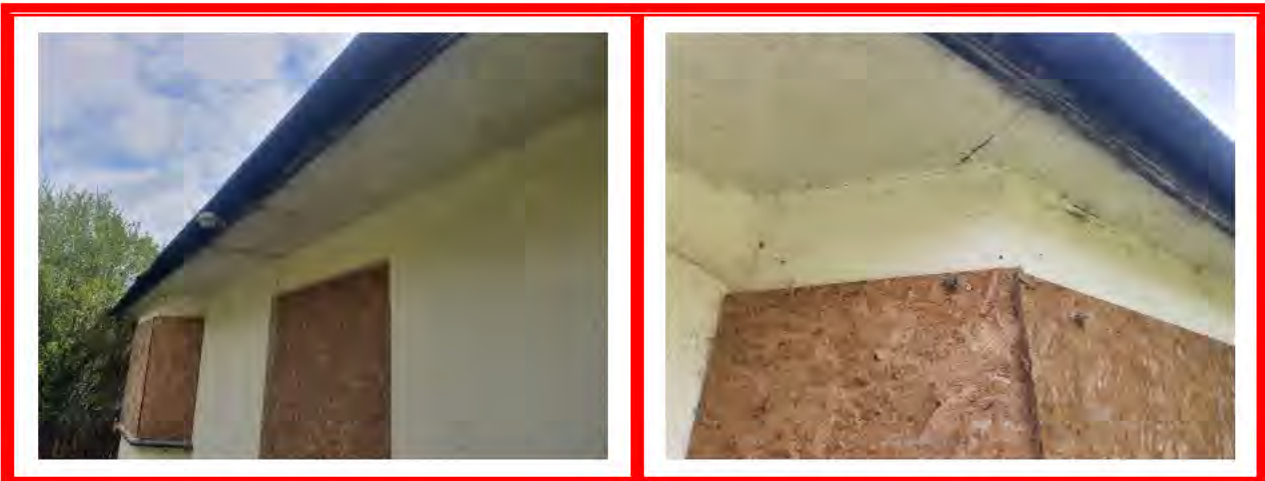
| Location: | External - Bungalow 1 013 | | |

| Material Description: | Soffit Boards - Cement Product | |
| Identification: | Sampled - Asbestos Detected | |
| Approx. quantity: | 12 LM | |
| Extent of Damage: | Slight / minor damage | 1 |
| Asbestos type: | Chrysotile | 1 |
| Material Assessment Score: | | 4 |
| Priority Assessment Score: | | Negligible |
| Comments: | Only found to one side of property. The other side is timber. | |

| Action: | Remove | |

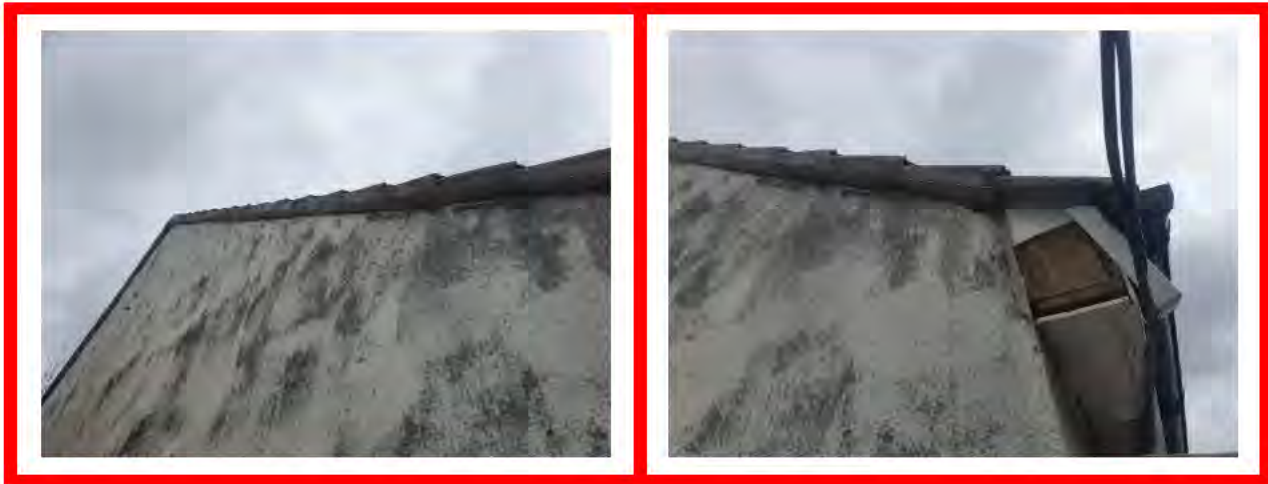
| Location: | External - Bungalow 2 015 | | |

| Material Description: | Cement Undercloaking - Cement Product | |
| Identification: | Sampled - Asbestos Detected | |
| Approx. quantity: | 16 LM | |
| Extent of Damage: | Slight / minor damage | 1 |
| Asbestos type: | Chrysotile | 1 |
| Material Assessment Score: | | 4 |
| Priority Assessment Score: | | Negligible |
| Comments: | Only found on bungalow 2 | |

| Action: | Remove | |

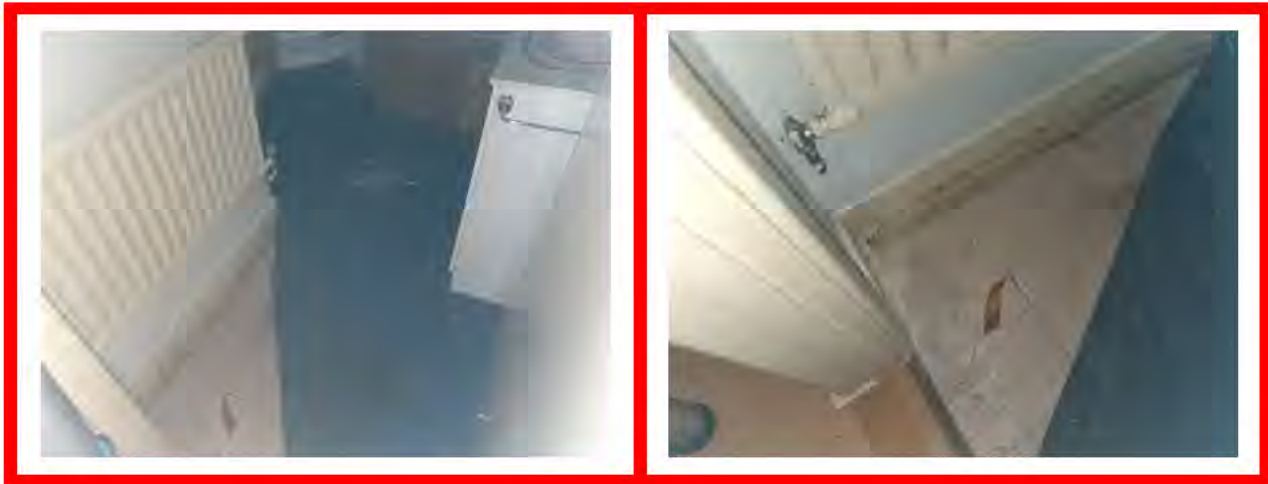
| Location: | Ground Floor - Bungalow 2 - Bathroom 021 | | |

| Material Description: | Floor Tiles - Vinyl Products | |
| Identification: | Sampled - Asbestos Detected | |
| Approx. quantity: | 4 m ² | |
| Extent of Damage: | Slight / minor damage | 1 |
| Asbestos type: | Chrysotile | 1 |
| Material Assessment Score: | | 3 |
| Priority Assessment Score: | | Negligible |
| Comments: | Non asbestos polystyrene ceiling tiles and plasterboard and timber ceilings. | |

| Action: | Remove | |

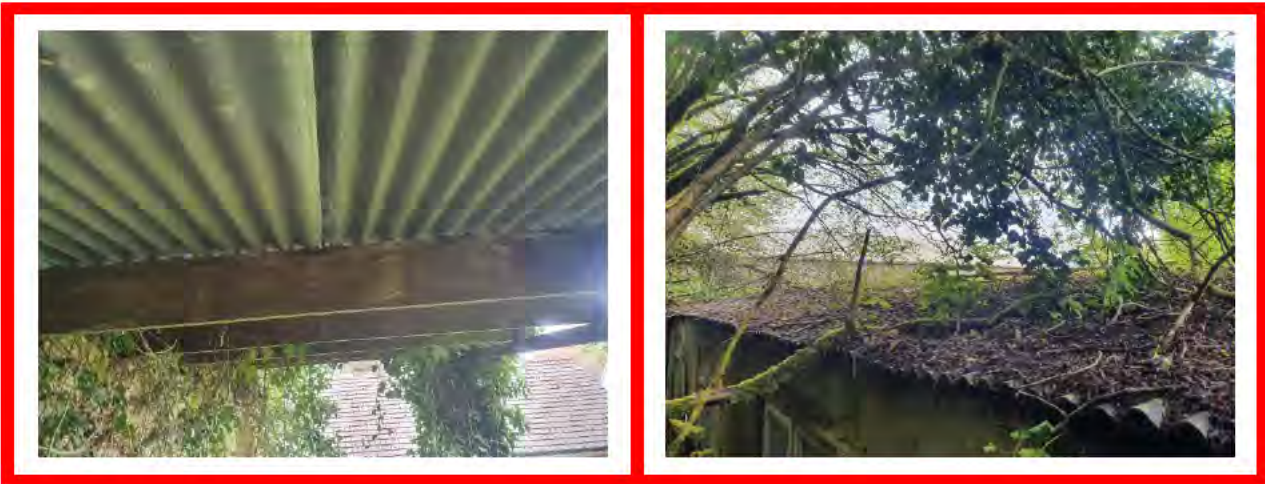
| Location: | External - Garage Block 029 | | |

| Material Description: | Profiled Roof - Cement Product | |
| Identification: | Sampled - Asbestos Detected | |
| Approx. quantity: | 130 m ² | |
| Extent of Damage: | Slight / minor damage | 1 |
| Asbestos type: | Chrysotile | 1 |
| Material Assessment Score: | | 4 |
| Priority Assessment Score: | | Negligible |
| Comments: | To entire block. A previous survey identified some cement debris to the back of the garages near the old tank. This could not be found during the survey but caution should be applied. | |

| Action: | Remove | |

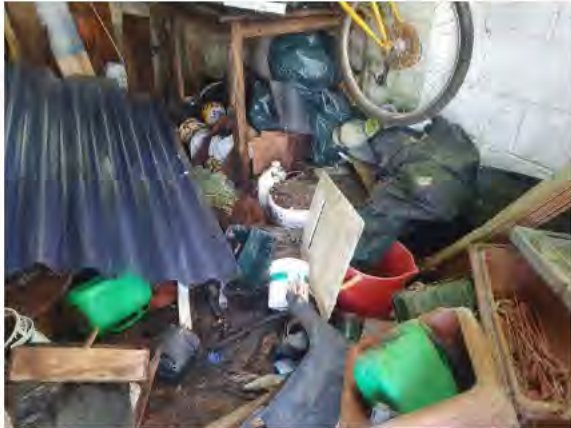
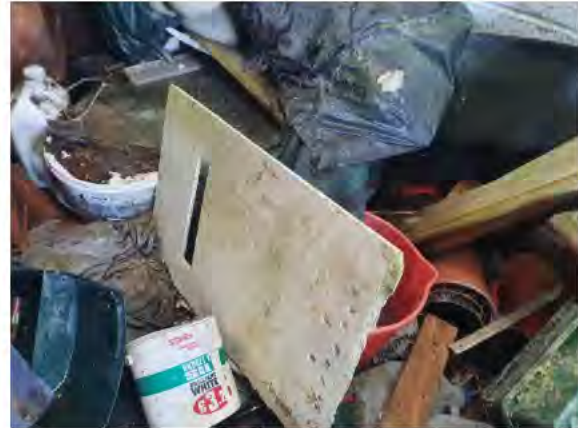
Location: Ground Floor - Garage Block - Stable 2 031

| Material Description: | Stored Panel - Insulating Board | |
| Identification: | Sampled - Asbestos Detected | |
| Approx. quantity: | <1 m ² | |
| Extent of Damage: | Moderate damage | 2 |
| Asbestos type: | Amosite, Chrysotile | 2 |
| Material Assessment Score: | | 8 |
| Priority Assessment Score: | | Medium |
| Comments: | Limited access within stored items throughout block | |

| Action: | Remove | |

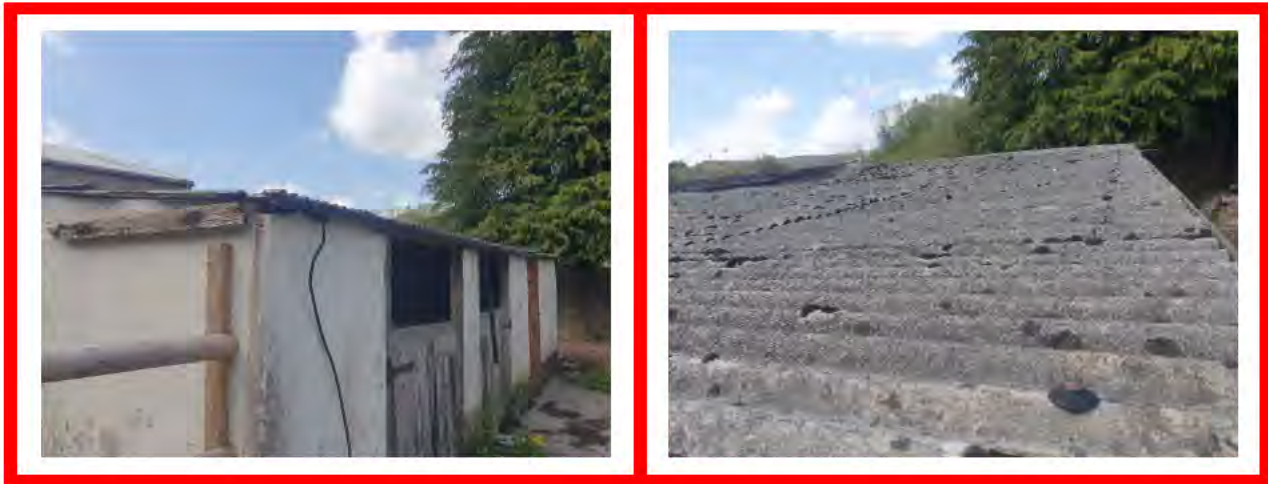
| Location: | External - Stable Block 034 | | |

| Material Description: | Profiled Roof - Cement Product | |
| Identification: | Sampled - Asbestos Detected | |
| Approx. quantity: | 20 m ² | |
| Extent of Damage: | Moderate damage | 2 |
| Asbestos type: | Chrysotile | 1 |
| Material Assessment Score: | | 5 |
| Priority Assessment Score: | | Low |

| Action: | Remove | |

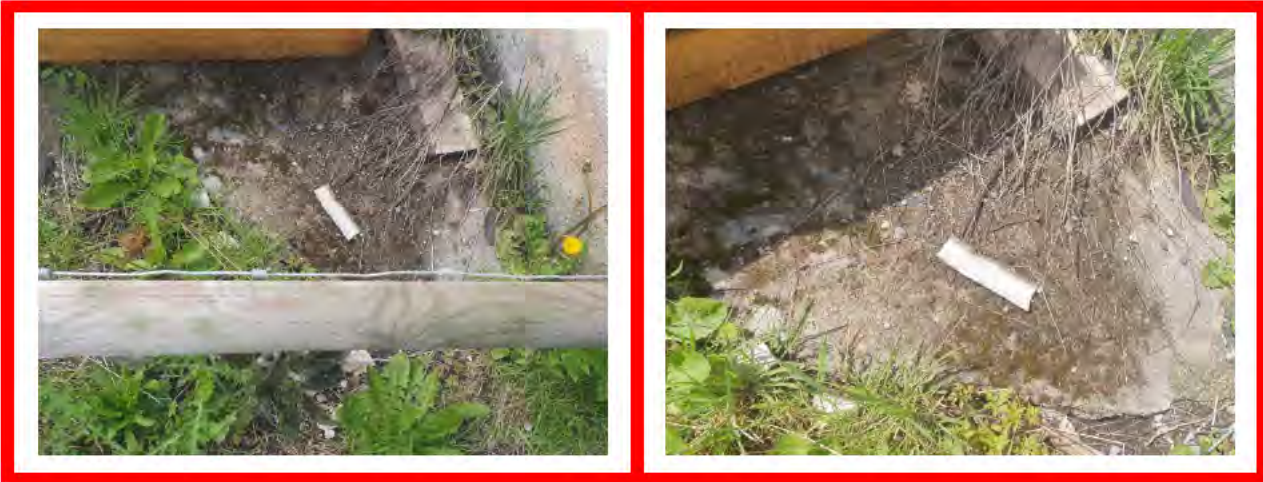
| Location: | External - Stable Block 035 | | |

| Material Description: | Cement Debris - Cement Product | |
| Identification: | As per sample DK/15 - Asbestos Detected | |
| Approx. quantity: | <1 m ² | |
| Extent of Damage: | Major damage | 3 |
| Asbestos type: | Chrysotile | 1 |
| Material Assessment Score: | | 6 |
| Priority Assessment Score: | | Low |
| Comments: | On floor next to stables | |

| Action: | Remove | |

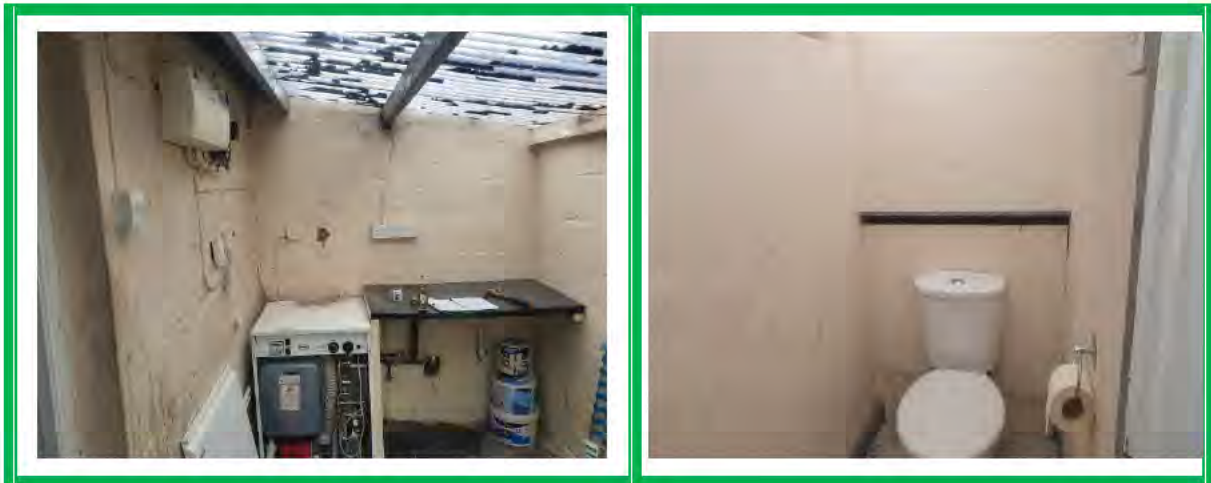
| Location: | Ground Floor - Bungalow 1 - Lobby & WC 001 | | |

| Material Description: | No Suspect Materials Found | |
| Comments: | Modern boiler and electrics. Non asbestos vinyl flooring | |

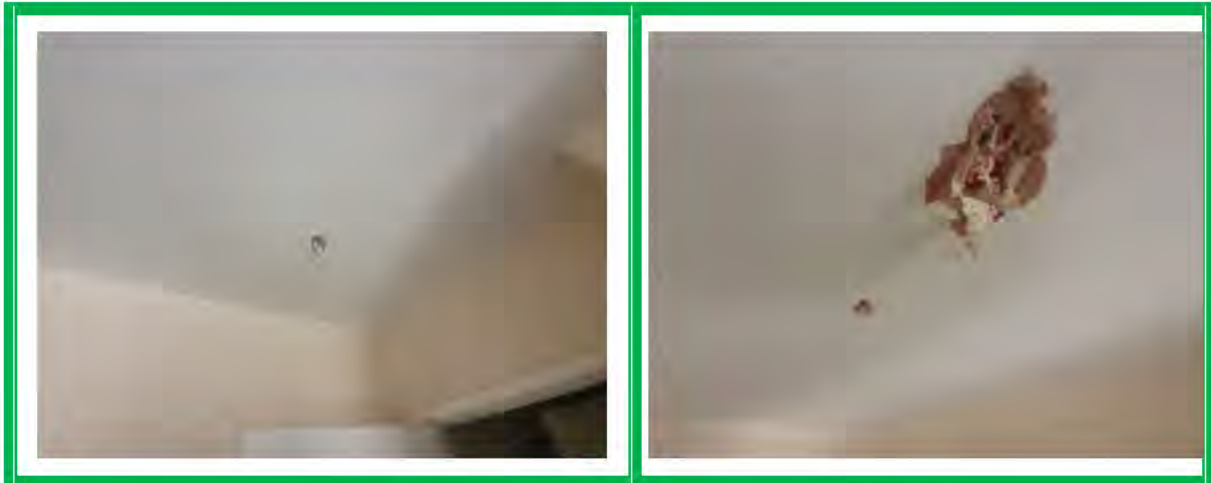
| Location: | Ground Floor - Bungalow 1 - Kitchen 002 | | |

| Material Description: | Panels above Plasterboard - Insulating Board | |
| Identification: | Sampled - No Asbestos Found | |
| Comments: | Located directly above plasterboard ceiling | |

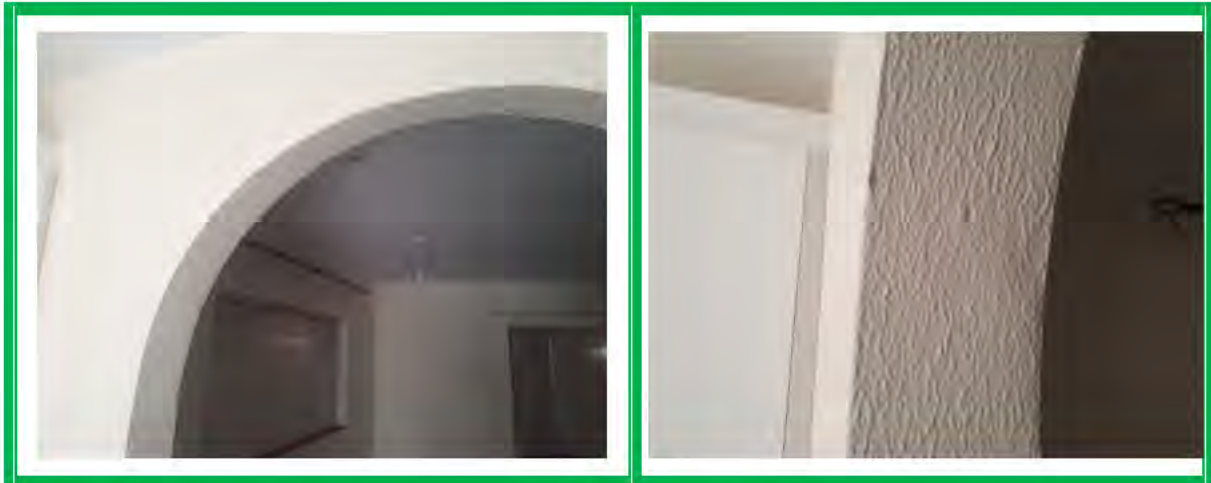
| Location: | Ground Floor - Bungalow 1 - Kitchen 003 | | |

| Material Description: | Archway - Textured Coating | |
| Identification: | Sampled - No Asbestos Found | |

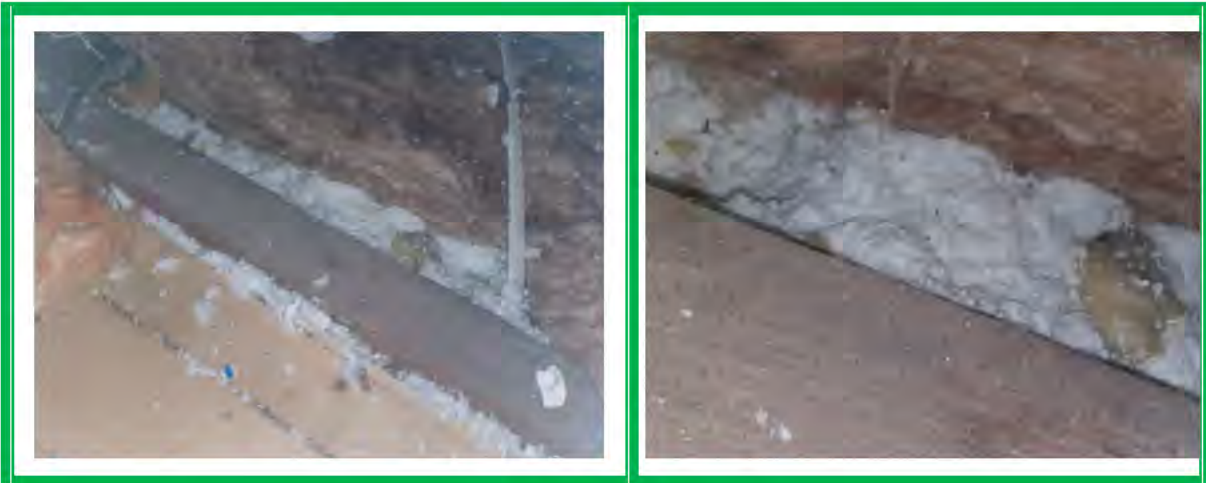
| Location: | First Floor - Bungalow 1 - Store 010 | | |

| Material Description: | White Insulation Debris - Insulation | |
| Identification: | Sampled - No Asbestos Found | |

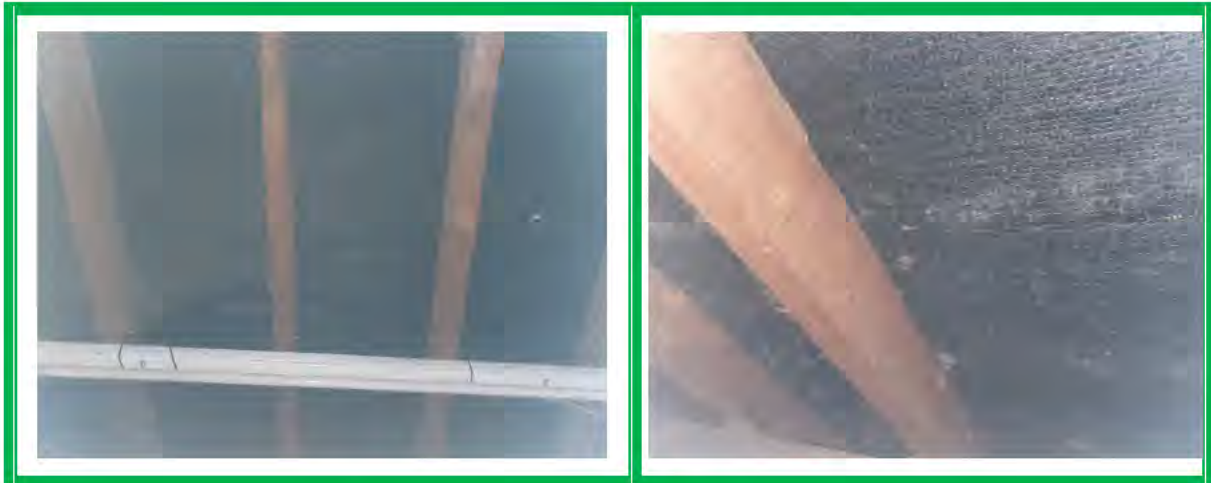
| Location: | First Floor - Bungalow 1 - Store 011 | | |

| Material Description: | Felt to Underside of Roof - Bituminous Product | |
| Identification: | Sampled - No Asbestos Found | |

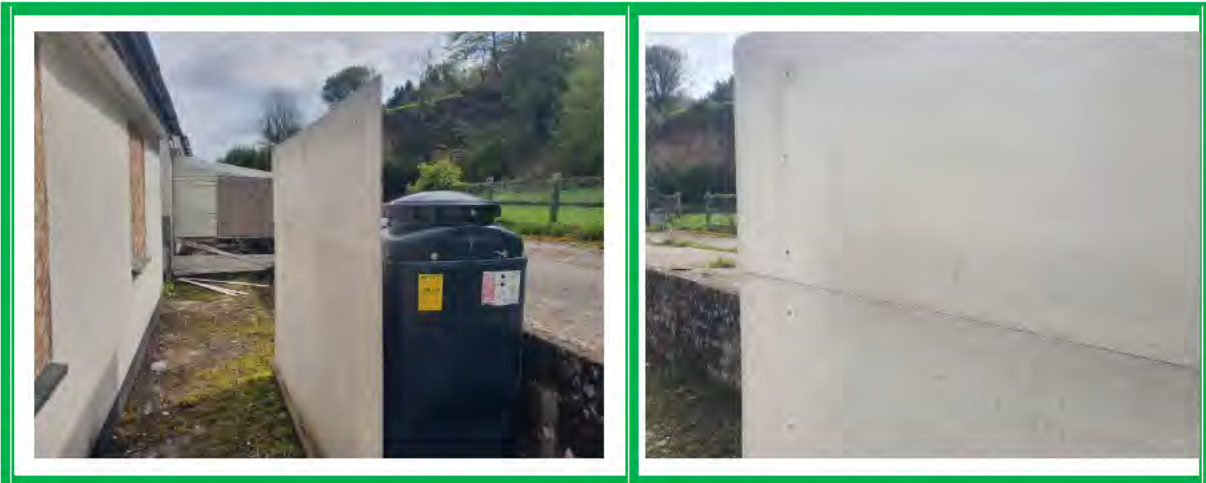
| Location: | External - Bungalow 1 014 | | |

| Material Description: | Panels to front of Oil Tank - Insulating Board | |
| Identification: | Sampled - No Asbestos Found | |

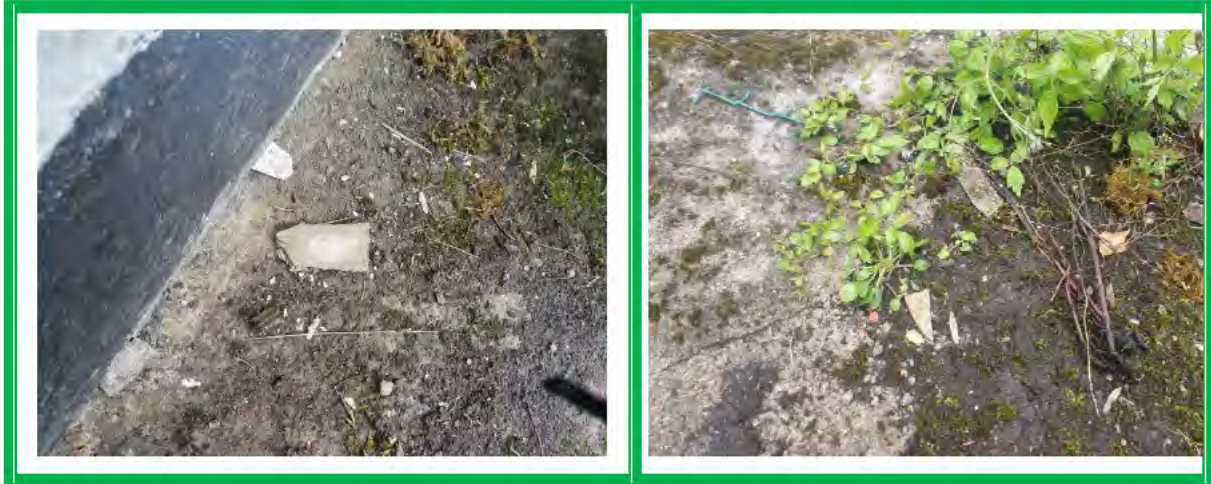
| Location: | External - Bungalow 2 016 | | |

| Material Description: | Cement Debris - Cement Product | |
| Identification: | Sampled - No Asbestos Found | |

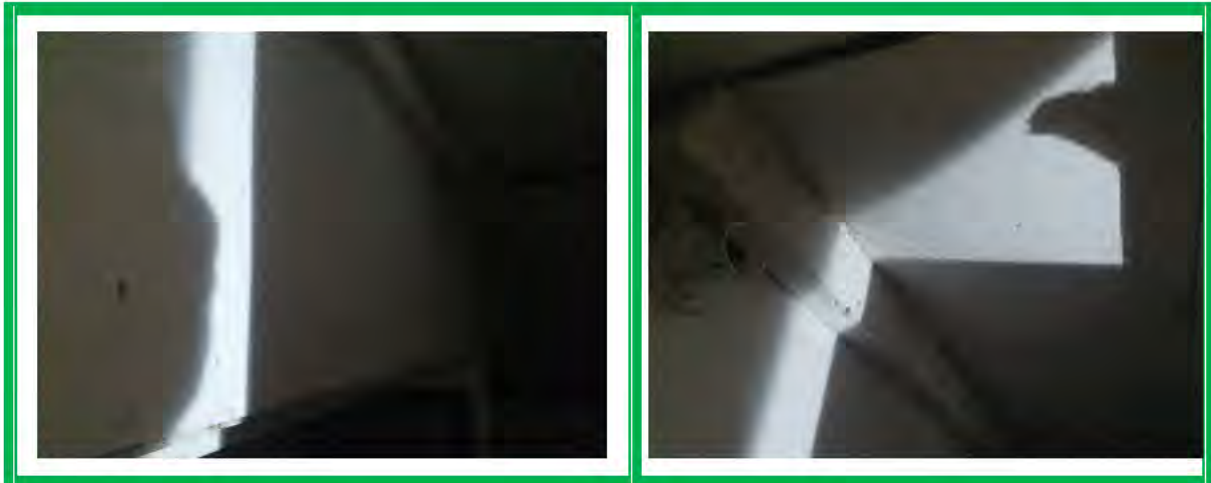
| Location: | First Floor - Bungalow 2 - Store and Voids 026 | | |

| Material Description: | Fiberboard Walls and Ceilings - Paper Product | |
| Identification: | Sampled - No Asbestos Found | |

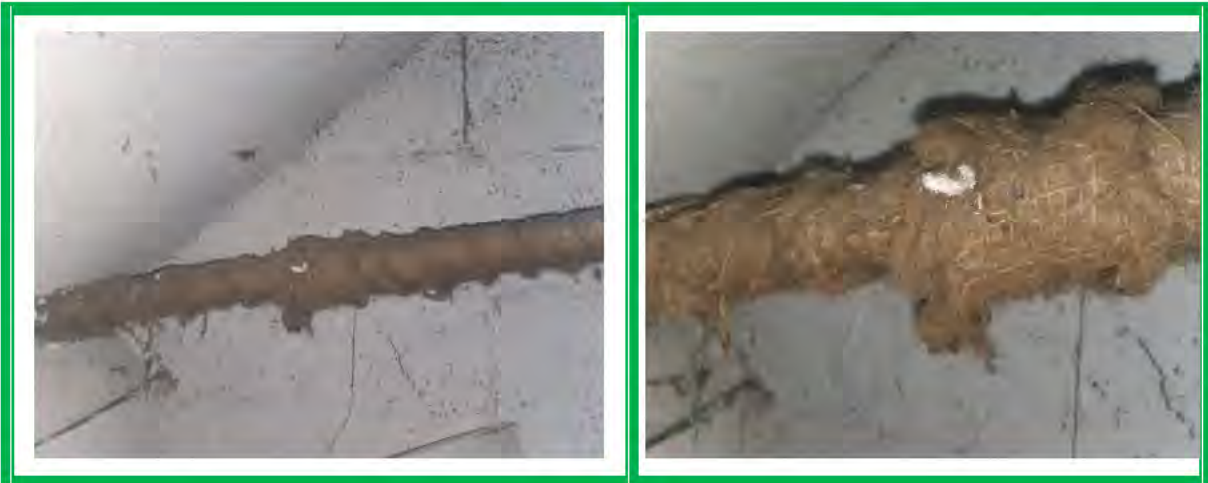
| Location: | First Floor - Bungalow 2 - Store and Voids 027 | | |

| Material Description: | Hessian Pipework insulation - Woven Product | |
| Identification: | Sampled - No Asbestos Found | |

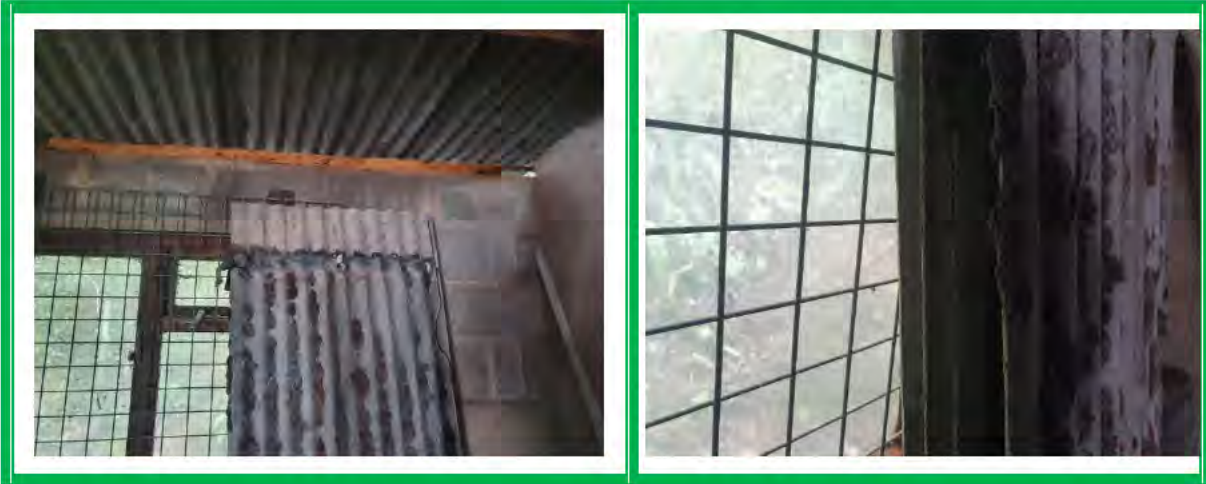
| Location: | Ground Floor - Garage Block - Stable 3 032 | | |

| Material Description: | Stored Cement Sheets - Cement Product | |
| Identification: | Sampled - No Asbestos Found | |
