**THE CORN MILL, Clee St Margaret**  
**SURVEY of WATER-POWERED MILLSTONES**

**July 2021**

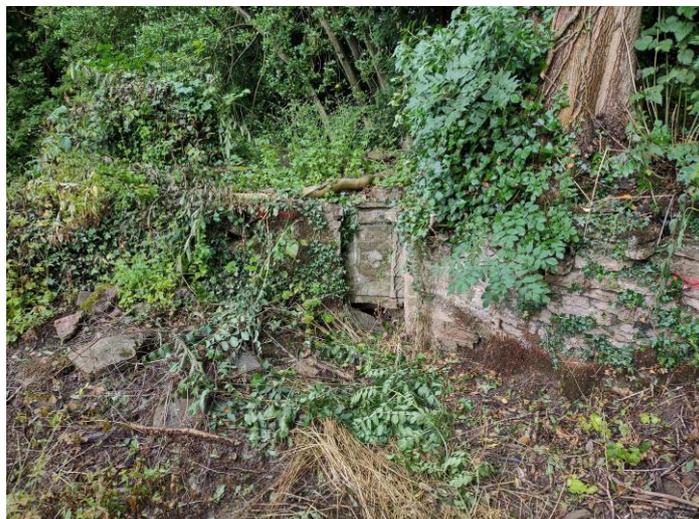
Currently the mill pond is dry and heavily overgrown. It is not known if it can hold water or where the water supply may come from. To the western edge of the pond there is a break in the walling which would have housed a by-pass sluice gate enabling water to be released from the pond back into Clee brook around the side of the mill.

- New bypass sluice gate manufactured in Oak to traditional methods
- Clear and seal the pond and provide water into it (by others)
- Locate and check condition of outlet pipe / renew if required
- Install gate valve on outlet pipe to enable control of water (this may require the pipe to be renewed anyway)

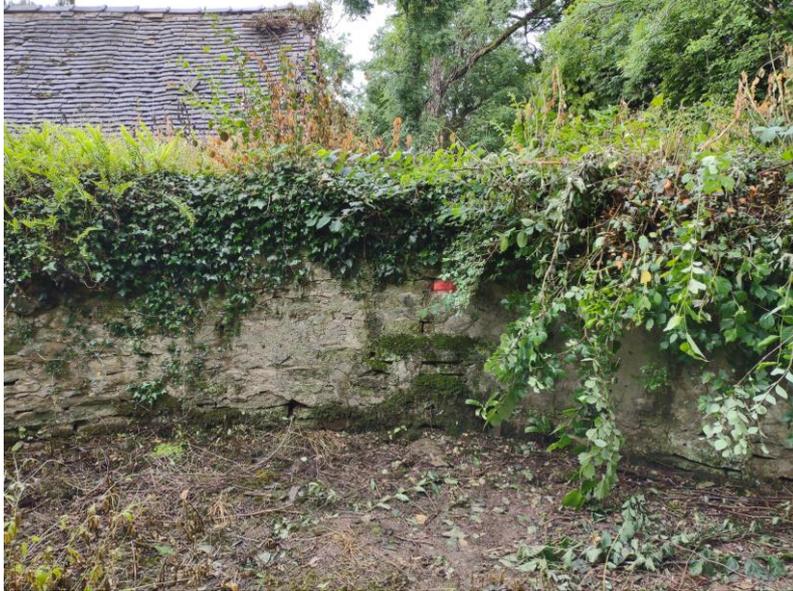
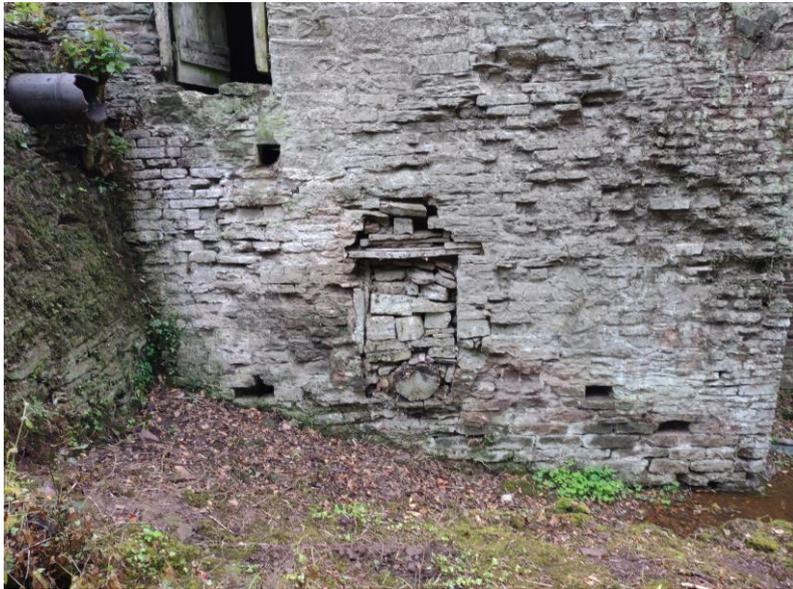
A red mark on the internal face of the wall pond shows the line at which a cast iron feed pipe provided water to the launder (now missing) Whilst this Cast iron feed pipe is evident on the other side of the wall no trace could be seen within the mill pond itself. This will require investigation and re-instating if missing. There should also be a way of controlling water into the pipe – again this could not be found.

The above picture shows the remains of the cast iron feed pipe (14" diameter), the end is broken and the pipe is rusting. There is good wall thickness left on the pipe so it could be re used if the other end and internal stability of the pipe can be ascertained.

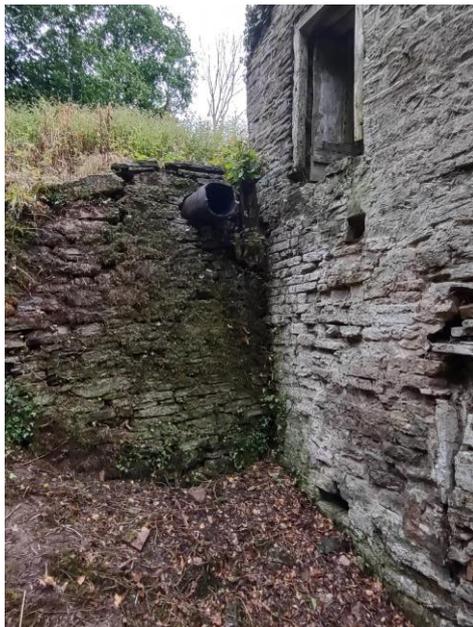
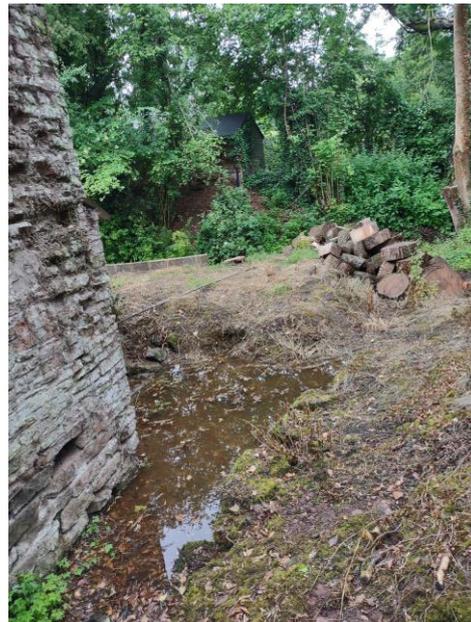
As seen in the photograph above, the launder and waterwheel are missing. The remains of the waterwheel shaft are evident and scrape marks on the side wall give a good indication as to the wheel diameter. Using this evidence we believe the wheel was around 12ft in diameter and 3ft in width. The shaft (now cut off) is 16" across flats and would have extended by a further 4ft to sit on a bearing block now no longer existing. Due to the pronounced scrape marks it is thought that the wheel consisted of cast iron shrouds, probably a cast iron central hub with the spokes, buckets and sole boards bring in timber. If as the history suggests, there has been a mill on this site for century's, it would originally have been all timber. Therefore the scrape marks seen could be from a latter style of wheel.

The cast iron pipe is broken at its outer most end. This may mean it continued as a pipe and supplied water to the wheel with timber supports underneath it. Alternatively, it may have fed a timber launder, supported on a timber trestle which in turn fed the waterwheel. This would have a control flap set within it to control the follow of water over the waterwheel. Opening the flap would waste water behind the wheel thus stopping it.

The waterwheel wheel pit is currently full of soil and will require excavating to enable any new wheel to sit at the correct height. It was noted that the soil level within the pit needs to be reduced by around 4ft. At the base of the wheel pit there should be a defined bottom, i.e. bricks, stones possibly slate or puddled clay. This, if discovered should be kept and will help decide the actual wheel diameter.

- Design & manufacture new launder in oak with control flap and mechanism
- Design and manufacture new waterwheel complete with new oak shaft, internal and external bearings. If possible re use internal gudgeon
- Dig out water wheel and pitwheel pits (by others)
- Dig out tail race channel back to Clee Brook (by others)

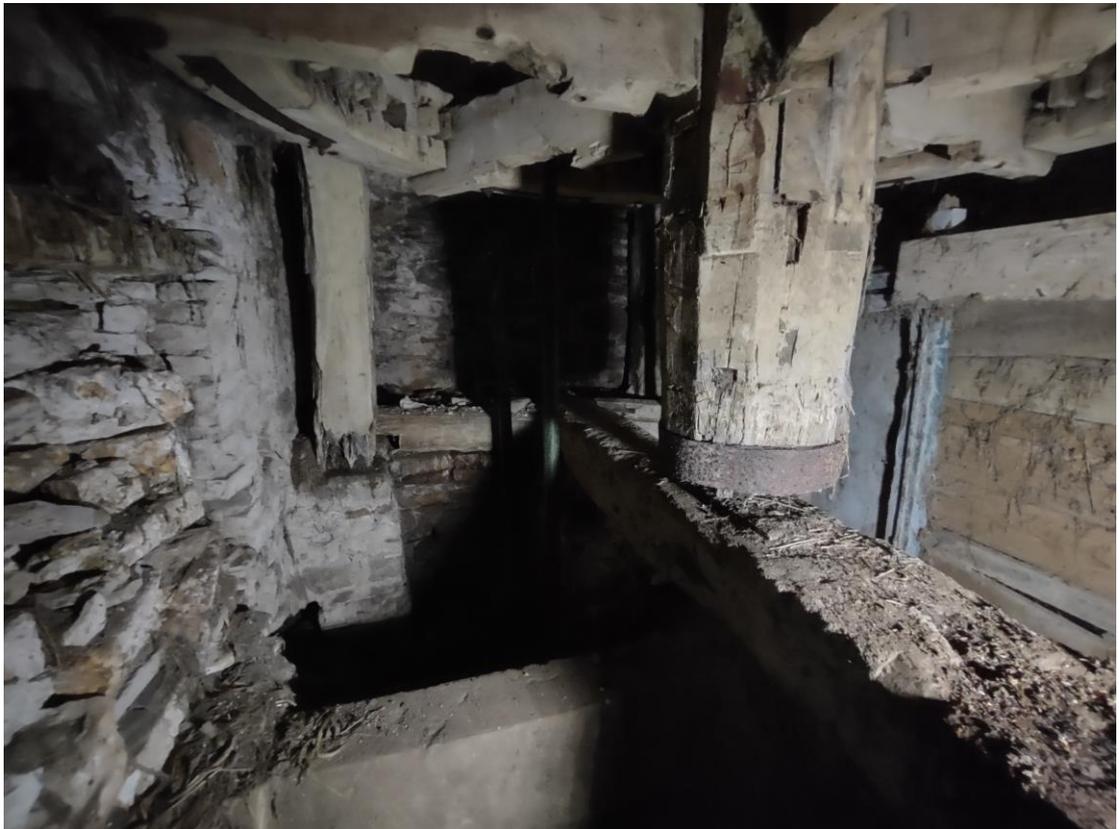
The hurst frame is the main internal timber structure that carried the millstones, allows for their adjustment and supports the main upright post. There is evidence of significant historic woodworm within the remaining timbers although nothing active could be seen. Two vertical posts nearest the waterwheel wall are rotten at the bottom and require new base sections around 1ft in length. Both sections supporting the millstones are rotten or missing along with both tentering arms. The main front horizontal timber is also missing. These timbers are generally 11" x 10". The main timber supporting the upright shaft appears generally sound apart from the last 2ft at the southern (downstream) end of the mill.

- Rebuild hurst frame saving as much of the original as possible
- Where required use oak to replace missing timbers or scarf in new
- Re install tenting control arms
- Treat remaining wood with a suitable woodworm treatment
- Rebuild / point stone plinths as required (by others)
- Remove later addition animal pen boarding
- First floor stabilisation and re boarding (by others)

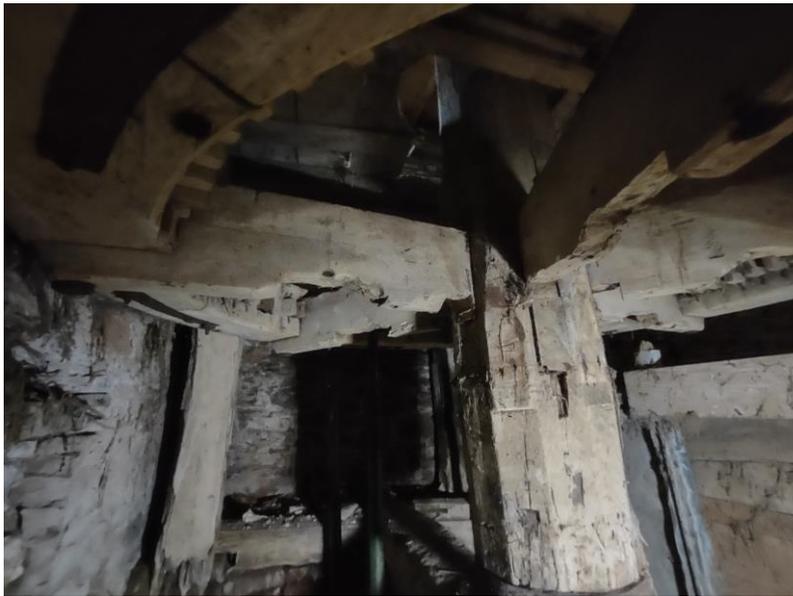
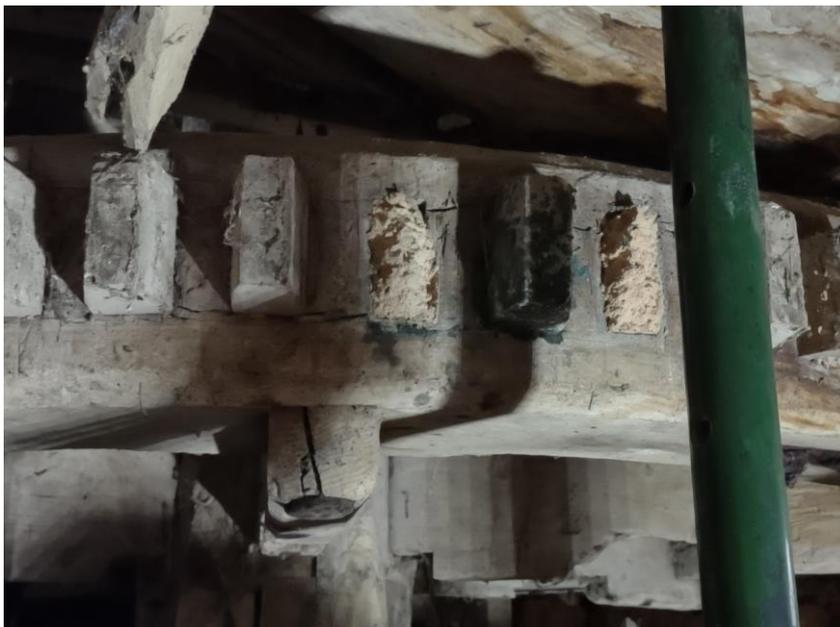
Upright shaft is the main vertical timber shaft that takes the drive from the waterwheel to all other operating elements. It passes from ground floor to first floor and is sat on a single bronze bearing within the hurst frame. This base bearing requires renewal. Due to uncertainty about the 1<sup>st</sup> floor stability the upper bearing could not be inspected closely but appears serviceable. The shaft itself appears serviceable.

The Wallower is a small gear sat underneath the spur wheel and takes a drive from the pit wheel. This is completely missing and will require replacement.

Great Spur wheel, this is the largest wheel, sitting above the wallower and attached to the upright shaft. This drives the stone nuts and subsequently the millstones. The one here is timber. Its main structure appears solid however all the teeth have suffered from woodworm and are now crumbling. These will all require replacement (112 nr). Some structural work may be required to the Spur wheel once it becomes operational if it starts to flex or move.

- Lift upright shaft and check / renew foot bearing
- Check upright shaft top bearing, clean, possibly renew
- Design and build wallower
- Renew all teeth in the great spur wheel
- Possible repairs to the main spur wheel structure

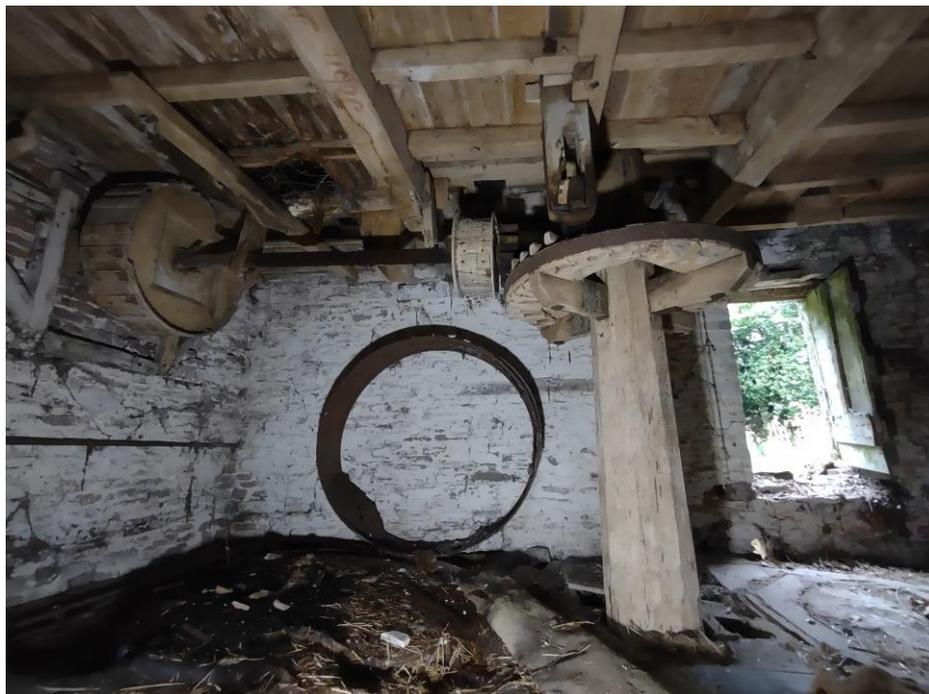
At the top of the upright shaft there is the crown wheel. This drives a lay shaft from which drives could be taken via flat belt pullies to other machinery such as a sack hoist or flour dressing machine.

The crown wheel appears stable however most of the teeth are missing, those remaining can be used as evidence to reproduce new.

- Replace missing teeth to crown wheel
- Clean and paint lay shaft ironwork
- Overhaul / replace lay shaft bearings
