# STRUCTURAL INSPECTION REPORT

Conversion of barn to a dwelling for visitor accommodation  
at  
Wilcroft Farm, Pecket Well, Hebden Bridge, HX7 8QY

27<sup>th</sup> October 2021

**Thornton Architects Ltd**

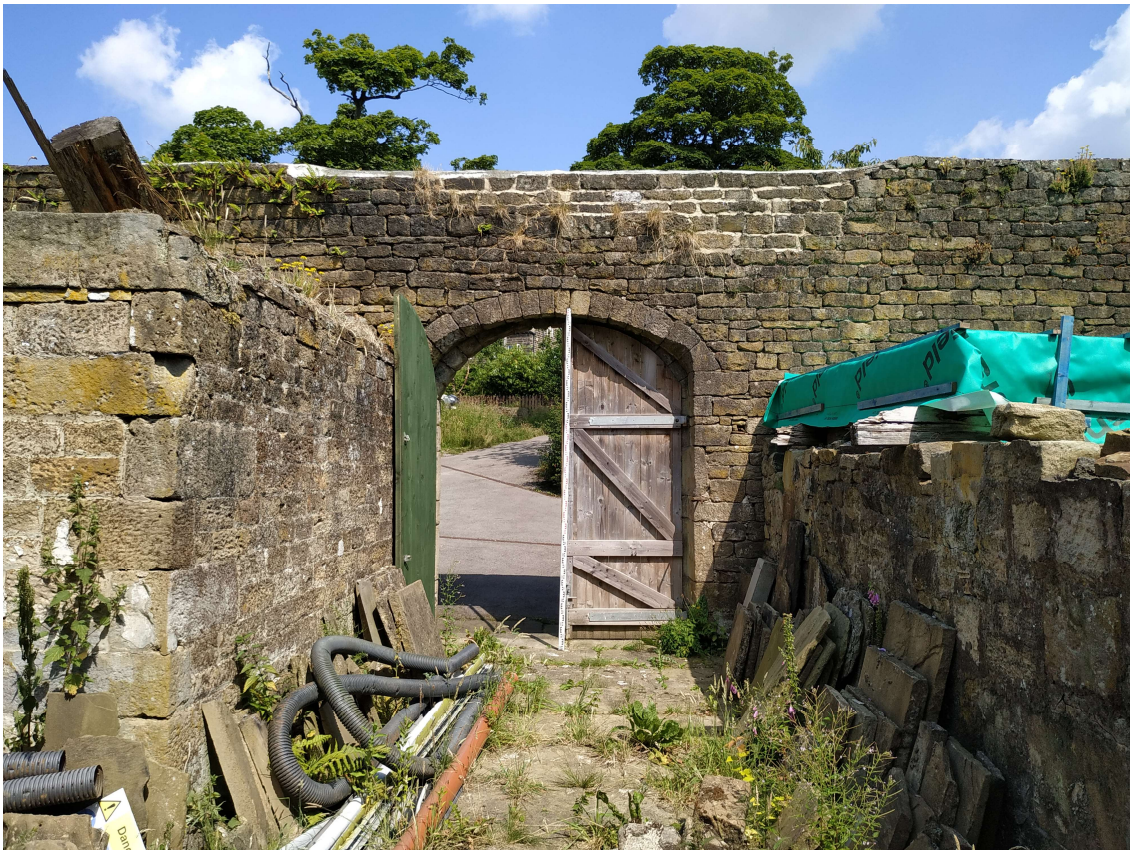
P3 Internal view of north cart entrance with remains of stone cross-walls either side

- 12.3. **North Elevation:** (see P3 and P4 above): Inspection of the north elevation wall reveals localised significant historic bulging and some displacement of stone to the upper central section, above the cart entrance and arch, requiring remedial rebuilding. This has been exacerbated by the collapse of the roof in 1996. Rebuilding of the upper section of the wall is required as indicated on the proposed elevation drawing above. It is noted that additional horizontal restraint will be provided by the proposed cellular internal masonry walls when conversion works are implemented. Re-pointing of all the external stone walls is required. The perished mortar should be raked out and re-pointing with a suitable sand and lime-putty mortar.

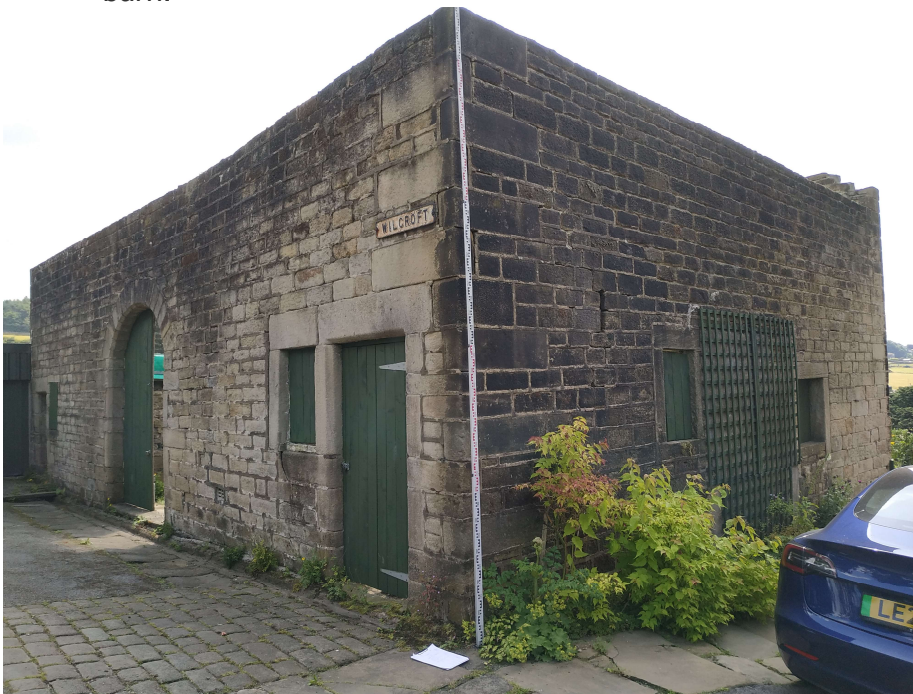
P5 Wilcroft Barn, north and west sides

- 12.4. **West Elevation** (see P5, 10 and 11): Inspection of the gable wall reveals the collapse of the apex part and localised loosening of the remaining top courses. The remaining substantial part of the gable below wall plate level however is capable of retention without significant rebuilding. It is noted that additional horizontal restraint will be provided by the proposed cellular internal masonry walls when conversion works are implemented. Re-pointing of all the external stone walls is required. The perished mortar should be raked out and re-pointing with a suitable sand and lime-putty mortar.

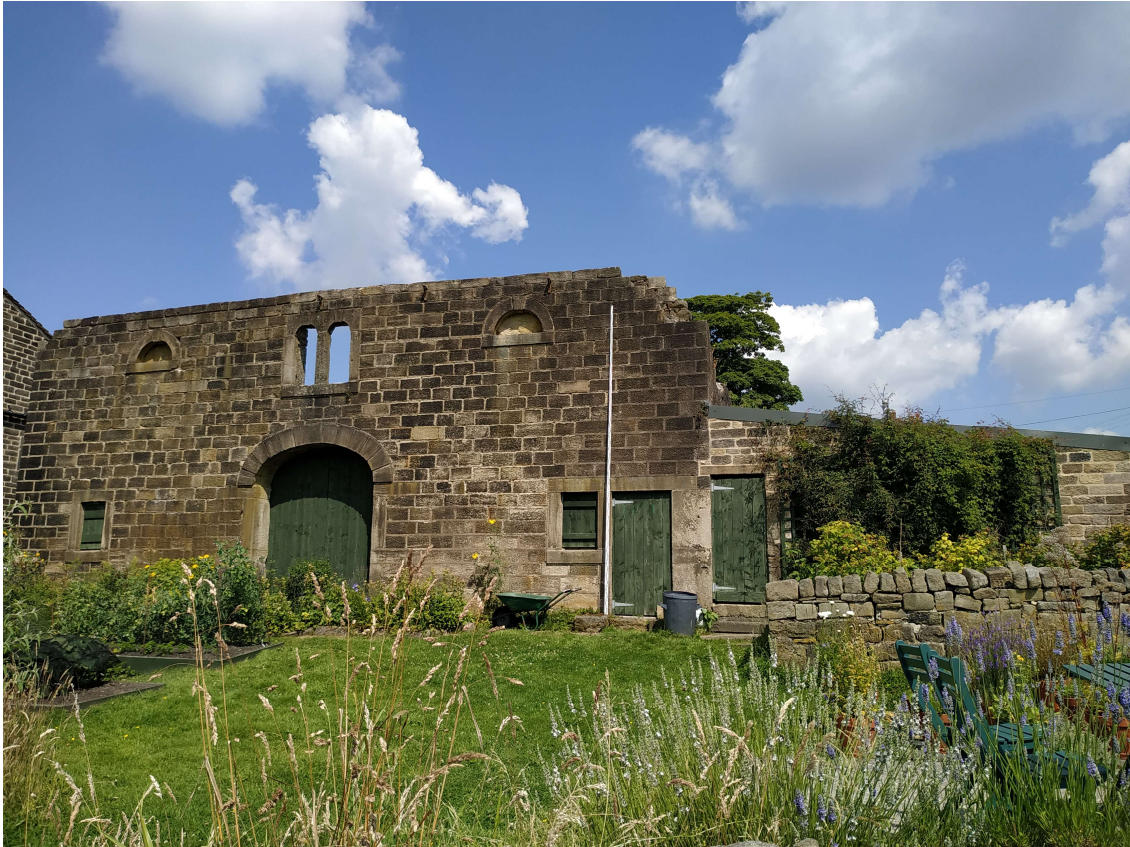
P6 Wilcroft Barn, south side

12.1. **South Elevation** (see P6 and P7): Inspection of the south elevation wall reveals localised significant historic bulging and some displacement of stone to the upper central section, around the cart entrance and arch, requiring remedial rebuilding. This has been exacerbated by the collapse of the roof in 1996. Rebuilding of the upper central section of the wall is required as indicated on the proposed elevation drawing above. Re-pointing of all the external stone walls is required. The perished mortar should be raked out and re-pointing with a suitable sand and lime-putty mortar.

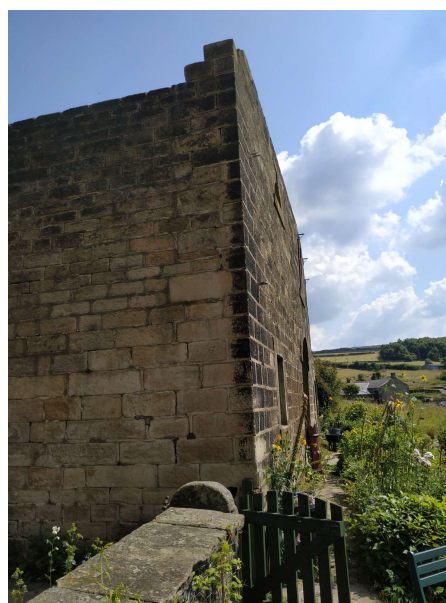
P8 South side from west corner

- 12.2. **East Elevation**(see P8): Inspection of the gable wall reveals the collapse of the apex part and localised loosening of the remaining top courses. The remaining substantial part of the gable below wall plate level however is capable of retention without significant rebuilding. The gable has benefitted from the support of the lean-to cattle byre since the roof collapse to the main barn. It is noted that additional horizontal restraint will be provided by the proposed cellular internal masonry walls when conversion works are implemented. Re-pointing of all the external stone walls is required. The perished mortar should be raked out and re-pointing with a suitable sand and lime-putty mortar. The external byre walls, except for the south side, comprise unsubstantial panels of random stone walling that will require rebuilding with regular coursed sandstone walling. The new stone piers can be integrated with the proposed new door and window openings.
