Environmental Phase 1 Statement

Conversion of barn to a dwelling for visitor accommodation
at Wilcroft Farm, Pecket Well, Hebden Bridge, HX7 8QY

27th October 2021

Thornton Architects Ltd

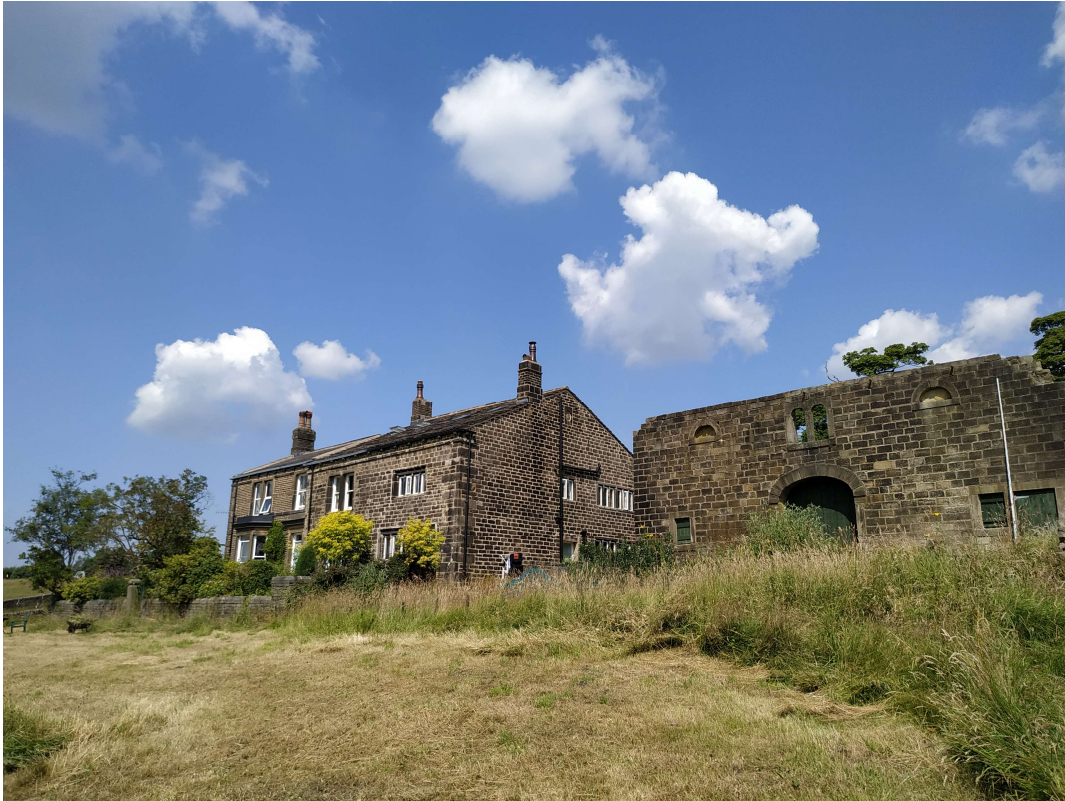
P1 Wilcroft House (left), Wilcroft Farmhouse and Barn viewed from south 05.08.2021

4.1. The adjacent eighteenth century farmhouse has been repaired and renovated for use as visitor accommodation in accordance with the Listed Building Consent 13/00410/LBC see P1. There is a yard approximately 5M wide between the east side of the farmhouse and the west gable of the subject barn.

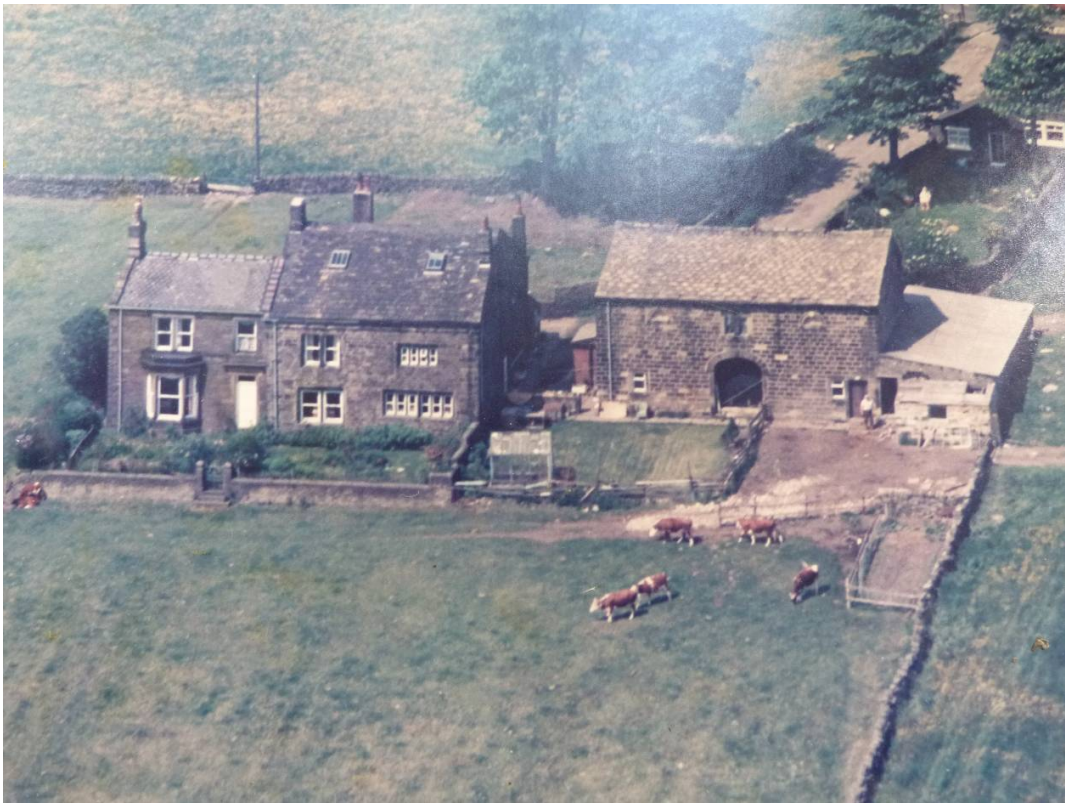
P2 Aerial view of Wilcroft House, Wilcroft Farmhouse and Wilcroft Barn (1982)

4.5. The mid 20th Century lean-to byre on the east side, visible on the 1982 aerial view, remains intact and is used for storage.

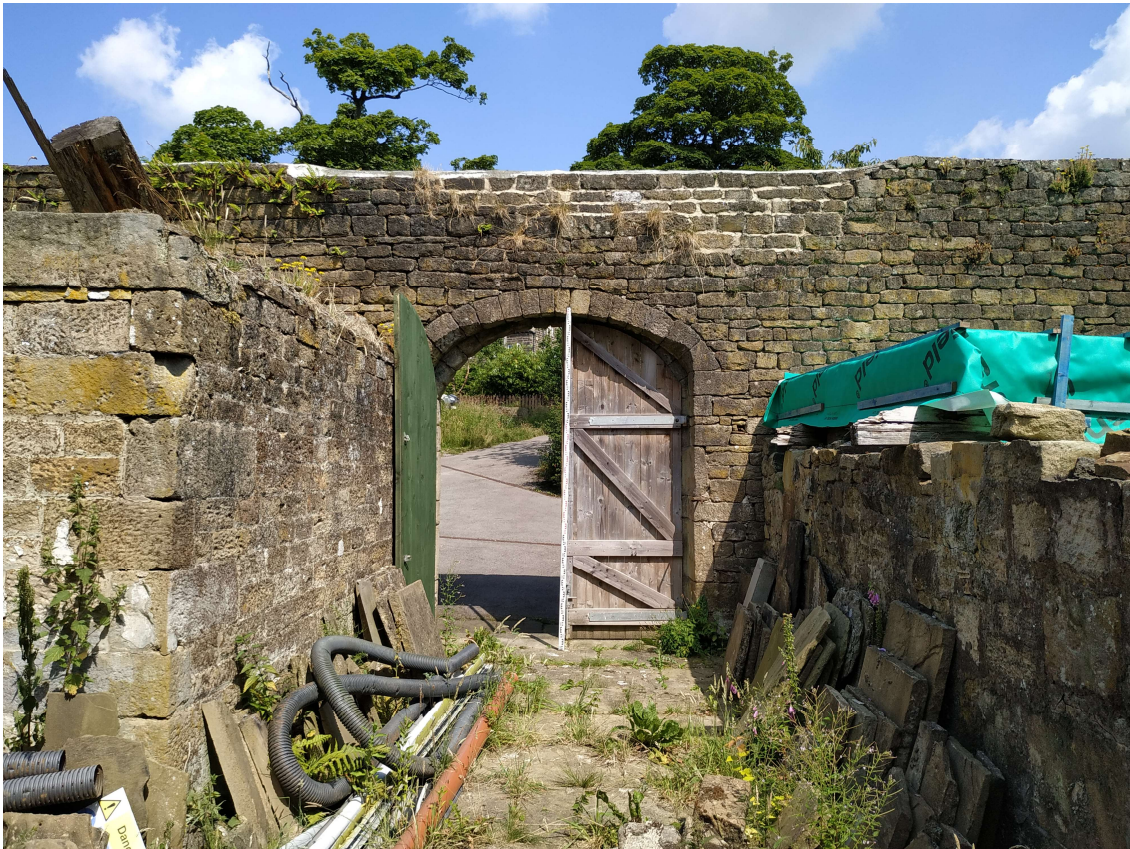
P3 Internal view of north cart entrance with remains of stone cross-walls either side

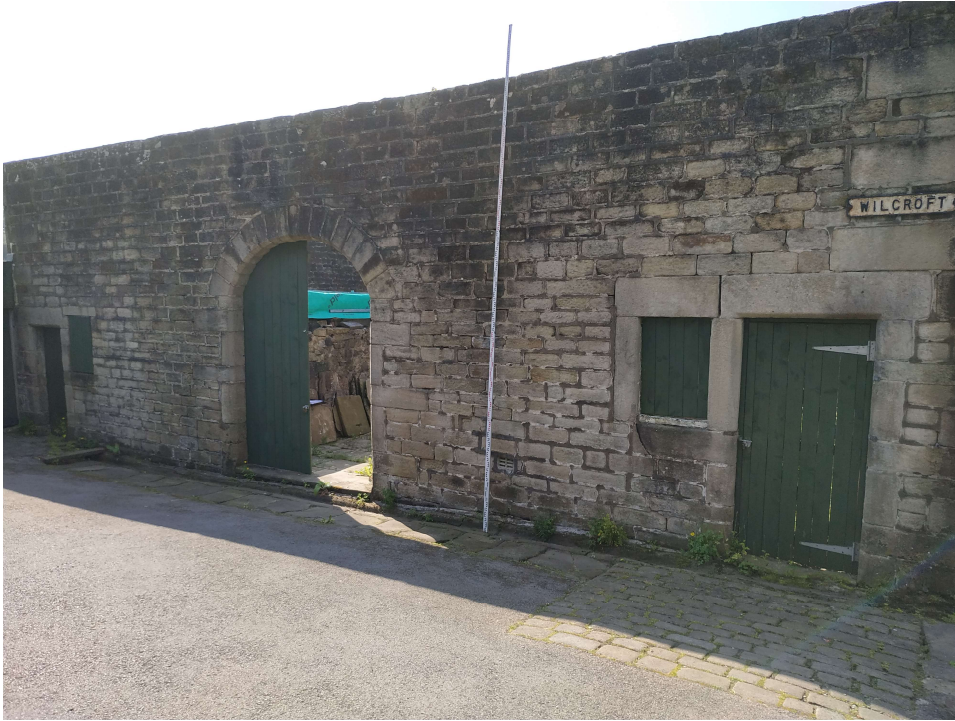
P4 Wilcroft Barn, north side

4.2. The barn has loadbearing coursed sandstone walls. As noted in the listing description, the stonework and dressing of stonework around the openings appears to be older on the north elevation indicating that the barn was rebuilt in the nineteenth century.

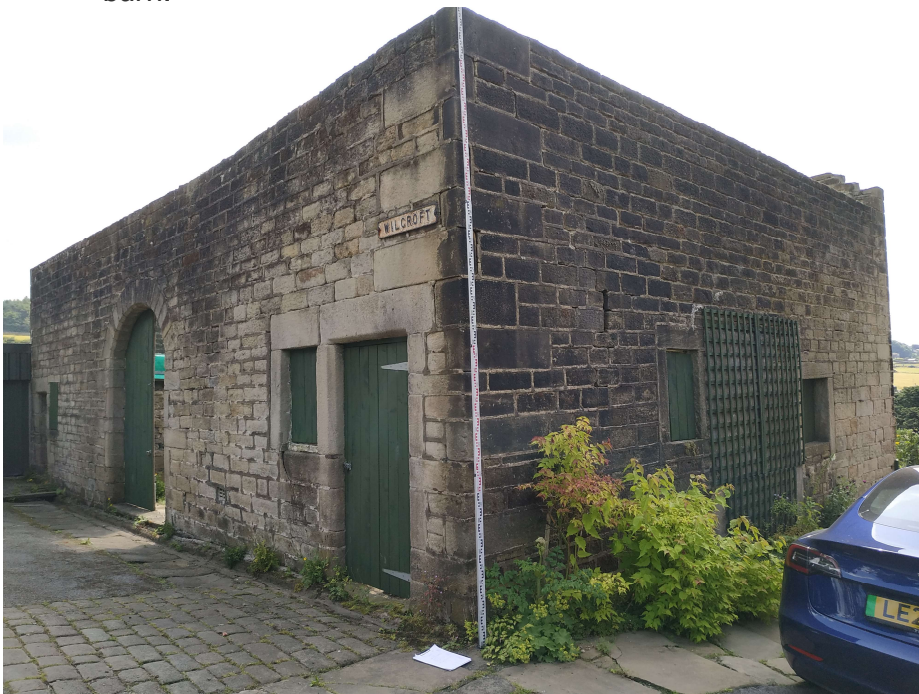
P5 Wilcroft Barn, north and west sides

4.3. Although the roof would have been carried on a pair of queen post trusses these decayed and rotted following the roof collapse. The upper parts of the gable walls collapsed down to wall plate level in 1996, approximately 5m height presently remaining above ground floor level.

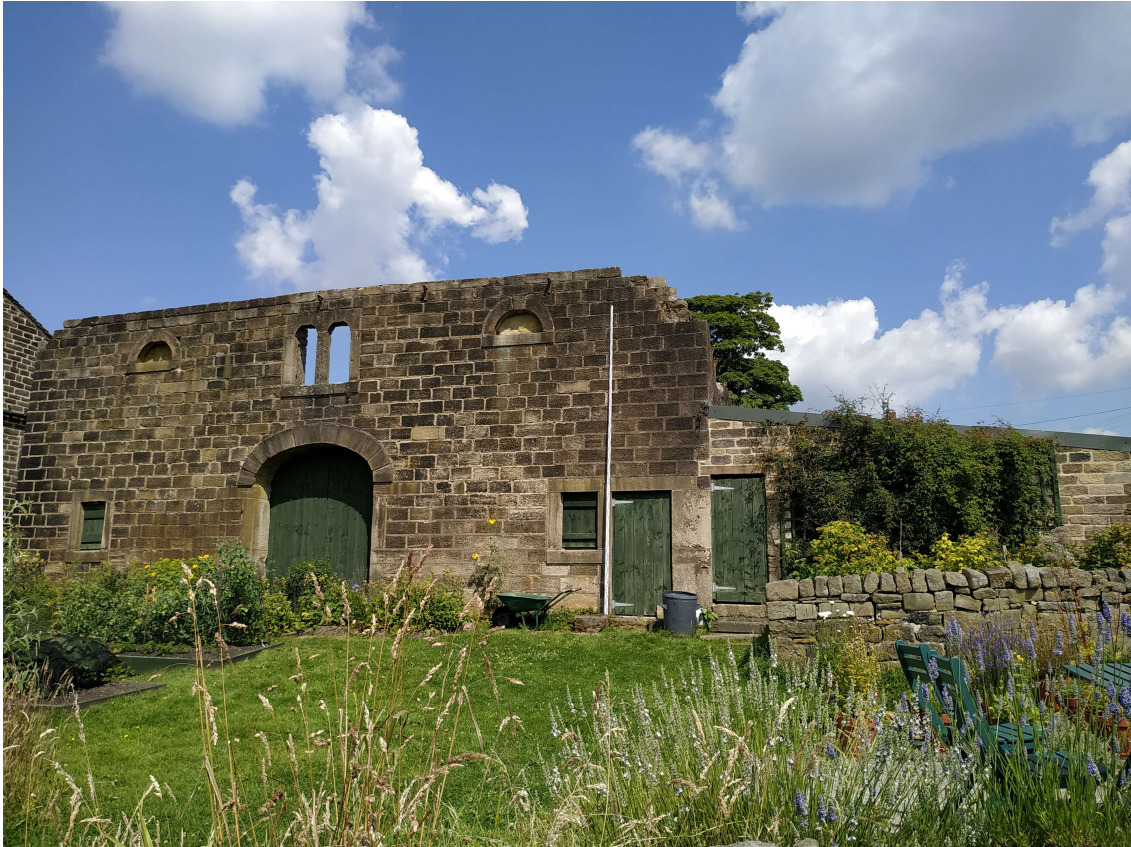
P6 Wilcroft Barn, south side

4.4. The north, west and south elevations of the barn remain as described in the listing except for the gable apex. The owl hole, referred to in the listing, is missing but may be recoverable amongst the stored walling stone within the barn.

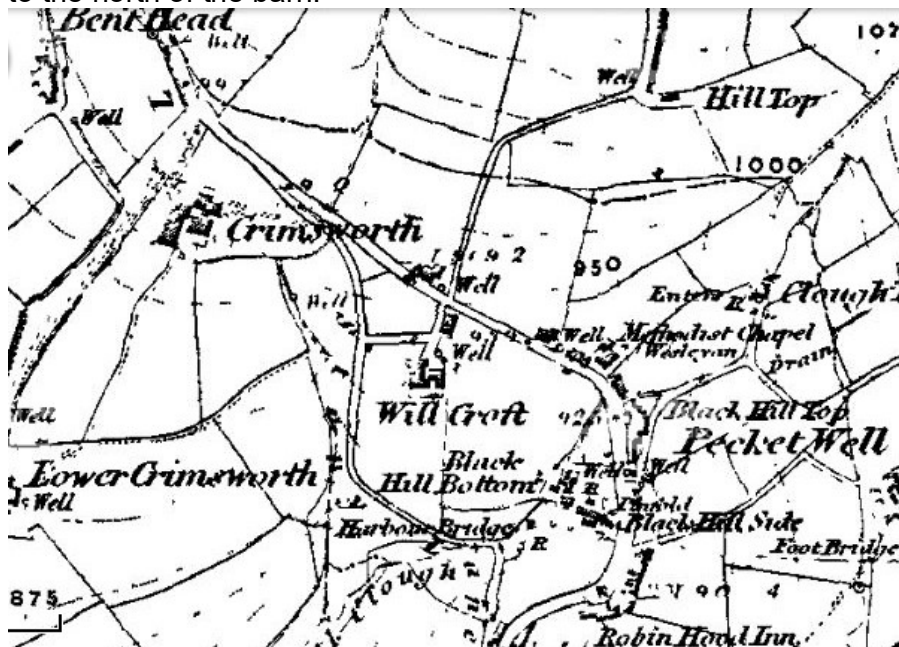
- 14.1. The Ordnance Survey Map (1851-1855) shows Wilcroft farmhouse and subject barn in approximately its present position mostly surrounded by pasture. There are nearby wells shown on either side of Keighley Road just to the north of the barn.

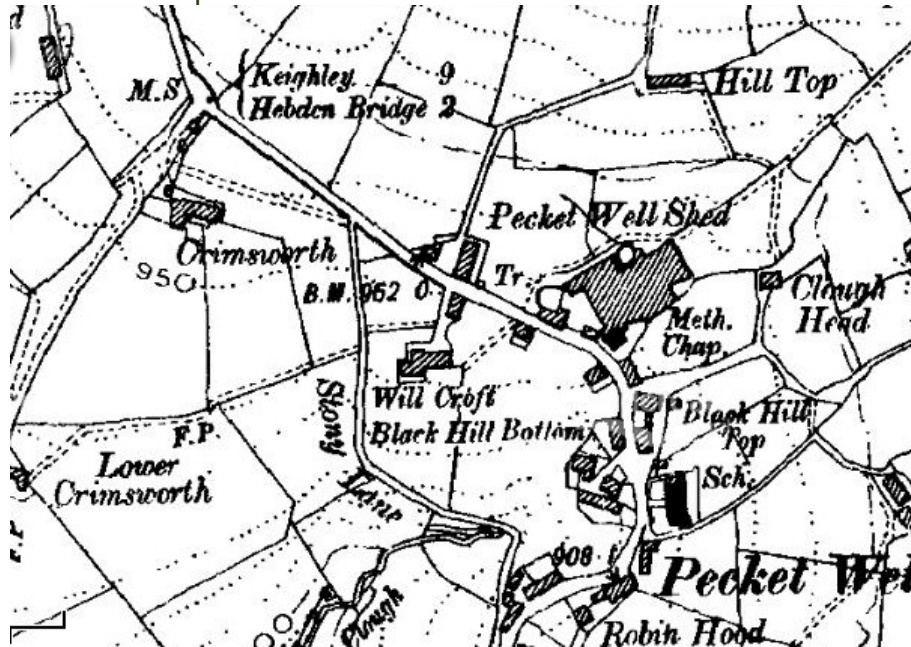
14.2. The Ordinance Survey Map (1894-1896) shows the enlargement of the Wilcroft Farmhouse to include the present attached Wilcroft House. To the north of the subject site it also shows the development of Pecket Well (weaving) shed and Wilcroft Terrace of houses at the bottom of the access lane to Hill Top Farm.
