Laurel Cottage, Tiptoe

Scope of Works and Repairs to Existing Building

Historic Building Condition Survey

**Laurel Cottage, Northover Lane,
Tiptoe, Lymington, Hampshire**

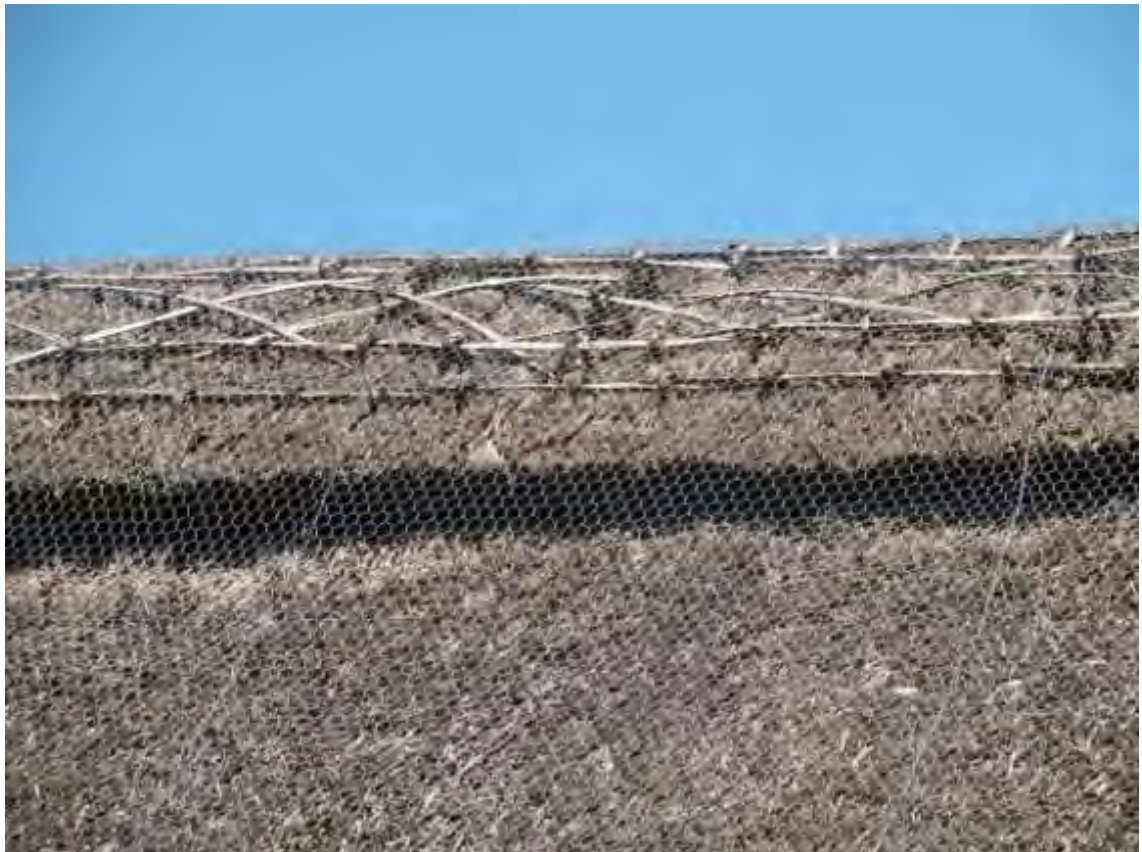
- 3.1.1 The roof is a gable ended structure covered with thatch which comprises of a top dressing of water reed over what appears to be a lower or undercoat of long straw thatch. This lower could be seen from a small section of the exposed roof within the west end of the house as well as over the east extension.
- 3.1.2 The slopes run up to a heavy block cut ridge with exposed ligger and other hazel work decoration to this. The roof is fully netted with the galvanised netting that is also turned under the eaves and fixed reasonably securely all the way around. The thatch sits tight to the head of the wall over the wall plate particularly on the north elevation.

Fig 3.1; Ridge condition

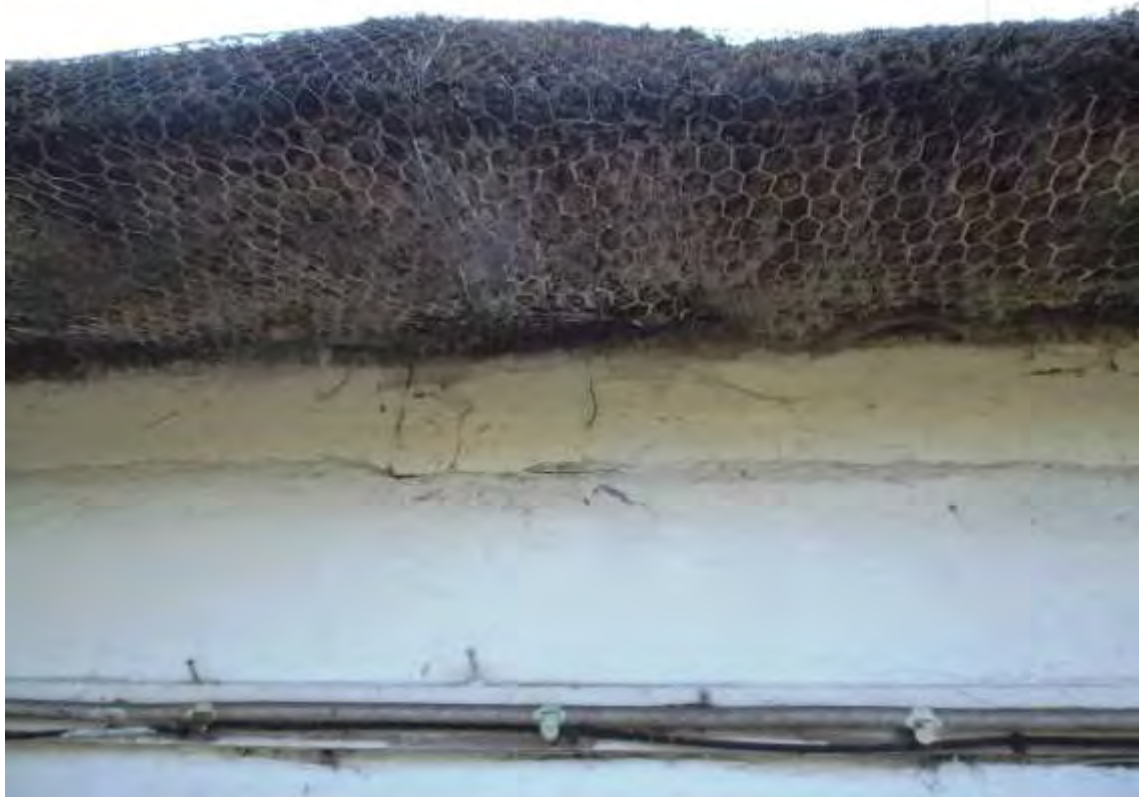
- 3.2.1 As with all traditional thatched roofs there are no formal eaves structures to this building with the bottom of the thatch overhanging the heads of the wall to an adequate extent so that any water running off it generally falls clear of the base of the walls all the way around.

Fig 3.2; Eaves overhang

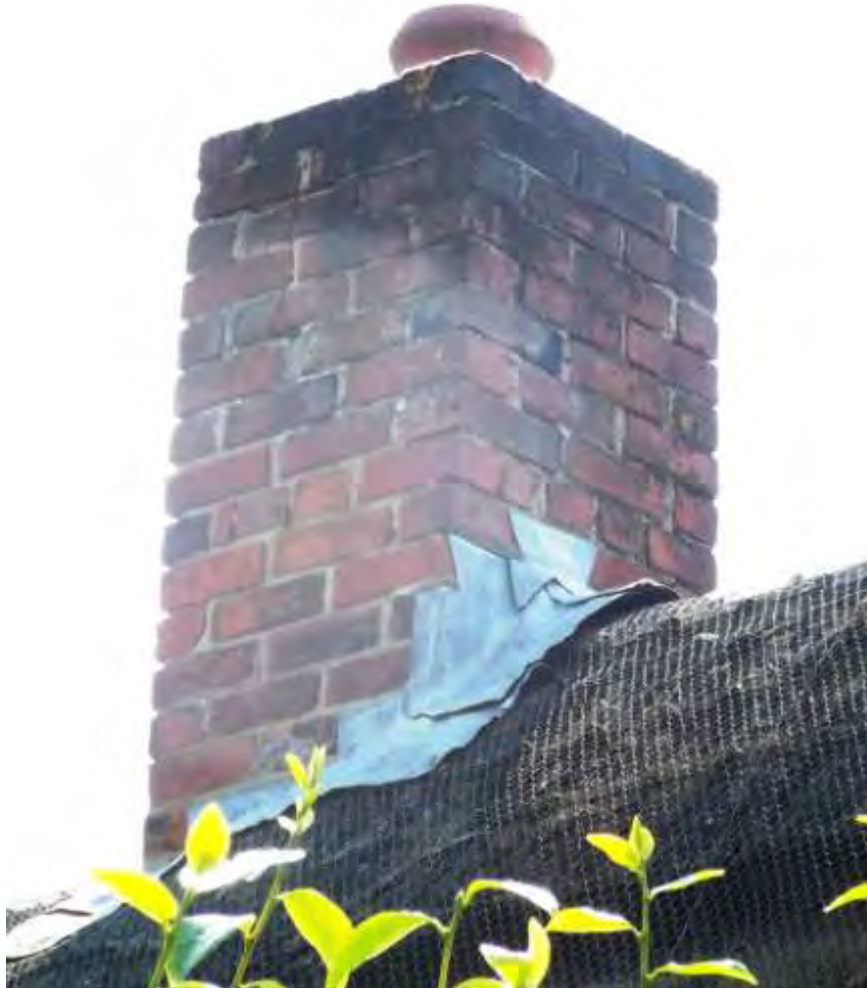
- 3.3.1 Two chimneys project up through the roof coverings, one is on the junction between the east extension and the main part of the house and the other is through the west gable.
- 3.3.2 The main chimney towards the east end is a straight brick stack that is surmounted by a single flue terminal (chimney pot) and this appears to be in a reasonable condition including the pointing. This is flashed weathered into the roof with lead sheeting dressed over the top of the netting so that it sits snug on the surface. There is some drop to the thatched ridge on this on the west side where the thatch has compressed but not to a severe extent.

Fig 3.3; Main chimney

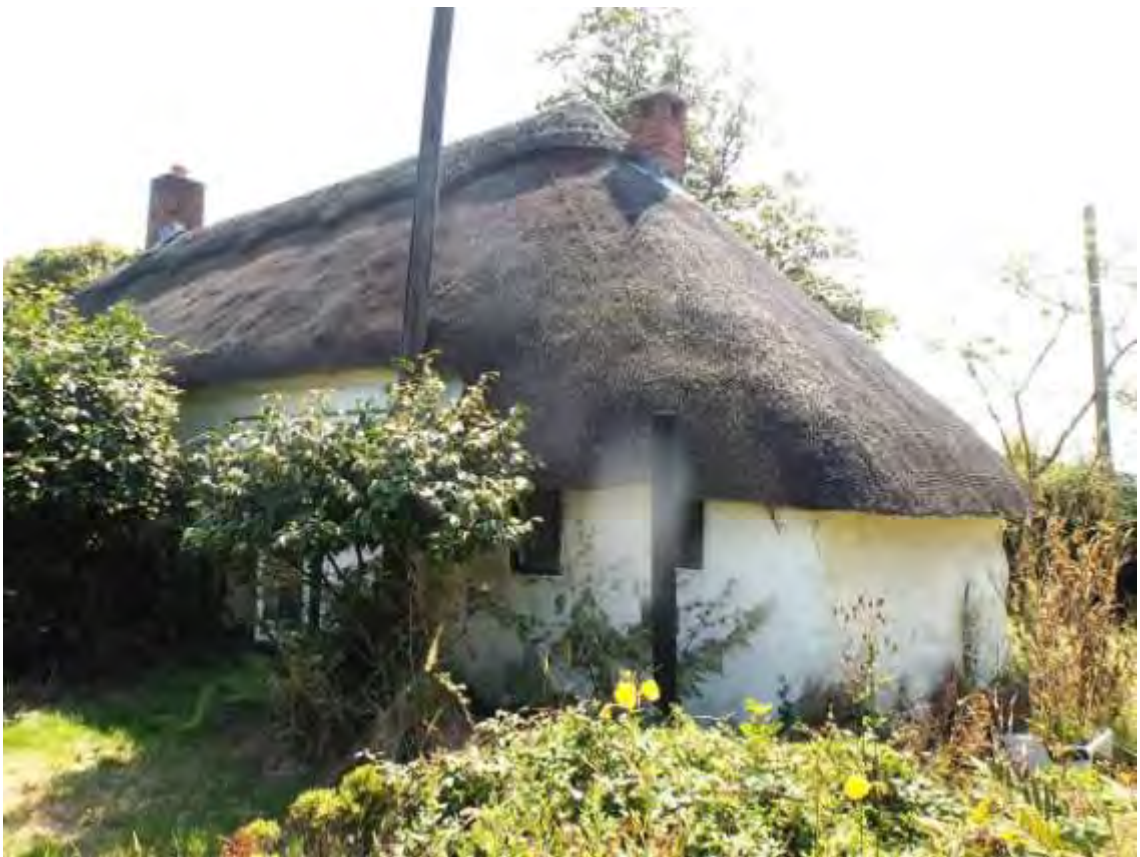
Fig 3.4.12; West end from northwest

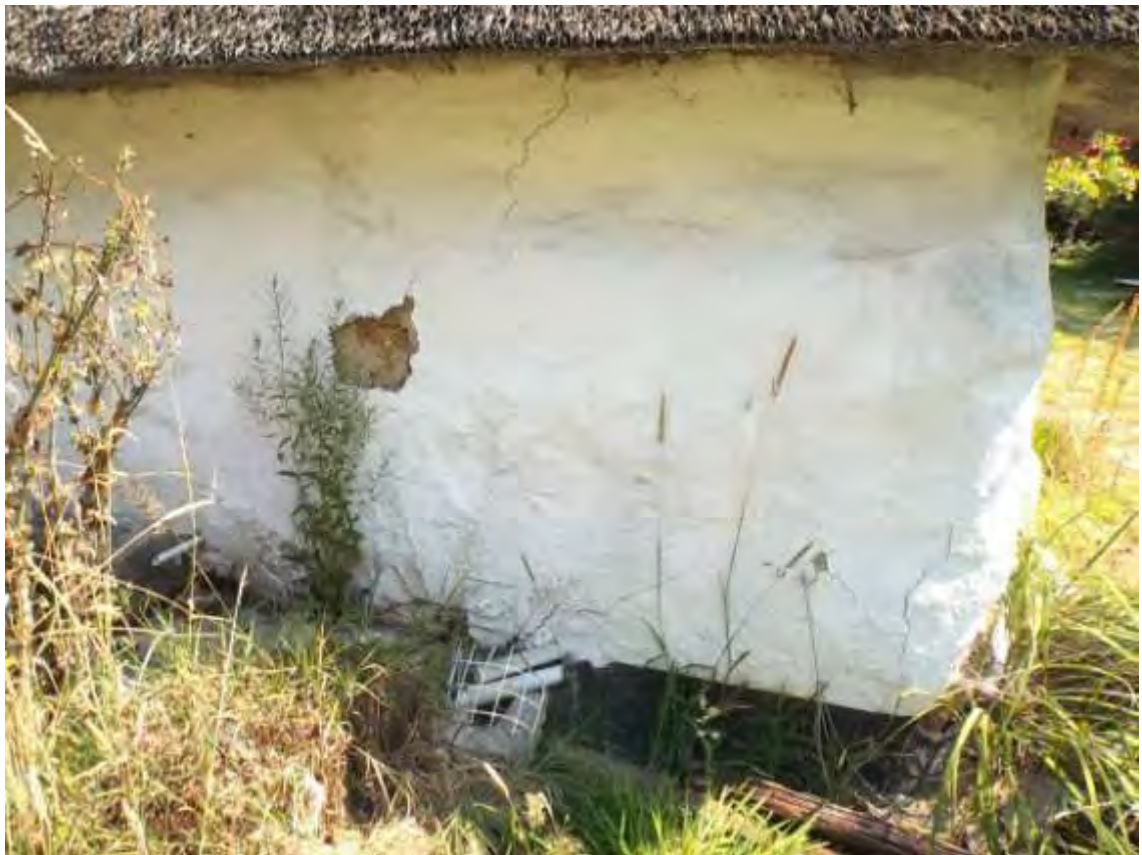
- 3.4.12 Across the west end wall there is high ground level against the end of the wall, largely because of what appears to be an inspection chamber that takes the drains from the bathroom at that end. This will have the effect of encouraging damp within the structure as previously mentioned. Therefore the ground level should be lowered as previously described, but it will require the removal of the drainage fittings.
- 3.4.13 Within the west wall there is cracking and displacement of the render particularly at low level and towards the south end where this is 'blowing' or coming off and showing signs of deterioration. The lower part of the wall is rendered in what appears to be hard cement render whilst the upper part is still in the softer or more permeable lime but has all been over-coated with polymer paint.

Fig 3.4.14; Southwest corner

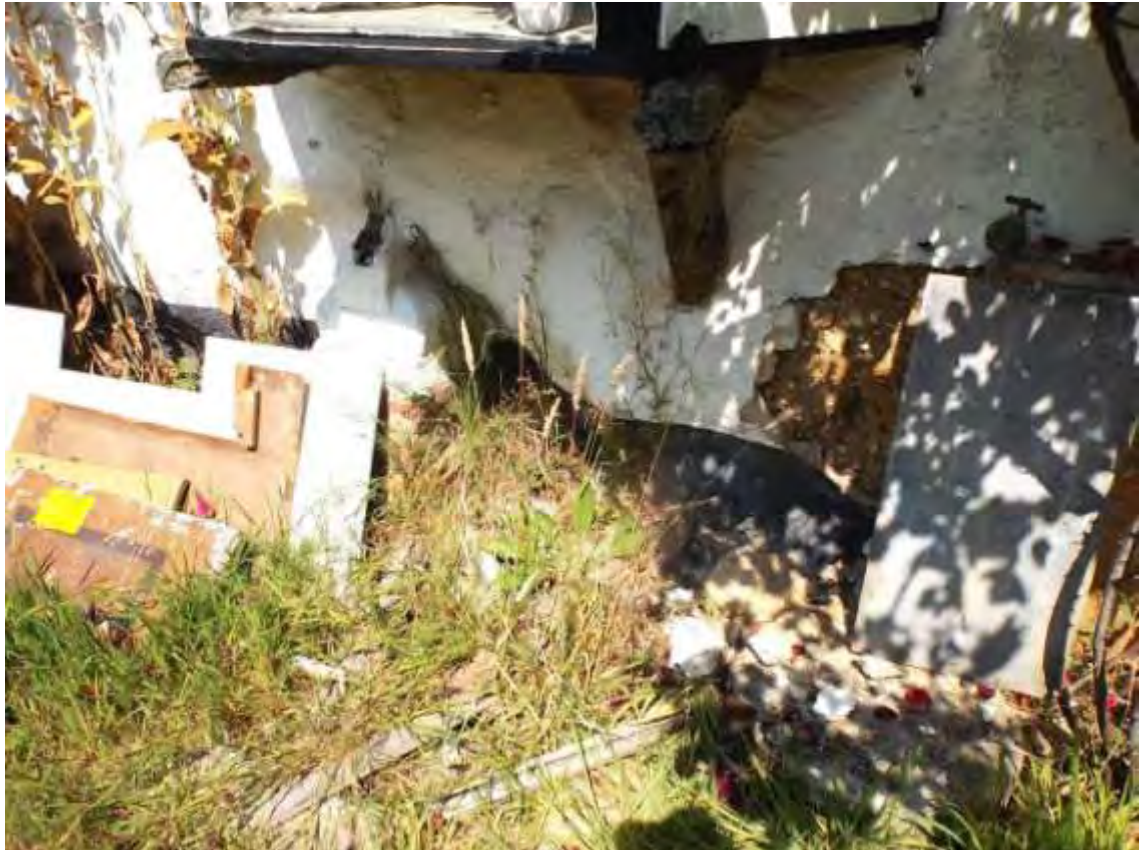
- 3.4.15 The south side of the west extension shows an area at the base of the wall as being rendered with a hard cement render and has resulted in frost and moisture related collapse. This is, not to an overly severe extent, but has left the face of the cob exposed although it is generally protected from the weather by the overhang of the thatch.

Fig 3.4.16; Rendered wall erosion on south wall

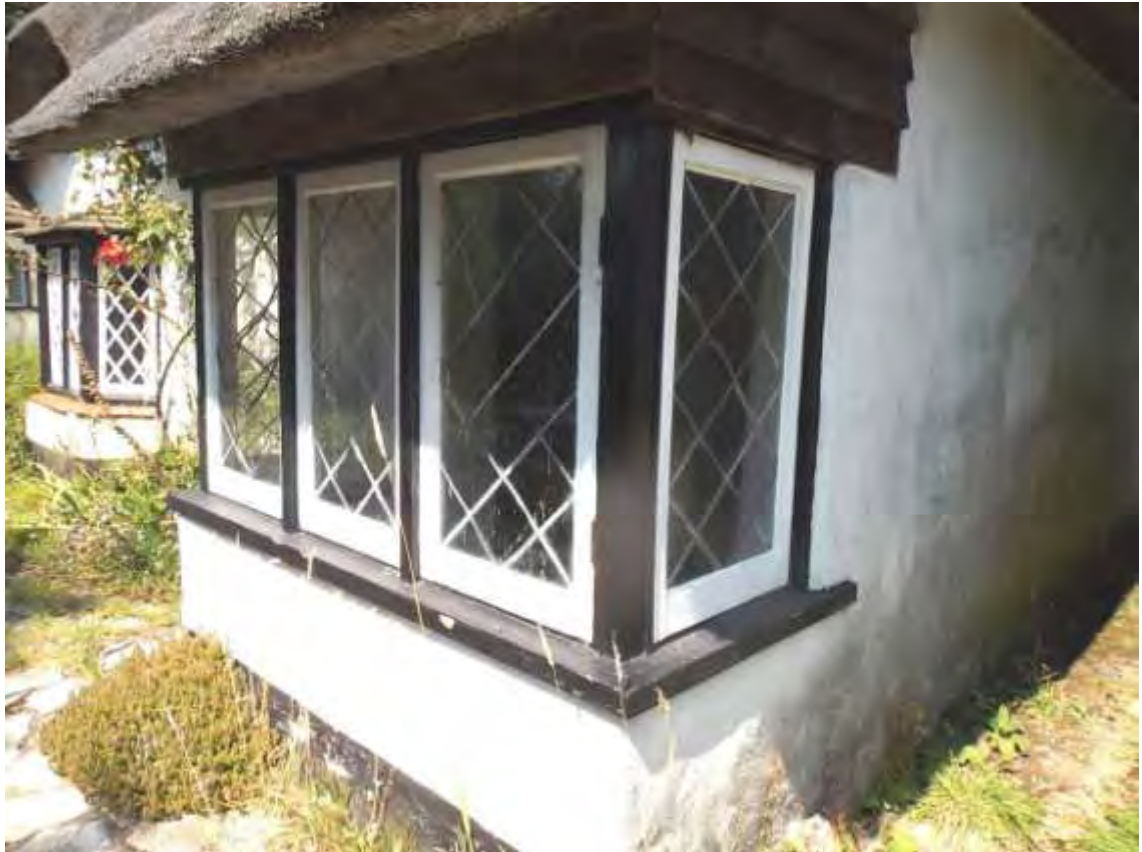
- 3.5.1 The front windows to the east extension are single glazed casements with applied adhesive lead tape to the glazing in an attempt to achieve a leaded light appearance. There is wet related decay to the base of the frame and sill and similar decay to the bottom rails and parts of the frames of the east and west front casements.

Fig 3.5.1; East extension window

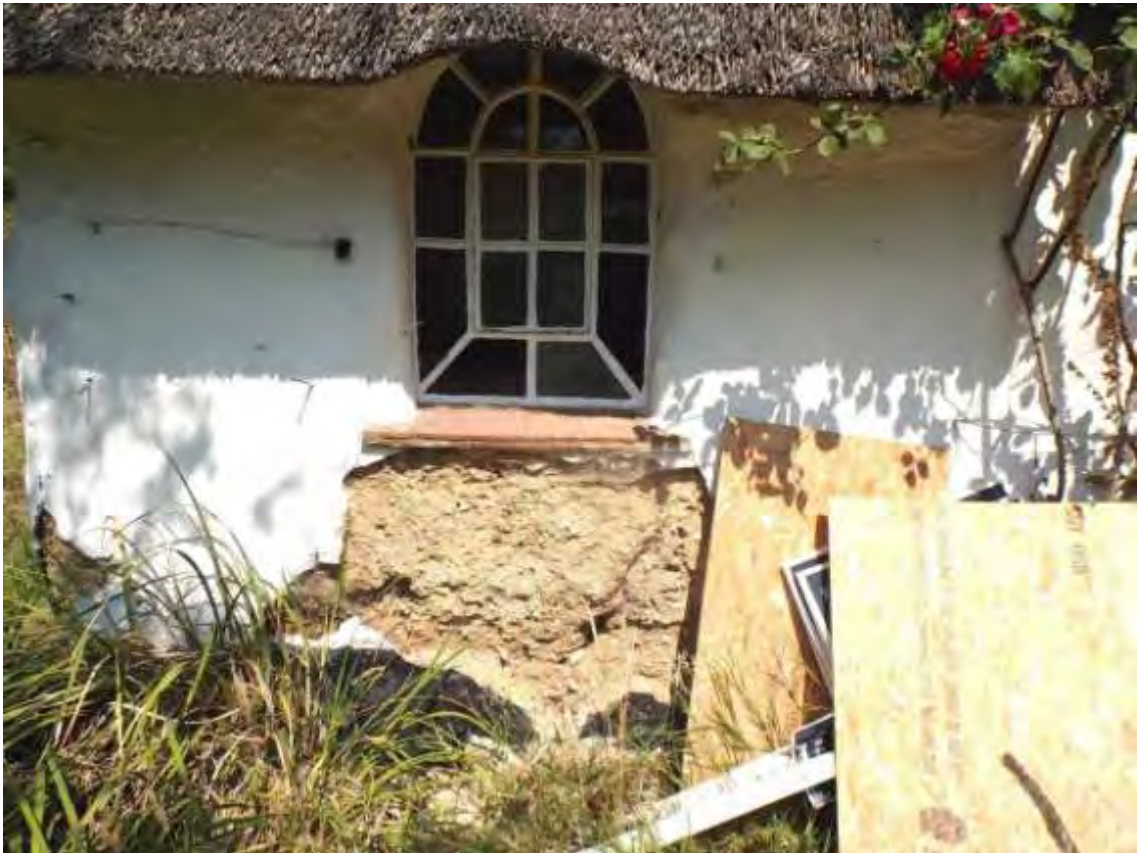
Fig 3.5.8; Bathroom window with decayed wall face & render below

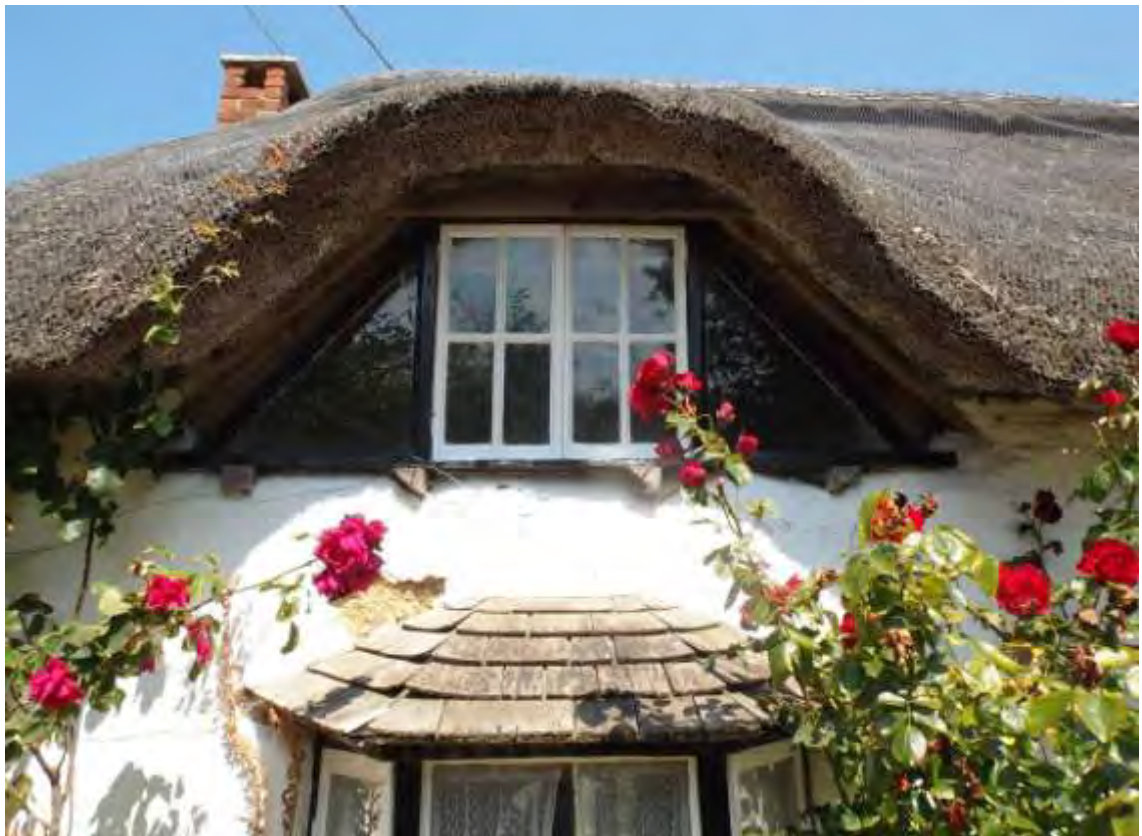
- 3.5.11 At first floor level on the front elevation there are eyebrow windows set within the thatch. These have small pane casement windows set centrally with fixed pane glazing on either side of a triangular shape. There is some general deterioration to the windows.

Fig 3.5.12; West eyebrow window over shingle roof to kitchen oriel window

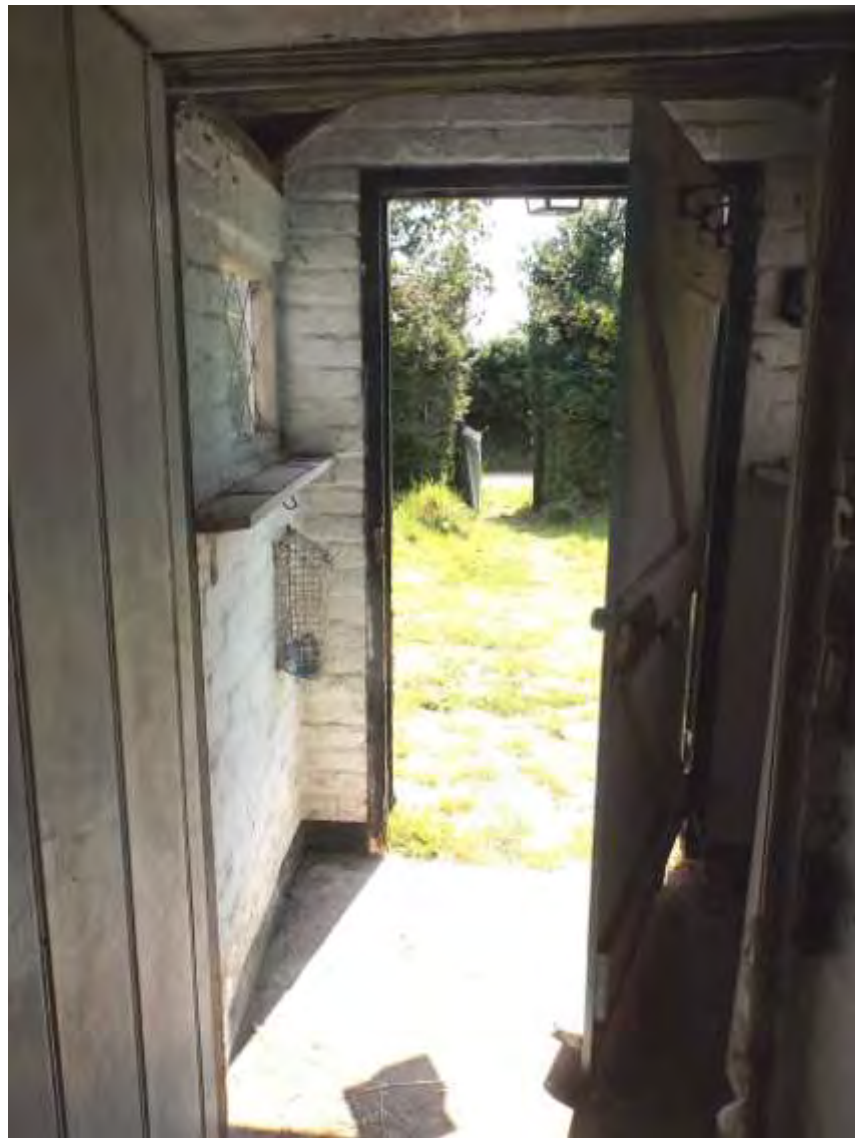
- 4.1.1 This has a floor of cast concrete which is slightly raised above the external path. This has a poor surface and shows much signs of wear and tear as well as general dirt and detritus to the surface.
- 4.1.2 The faces of the walls are of brickwork that has been painted and is in structurally fair condition.

Fig 4.1; Porch from living room

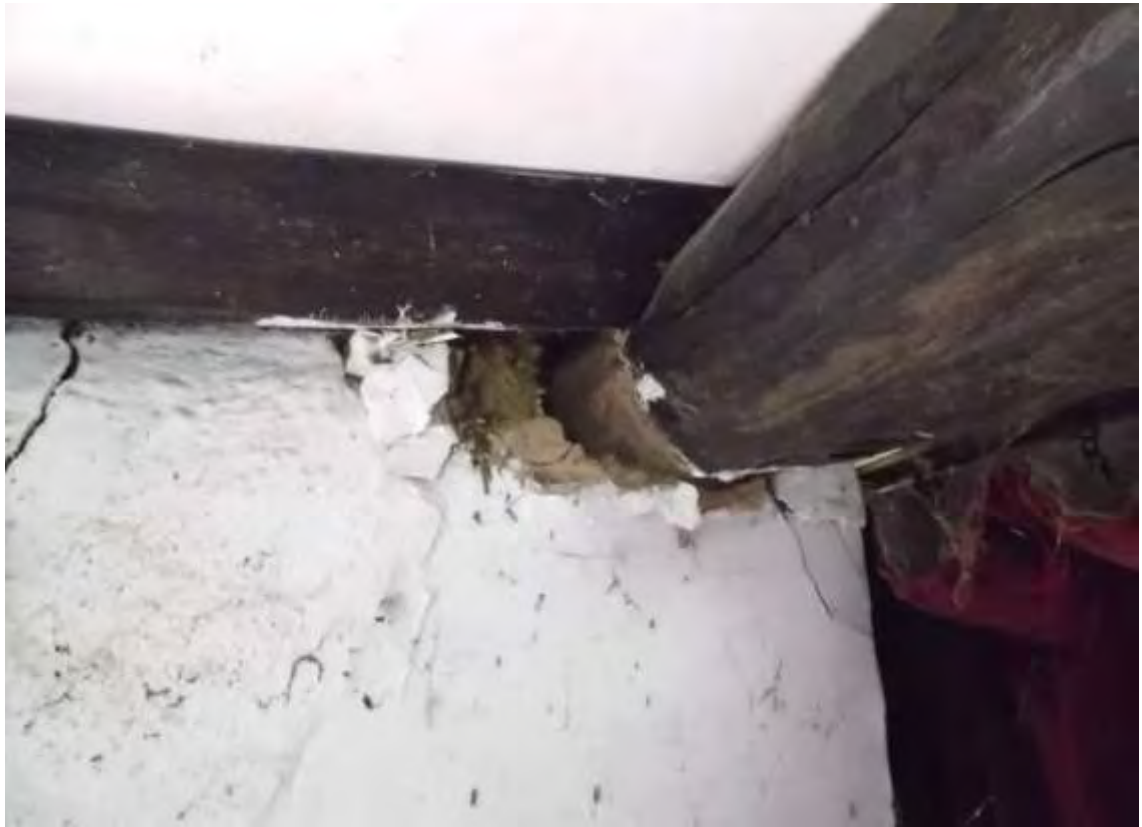
- 4.2.12 There is some displacement of the western beam into the wall head at its south end possibly due to outward movement in the external fabric. There is no subsequent movement to the end of these beams at the north end.

Fig 4.2.12; Displacement of west beam end into south wall

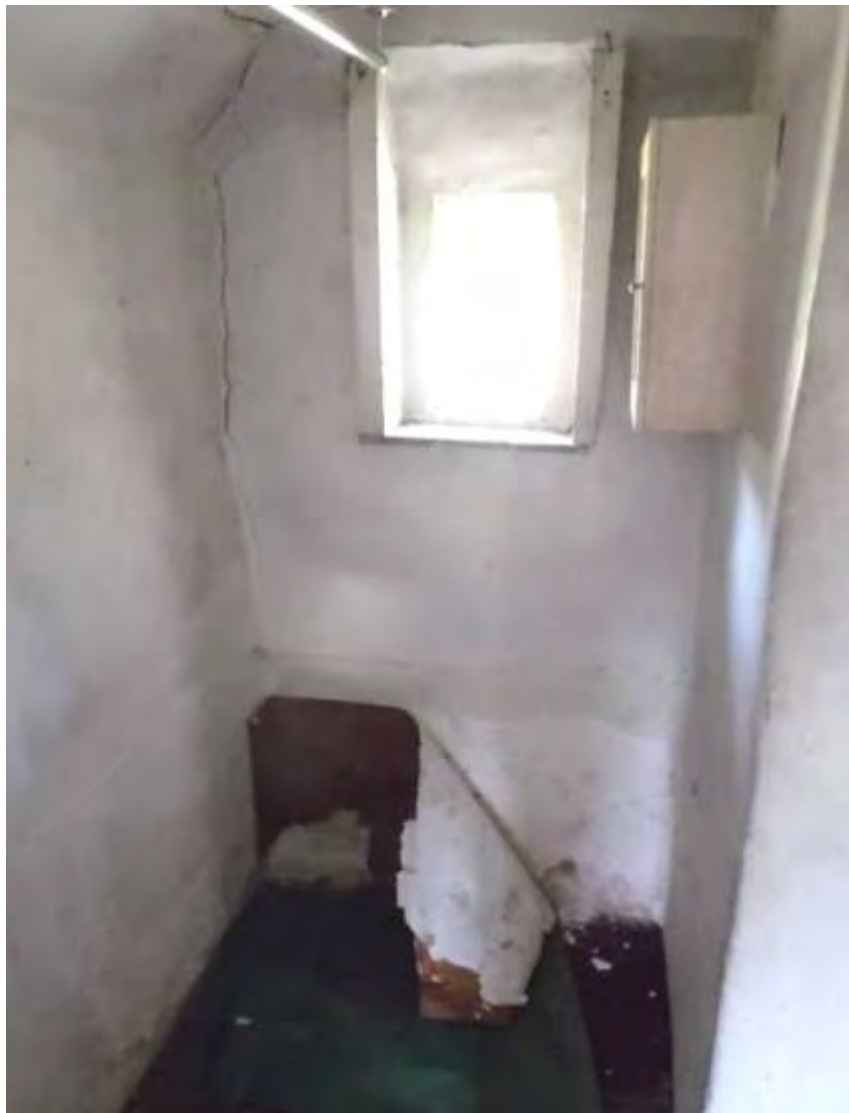
Fig 4.4; Lobby in northwest corner showing crack

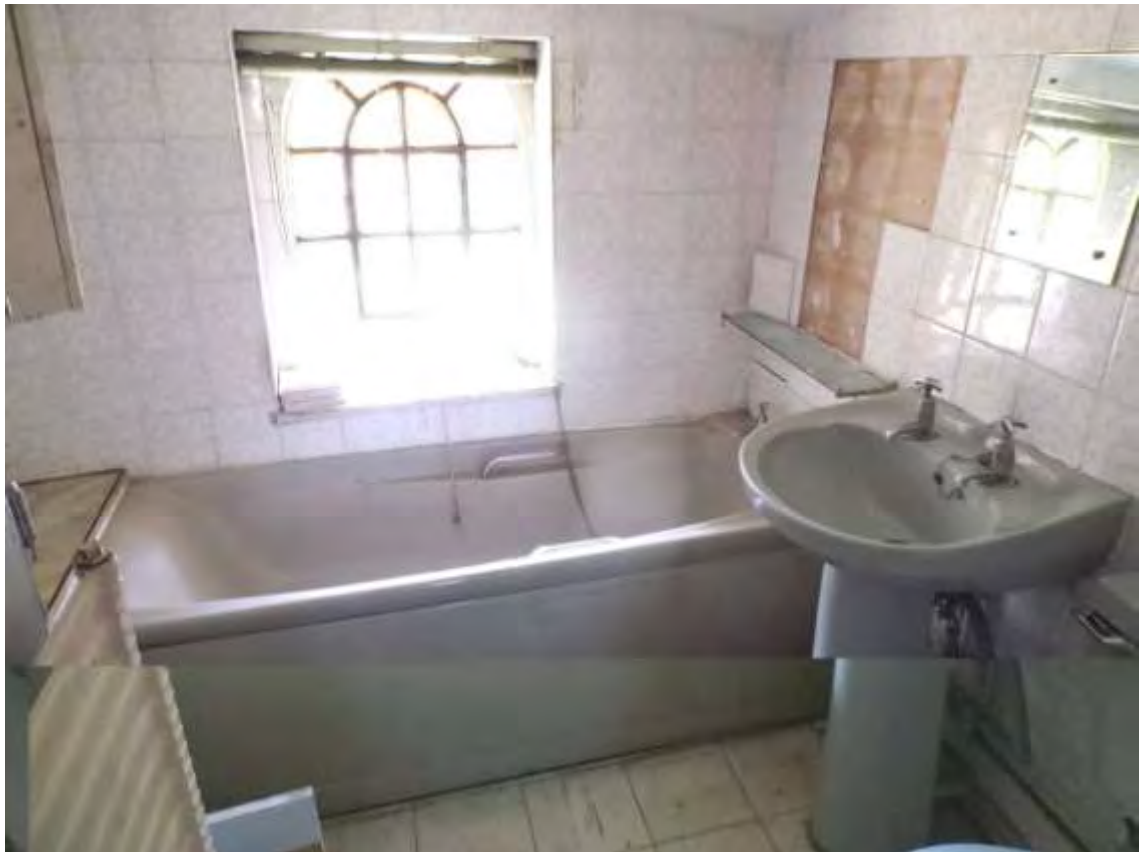
- 4.6.1 This has a solid floor covered with vinyl tiles which, due to their age, probably contain asbestos and so care should be taken when any work is undertaken on this surface. Where it was possible to see into the cupboard space at low level, adjacent to this it confirmed that this was a concrete structure below.
- 4.6.2 The walls are generally of glazed ceramic tiles applied to plywood fixed to the face of the external walls with the internal walls being faced with a hard cement type render and then decorated.

Fig 4.6; Bathroom

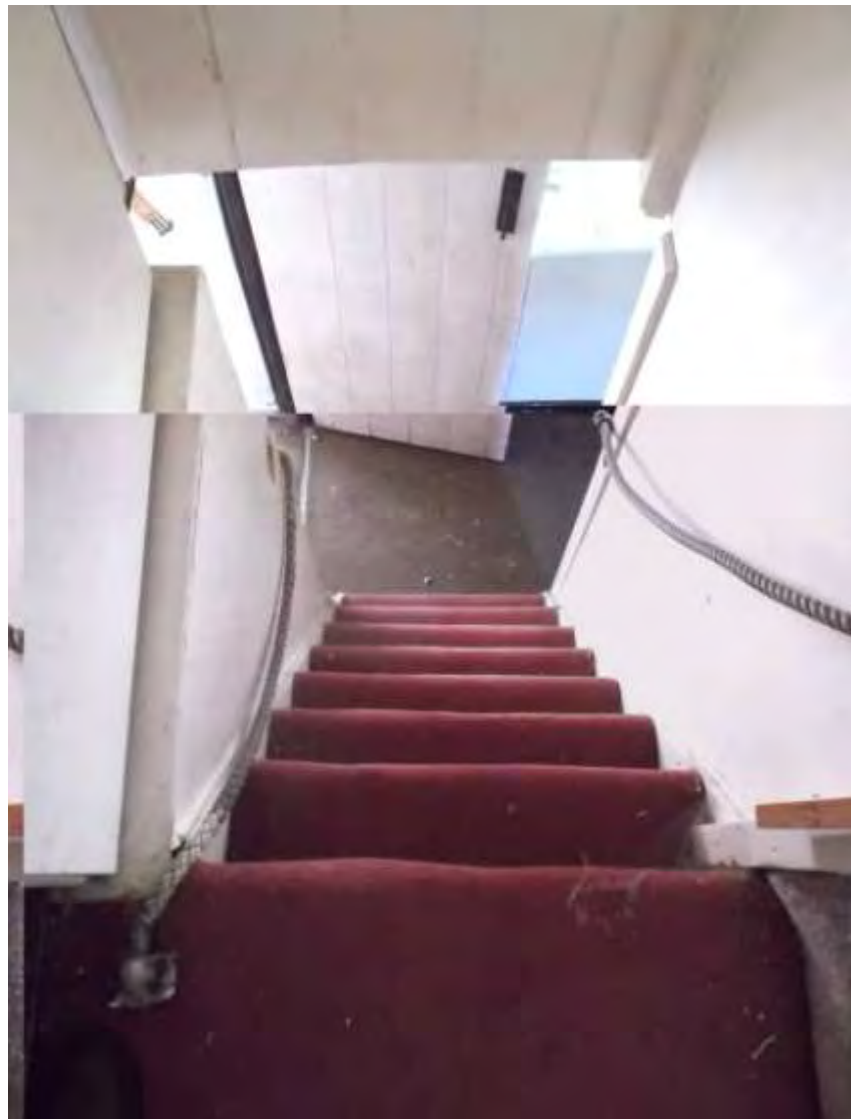
- 4.7.1 These rise as a single flight from adjacent to the kitchen to living room door to a small first floor landing. They are extremely steep with very narrow treads and high risers. The tread width is approximately 150 mm (6") and the rise is approximately 200 mm (8"). Assistance is provided by a rope hand rails on both sides.

Fig 4.7; Looking down stairs from first floor

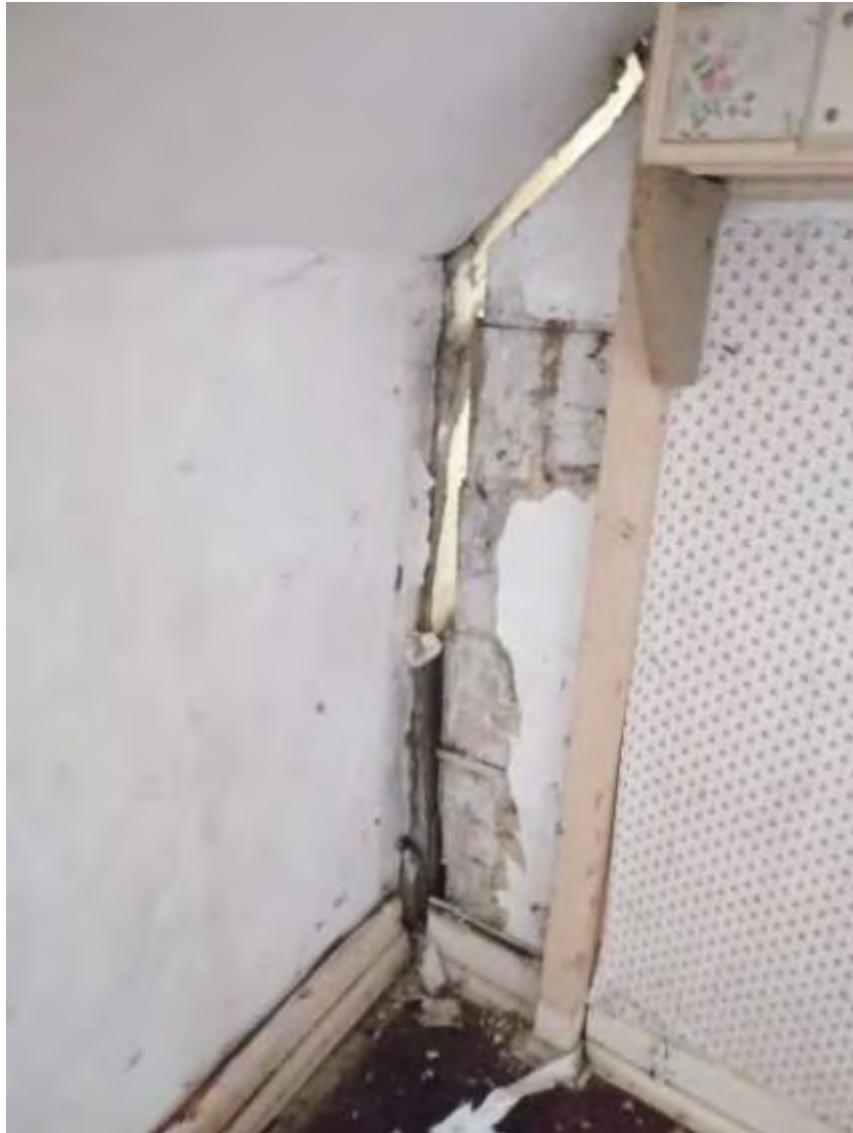
Fig 4.9 2; Movement between floor boards and wall to landing and south wall

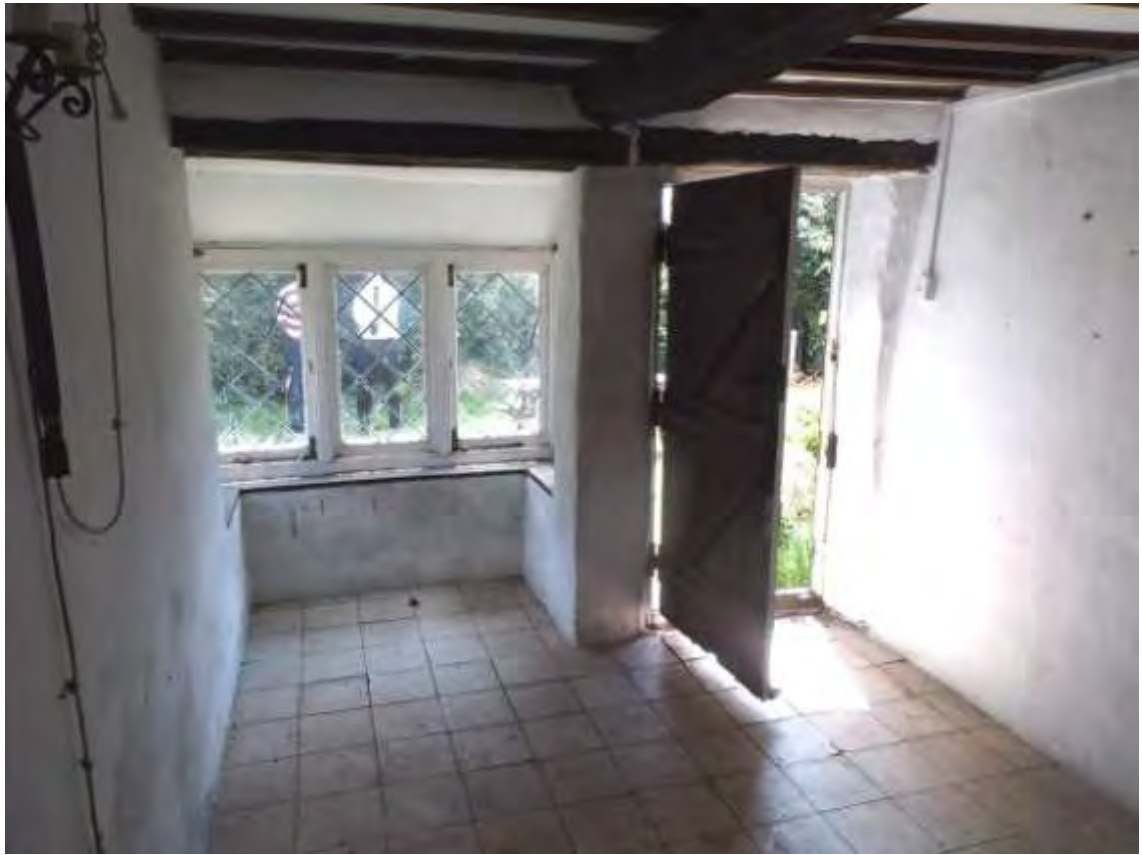
- 4.10.1 This is a single storey structure that sits against the east chimney gable of the house and is approached by a door from the outside only.
- 4.10.2 The floor is of concrete or similar solid structure covered with vinyl tiles and similar comments apply as made to the bathroom as these may contain asbestos.
- 4.10.3 The walls are of solid construction with that on the west being the cob end wall to the main part of the house and the other three appear to be brick or similar. These are all finished with a hard form of render that has subsequently been painted. From what could be seen in one section where surfaces coating has been lost, this appeared to be a hard cement type render.

Fig 4.10; East extension room looking from rear to front

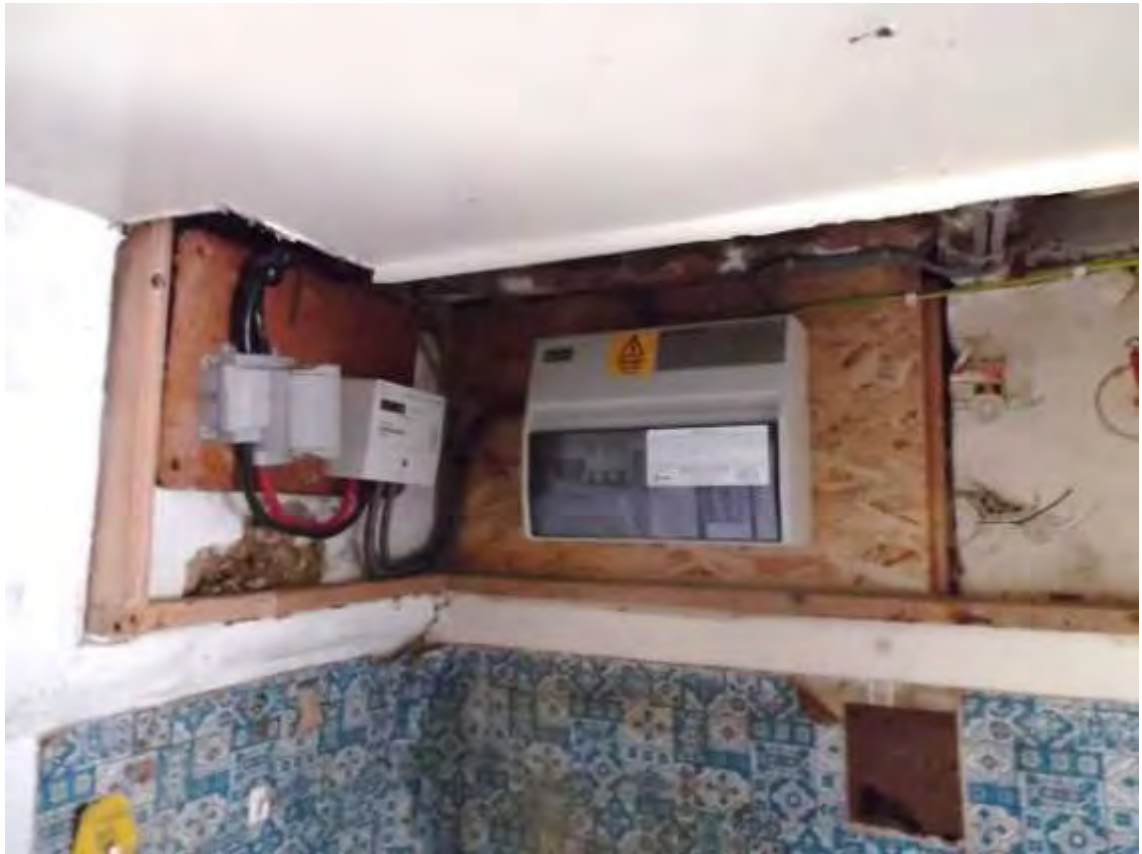
- 5.1.1 Mains electricity is connected to the site and there is a meters and consumer unit fitted with miniature circuit breakers mounted on a board in the kitchen and appear to be in reasonable condition.

Fig 5.1; Electricity in-take board

1.4.2 Remove the existing fuse board and replace with a new consumer board in accordance with current electrical standards, NICEIC. Works to be completed by competent qualified electrician with certification and sign off as required by building control.

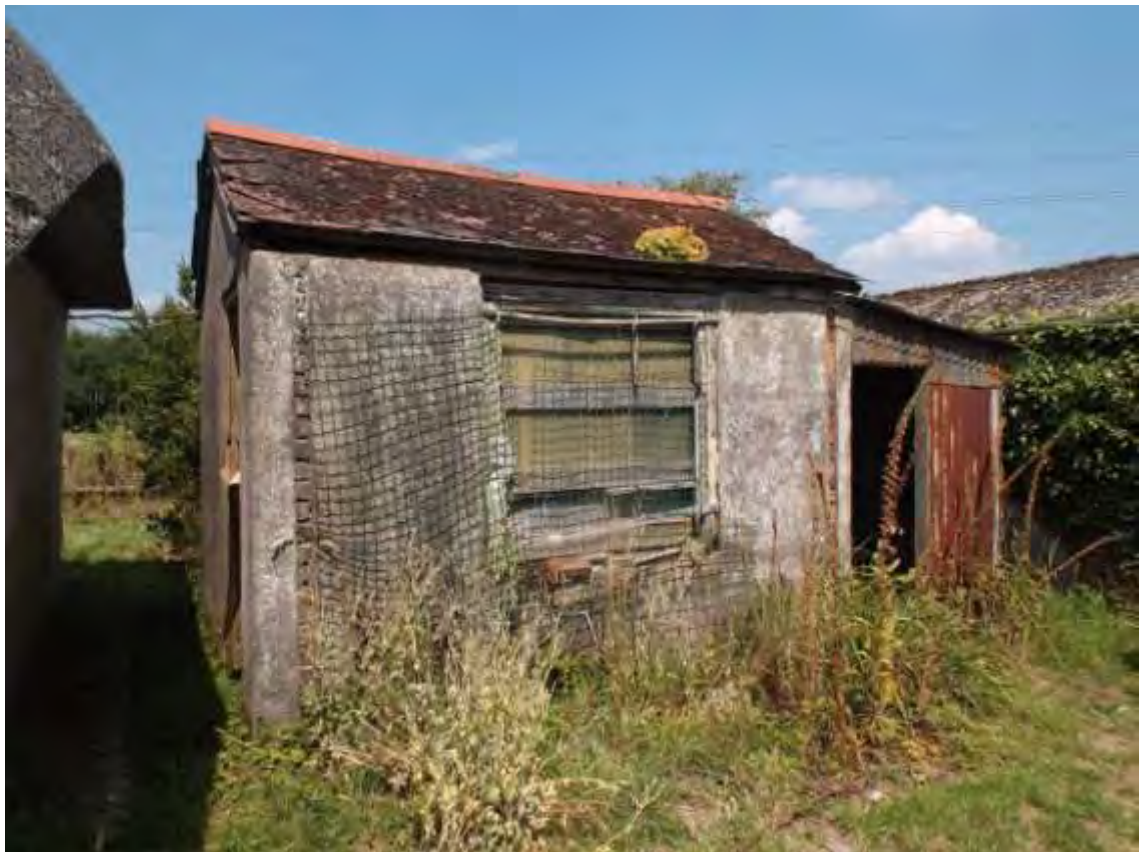
- 6.2.1 To the east of the property there is a shed built of brickwork that has been rendered and has traditional timber cut roof that is covered with asbestos cement tiles. This is in semi-derelict condition and no further inspection was undertaken on this.

Fig 6.2.1; Shed
