**BAYTREE BARN
OTFORD LANE
HALSTEAD
TN14 7EF
KENT:
BAT BUILDING SURVEY**

9th November 2021

D161. Halstead (TQ49236053) R

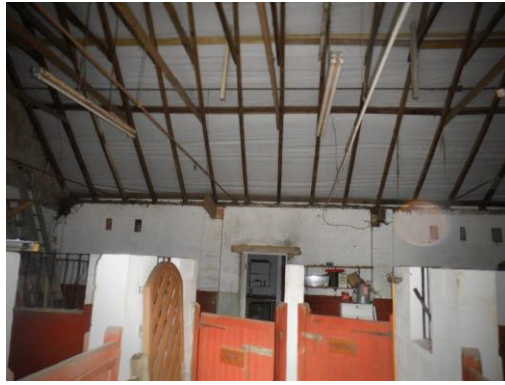
FIGURE 5: ROOM 1 SHOWING THE INSIDE OF THE ROOF.

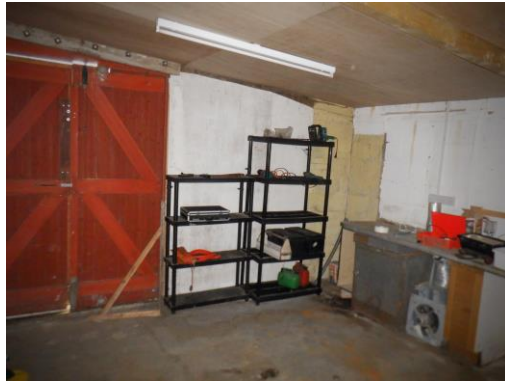
FIGURE 6: ROOM 2.

Constraints on survey:	Inability to inspect outer south wall due to lack of access permission from neighbour.
Additional notes	1. Whitewashed externally.
	2. Room 2 with incomplete plywood ceiling.
	3. Garage with one window.
	4. Sealed bargeboards throughout.
	5. Garage with strong organic chemical smell.
	6. Roof repaired c. 7 years ago.

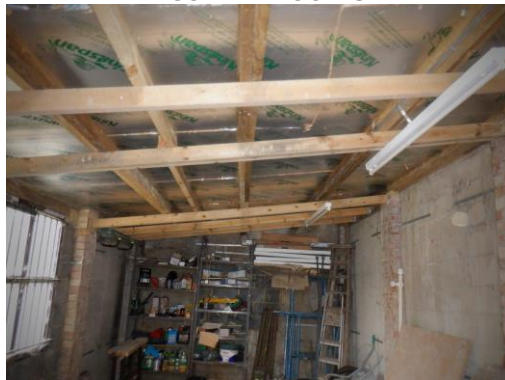
FIGURE 8: THE INTERIOR OF THE GARAGE.

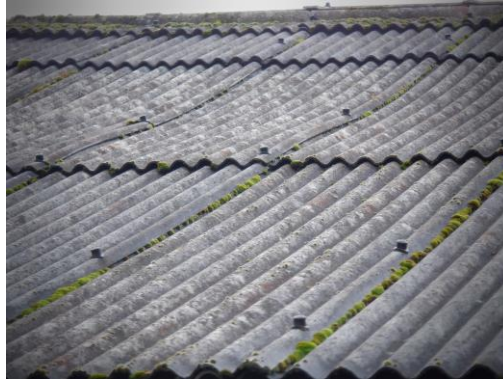
FIGURE 9: THE ASBESTOS / CONCRETE FIBRE ROOF OF THE BARN.

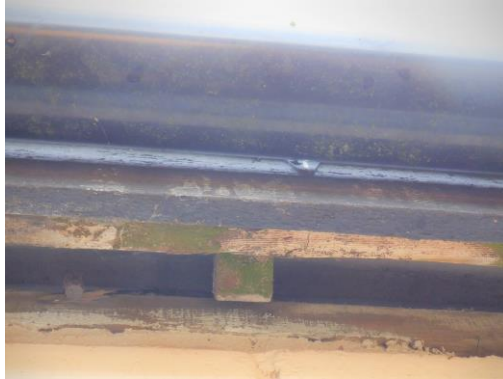
FIGURE 10: SHOWING THE OPEN GAPS AT THE EAVES.

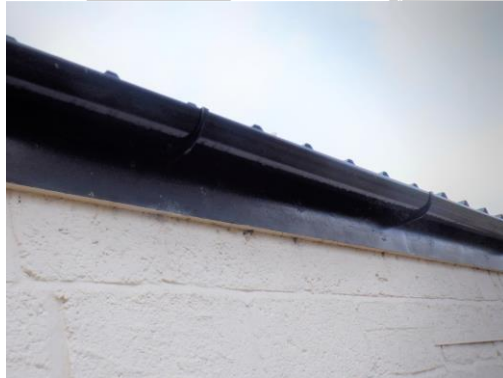
- 4.3** The absence of any evidence of **bat roosting** from the barn was not surprising; no droppings were found anywhere, even though the entire site was thoroughly surveyed as were the external surfaces of the walls. The absence of gaps between the bargeboards and walls, the small size of the roof timbers, and the tight – fitting nature of the slabs of corrugated asbestos / concrete fibre that made up the roof, as well as a paucity of suitable cracks and crannies made searching easier. Overall, the building was cold and dry and lacked any physical features which would provide habitat for roosting bats. The presence of the shading trees on the southern side of the building probably also mitigated against the presence of roosting bats, had there even been anywhere for them to roost, by preventing temperatures from being high enough for maternity use. Similarly, in both winter and summer the building would be very draughty and dry, especially in rooms 1 and 2, and there was nowhere in which hibernating bats could roost. Overall, the building had negligible potential for use by roosting bats.

FIGURE 11: THE GARAGE BARGEBOARDS.
