Issue date: 24/09/2021

Monitoring visit 6 of tbc

### Monitoring Plus Report

Owners name	Mrs. Julia Oakley	Suspected cause	to be advised	Monitoring type	levels & cracks
Address	9 Rudlands Ipswich Suffolk  IP8 3RQ	Principal area of damage	to be advised	Installed	24/10/2020
		Damage category	to be advised	Frequency (weeks)	8.7
		Surface geology	to be advised	Completion date	tbc
Comment				Status	open
Max movement	23.7 mm	Feedback from last visit	no feedback for this visit		
Focal area	Pts 7, 8, 12,				
no comment for this visit		Sketch showing location of monitoring points			
		<p>Points 7 &amp; 8 Long screws</p> <p>Conservatory</p> <p>Garage</p> <p>Crack B</p> <p>Crack A</p> <p>EXT</p> <p>No 9</p> <p>1 (ref)</p> <p>Front Elevation</p>

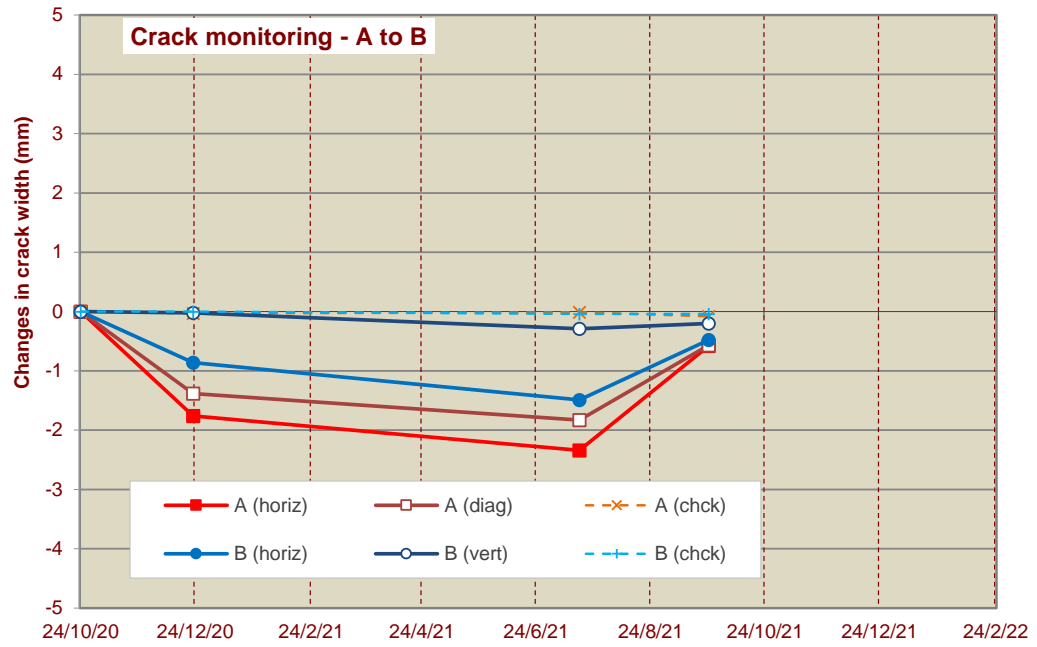
# Crack monitoring

Survey: By: Date:		1 CV 24/10/2020		2 CV 23/12/2020		5 CV 17/07/2021		6 CV 24/09/2021		7 #N/A	
Crack ID	initial width mm	sprtn mm	chngs mm	sprtn mm	chngs mm	sprtn mm	chngs mm	sprtn mm	chngs mm	levels mm	chngs mm
A (horiz)	4.50	100.91	0.0	99.15	-1.8	98.57	-2.3	100.33	-0.6		#N/A
A (diag)		129.80	0.0	128.42	-1.4	127.97	-1.8	129.23	-0.6		#N/A
A (chck)		77.13	0.0	77.10	0.0	77.12	0.0	77.05	-0.1		#N/A
B (horiz)	2.80	78.66	0.0	77.80	-0.9	77.17	-1.5	78.18	-0.5		#N/A
B (vert)		73.68	0.0	73.66	0.0	73.39	-0.3	73.48	-0.2		#N/A
B (chck)		108.29	0.0	108.29	0.0	108.25	0.0	108.25	0.0		#N/A

A (horiz)	Demec triplet, internal, crack below landing window
B (horiz)	Demec triplet, internal, crack above landing window

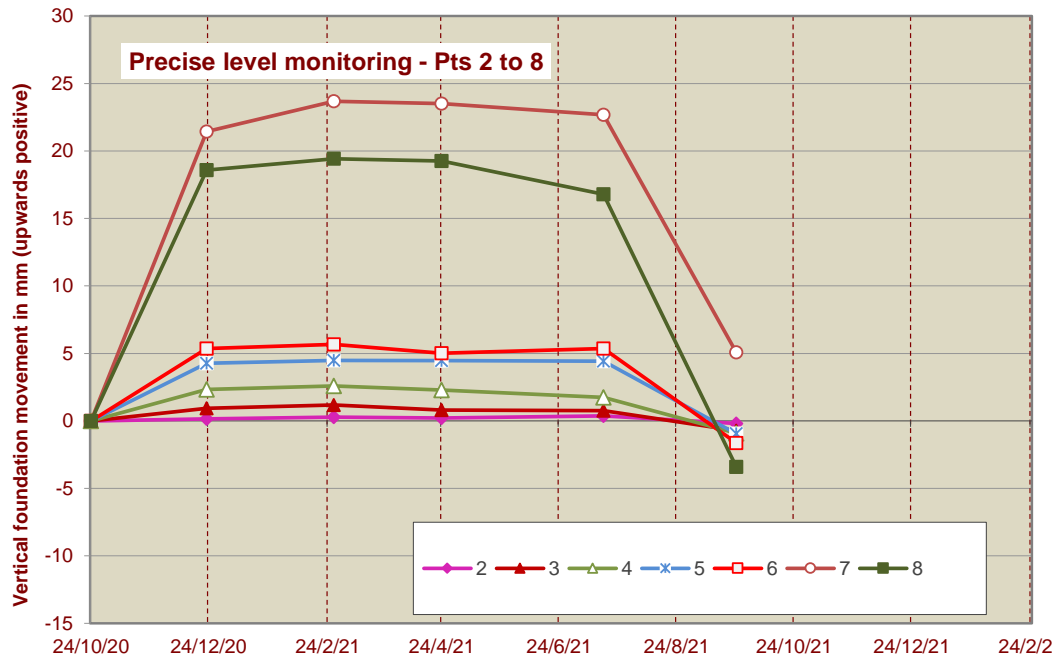
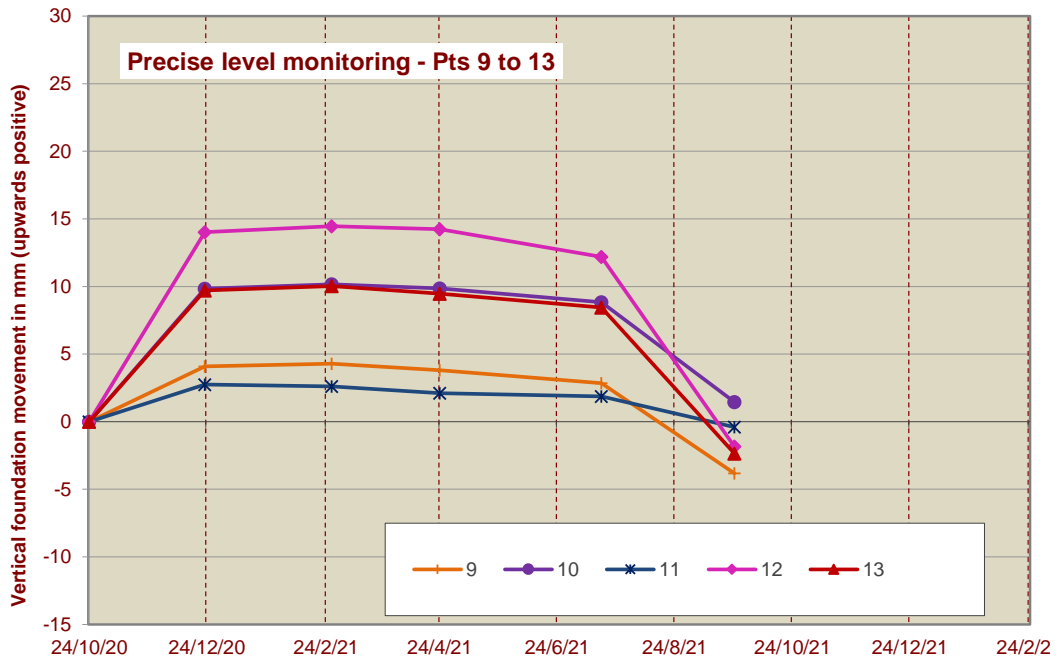
## Precise level monitoring related to Point 1

Survey:	1		2		3		4		5	
By:	CV		CV		CV		CV		CV	
Date:	24/10/2020		23/12/2020		27/02/2021		24/04/2021		17/07/2021	
Point ID	levels mm	chngs mm	levels mm	chngs mm	levels mm	chngs mm	levels mm	chngs mm	levels mm	chngs mm
1	1000.00	0.0	1000.00	0.0	1000.00	0.0	1000.00	0.0	1000.00	0.0
2	1007.17	0.0	1007.32	0.1	1007.46	0.3	1007.38	0.2	1007.54	0.4
3	1004.08	0.0	1005.02	0.9	1005.26	1.2	1004.88	0.8	1004.84	0.8
4	996.67	0.0	998.99	2.3	999.26	2.6	998.95	2.3	998.42	1.7
5	990.52	0.0	994.79	4.3	995.00	4.5	994.98	4.5	994.94	4.4
6	993.63	0.0	998.99	5.4	999.30	5.7	998.65	5.0	999.00	5.4
7	963.16	0.0	984.60	21.4	986.84	23.7	986.67	23.5	985.83	22.7
8	806.36	0.0	824.94	18.6	825.78	19.4	825.61	19.2	823.15	16.8
9	738.12	0.0	742.22	4.1	742.41	4.3	741.93	3.8	740.98	2.9
10	1093.81	0.0	1103.66	9.9	1103.97	10.2	1103.68	9.9	1102.64	8.8
11	1119.77	0.0	1122.52	2.8	1122.39	2.6	1121.88	2.1	1121.64	1.9
12	1085.02	0.0	1099.04	14.0	1099.48	14.5	1099.25	14.2	1097.21	12.2

13	1180.03	0.0	1189.74	9.7	1190.06	10.0	1189.51	9.5	1188.48	8.4

Survey:	6		7		8		9		10	
By:	CV		#N/A		#N/A		#N/A		#N/A	
Date:	24/09/2021		#N/A		#N/A		#N/A		#N/A	
Point ID	levels mm	chngs mm	levels mm	chngs mm	levels mm	chngs mm	levels mm	chngs mm	levels mm	chngs mm
1	1000.00	0.0		#N/A		#N/A		#N/A		#N/A
2	1006.98	-0.2		#N/A		#N/A		#N/A		#N/A
3	1003.36	-0.7		#N/A		#N/A		#N/A		#N/A
4	995.76	-0.9		#N/A		#N/A		#N/A		#N/A
5	989.57	-1.0		#N/A		#N/A		#N/A		#N/A
6	992.00	-1.6		#N/A		#N/A		#N/A		#N/A
7	968.23	5.1		#N/A		#N/A		#N/A		#N/A
8	802.96	-3.4		#N/A		#N/A		#N/A		#N/A
9	734.30	-3.8		#N/A		#N/A		#N/A		#N/A
10	1095.26	1.5		#N/A		#N/A		#N/A		#N/A
11	1119.37	-0.4		#N/A		#N/A		#N/A		#N/A
12	1083.18	-1.8		#N/A		#N/A		#N/A		#N/A
13	1177.68	-2.3		#N/A		#N/A		#N/A		#N/A
