**CCTV REPORT FOR: 9 RUDLANDS
IPSWICH
SUFFOLK
IP8 3RQ**

Insured: Mrs J Oakley
Reference: DLG-SN-20-002038 Ins Ref: 074634619

1st Site Visit: 13-Oct-20
1st Report Date: 25-Nov-20

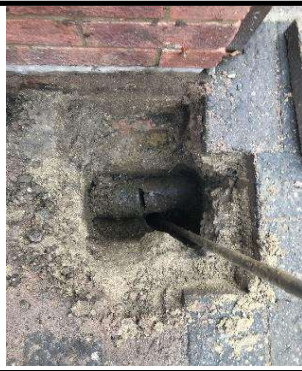
General Comments :
 Run 7 visible in trial hole.

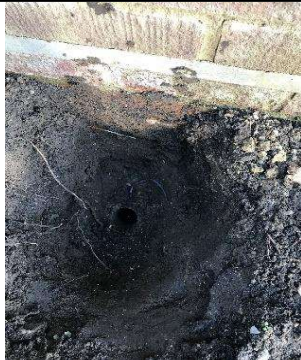
Run 7 visible in trial hole.

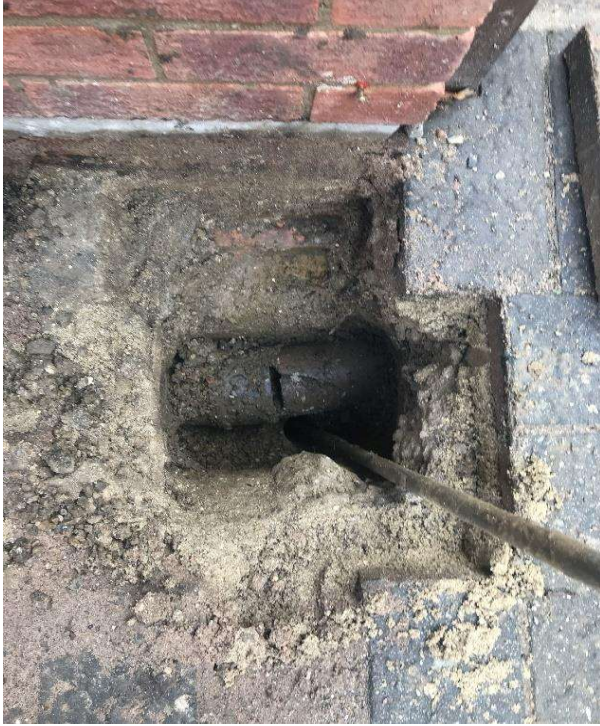
T/H1 - Run 7 visible

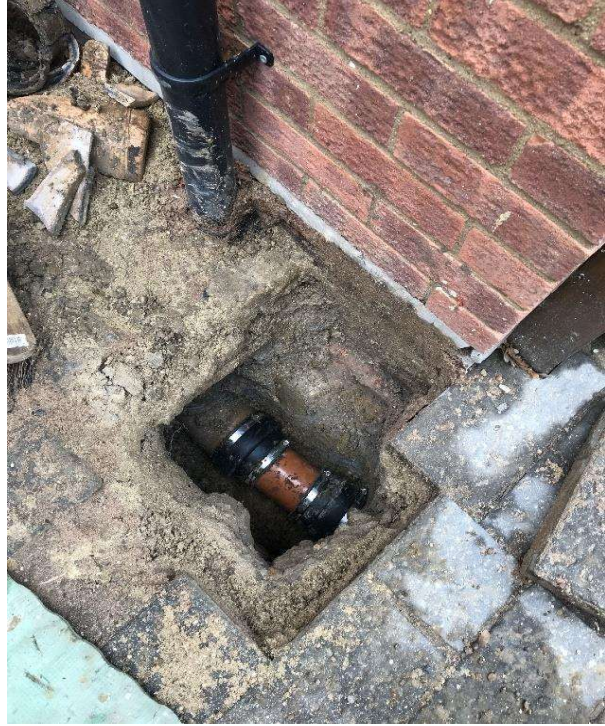
Small section of Run 7 pipework was replaced due to damage caused when performing access cut and T/H1.

T/H1 - Repair to Run 7 following survey
