Engineers Report

Risk Address 9 Rudlands
Ipswich
Suffolk
IP8 3RQ

360 Reference DLG-SN-20-002038
Claim Refence 074634619
Policy Holder Mrs. J. Oakley

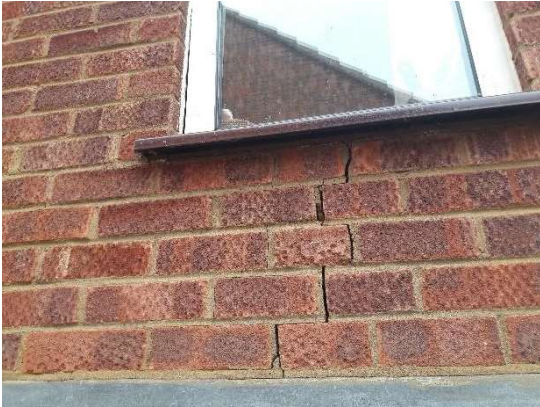
Cracking Below Landing Window

Staircase / Landing - There is significant cracking above and below the landing window at the head of the staircase and this is in excess of 5mm wide.

At this stage the damage is localised, and repairs will likely entail crack stitching and re-decoration. A detailed schedule of repairs will be prepared following an assessment by a contractor.

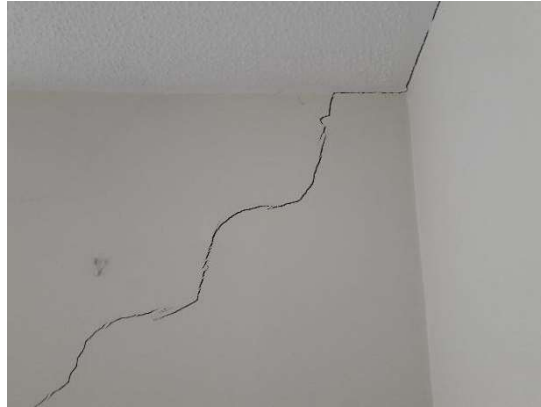
Internal Cracking

Kitchen - Cracking is evident above the door head.

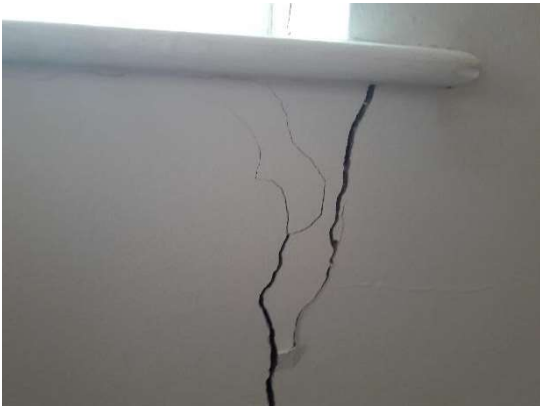
Cracking Below Landing Window

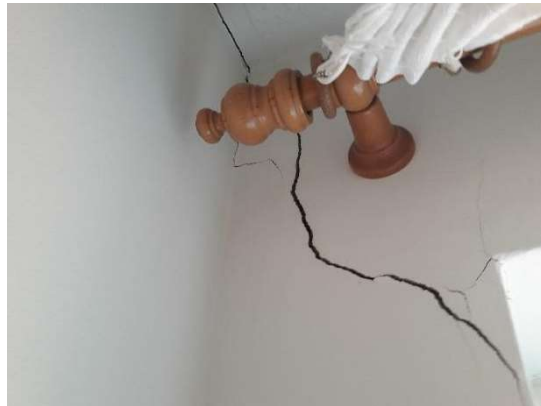
Cracking Above Landing Window

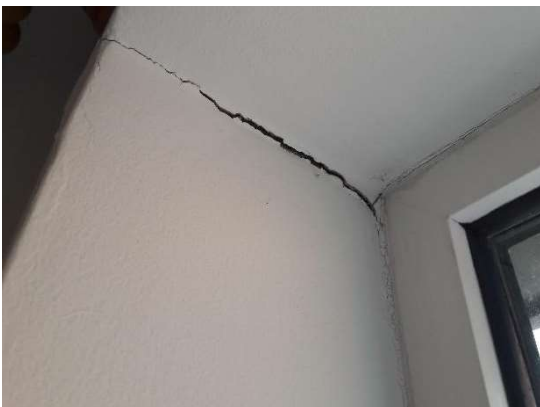
Cracking to Landing Window Head

There is significant crack above the kitchen door, and this extends up to the landing window above. Cracking is evident above the landing window and below the kitchen door and both frames have been pulled.

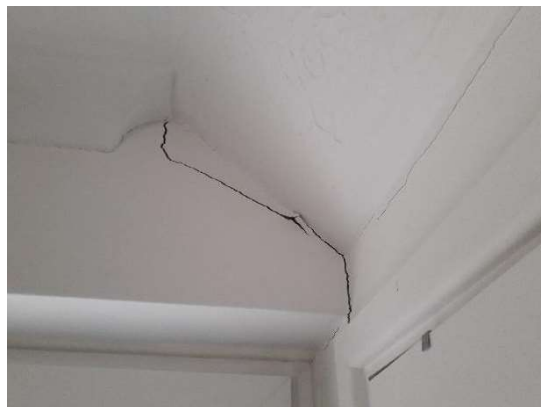
Cracking Above External Door
