Date: 22.10.2019  
Ref: 19 079

### **Barn and Stables at Shepherds Fold**

I refer to my site visit on 18.10.2019, made to carry out a Visual Structural Survey. This Survey and report are required to accompany a planning application to be made on your behalf made by architect Richard Crook, for conversion to living accommodation. This report will comment on the structural condition of the two buildings, and the structural works likely to be necessary for conversion to living accommodation.

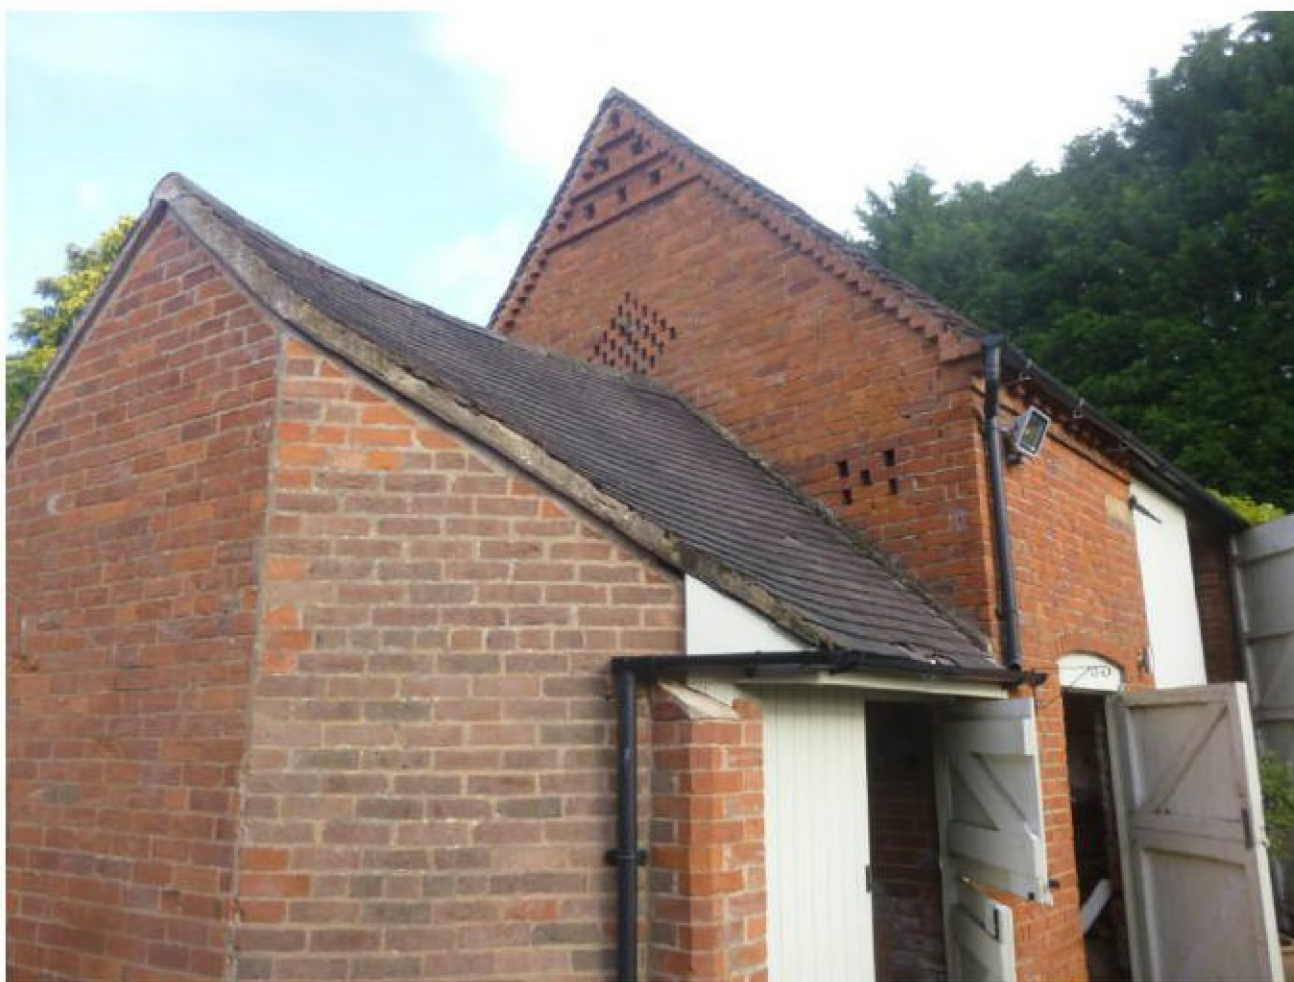
### **Barn Building**

The Barn building is the northern and larger of the two. It is of traditional construction with plain tiled duopitch roof on timber rafters, purlins and trusses. External walls are of solid brick construction with timber lintels generally over openings, and with a brick arch externally over one door opening. Timber first floors are present in the east and west ends, with a full-height open cartway through in the central section. A small single-storey extension is present on the western end, being of similar age and construction. The Barn may be 100 to 200 years old. However, the roof and first floor construction is all of regular sawn timber, and with black bitumen felt lining to the underside of the tiles, so may be more recent than the brick walls. The building may well have been re-roofed in the last 50 years.

The ground level is higher than the internal floor level at the eastern end and accessed by a ramp on the south side. A large oil tank is situated on this higher ground, and a line of large conifer trees is present beyond this and parallel with the eastern gable wall.

The barn building is generally in good structural condition for its age, with the main two-storey roof being to a good line, and with the external walls also being to a good line. The roof to the single-storey extension has sagged significantly on the southern pitch. Areas of weathered pointing generally, and small localised areas of perished brickwork are present at lower level on all external elevations. Minor brickwork cracks are present locally at high level on north and south elevations.

The external tarmac surfacing extended up to the brickwork on the western end, and two rainwater pipes were noted as being unconnected to underground drainage. These factors will have contributed to perished brickwork and weathered mortar in those areas.

Since the building does not seem to have suffered major differential foundation movement, with consequent cracking of the brick walls, and bearing in mind the age of the building, this suggests that the existing foundations have performed adequately, and may not need to be underpinned. However, a final decision on this aspect can only be made after existing foundation depths have been investigated.

**Overall the Barn building is generally in good structural condition for its age, and conversion to living accommodation is quite feasible.**

- 1 – strengthening of timber purlins for increased roof load
- 2 – strengthening of first floor joists for increased load from living accommodation
- 3 – generalised repointing, and localised replacement of perished bricks

- 4 – replacement of timber lintels internally with modern concrete alternatives
- 5 – removal of large oil tank, removal of external ramp, and lowering of external ground level at the eastern end to below the proposed internal ground floor level. A low path and retaining wall beyond will then need to be created.

- 6 – removal of the large conifer trees at the eastern end within 10m of the building to ensure a stable ground moisture foundation for the existing foundations

- 7 – cutting back of tarmac and other surfacing abutting the external brick walls, to limit further damp problems, and provision of a gravel filled french drain around the full perimeter of the building

- 8 – provision of a new underground drainage system to ensure that rainwater is collected and discharged at least 5m from the building

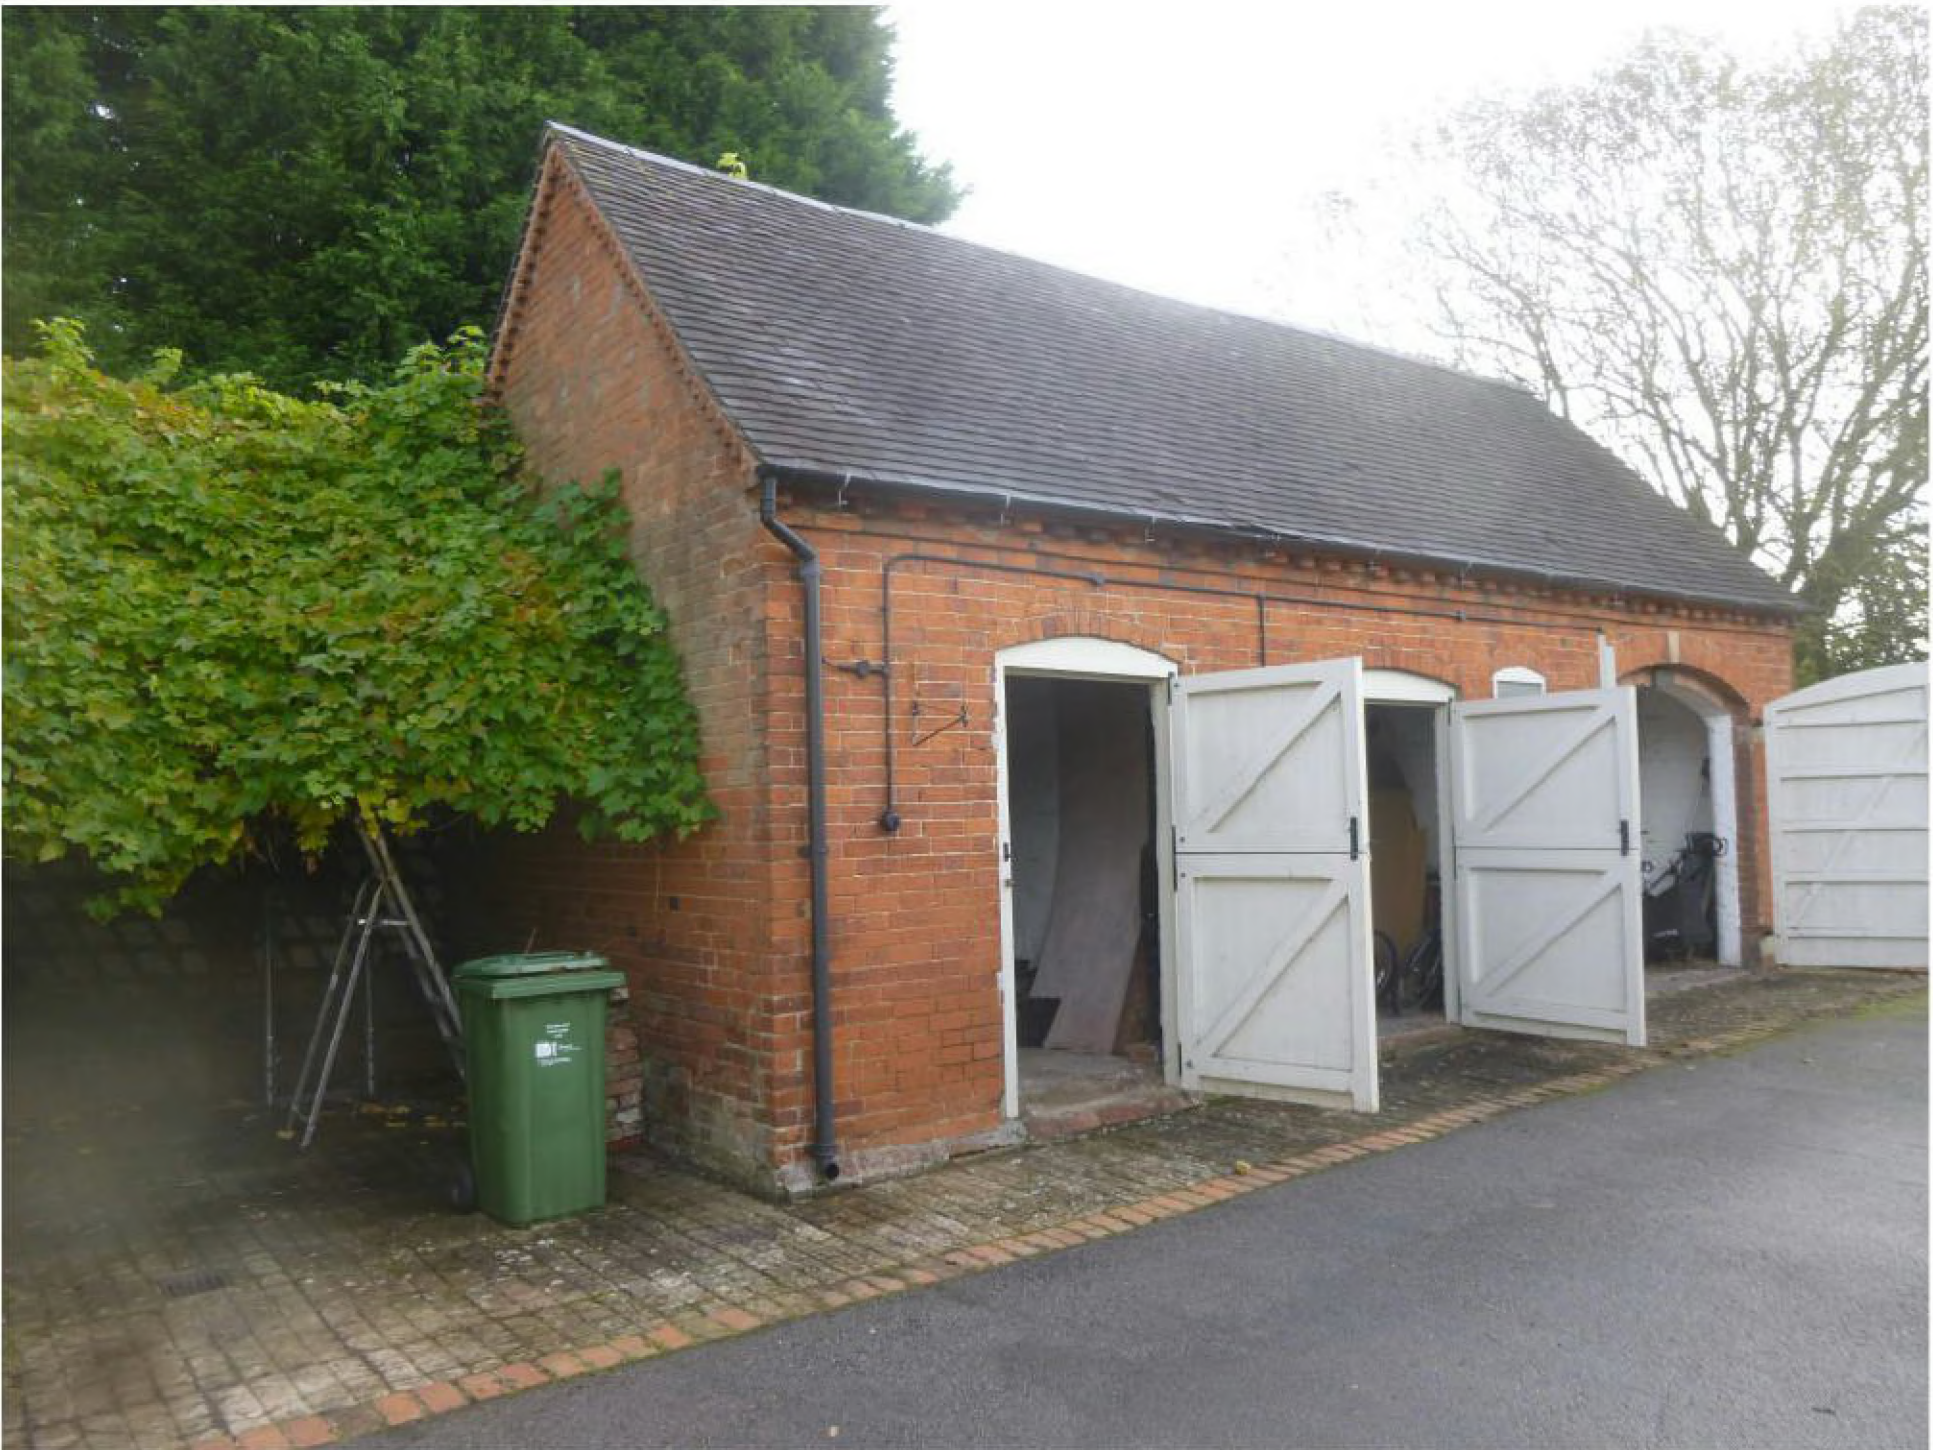
## Stables Building

The Stables building is the southern and smaller of the two buildings. It is of traditional construction with plain tiled duopitch roof on timber rafters, and purlins. The internal brick crosswalls provide intermediate support to the purlins. External walls are of solid brick construction with timber lintels internally over openings, and with brick arches externally over the door openings. A small single-storey extension is present on the southern end, being of similar age and construction, but with a shallow-pitched monopitch roof covered with corrugated asbestos-cement sheeting. The Stables may be 100 to 200 years old, with original roof timbering. Black bitumen felt lining is present on the underside of the tiles, suggesting that the building may have been re-tiled within the last 50 years.

The ground level is higher than the internal floor level along the eastern side, and with the continuation of a line of large conifer trees a few metres away. A large broad-leaved tree is present close to southern end, adjacent to the single-storey extension.

The Stables building is generally in good structural condition for its age, with the main roof being to a good line, and with the external walls also being to a good line. Areas of weathered pointing generally, and also small localised areas of perished brickwork, are present at lower level on all external elevations. Minor brickwork cracks are present over door openings on the western elevation.

The external surfacing extended up to the brickwork on the western side, and one rainwater pipe was noted as being unconnected to underground drainage. These factors will have contributed to perished brickwork and weathered mortar in those areas.

Since the Stables building does not seem to have suffered major differential foundation movement, with consequent cracking of the brick walls, and bearing in mind the age of the building, this suggests that the existing foundations are performing adequately, and may not need to be underpinned. However, a final decision on this aspect can only be made after existing foundation depths have been investigated.

**Overall the Stables building is generally in good structural condition for its age, and conversion to living accommodation is quite feasible.**

- 1 – strengthening of timber purlins for increased roof load
- 2 – generalised repointing, and localised replacement of perished bricks
- 3 – replacement of timber lintels internally with modern concrete alternatives

- 4 – lowering of higher external ground level along the eastern side to below the proposed internal ground floor level. A low path and retaining wall beyond will then need to be created.

- 5 – removal of the large conifer trees along the eastern end within 10m of the building to ensure a stable ground moisture foundation for the existing foundations

- 6 – cutting back of tarmac and other surfacing abutting the external brick walls, to limit further damp problems, and provision of a gravel filled french drain around the full perimeter of the building

- 7 – provision of a new underground drainage system to ensure that rainwater is collected and discharged at least 5m from the building

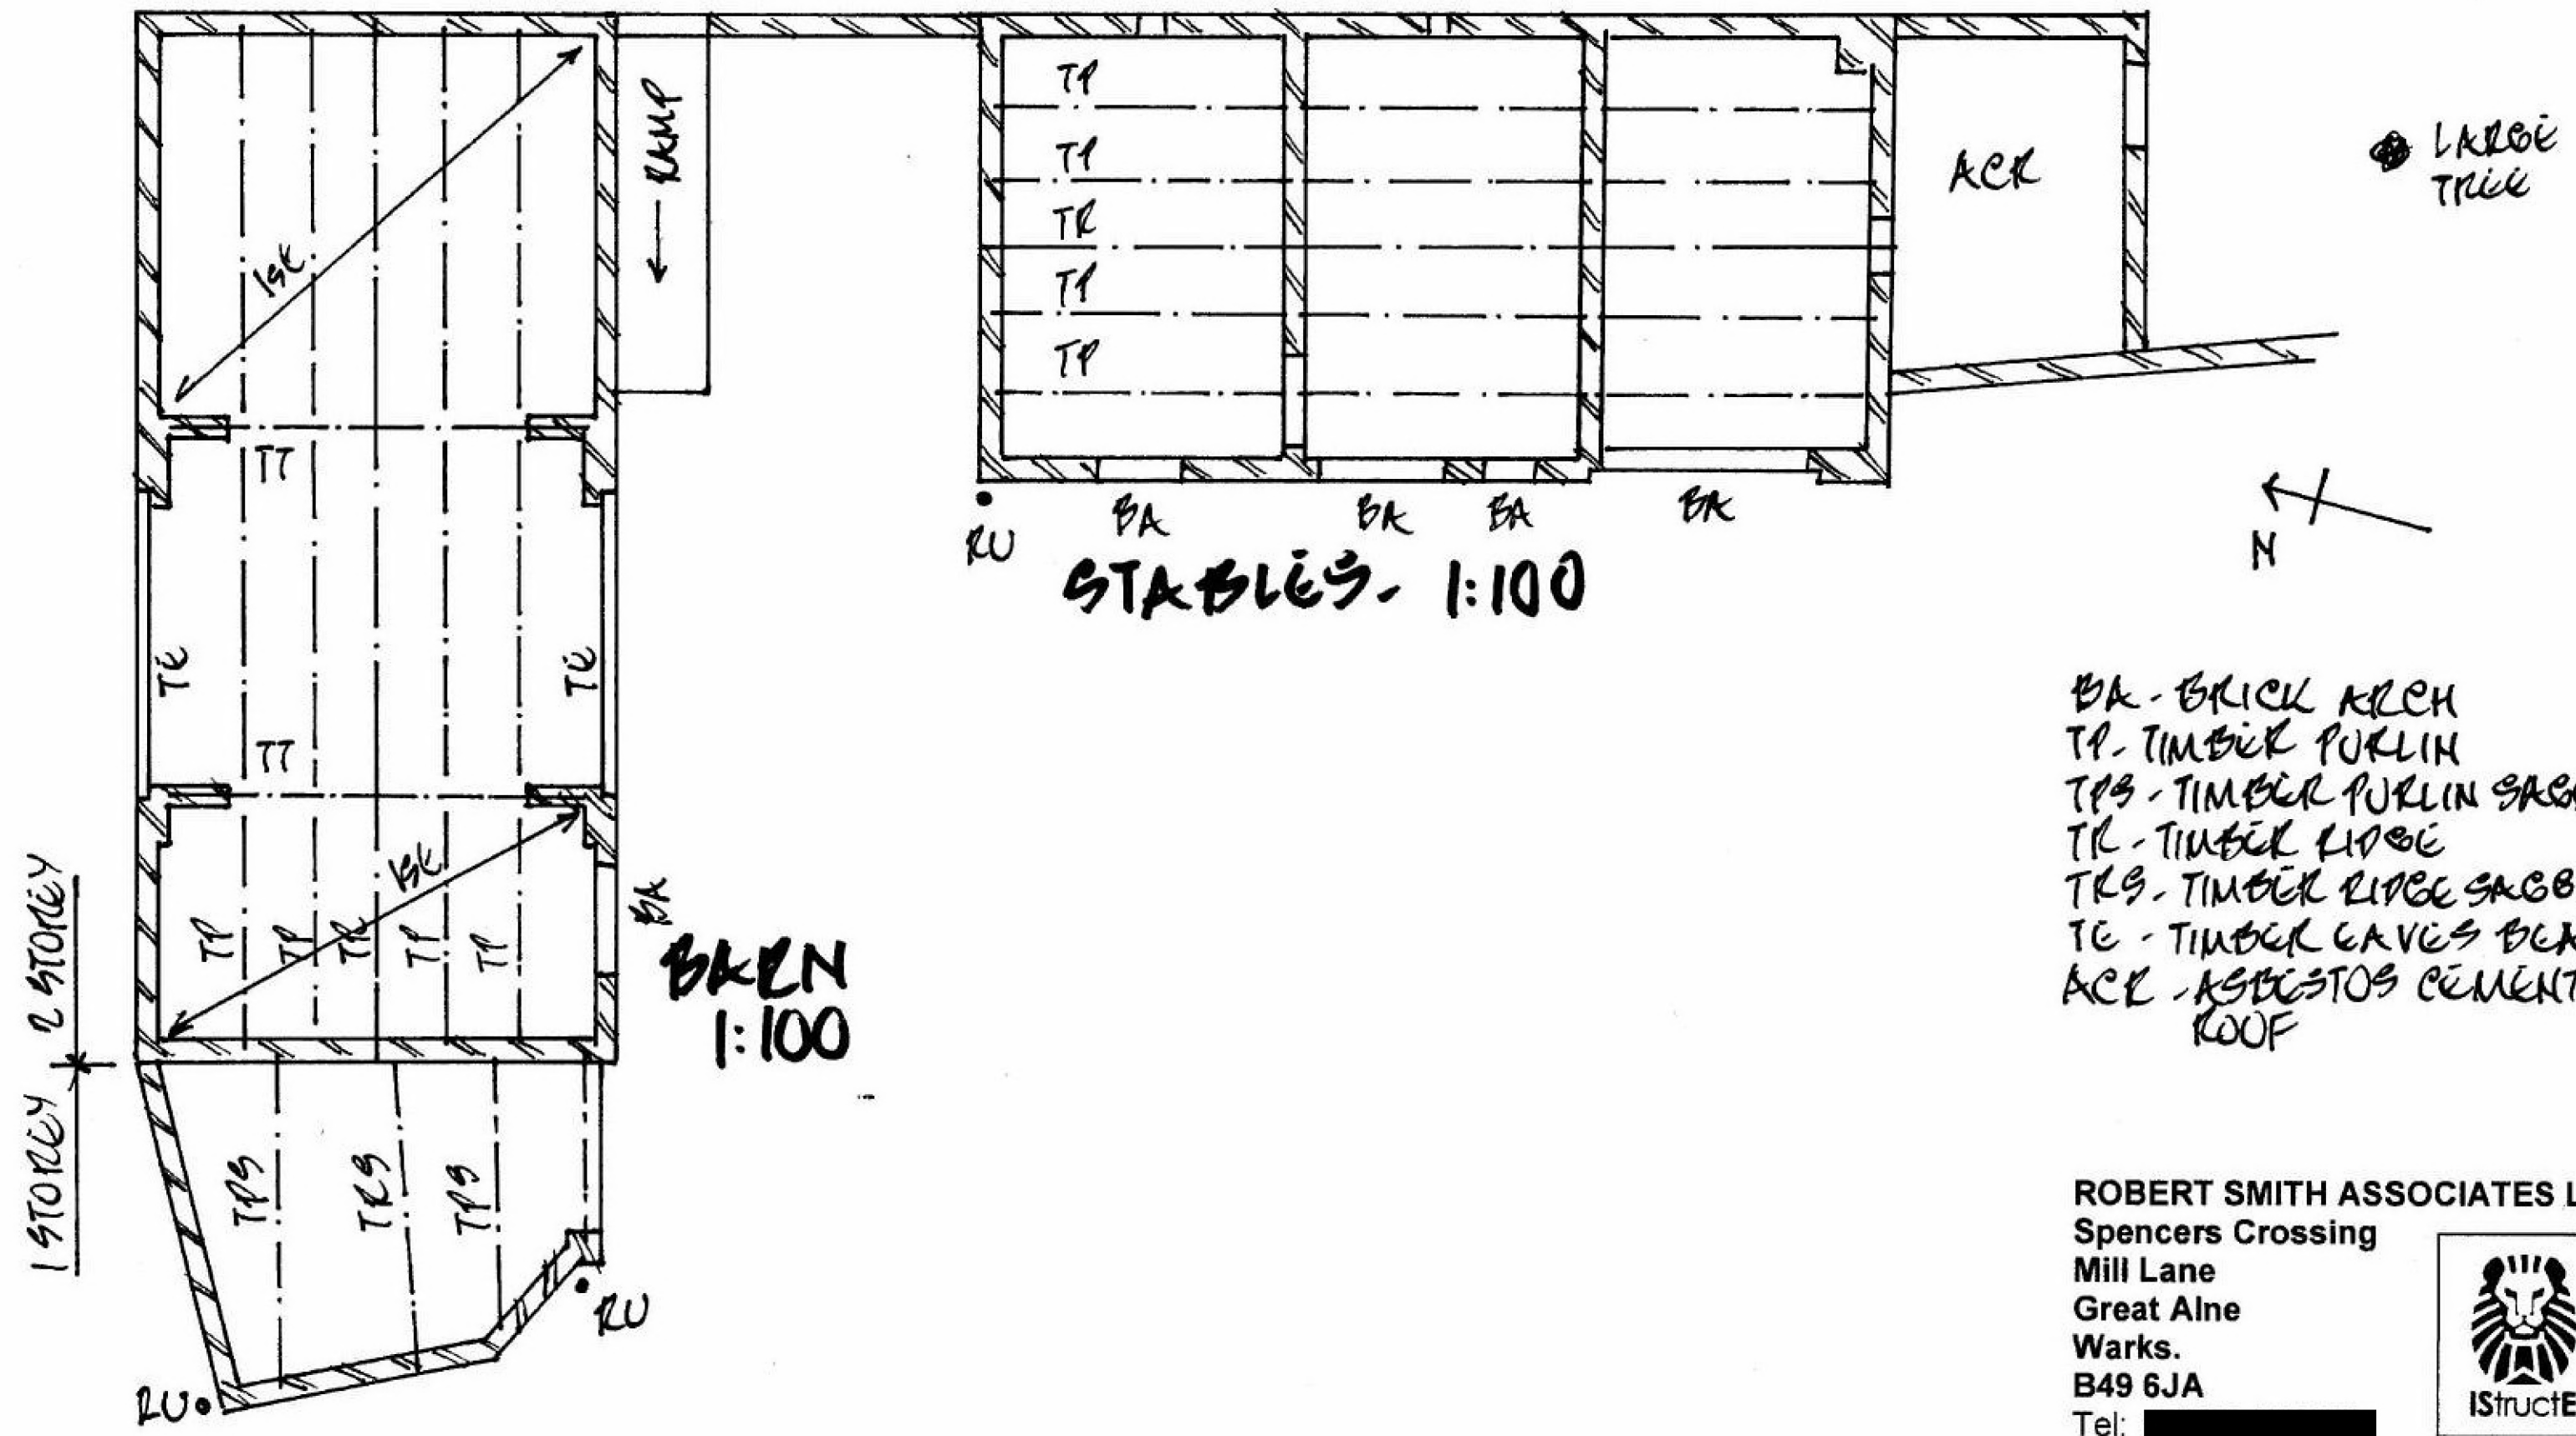
19079/SKL  
18.10.2019

LINE OF LARGE DEYLANDIA TREES

OIL TANK

GROUND HIGHER ALONG THIS SIDE
