# Arboricultural Appraisal Report

## Subsidence Damage Investigation at:

402 Old Road  
Clacton-on-Sea  
Essex  
CO15 3SB

CLIENT:	B Maule & Co Ltd
CLIENT REF:	W4588/TJD/AWN
MWA REF:	SUB210805-9329
MWA CONSULTANT:	Andy Clark
REPORT DATE:	25/08/2021

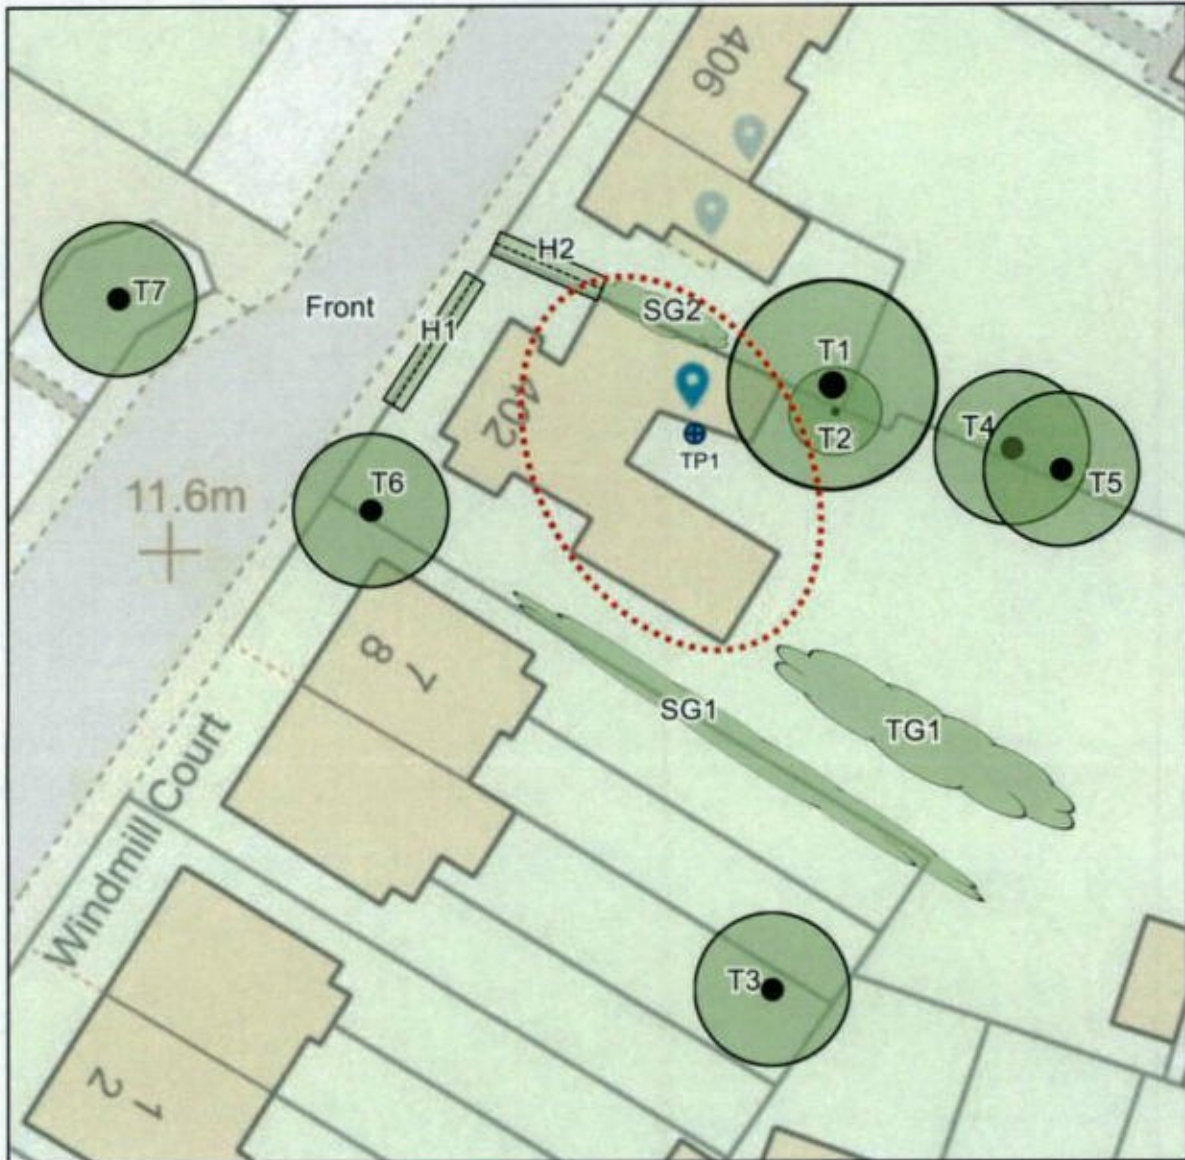
Site Plan

Approximate areas of damage

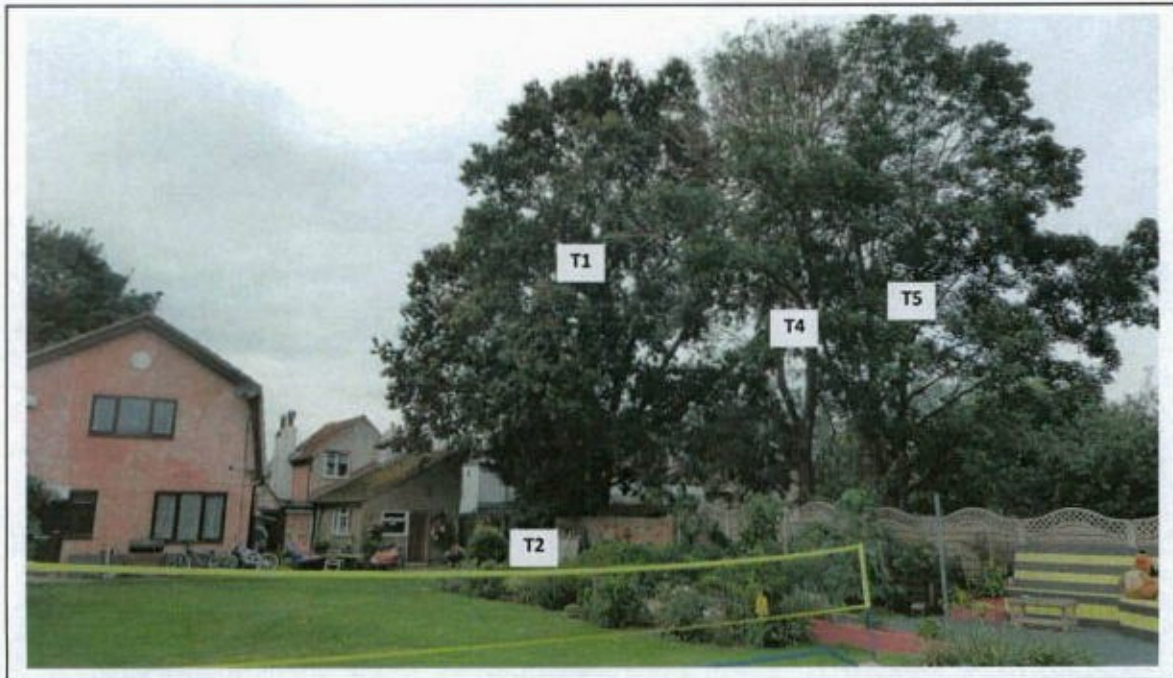
Roots were observed to a depth of 1.75m bgl in TP/BH1, and recovered samples have been positively identified (using anatomical analysis) as *Quercus* spp.; the origins of which will be T1 Oak, confirming its influence on the soils below the foundations.

Based on the technical reports currently available, engineering opinion and our own site assessment we conclude the damage is consistent with shrinkage of the clay subsoil related to moisture abstraction by vegetation. Having considered the information currently available, it is our opinion that T1 Oak is the principal cause of the current subsidence damage with a localised contributory influence from T2 Bay and the nearby shrub and Ivy growth of SG2.

View of T1 Oak, T2 Bay, T4 Ash and T5 Sycamore

If an arboricultural solution is to be implemented to mitigate the influence of the implicated trees/vegetation we recommend that T1 Oak, T2 Bay and the nearby shrub and Ivy growth of SG2 are removed in the first instance. If movement persists, attention will need to turn to T6 Sycamore. Other vegetation recorded presents a potential future risk to building stability and management is therefore recommended. Recommended tree works may however be subject to change upon receipt of additional information.

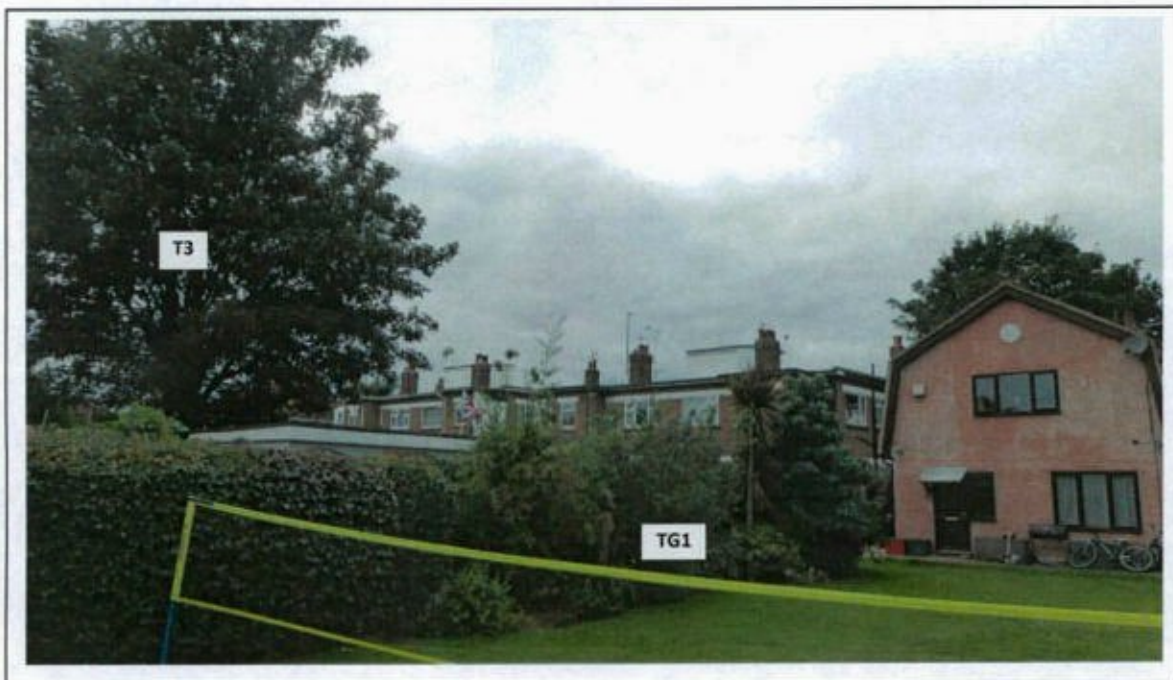
View of T3 Sycamore and TG1 group

Tree No.	Species	Ht (m)	Dia (mm)	Crown Spread (m)	Dist. to building (m)	Age Classification	Ownership
T3	Sycamore	15.0	500 *	12.0	18.3	Younger than Property	Third Party 5 Windmill Court CO15 3SD
Management history		No significant past management noted.					
Recommendation		Maintain broadly at no more than current dimensions by periodic pruning.					
T4	Ash	16.5	400 *	11	13.4	Younger than Property	Third Party 406 Old Road CO15 3SB
Management history		No significant past management noted. Significant dieback in upper crown – Chalara Ash Dieback Disease [Notifiable under PHC legislation].					
Recommendation		Owner to deal with CADB disease and take appropriate steps which may be removal.					
T5	Sycamore	14.0	400 Ms *	12.0	15.9	Younger than Property	Third Party 406 Old Road CO15 3SB
Management history		No significant past management noted.					
Recommendation		Maintain broadly at no more than current dimensions by periodic pruning.

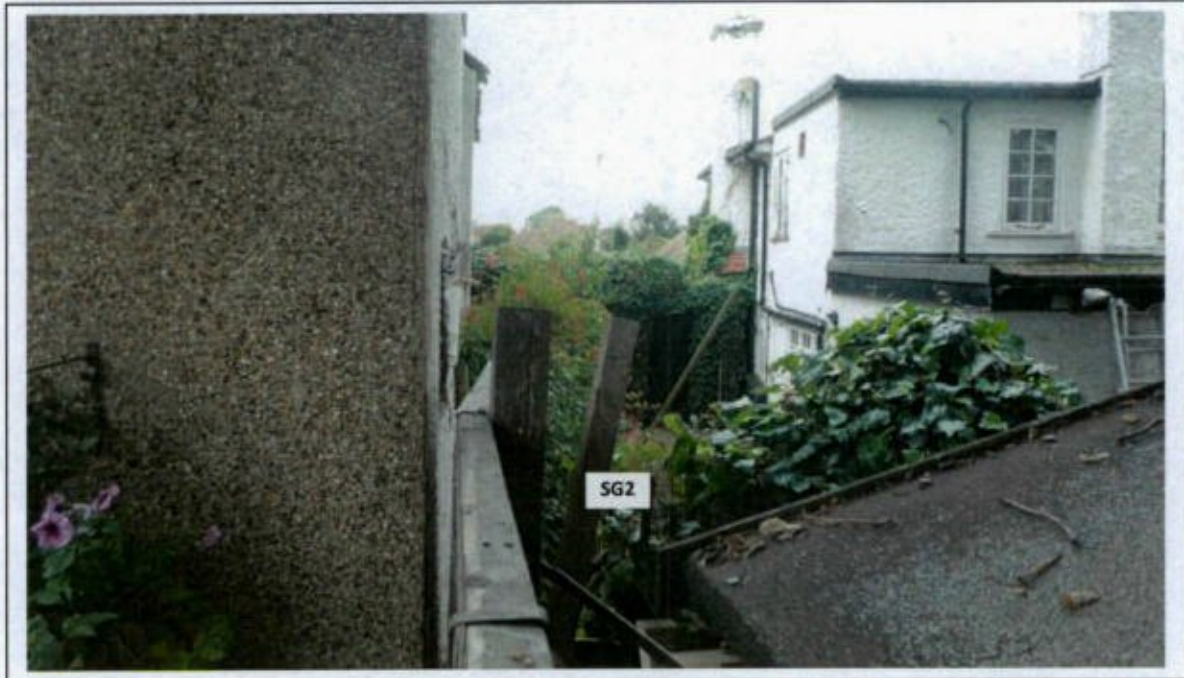
Irrespective of the identification of recovered root samples, the roots of the T2 Bay and the nearby shrub and Ivy growth of SG2 are also likely to be present below foundation level in proximity to the area of movement/damage and influencing soil moisture and volumes. T6 Sycamore may also pose a degree of influence; however this is not clear or quantifiable while the higher moisture demanding larger T1 Oak remains in situ.

View of SG2 group adjacent to left hand flank

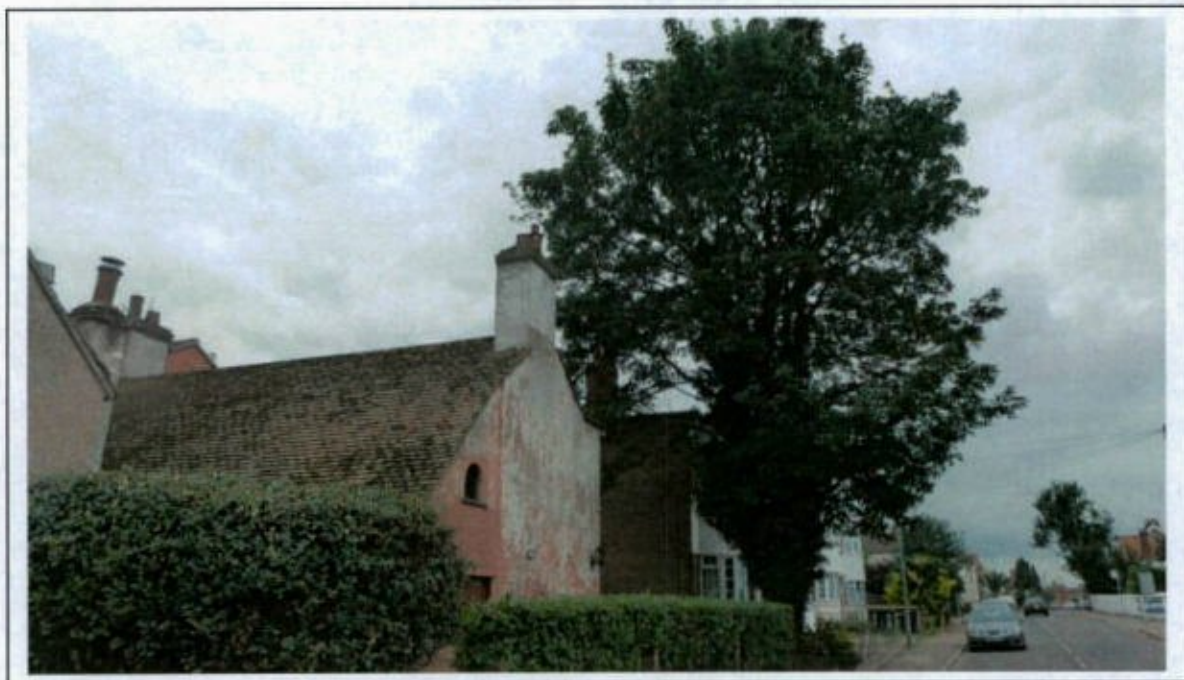
View of T6 Sycamore

T6	Sycamore	15.0	700 *	12.0	4.5	Younger than Property	Policy Holder
Management history		No significant past management noted.					
Recommendation		No works required at present (subject to review if movement persists).					
T7	Oak	14.0	700 *	12.0	18.4	Younger than Property	Third Party 365-371 Old Road CO15 3RJ
Management history		No significant past management noted.					
Recommendation		No works required at present (subject to review if movement persists).
