Issue date: 06/11/2021

Monitoring visit 5 of tbc

Monitoring Plus Report

Owners name	Mrs. F. Kelman	Suspected reason	to be advised	Monitoring type	levels & cracks
Address	14 Buckfast Avenue Kirby Cross Frinton-on-Sea Essex CO13 0PU	Principal area of damage	to be advised	Installed	06/11/2020
		Damage category	to be advised	Frequency (weeks)	8.7
		Surface geology	to be advised	Completion date	tbc
				Status	open
Comment		Feedback from last visit	no feedback for this visit		
Max movement	8.5 mm				
Focal area	Pts 4, 5, 9, 10,				
	no comment for this visit				
		Sketch showing location of monitoring points	<p>Front Elevation</p>

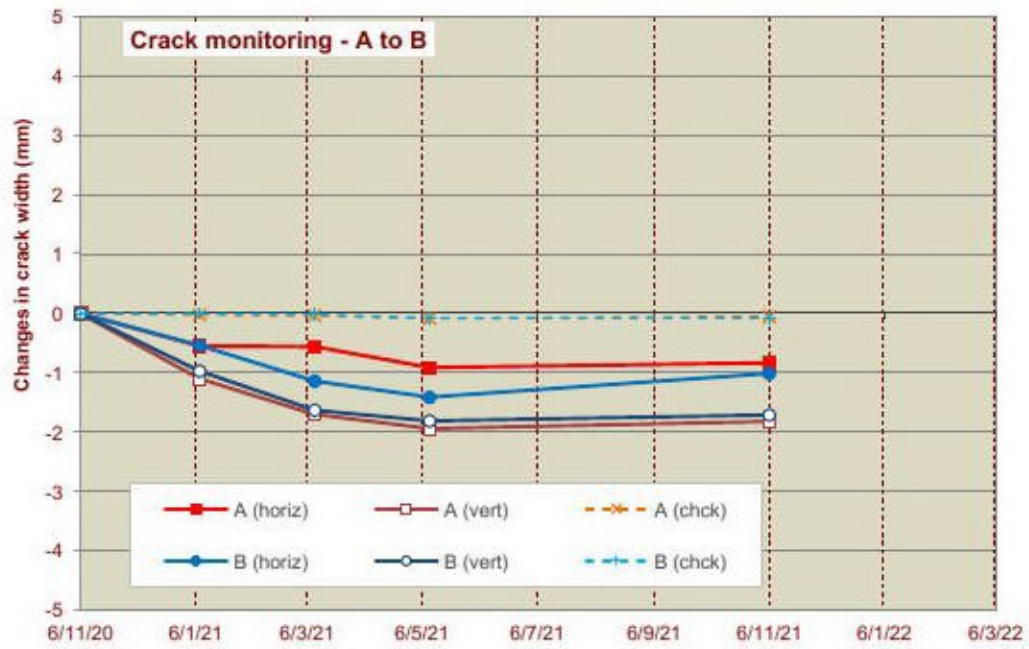
Crack monitoring

A (horiz)	External Crack to rear wall
B (horiz)	External Crack to right-hand wall at rear
