ARBORICULTURAL SURVEY
14 Buckfast Avenue
Kirby Cross
Frinton-on-Sea
Essex
CO13 0PU

360 Globalnet
on behalf of DLG-SN-20-002040

16409/AJB

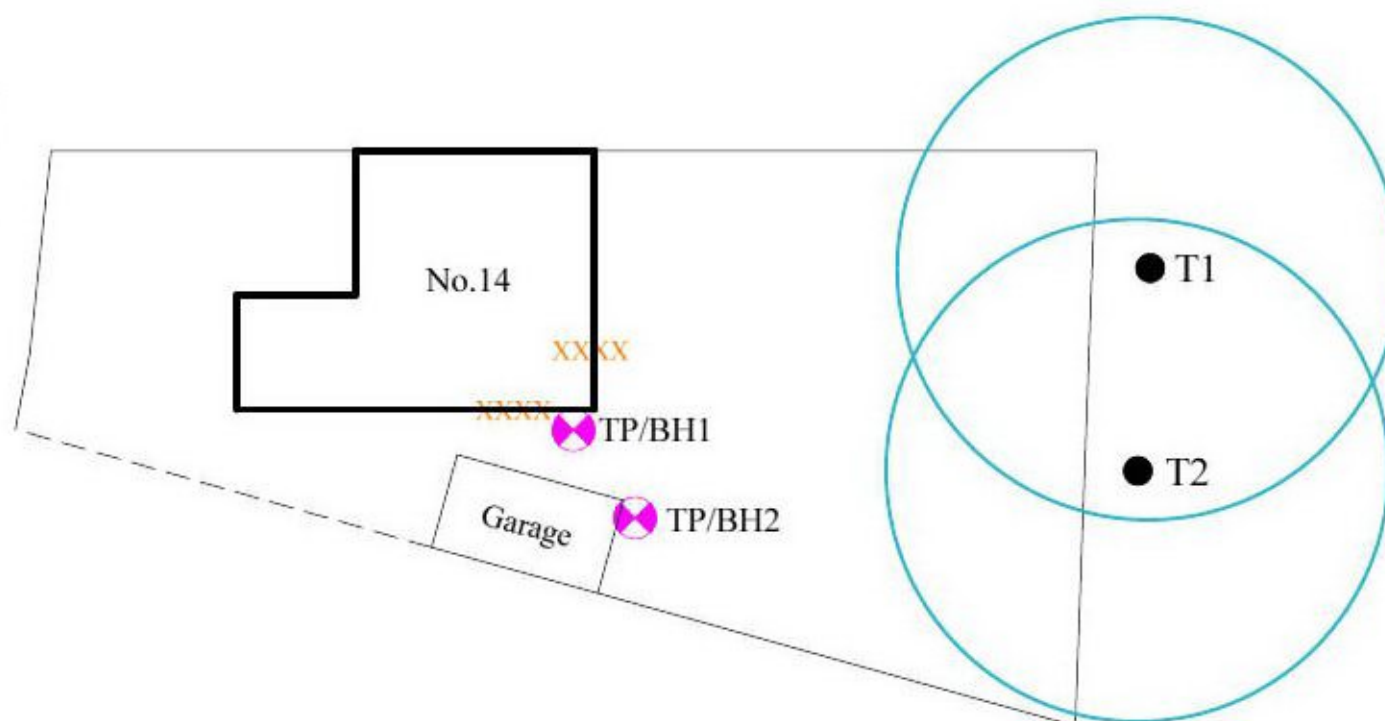
Appendix 5: Site Plan

- 6.1 We have been informed by our client that the damage observed at the property is due to clay shrinkage caused by vegetation.
- 6.2 Whilst tree roots were found in the drainage system, no tree roots were encountered at/below foundation level within Trial Holes 1 and 2. Whilst **T1** and **T2** are high water demand trees which are considered to be within influencing distance of the subject property, they cannot be directly implicated as the cause of the damage.

- 6.3 We do consider the vegetation identified as **T1** and **T2** to be of possible future concern to the subject property. We have therefore recommended that **T1** and **T2** be maintained at their current height and spread over the forthcoming years. These works are only recommended as a precaution and are not considered a priority to resolve the damage observed at the subject property.

Item	Species	Recommended Action	Location	Planning Restriction
T1	English Oak	Maintain at current height and spread over the forthcoming years.	Ownership unknown	Unknown
T2	English Oak	Maintain at current height and spread over the forthcoming years.	Ownership unknown	Unknown
