Monitoring Visit: 3 of 4

Monitoring Plus Report

Owners name	Mrs. F. Kelman	Suspected cause	To be advised	Monitoring type	Levels & Cracks
Address	14 Buckfast Avenue Kirby Cross Frinton-on-Sea Essex CO13 0PU	Principal area of damage	To be advised	Installed	06/11/2020
		Damage category	To be advised	No of visits / weeks	4 @ 8.7
Home phone		Surface geology	To be advised	Completion date	
Work phone		Feedback from last visit		Status	open
Correspondence address		0			
Comment		Sketch showing location of monitoring points			
Max movement	7.2	<p>Front Elevation</p>			
Focal area					
0

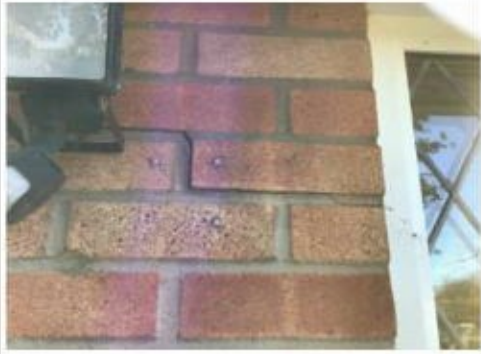
Crack A

A (horiz)	External Crack to rear wall
B (horiz)	External Crack to right-hand wall at rear
