Engineers Report

Risk Address 14 Buckfast Avenue
Kirby Cross
Frinton-on-Sea
Essex
CO13 0PU

360 Reference DLG-SN-20-002040
Claim Refence 074640111
Policy Holder Mrs. F. Kelman

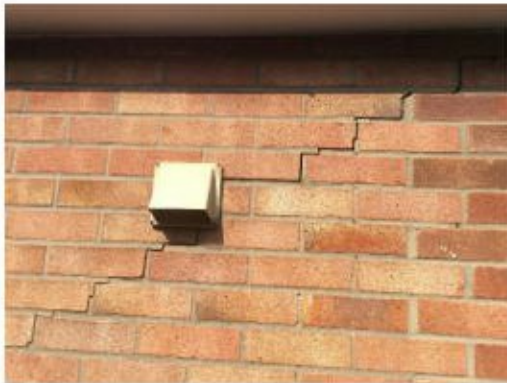
There is a stepped cracking rising up from the rear kitchen door up to eaves level at the corner and the crack then returns around the rear wall down to the kitchen window. The cracking is around 5mm wide.

Stepped Crack to Side Wall

It is common practice to categorise the damage in accordance with B.R.E. Digest 251 "Assessment of Damage in Low-Rise Buildings". In this case, the localised damage to the rear right-hand corner falls into Category 3 "Moderate".

At this stage the damage is localised, and repairs will likely entail crack stitching and re-tiling of the affected walls. A detailed schedule of repairs will be prepared following an assessment by a contractor.

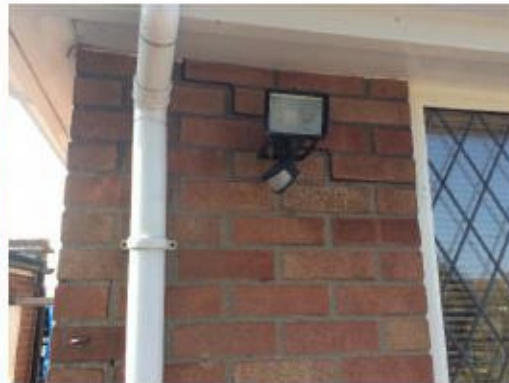
Stepped Crack to Rear Wall

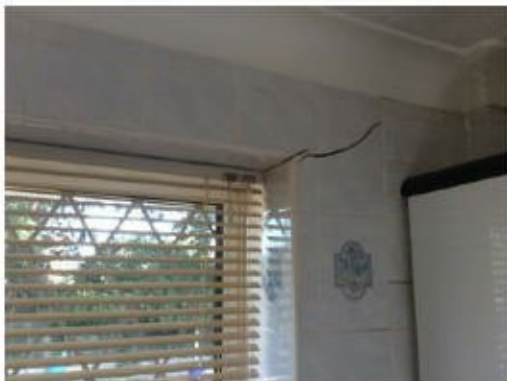
There is cracking through the wall tiling above the rear of the external door and this is also evident below the adjacent wall unit. Cracking extends through the wall tiles and along the ceiling junction to the rear wall, where significant cracking is evident through the wall tiling down to the window frame. The cracking is around 8mm wide.

Cracked Tiling Above Rear Window

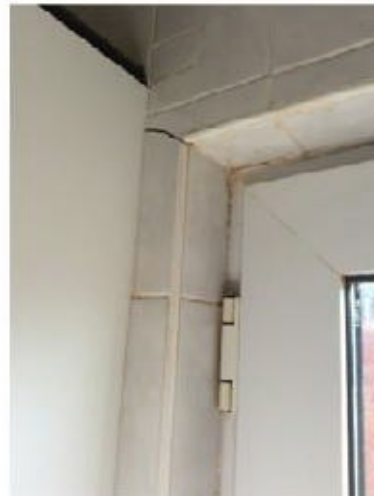
Cracked Tiling Above Rear Door

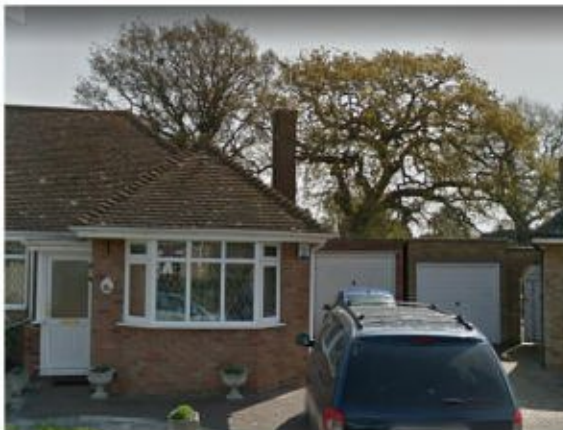
There are two mature Oak trees in the public footpath at the rear, close to the boundary. These are estimated to be 14 metres away and 15 metres tall. It is understood that the Local Authority deny ownership of the trees.

The cause of the subsidence is almost certainly clay shrinkage due to the moisture demand of the surrounding vegetation, notably the Oak trees to the rear. The property is built off a shrinkable clay soil and the last three years have been extremely dry, and this leads to a progressive drying of the sub-soil, causing the tree roots to extend further to obtain moisture and desiccating the clay over a wider area. This has now been sufficient to cause some movement to the right-hand side of the property.

Movement due to clay shrinkage is not progressive and movement will cease as the clay rehydrates over the winter and spring. However, unless the moisture demand of the vegetation is reduced, further movement will occur following the next period of prolonged, dry weather. It will therefore be necessary to remove, or at least reduce, the Oak trees. The ownership of the trees is unclear as the Local Authority have previously denied ownership when the insured has requested tree management to improve light etc. Ownership will need to be clarified before any tree management can be undertaken. If no owner is found then there is a legal process that can be followed to arrange removal.

An arborist will be instructed to review all of the vegetation and make recommendations for tree management. Level monitoring will also be required in order to provide the level of evidence require to obtain tree removal or reduction. Ultimately if tree works are not permitted then a root barrier or underpinning may be needed.
