Title: BS5837 Tree Report

Site: Sidcup Library
Hadlow Road
Sidcup
Kent
DA14 4AQ

Client: Hill-Wood & Co. (Kent) Limited

Survey Date: 8th July, 2021

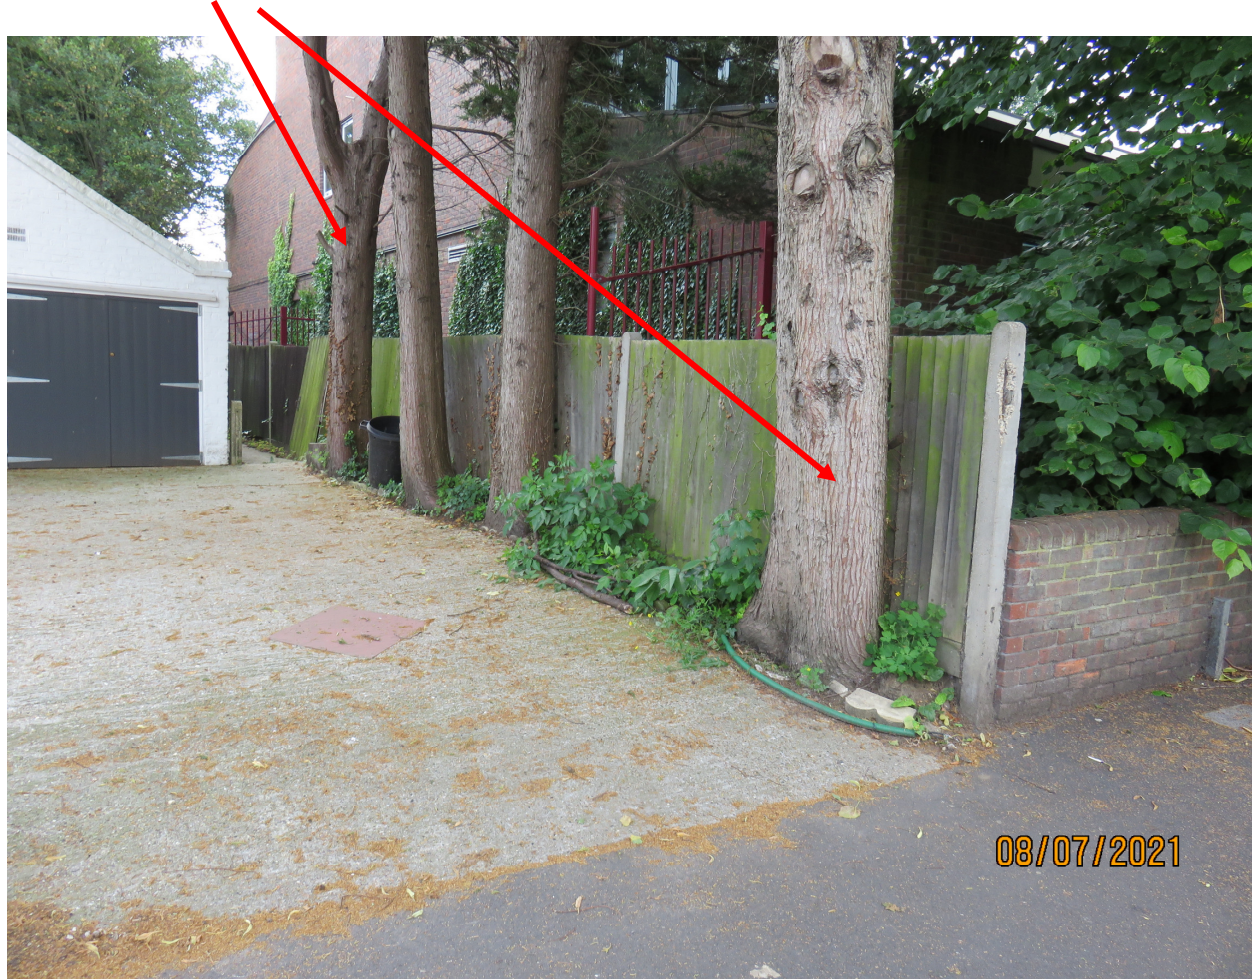
T2	Leylandii	16	400	1	1	4	1	1	10	M	Fair.	Poor. Neighbour's tree. Previously suppressed to south east and north west by tree that has been removed. Poor buttress development due to constrained rooting environment from adjacent concrete drive. Leverage from height of tree and continuing large growth potential and poor buttress development suggest a relatively high risk of failure in high winds within the next 10 years. Previous crown lifting has removed low and medium height screening benefits. Stem very close to boundary pavement.	Inform Neighbour of condition of tree and negotiate to reduce height of trees by 3 – 4 metres and radial width by 1 -2 metres or remove.	>10	U	4.8

T4	Leylandii	16	500	1	5	5	1	1	2.5	M	Fair.	Poor. Neighbour's tree. Previously suppressed to south east by tree that has been removed. Poor buttress development due to constrained rooting environment from adjacent concrete drive. Leverage from height of tree and continuing large growth potential and poor buttress development suggest a relatively high risk of failure in high winds within the next 10 years. Previous crown lifting has removed low and medium height screening benefits. Stem very close to boundary pavement.	Inform Neighbour of condition of tree and negotiate to reduce height of trees by 3 – 4 metres and radial width by 1 -2 metres or remove.	>10	U	4.8

Photograph 1: T1-T4: Poor buttress development

- 1.2 There will be negotiations to remove 1 No. U category tree (T19) and to reduce the size of 4No. U category trees (T1-T4) outside the site boundaries. **Mitigation: Due to their poor quality or the damage they are likely to cause in the next ten years these trees are likely to have been removed or require tree surgery irrespective of development.**

T4	Leylandii	16	500	1	5	5	1	1	2.5	M	Inform Neighbour of condition of tree and negotiate to reduce height of trees by 3 – 4 metres and radial width by 1 -2 metres or remove.	As previous column	
T5	Lime	16	400	1	3	5	5	2	4	M	Monitor damage to boundary wall.	As previous column and re-pollard to previous points at approximate height of 4m.

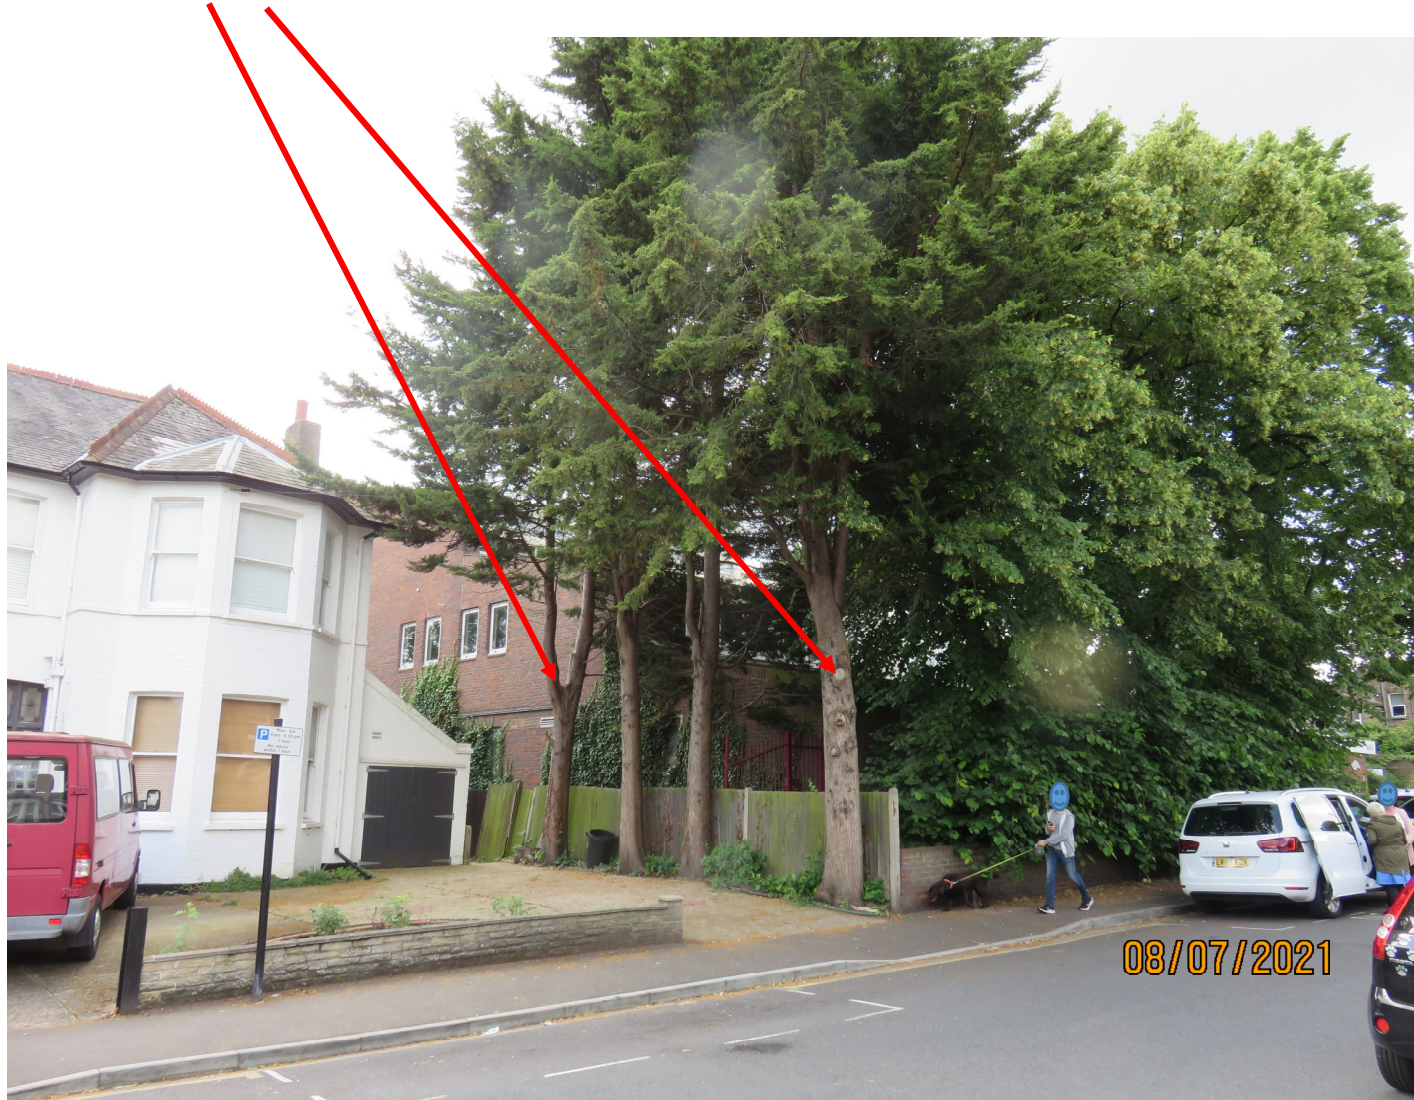
Photograph 2: T1- T4: Long lever arms above poor buttress development.

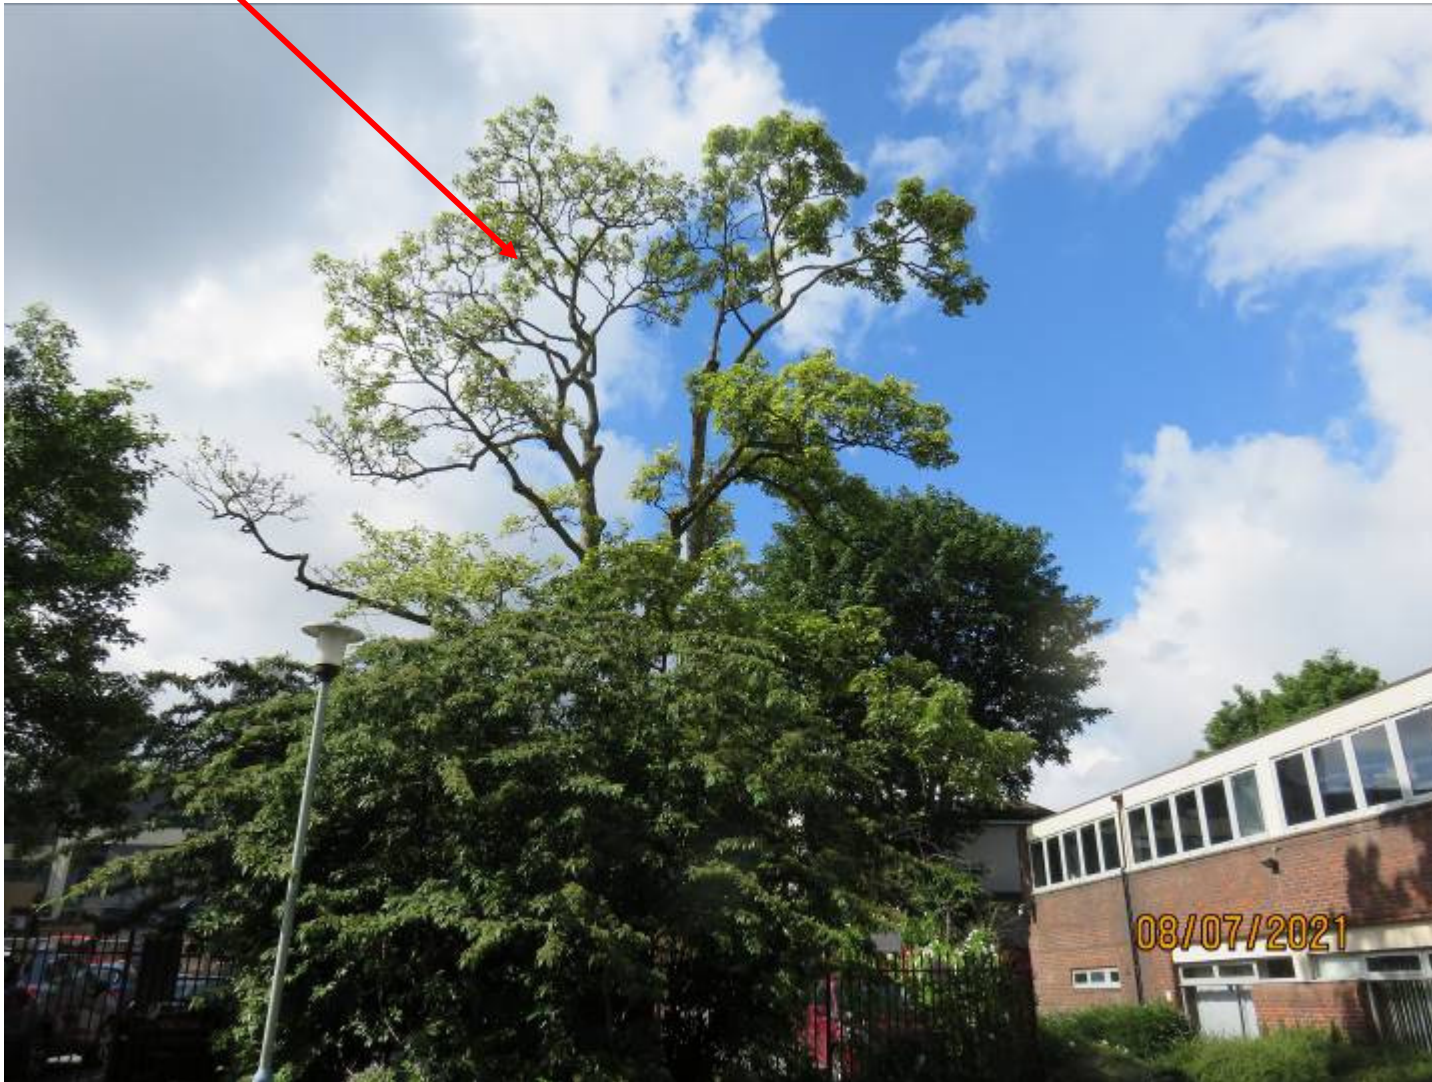
removal or consult the Local Authority concerning the Miscellaneous Provisions Act 1976 that can be used to ensure that the tree is made safe at the tree landowners eventual cost. T1-T4 and T19 are approaching this condition and it would be prudent to consider informing the owner of the trees and negotiating their removal or making relatively safe irrespective of development.

Photograph 3: T19: Poor condition and vigour

4.2 Confirm whether U category tree T19 will be removed and reduction recommendations will be carried out in relation to T1-T4 with tree owners
