Heritage Impact Assessment for St Erney House, St Erney, Cornwall,
PL12 5EZ

The proposed method to be used for further repair work and restoration of St Erney House.

Dated: August 2021

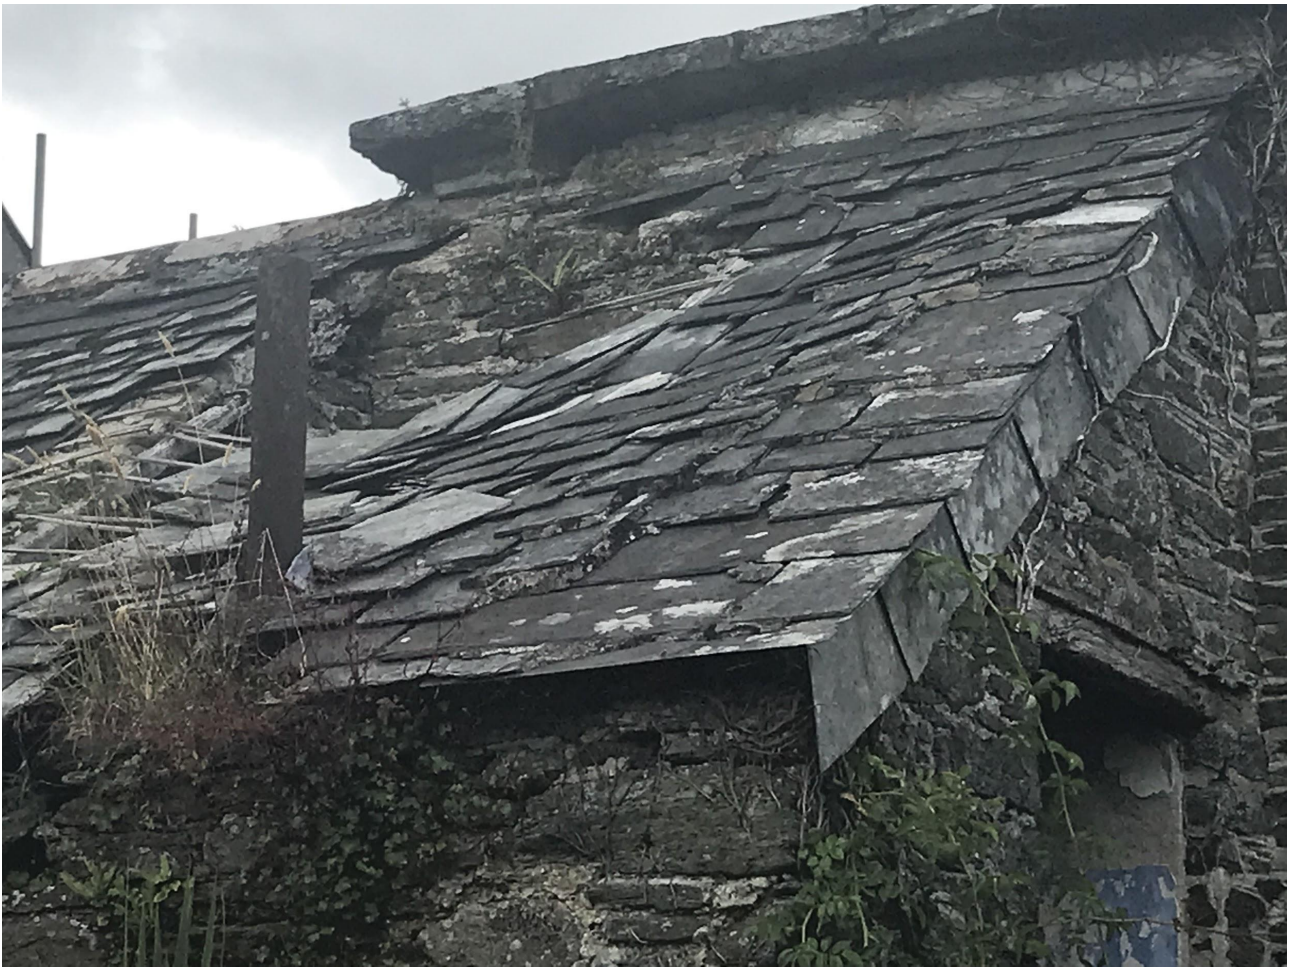
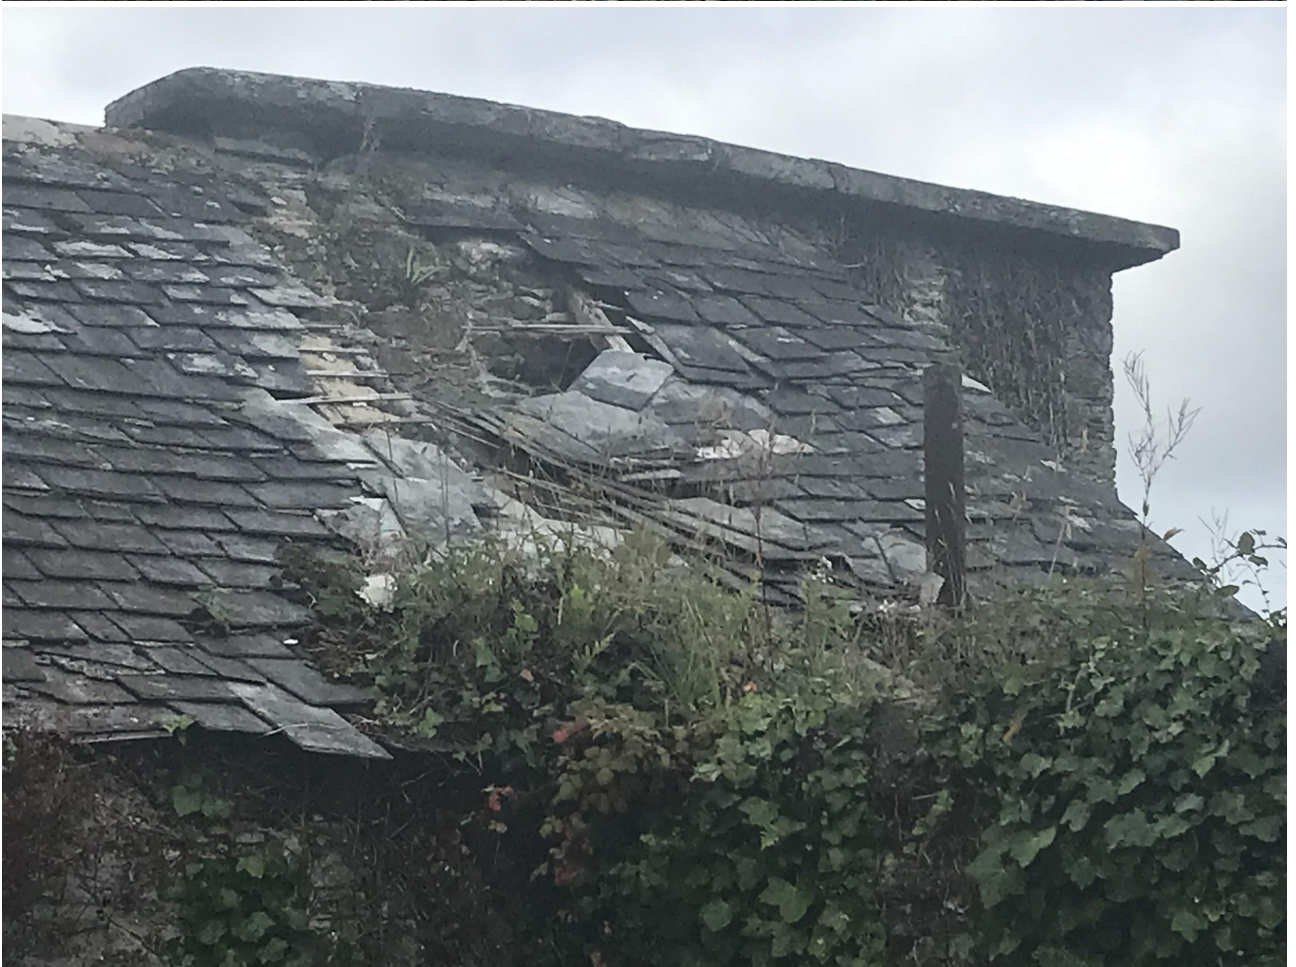
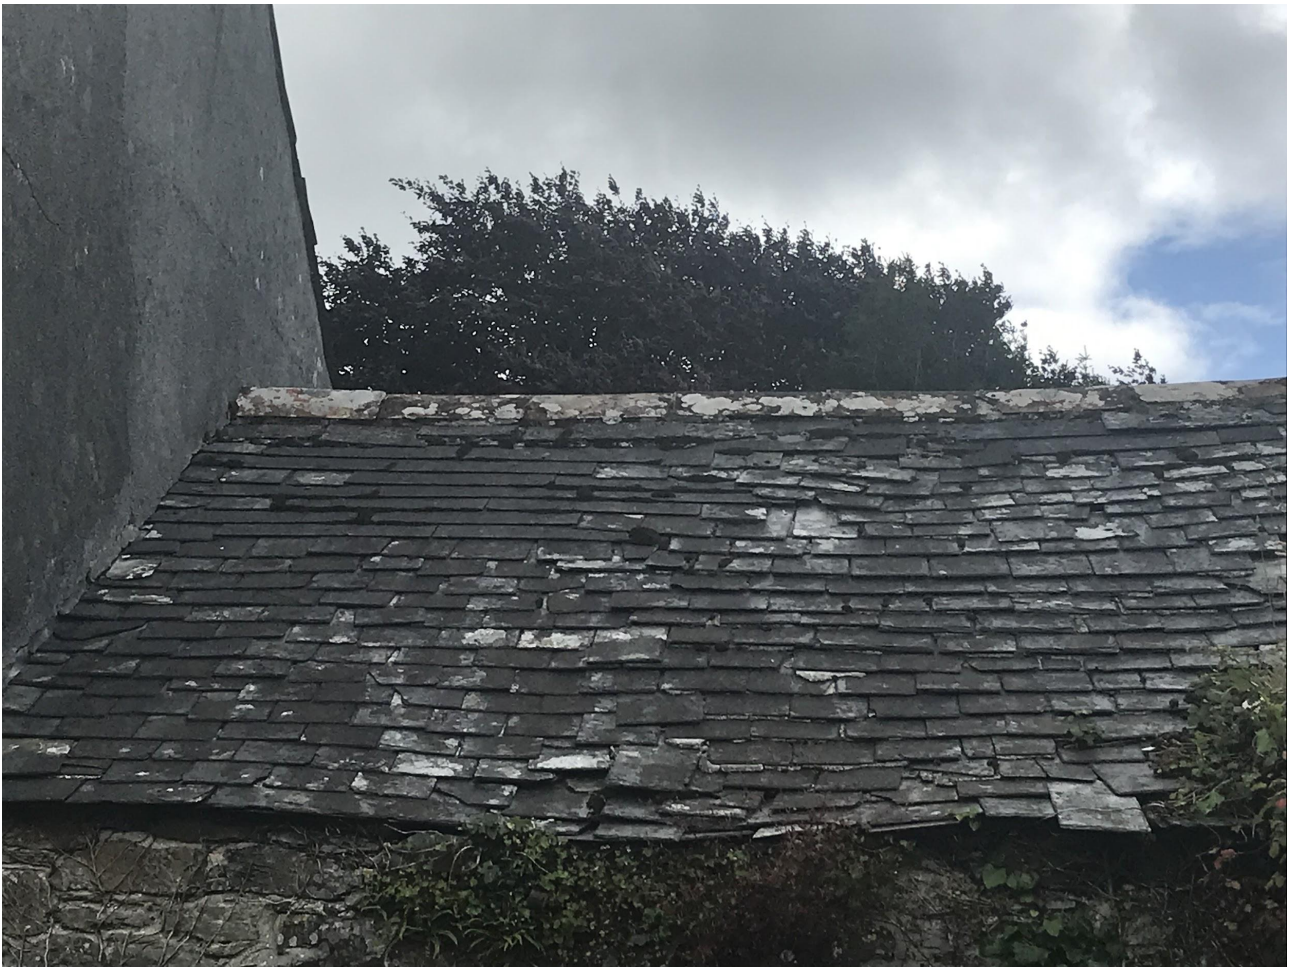
-The outside privy and shed alongside.(Location 1)

Up until five years ago the privy was completely concealed by heavy vegetation. As can be seen from the photo below, the roof collapsed many years ago and the slate area alongside (over an open store) is in a very poor condition.

Area to be restored:

The proposed repair work consists of taking off all the roof covering in this area. The natural slate will be set aside for re-use and the man made slate on the store south elevation will be disposed of.

New treated softwood timbers will be used to repair the privy roof and the broken window lintel will be replaced with seasoned oak. The stonework above the lintel will be repaired using a hydraulic lime based mortar in conjunction with the original stone.

New treated battens will be placed on top of the new and existing rafters, followed by Delabole natural slates, whilst re-using as many as possible of those previously set aside. No roof felt is proposed in this area, as none would have been used originally.

Roof abutment flashings will be replaced in code 4 lead.

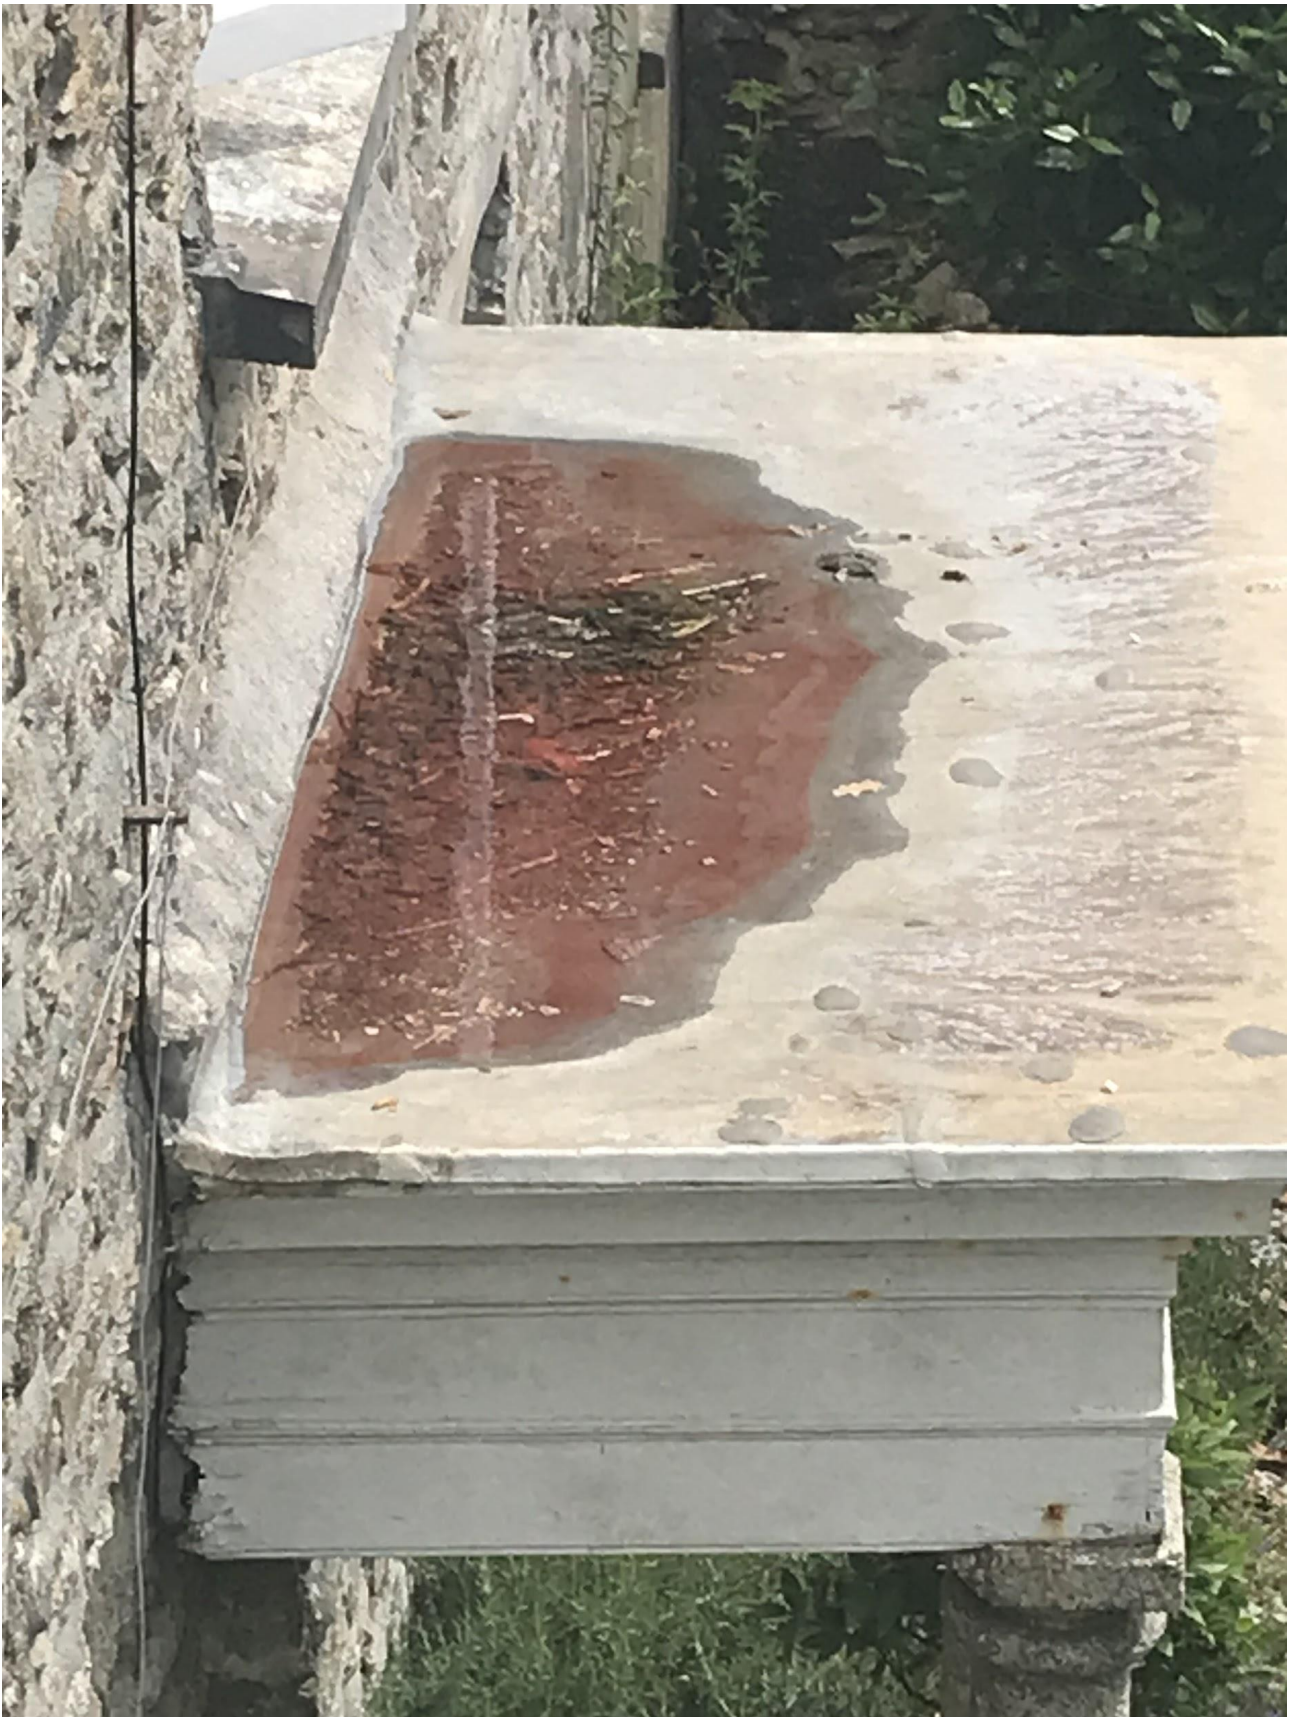
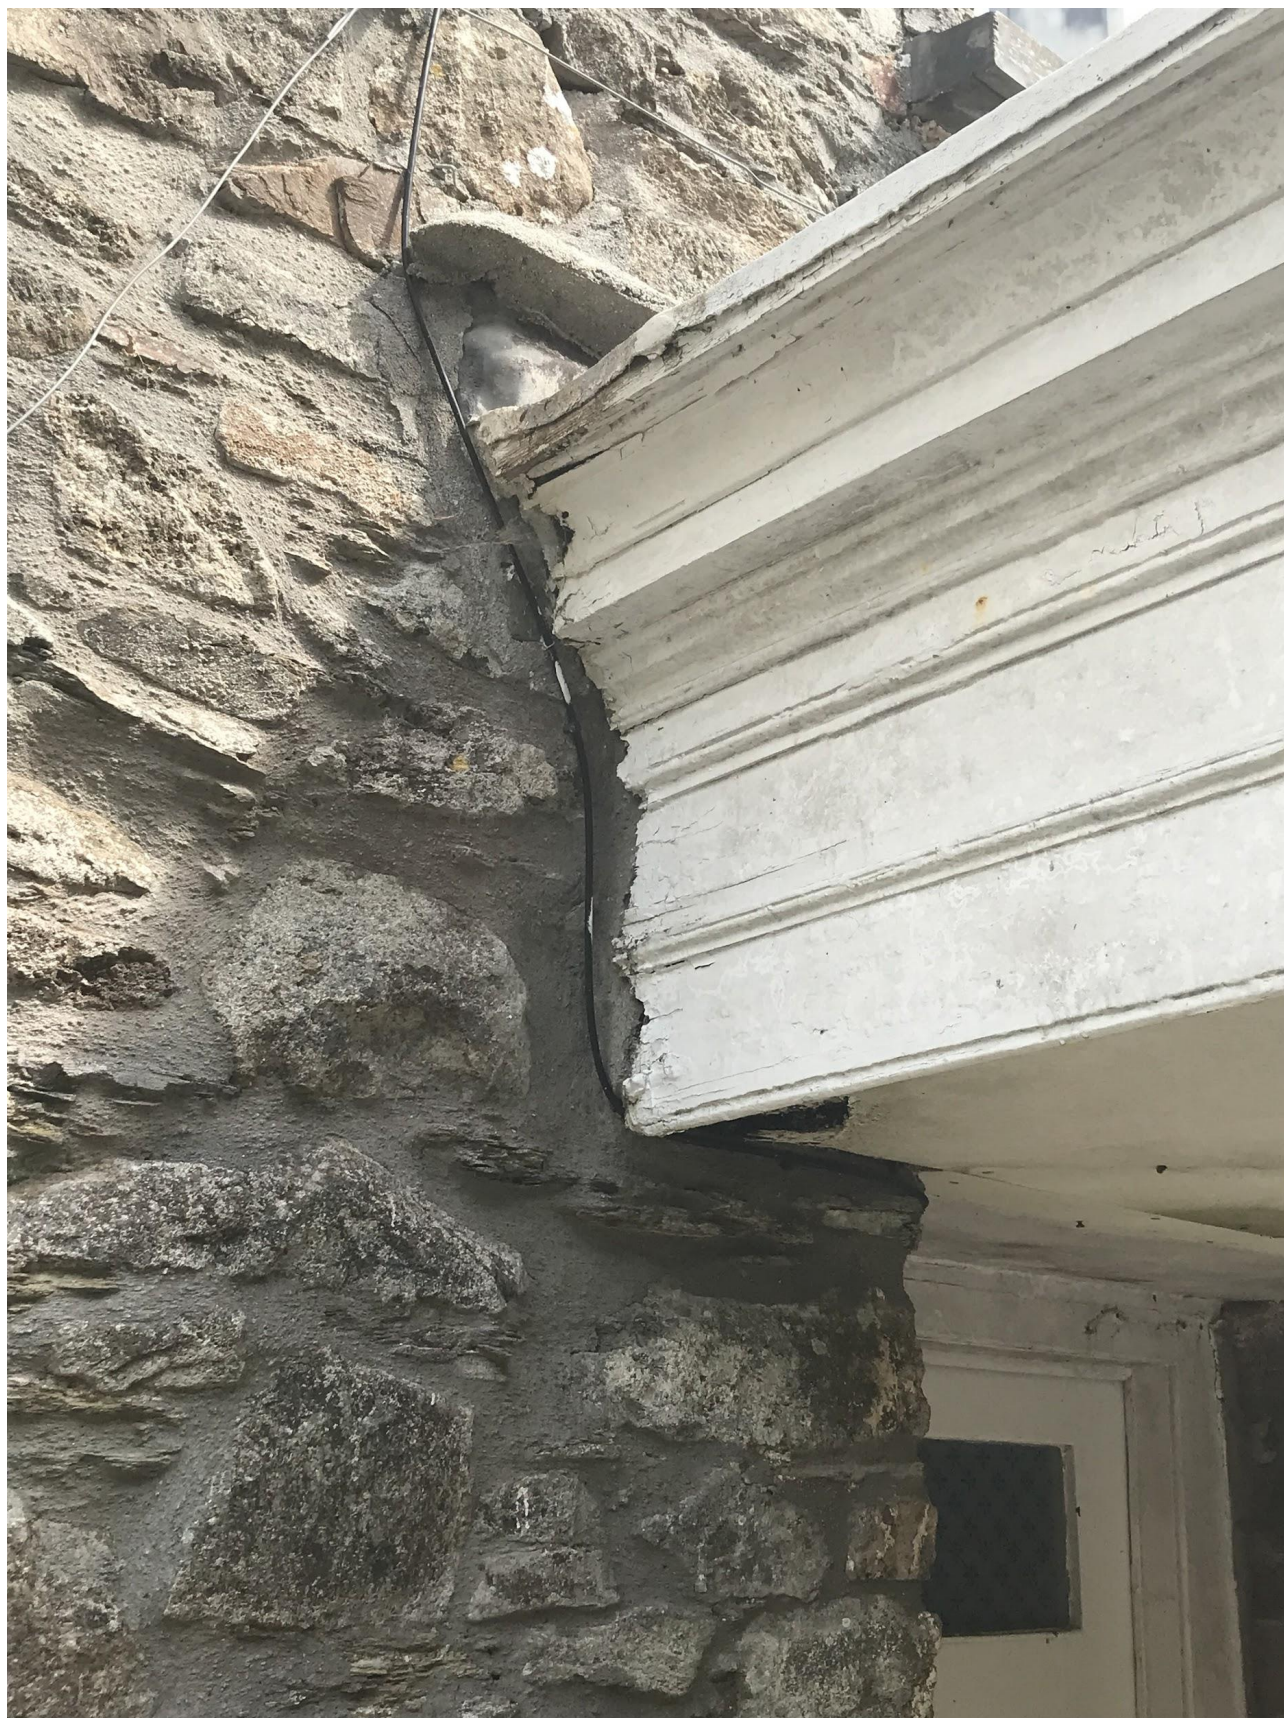
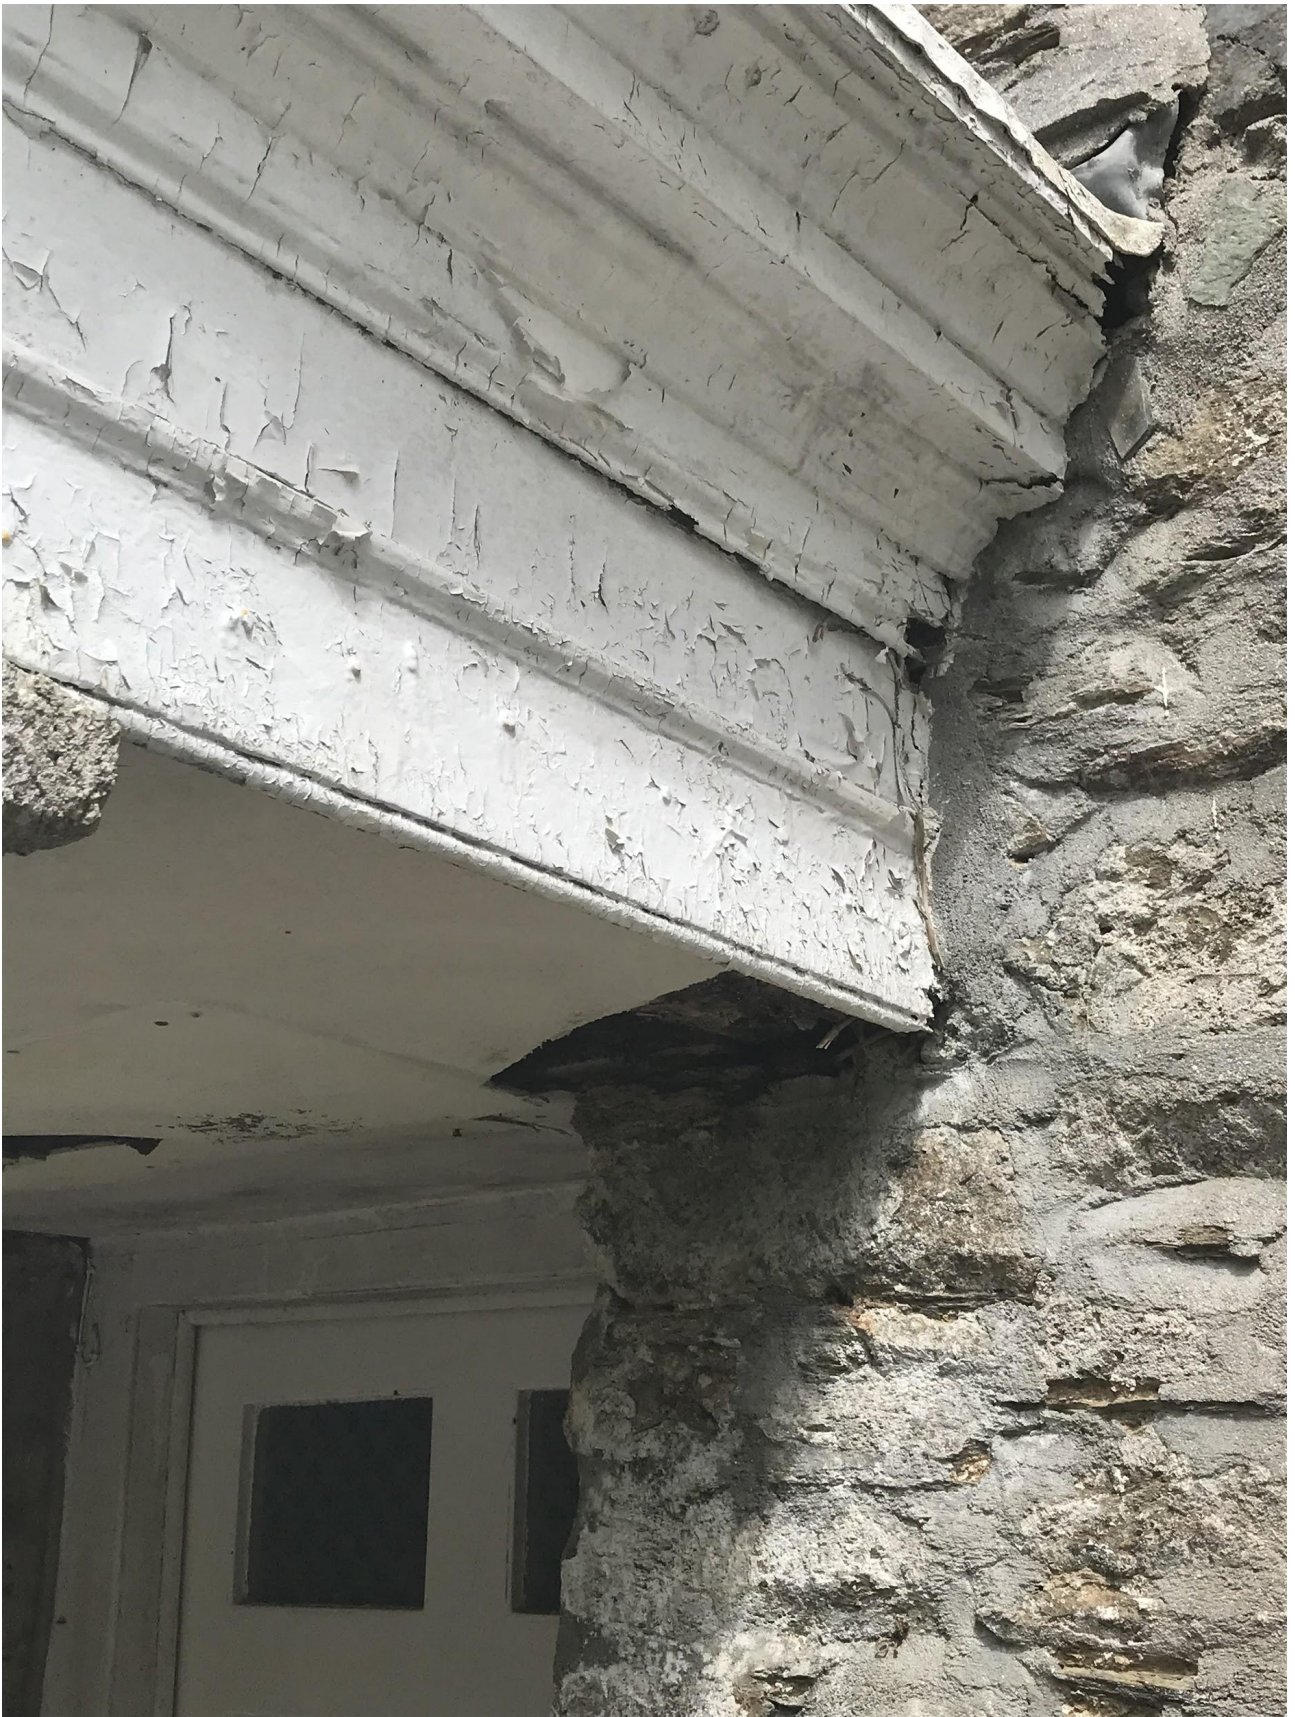
-Exterior front canopy.(Location 2)

The canopy roof to the front of the property is in a very poor condition. The flat roof has dropped back towards the main house wall at some point and this has split the lead covering, water ingress has caused extensive rot to the supporting framework. The underside is lined with an asbestos cement type product. The supporting granite columns are currently unaffected by the damaged roof over.

Images of roof currently, with severe back fall:

The proposed works consist of providing temporary support if needed to the columns so that they remain in place whilst the canopy is restored. This will require the side and front cornice to be copied in treated softwood sections to replicate the original. All flat roof joists will be replaced in treated softwood and the roof realigned to the height of the original flashing. This will then provide an adequate fall to avoid ponding on the surface. The roof will be replaced in code 5 lead on exterior grade ply with a central rolled expansion joint. The lead will have chalk applied to the underside.

The new soffit and sides will be formed in exterior grade ply and be painted white.

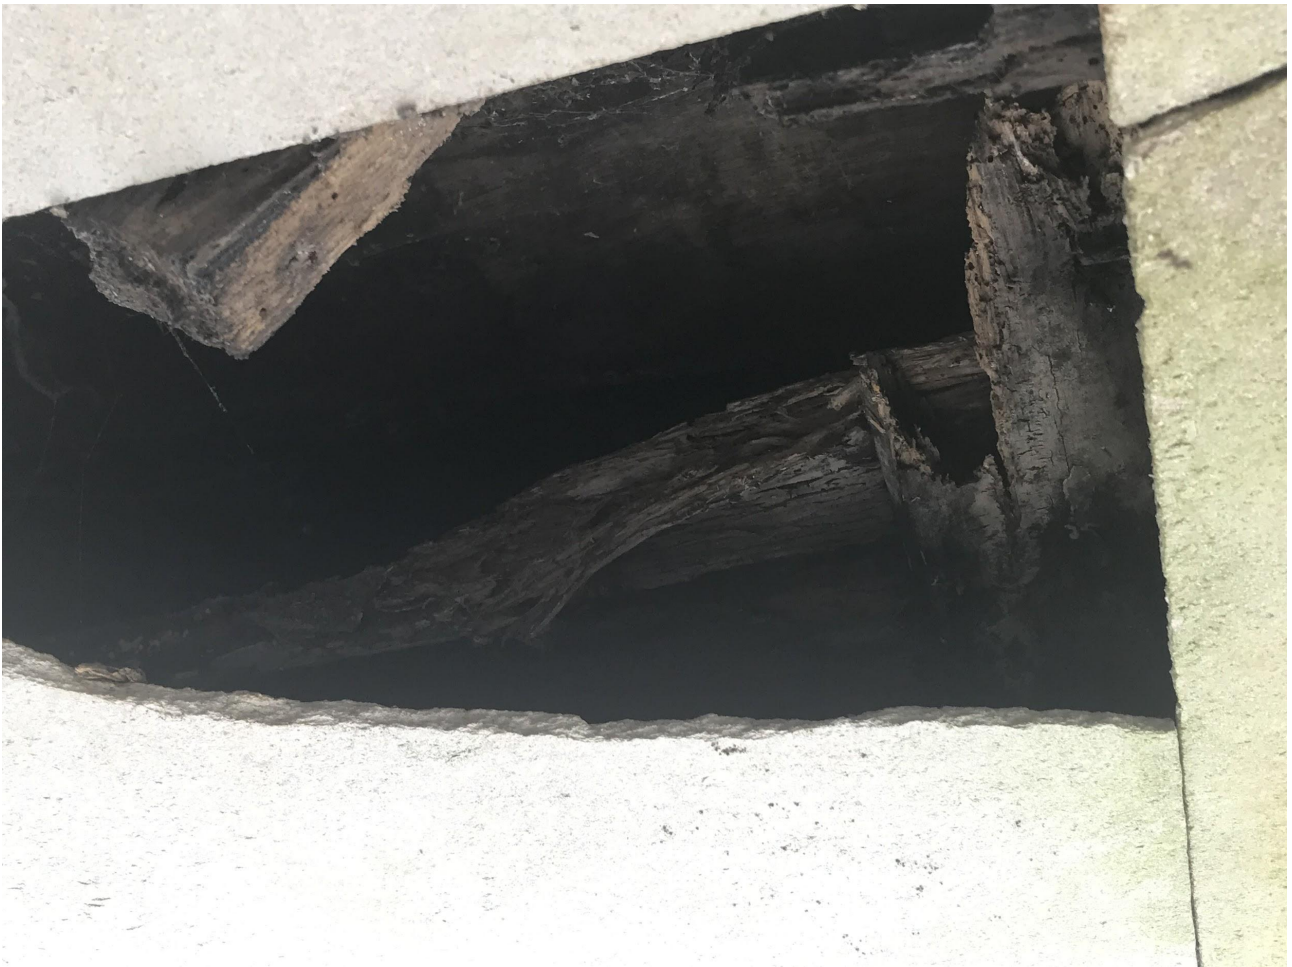
View from underside showing rotting timbers and inappropriate soffit:

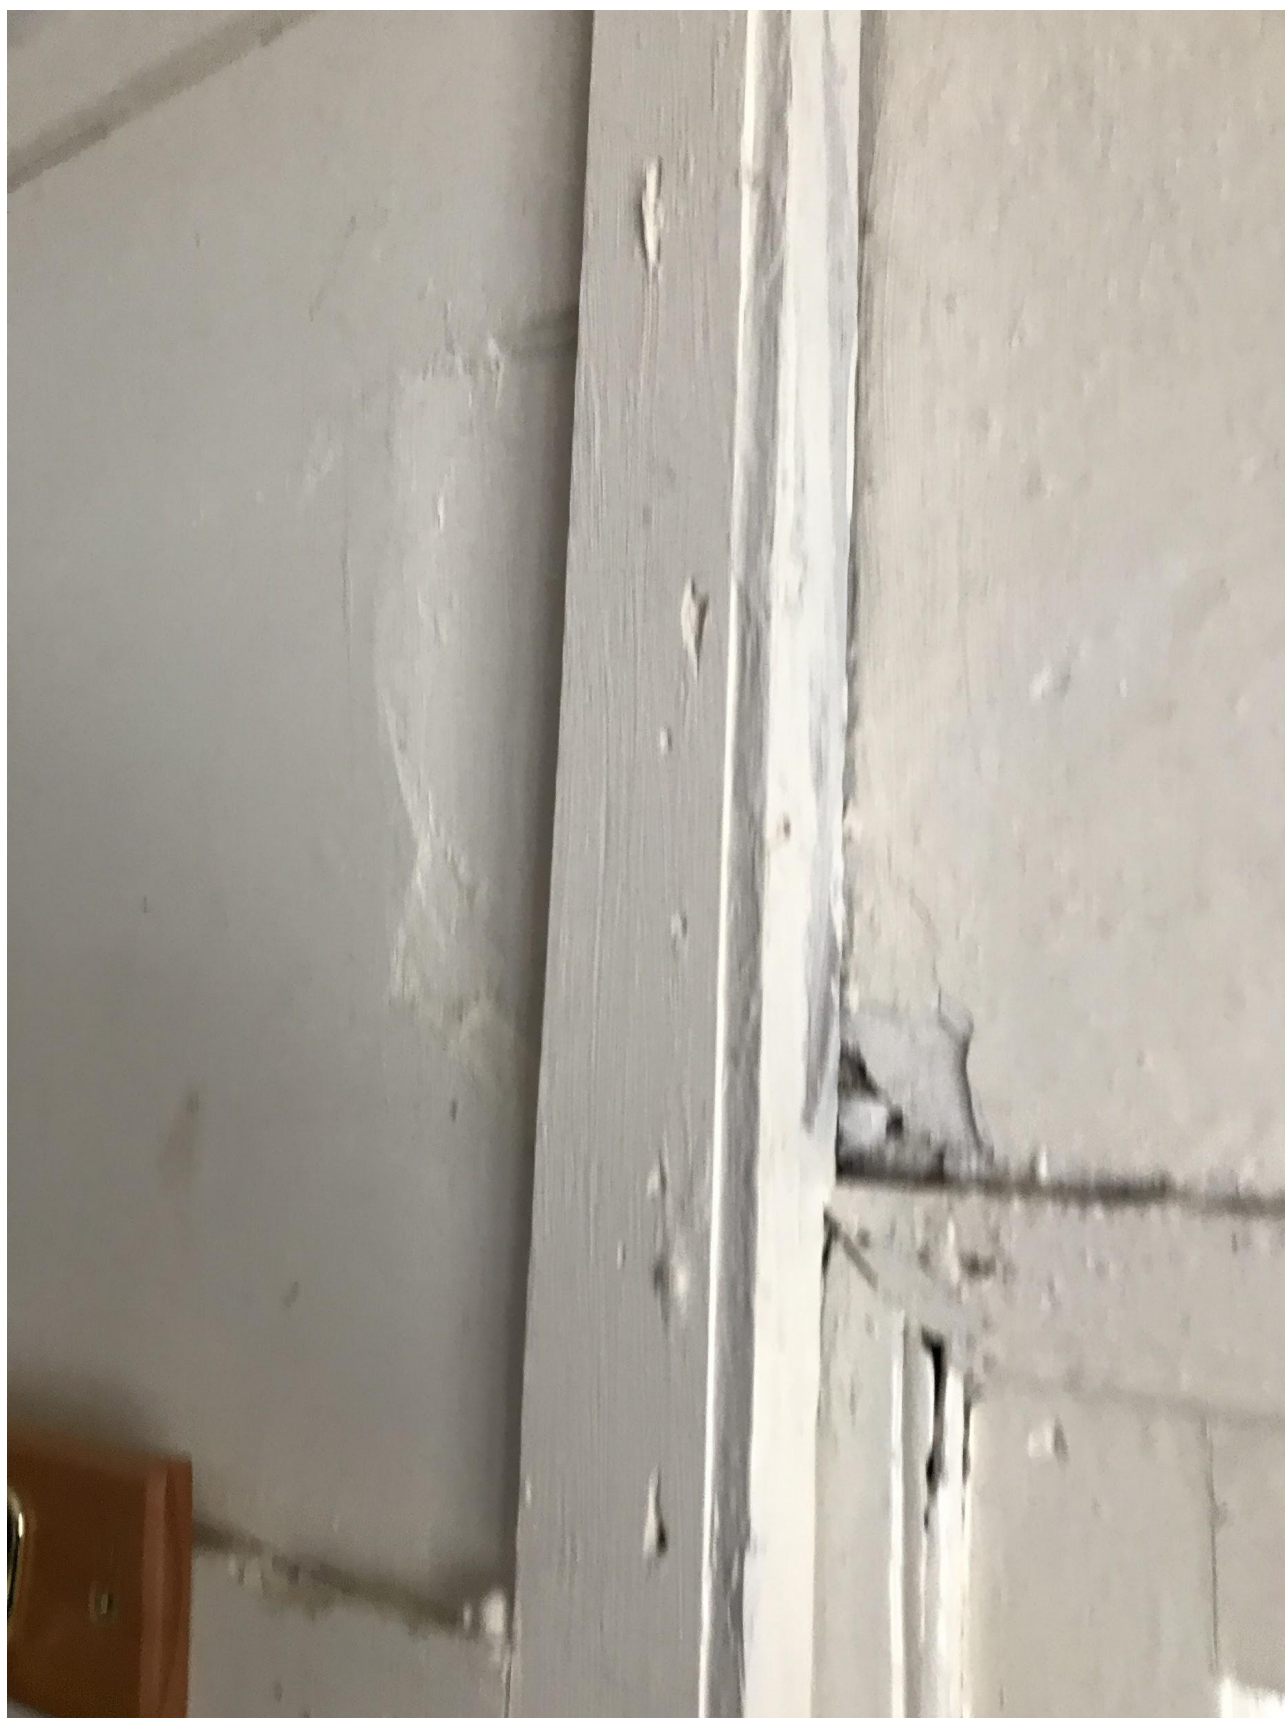
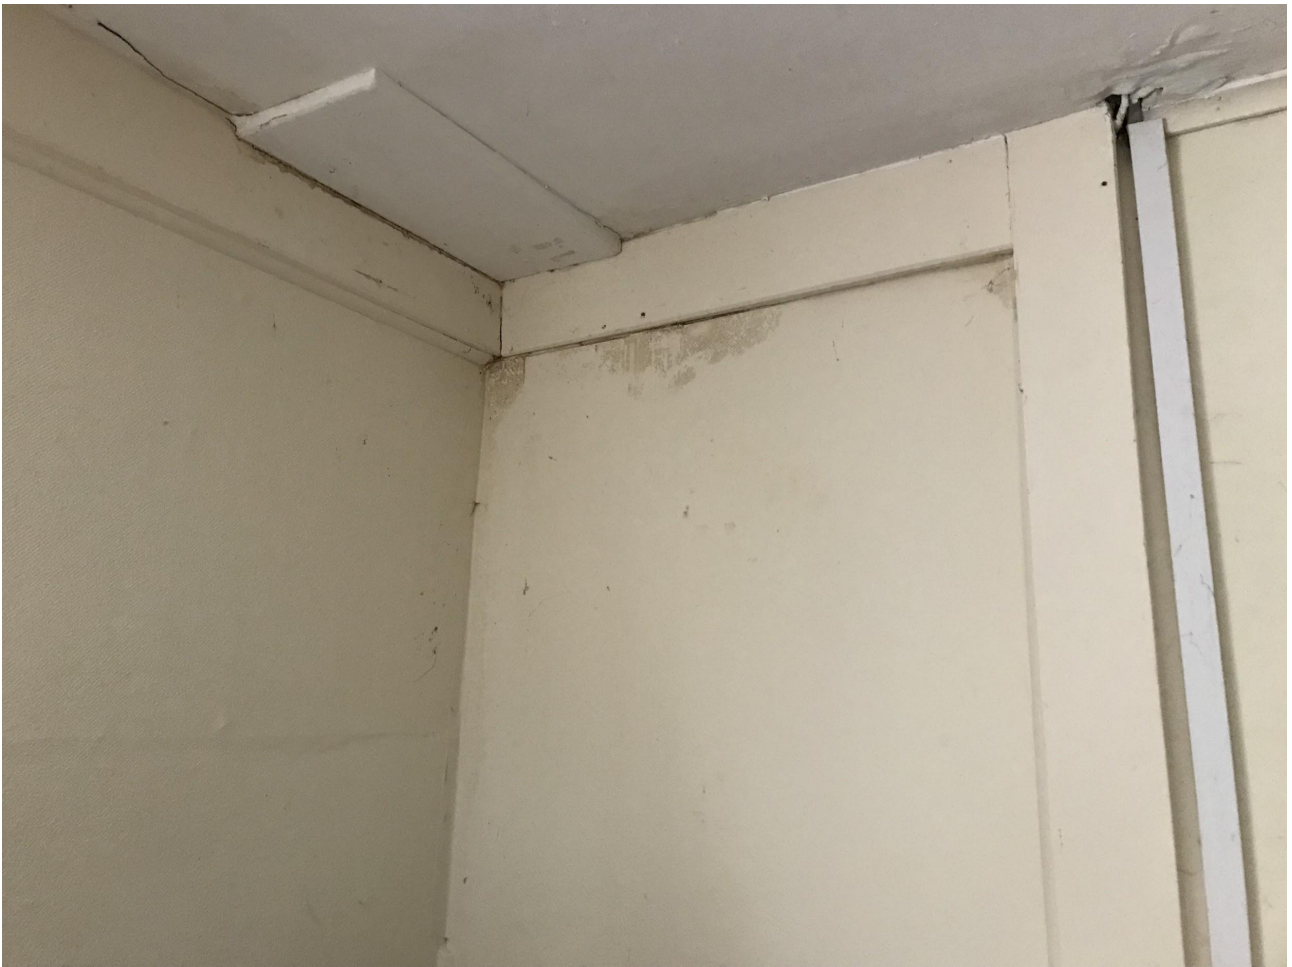
-Rear ground floor room, the old diary. (Location 3)

This area of the house currently suffers from unsympathetic restoration work, possibly intended to hold back damp penetration through the external wall. The walls are generally lined with timber battens, polythene and a fibreboard facing.

Detail views of current finish:

The proposed repair works consist of carefully taking out and setting aside the slate shelves for reuse, then removing all battens, polythene and fibreboard for disposal. The existing stone walls will then be carefully cleaned of any remaining fixings and other 20th century interventions. The walls will then be lined with Newton 803 or equivalent, fixed in accordance with the manufacturer's instructions, followed by lime plaster in three layers of diminishing strength. This is a similar proposal to the work previously undertaken in the lounge under approval reference PA16/5325

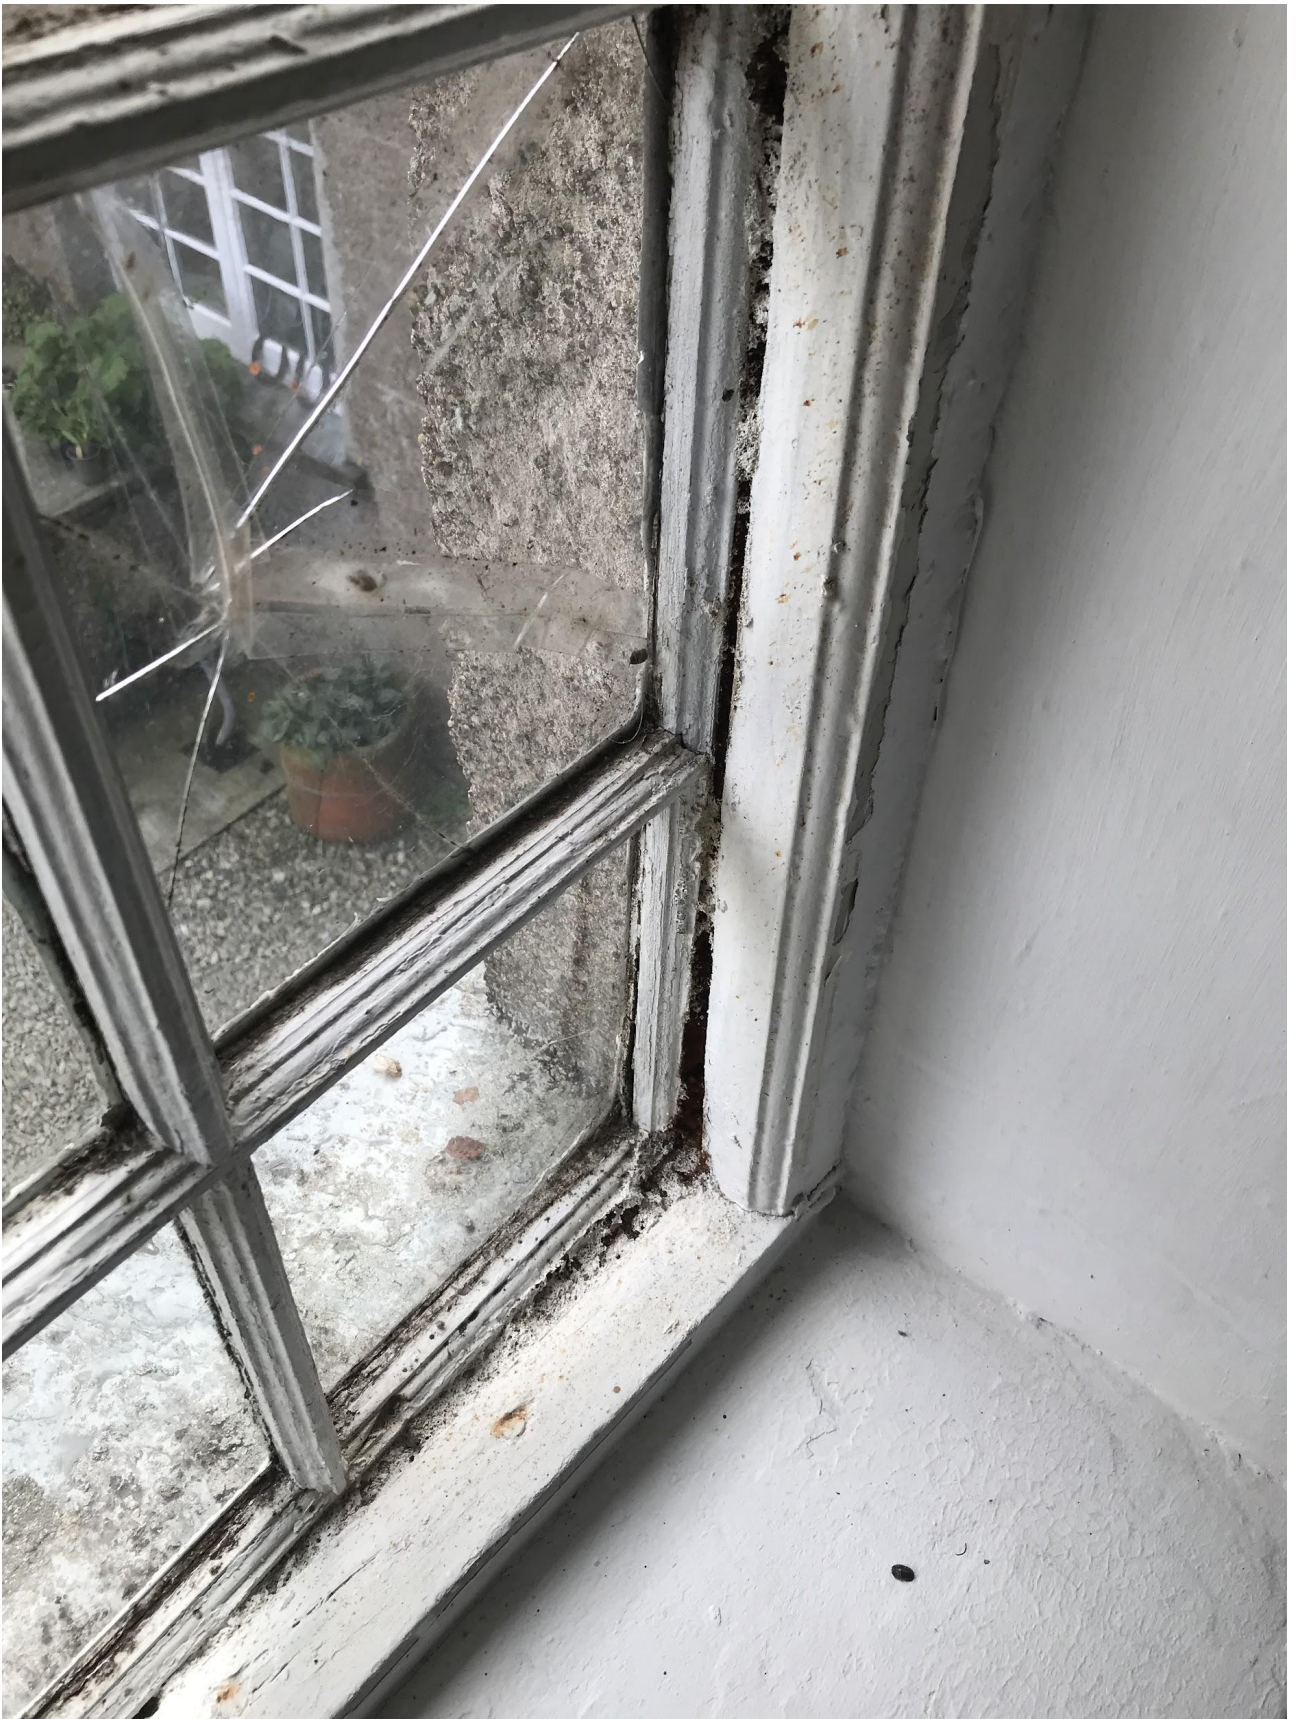
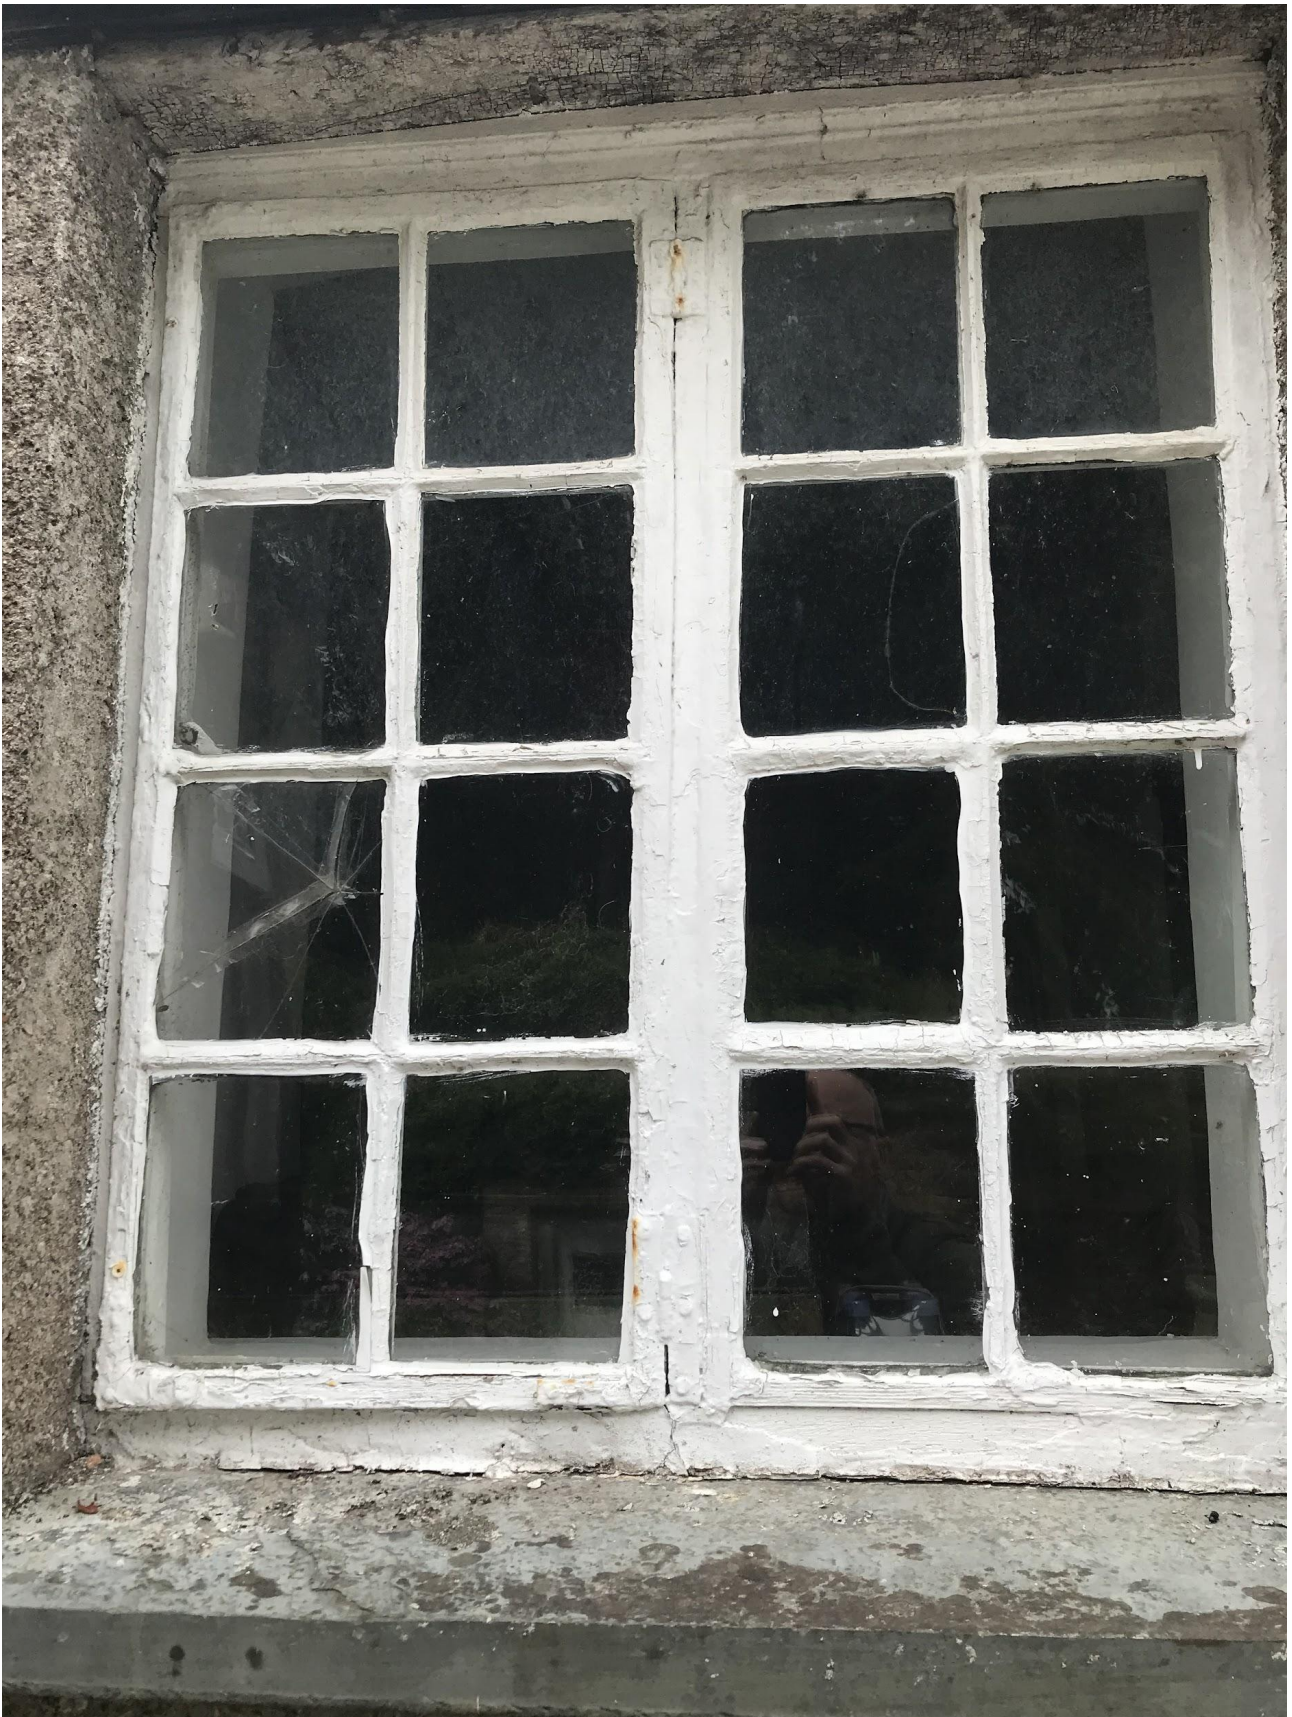
Images of window to bedroom 4 (location 4A):

These windows are suffering from rot and have clearly not been openable for many years. The first serves the rear bathroom (rear north elevation) and the second the rear bedroom 4 window (east elevation). The location of both is marked on the submitted floor plans.

The proposed work is to install two new opening screen casements formed in Iroko hardwood and glazed in 4mm single clear float glass. Profile and elevation of replacements to be copied off originals and manufactured to match. The opening casements to bedroom 4 will be hinged off the centre mullion as the original does.
