Heritage Impact Assessment for St Erney House, St Erney, Cornwall,
PL12 5EZ

The proposed method to be used for further repair work and restoration of St Erney House.

Dated: August 2021

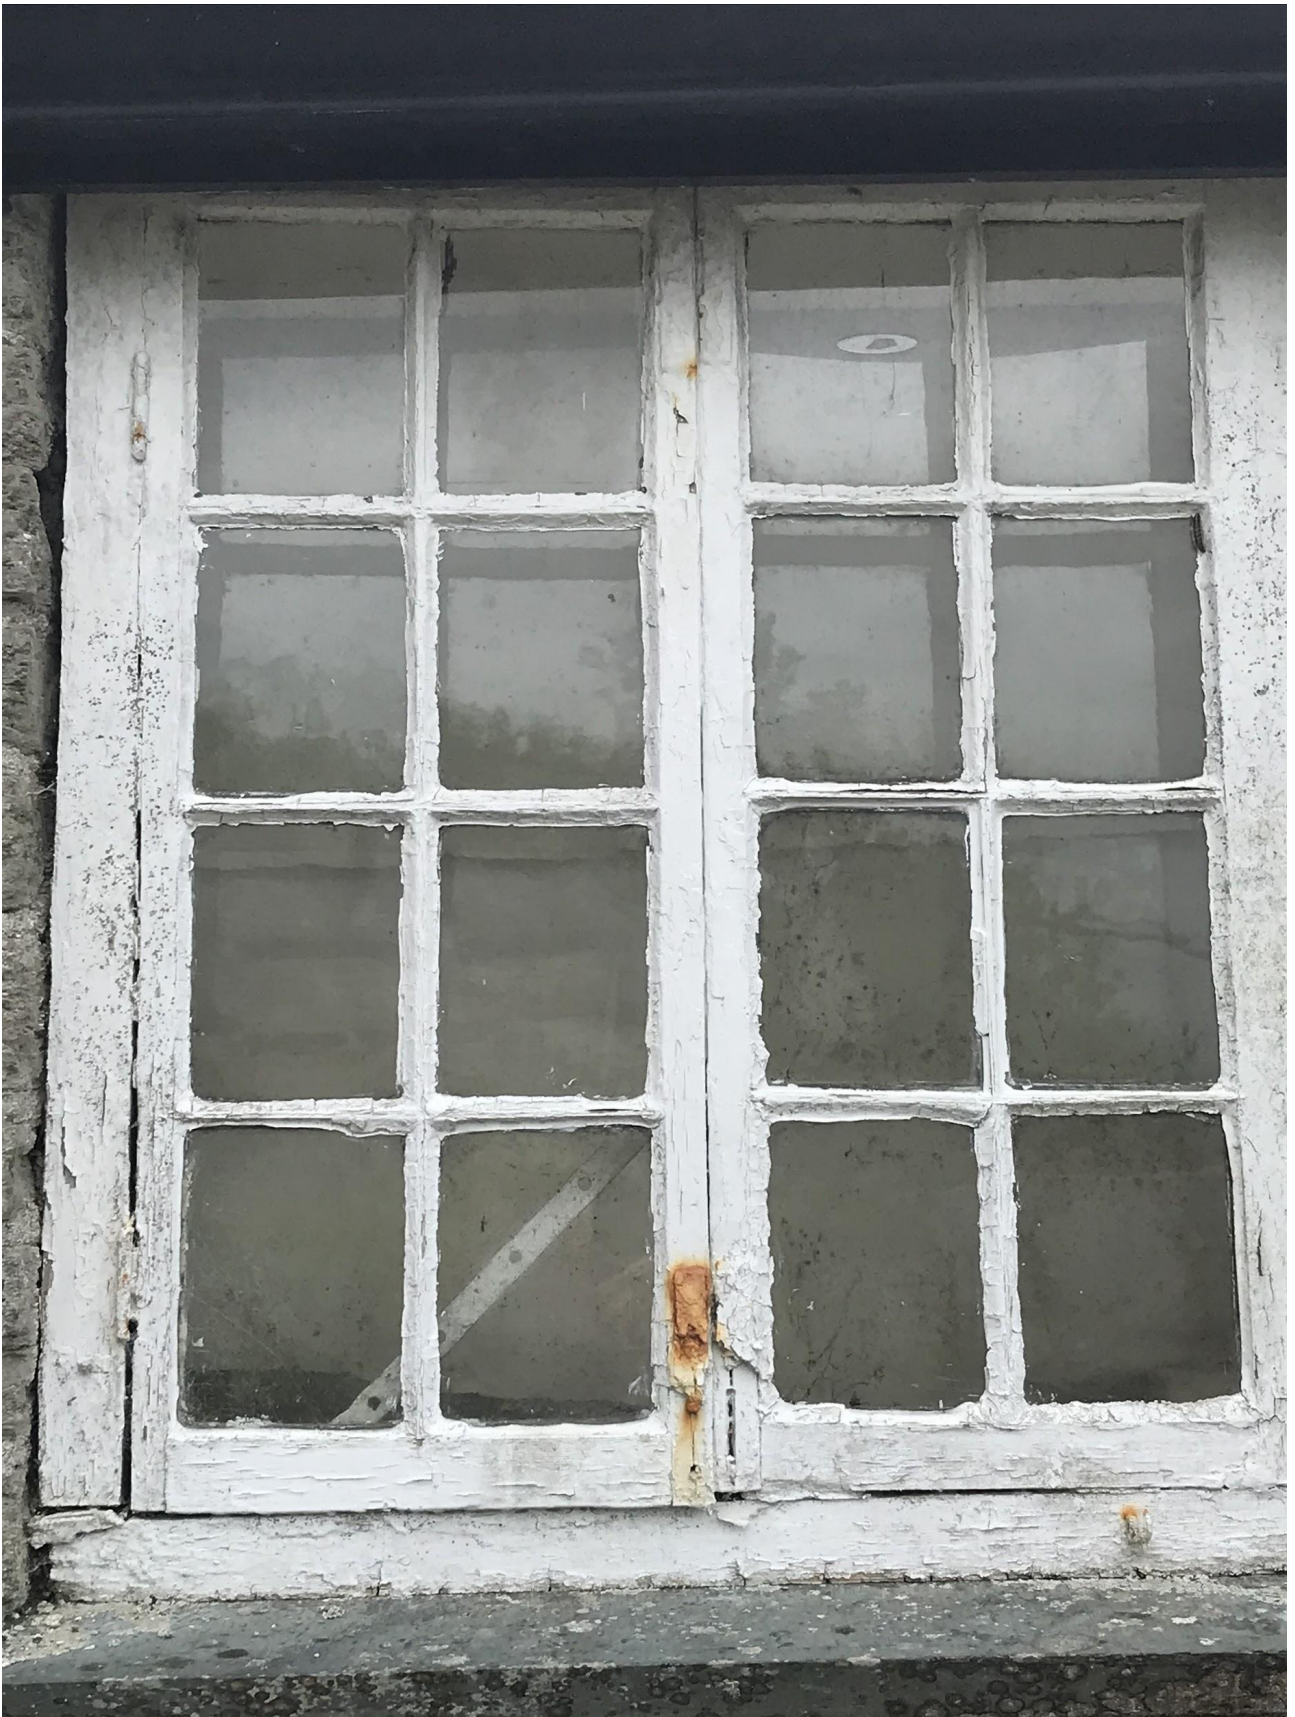
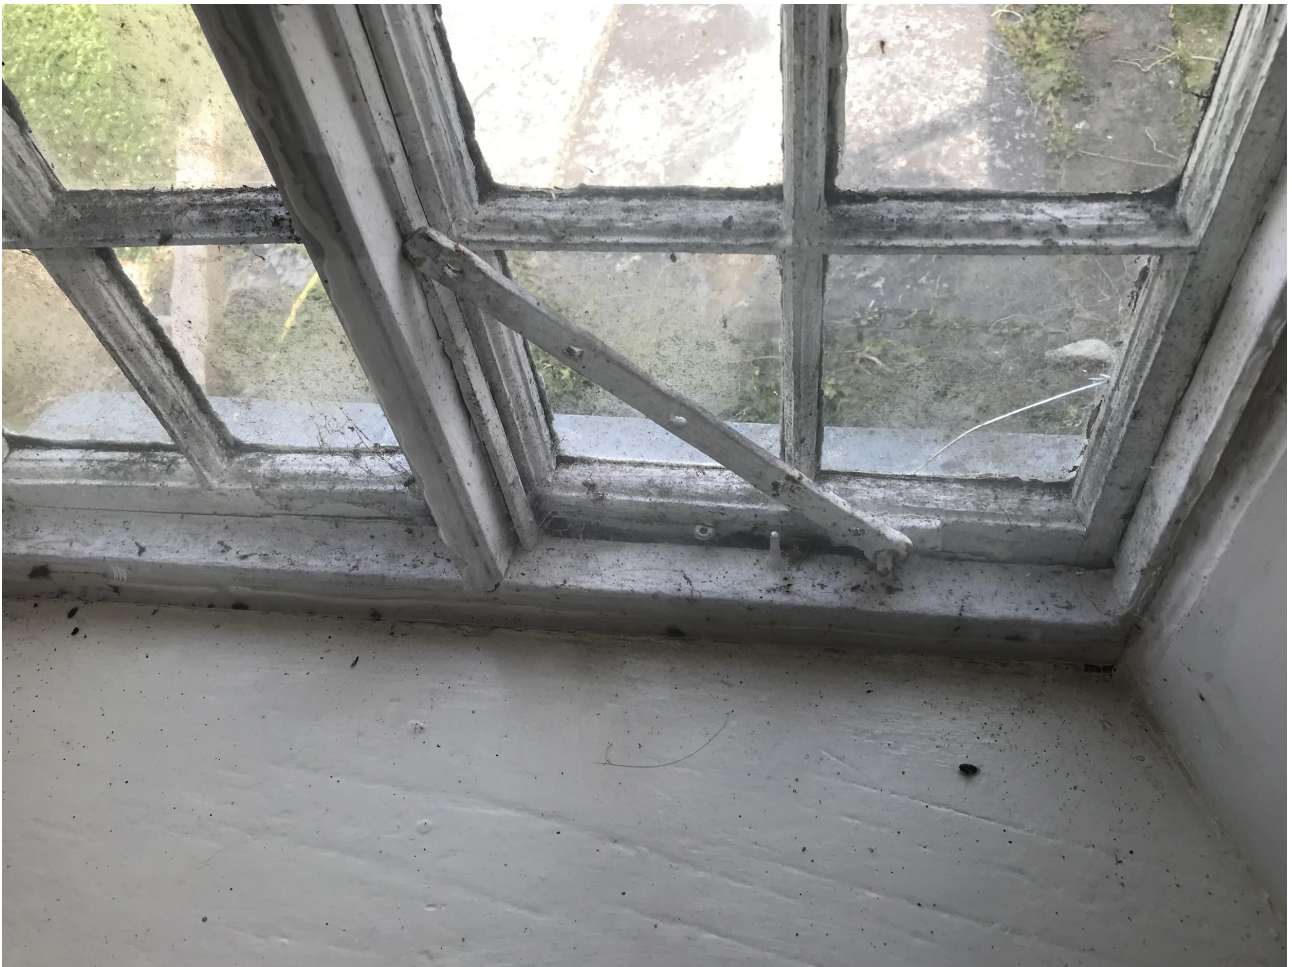
Images or rear bathroom window (location 4A):

These windows are suffering from rot and have clearly not been openable for many years. The first serves the rear bathroom (rear north elevation) and the second the rear bedroom 4 window (east elevation). The location of both is marked on the submitted floor plans.

The proposed work is to install two new opening screen casements formed in Iroko hardwood and glazed in 4mm single clear float glass. Profile and elevation of replacements to be copied off originals and manufactured to match. The opening casements to bedroom 4 will be hinged off the centre mullion as the original does.

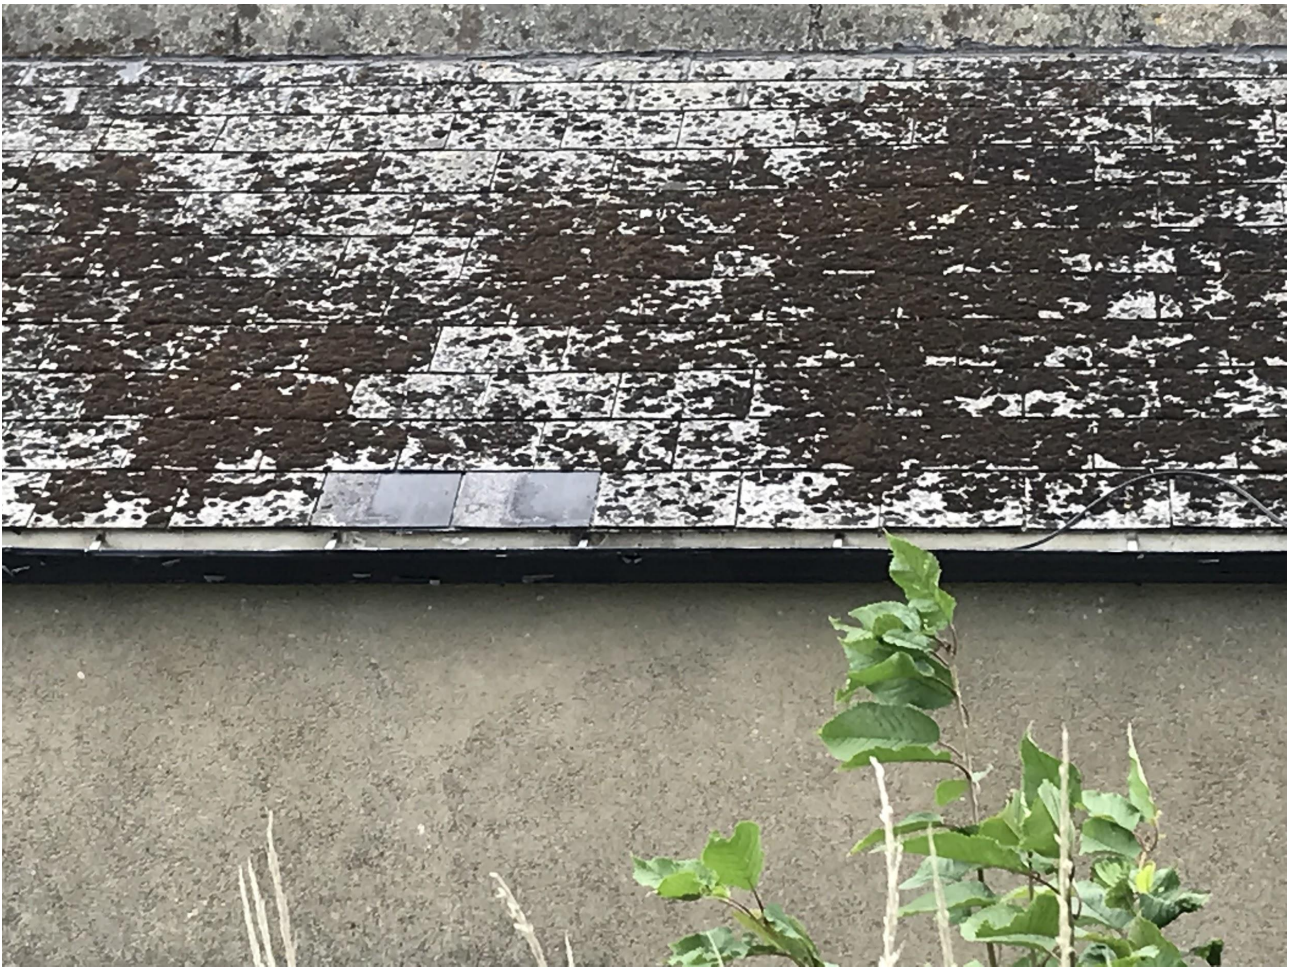
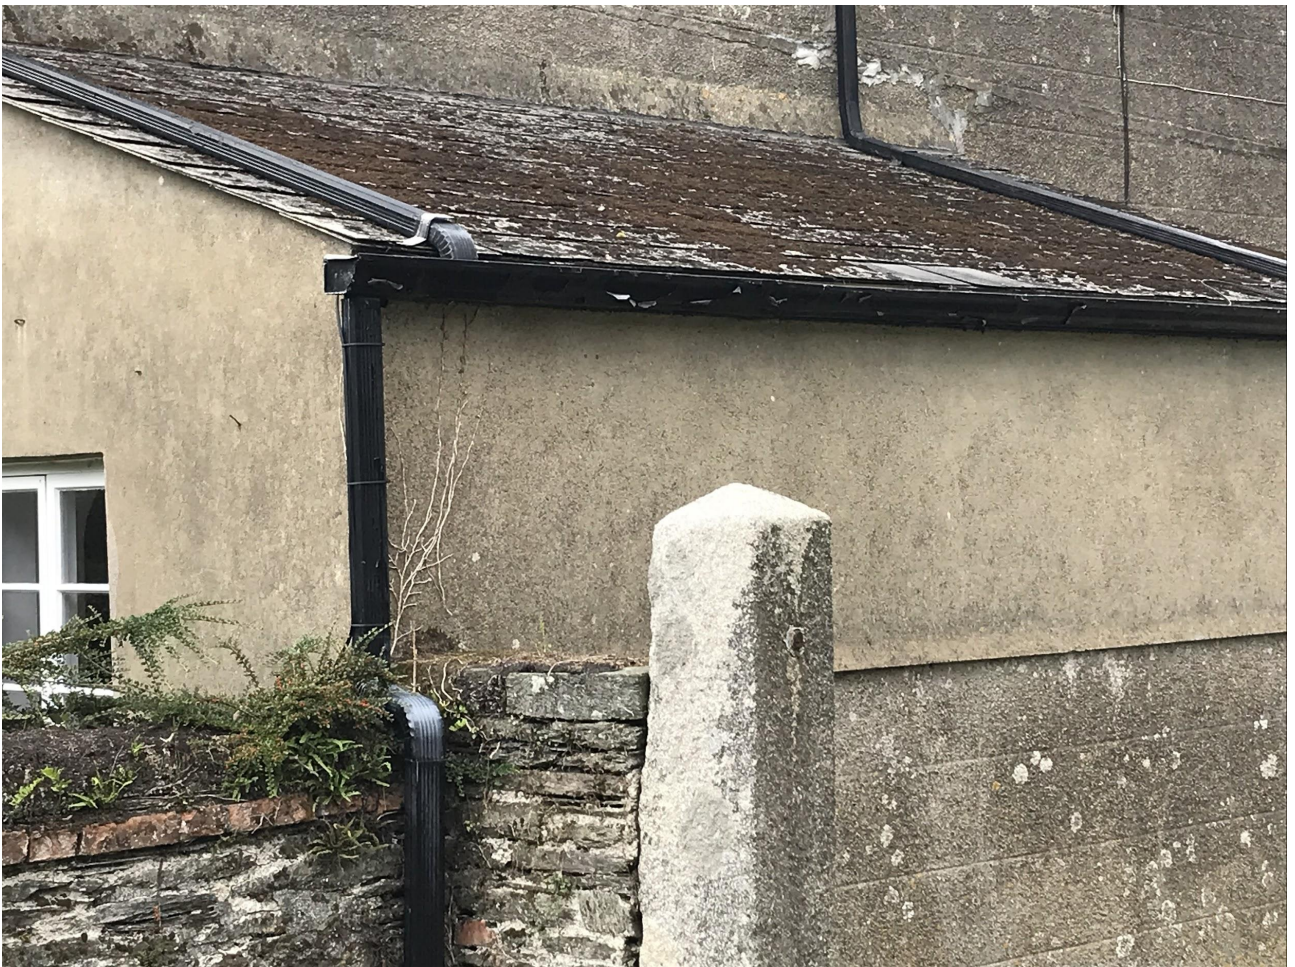
-Exterior right (when viewed from road) side addition roof. (Location 5)

This lean to roof currently has a 20th artificial slate finish.

Images of current roof finish:

The proposed repair works will involve complete removal and replacement with Delabole slates on treated battens. A new code 4 lead flashing will be introduced at the junction with the main house wall, with a 150mm upstand.

Slates will be sized to match those of the main house roof and be fixed in accordance with BS:5534: Part 1; rev 1990, and BS:8000 Slating and Tiling Workmanship.
