Design and Access Statement and Heritage Impact Assessment for St Erney House, St Erney, Cornwall, PL12 5EZ

The proposed method to be used for further repair work and restoration of St Erney House.

Dated: August 2021

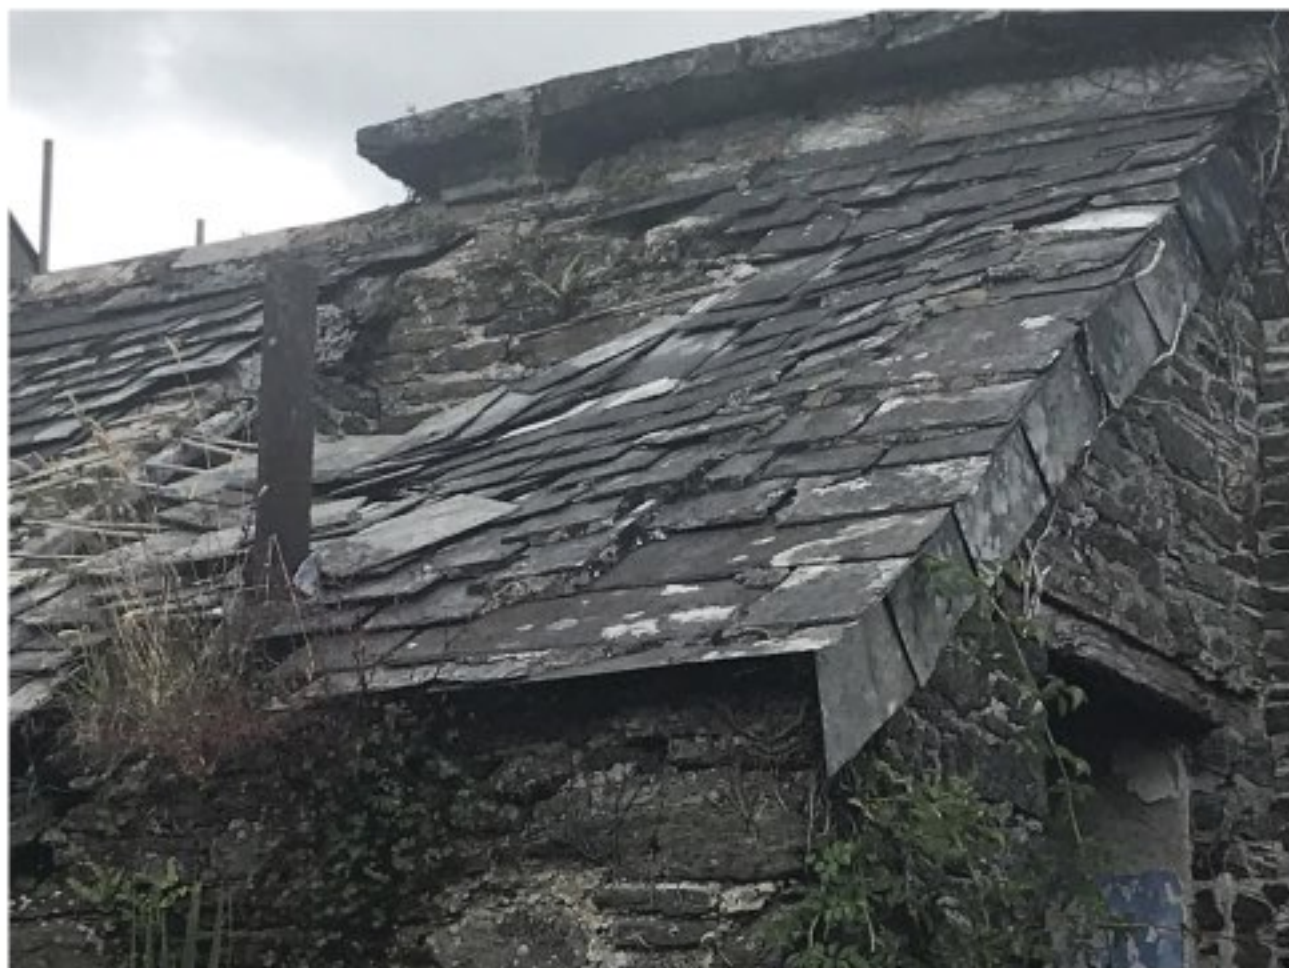
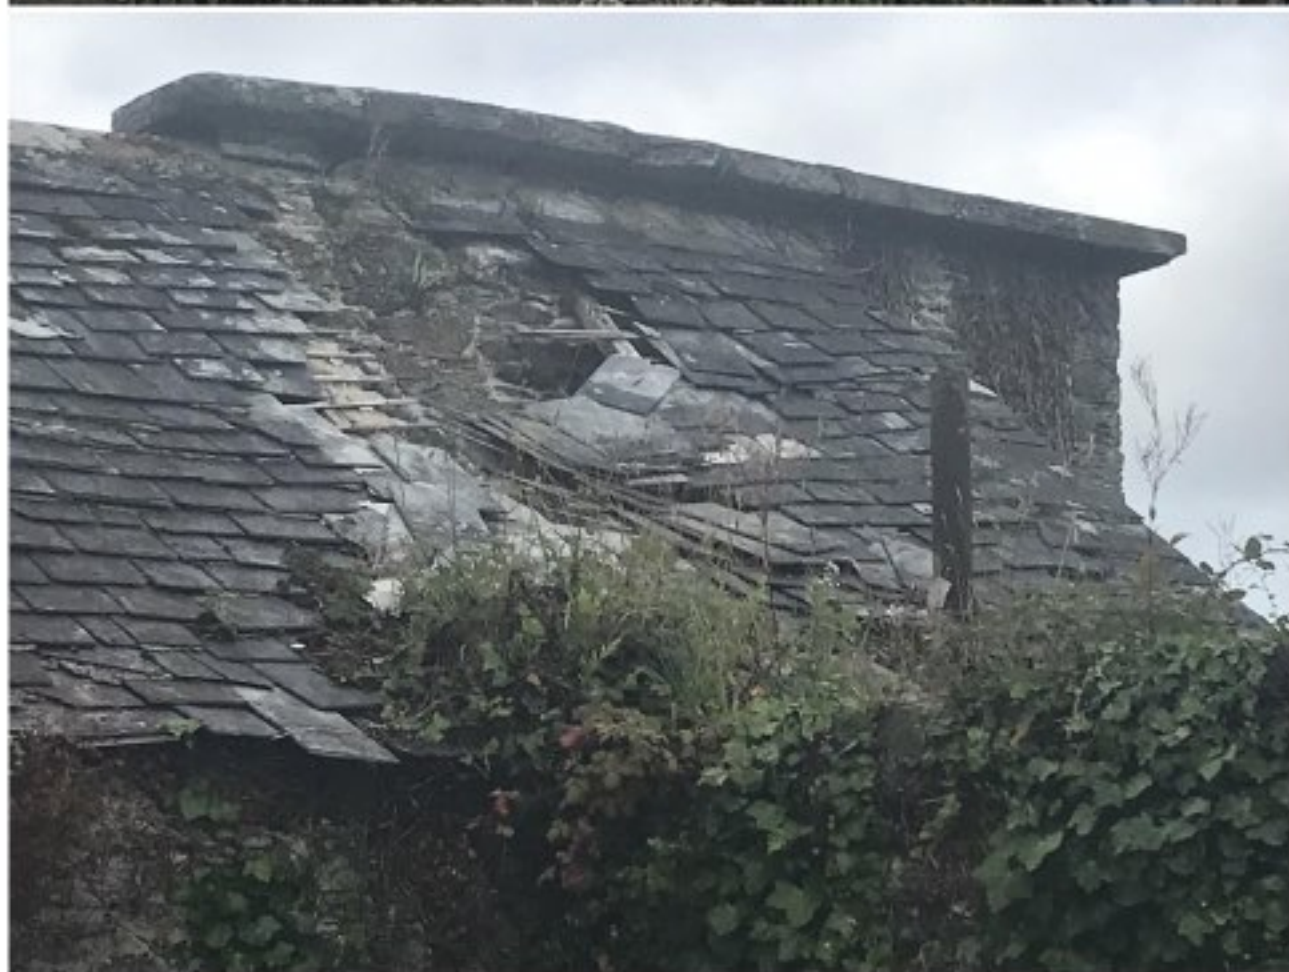
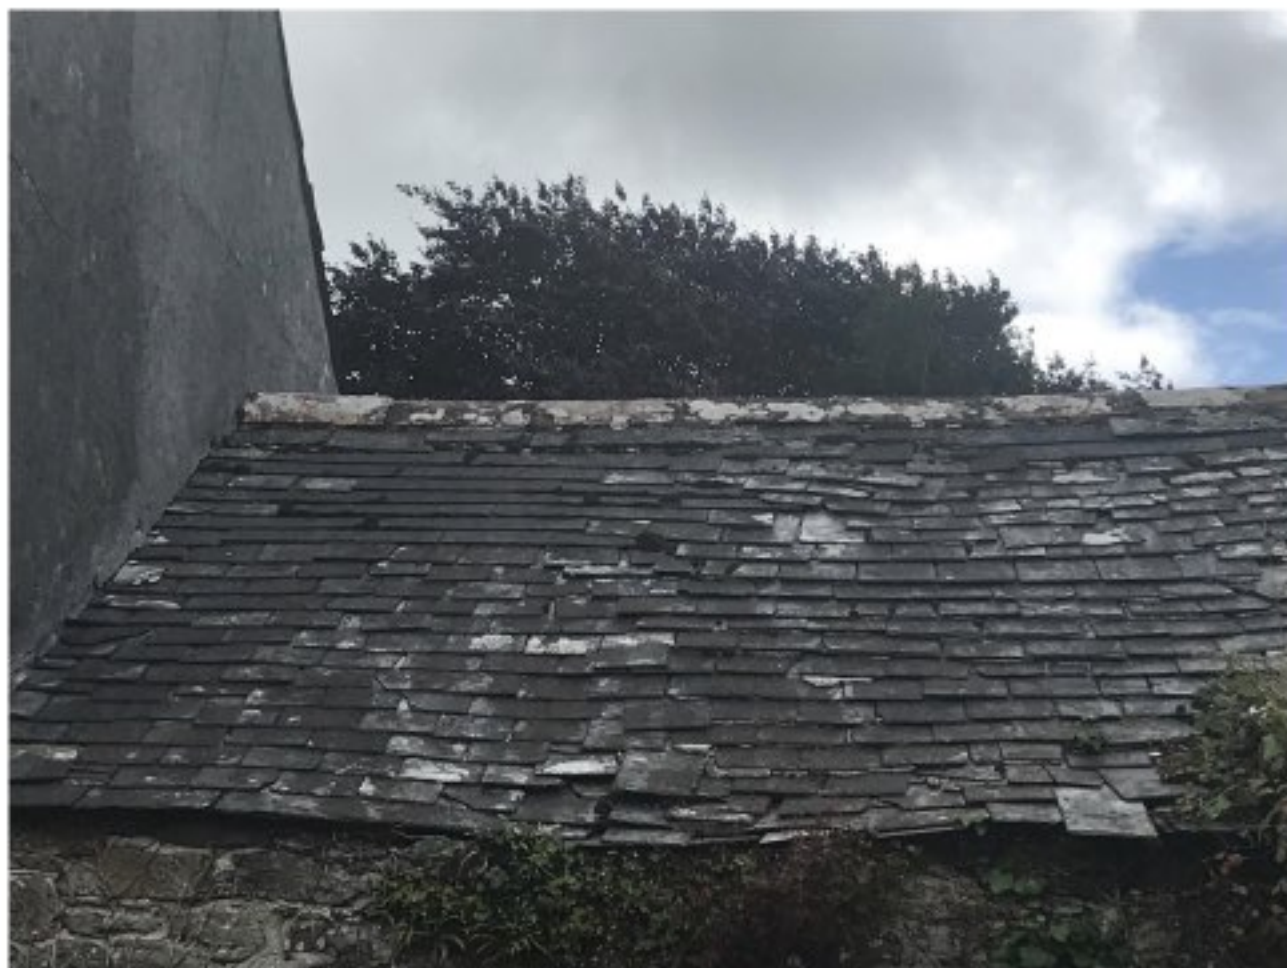
Area to be restored:

Up until five years ago the privy was completely concealed by heavy vegetation. As can be seen from the photo below, the roof collapsed many years ago and the slate area alongside (over an open store) is in a very poor condition. It is letting in rain water onto the shillet and stone wall, which in part supports a first floor gable end. The lintel over the small window has collapsed and the parapet at the top of the lean to roof is very unstable. The lintel over the store opening is an inappropriate concrete plank lintel.

The proposed repair work consists of taking off all the roof coverings in this area. The natural slate will be set aside for re-use and the man made slate on the store south elevation will be disposed of.

New treated softwood timbers will be used to repair the roof and the broken window lintel will be replaced with seasoned oak. The concrete plank lintel over the shed opening will also be replaced in local seasoned oak. The stonework above the lintel will be repaired using a hydraulic lime based mortar in conjunction with the original stone.

New treated battens will be placed on top of the new and existing rafters, followed by locally sourced second hand Delabole natural slates, re-using as many as possible of those previously set aside.

Roof abutment flashings will be replaced in code 4 lead. Gutters and down pipes will be new Marley Alutec traditional black aluminium half round profile.

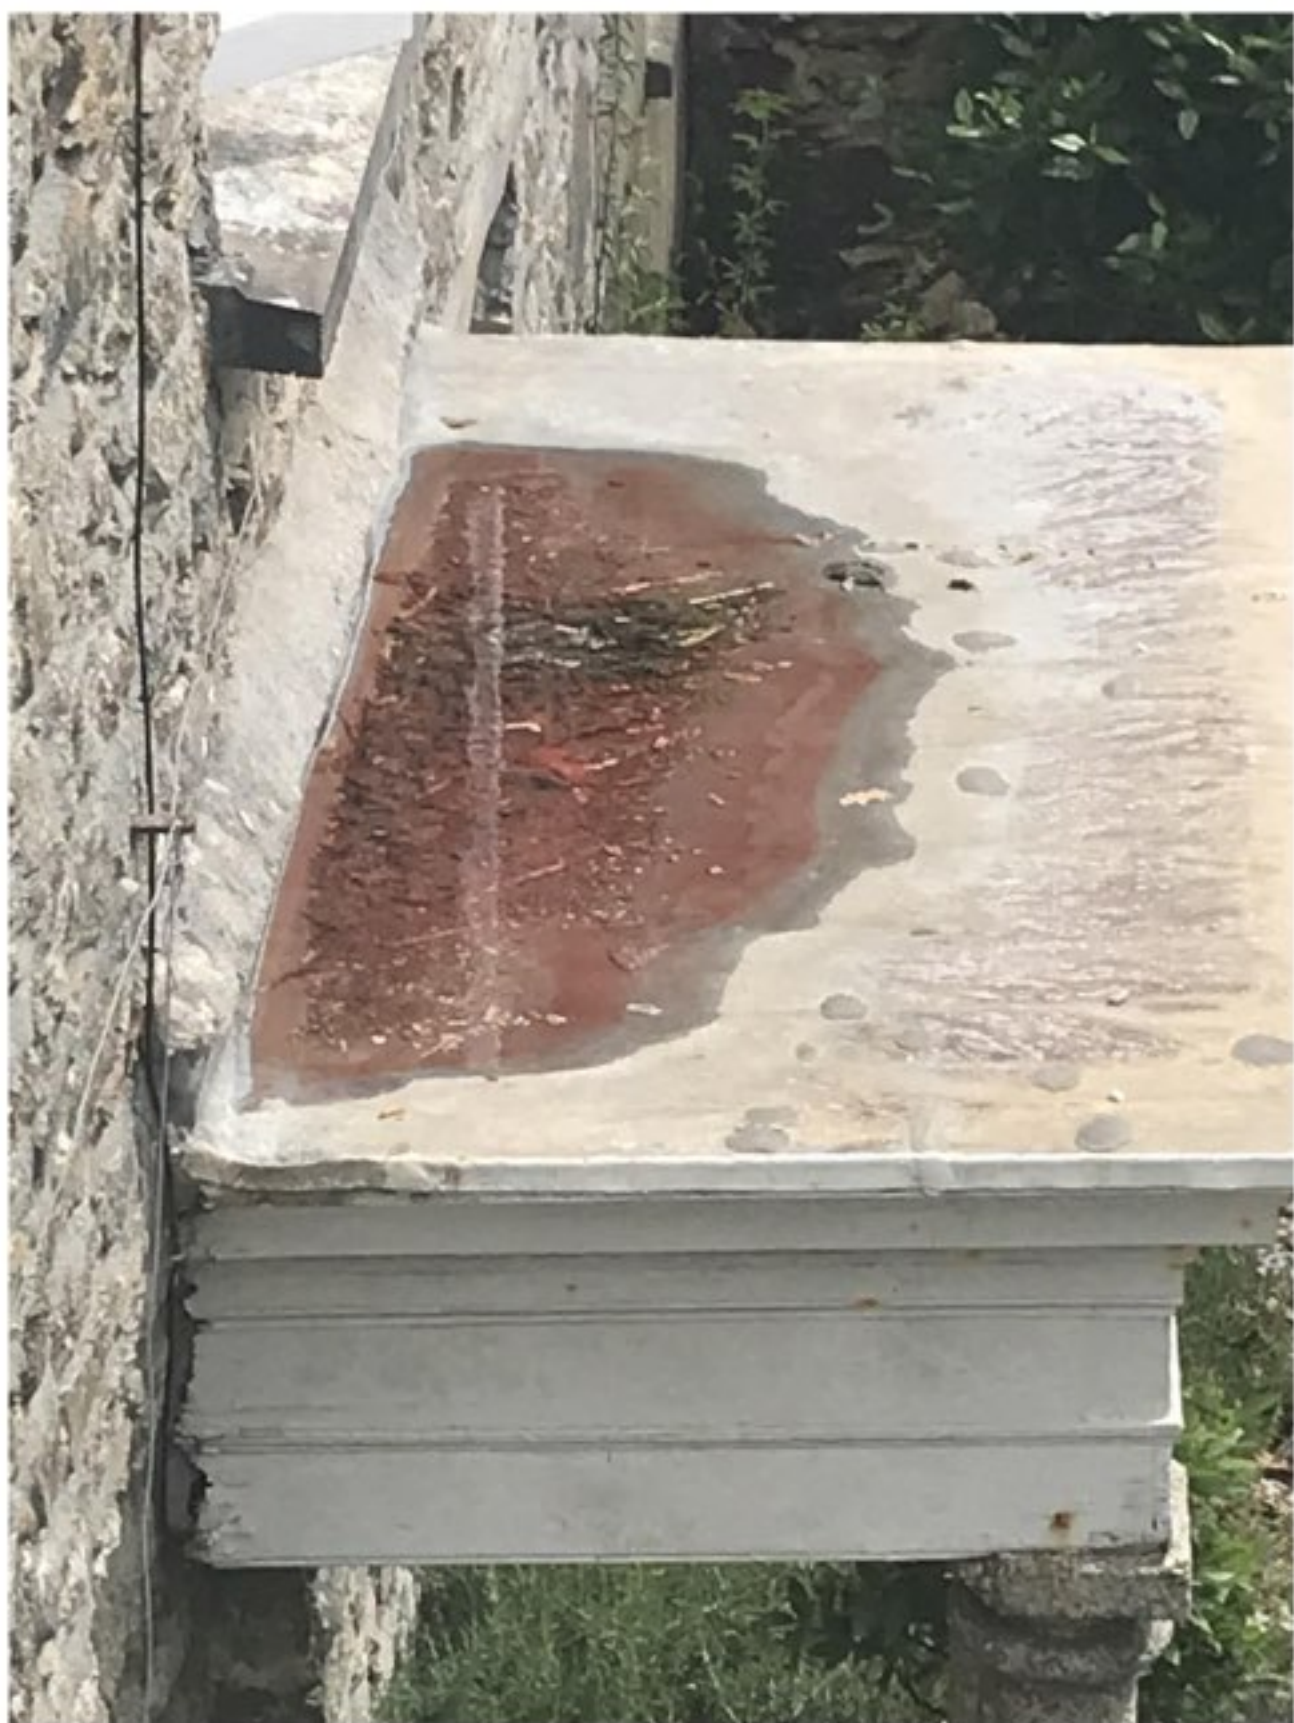
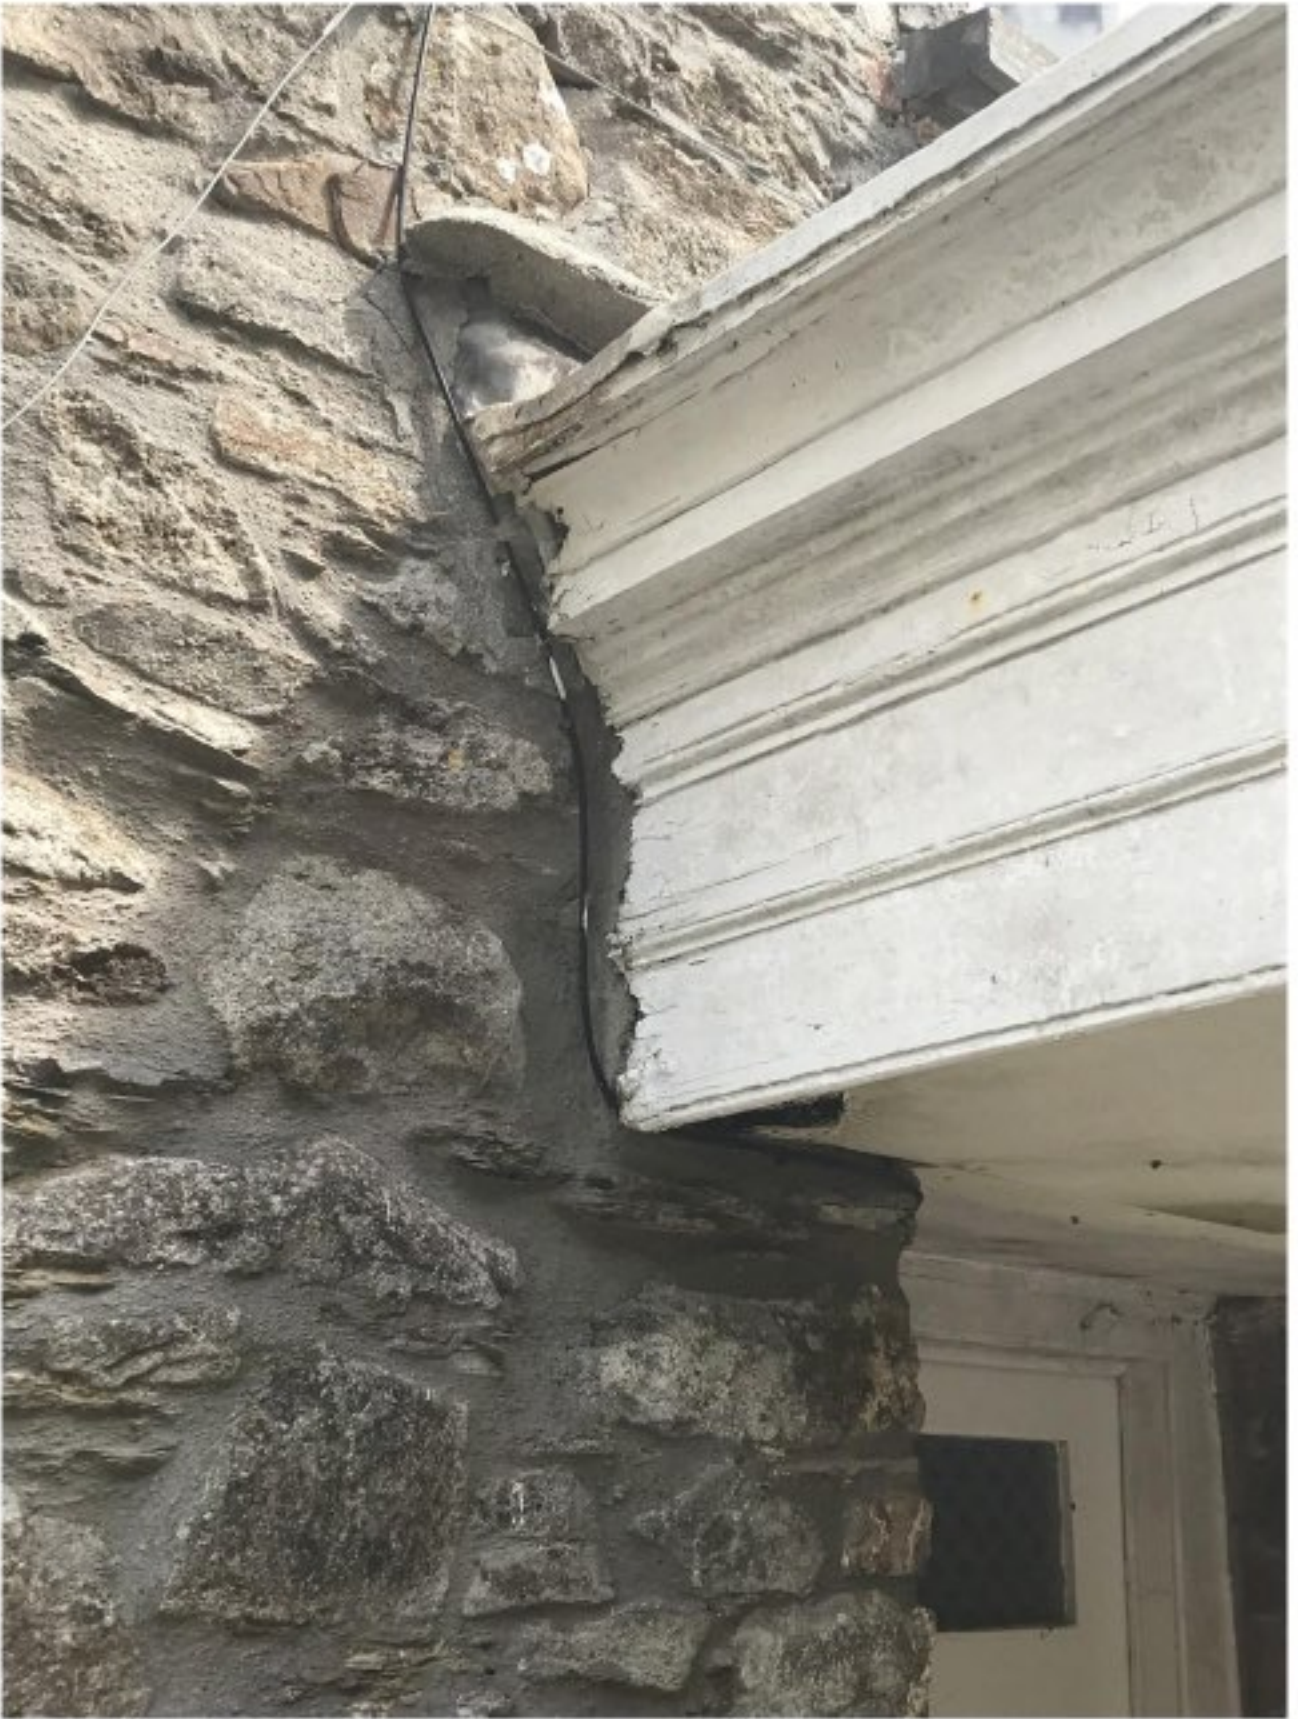
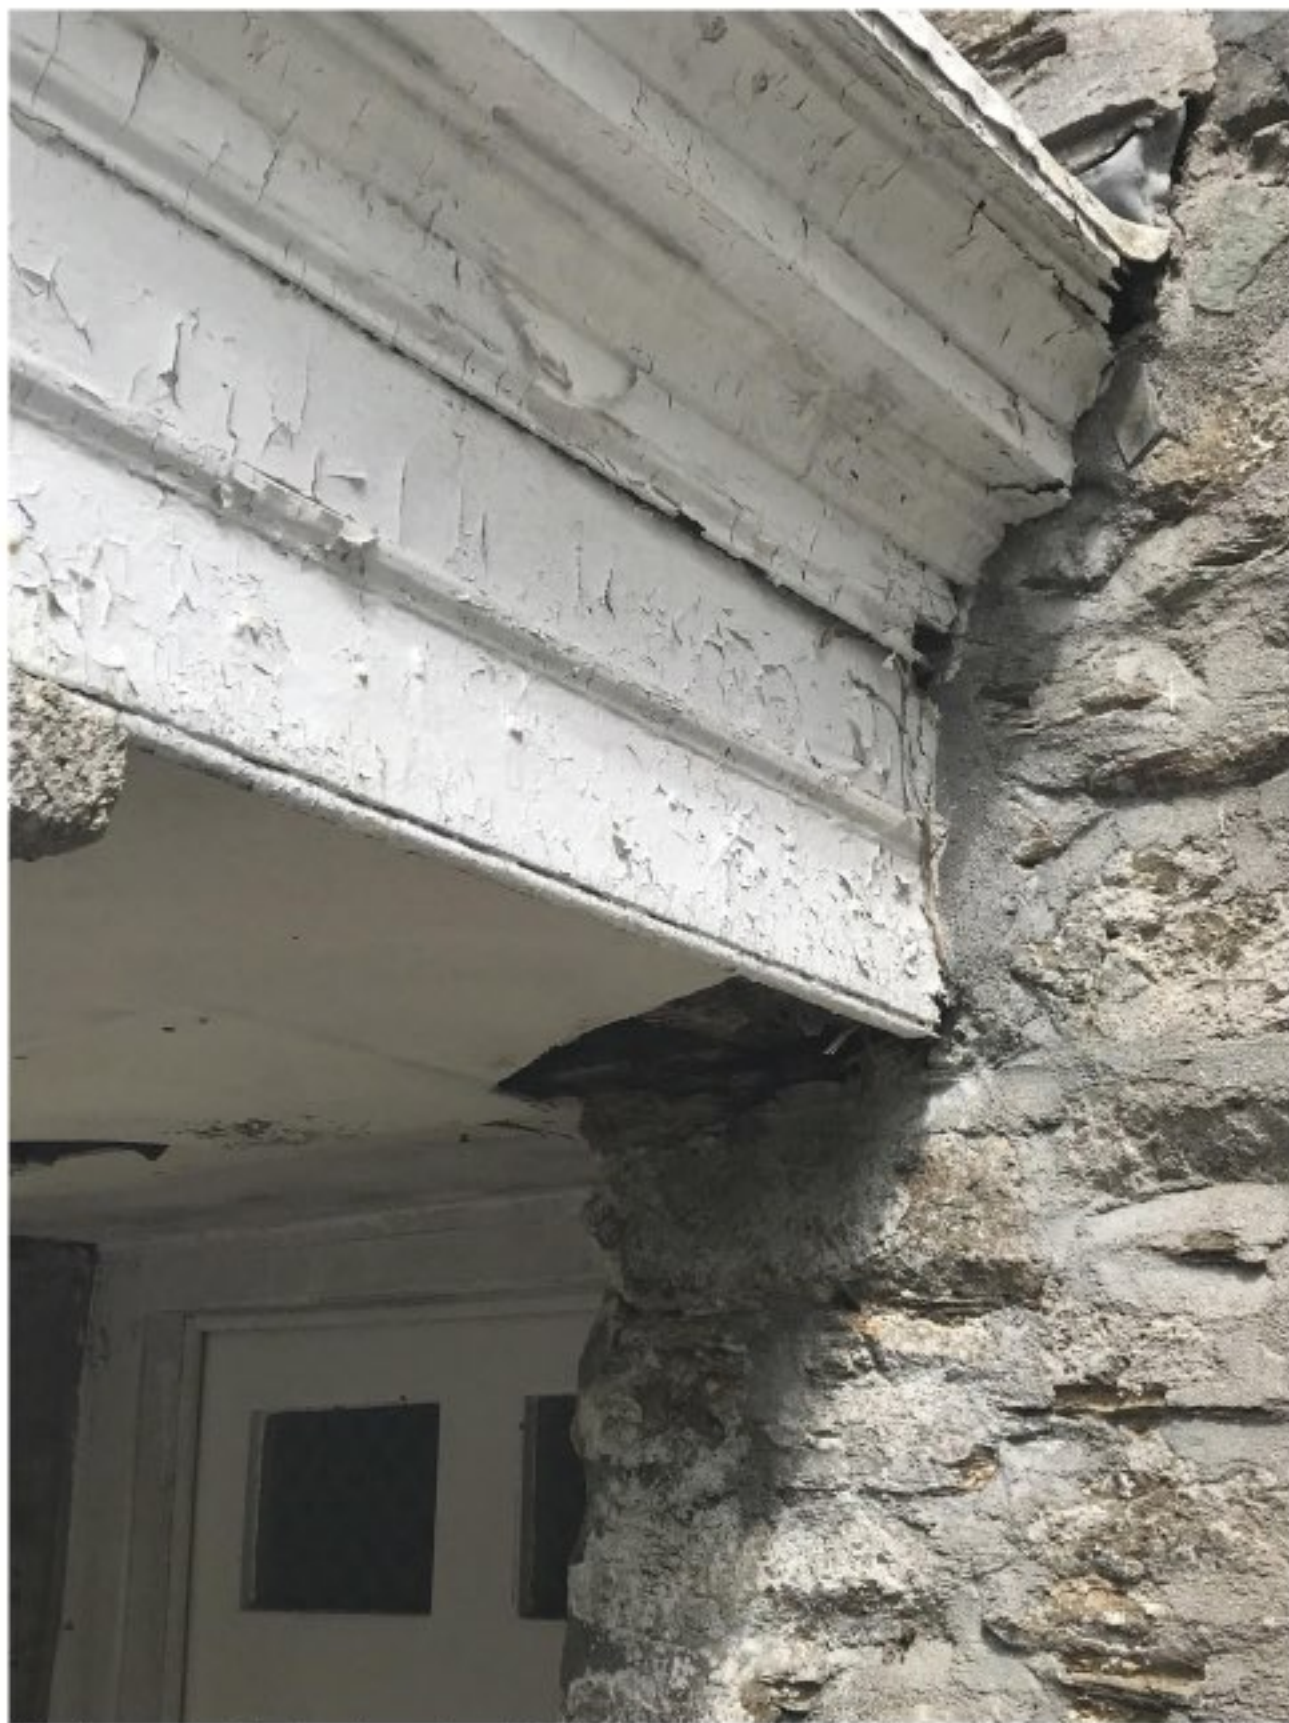
The canopy roof to the front of the property is in a very poor condition. The flat roof has dropped back towards the main house wall at some point and this has split the lead covering, water ingress has caused extensive rot to the supporting framework. The underside is lined with an asbestos cement type product. The supporting granite columns are currently unaffected by the damaged roof over.

Images of roof currently, with severe back fall:

The proposed works consist of providing temporary support if needed to the columns so that they remain in place whilst the canopy is restored. This will require the side and front cornice to be copied in treated softwood sections to replicate the original. All flat roof joists will be replaced in treated softwood and the roof realigned to the height of the original flashing. This will then provide an adequate fall to avoid ponding on the surface. The roof will be replaced in code 5 lead on exterior grade ply with a central rolled expansion joint. The lead will have chalk applied to the underside.

The new soffit and sides will be formed in exterior grade ply and be painted white.

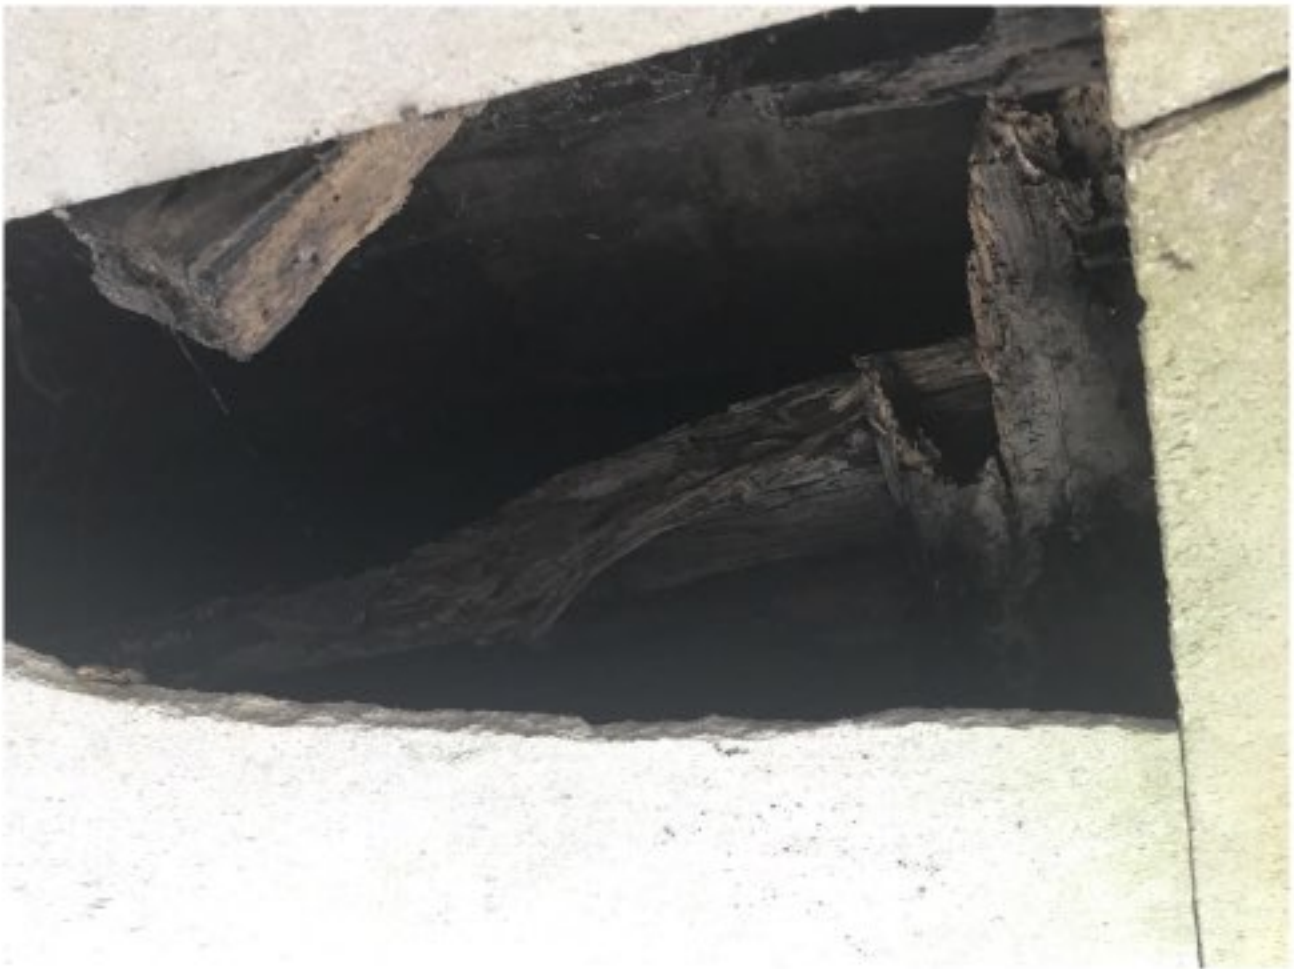
View from underside showing rotting timbers and inappropriate soffit:

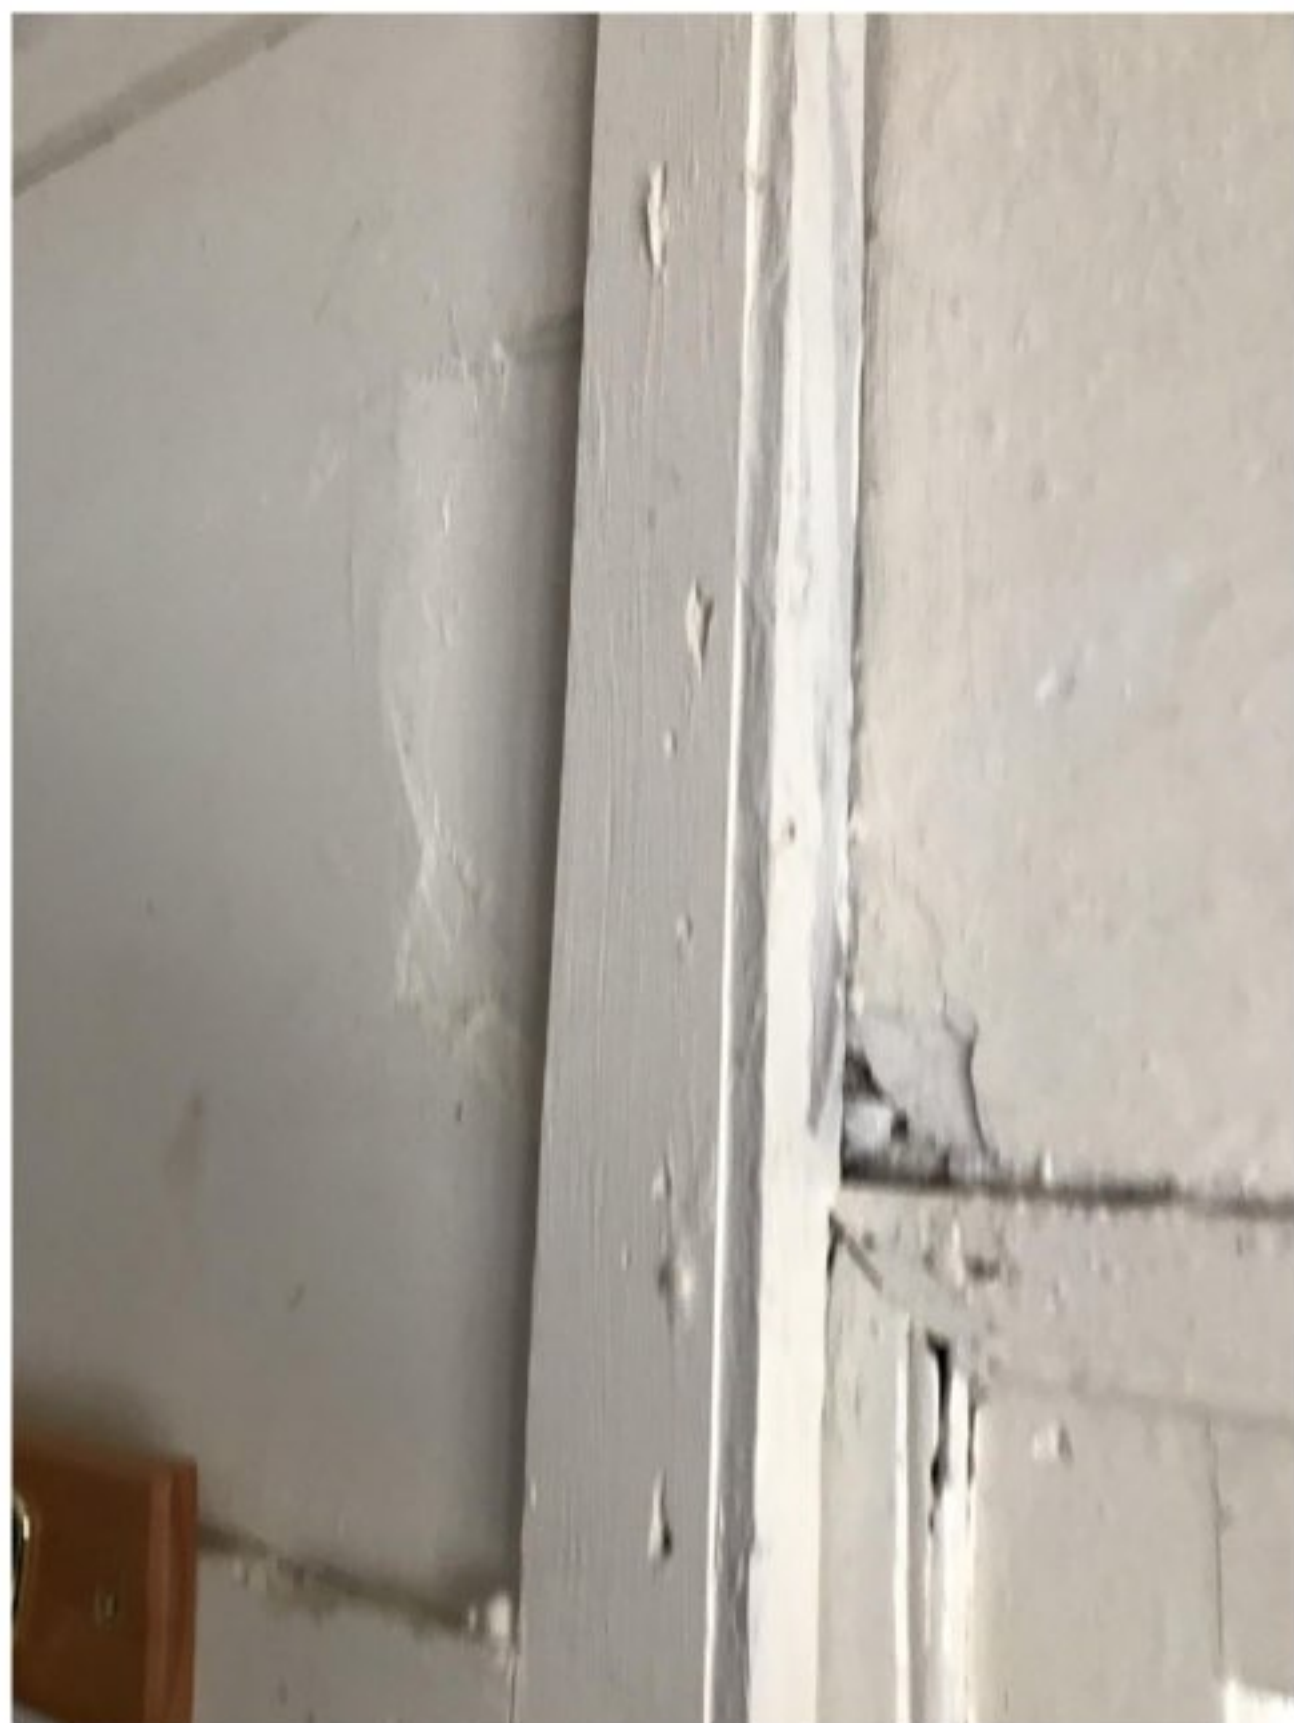
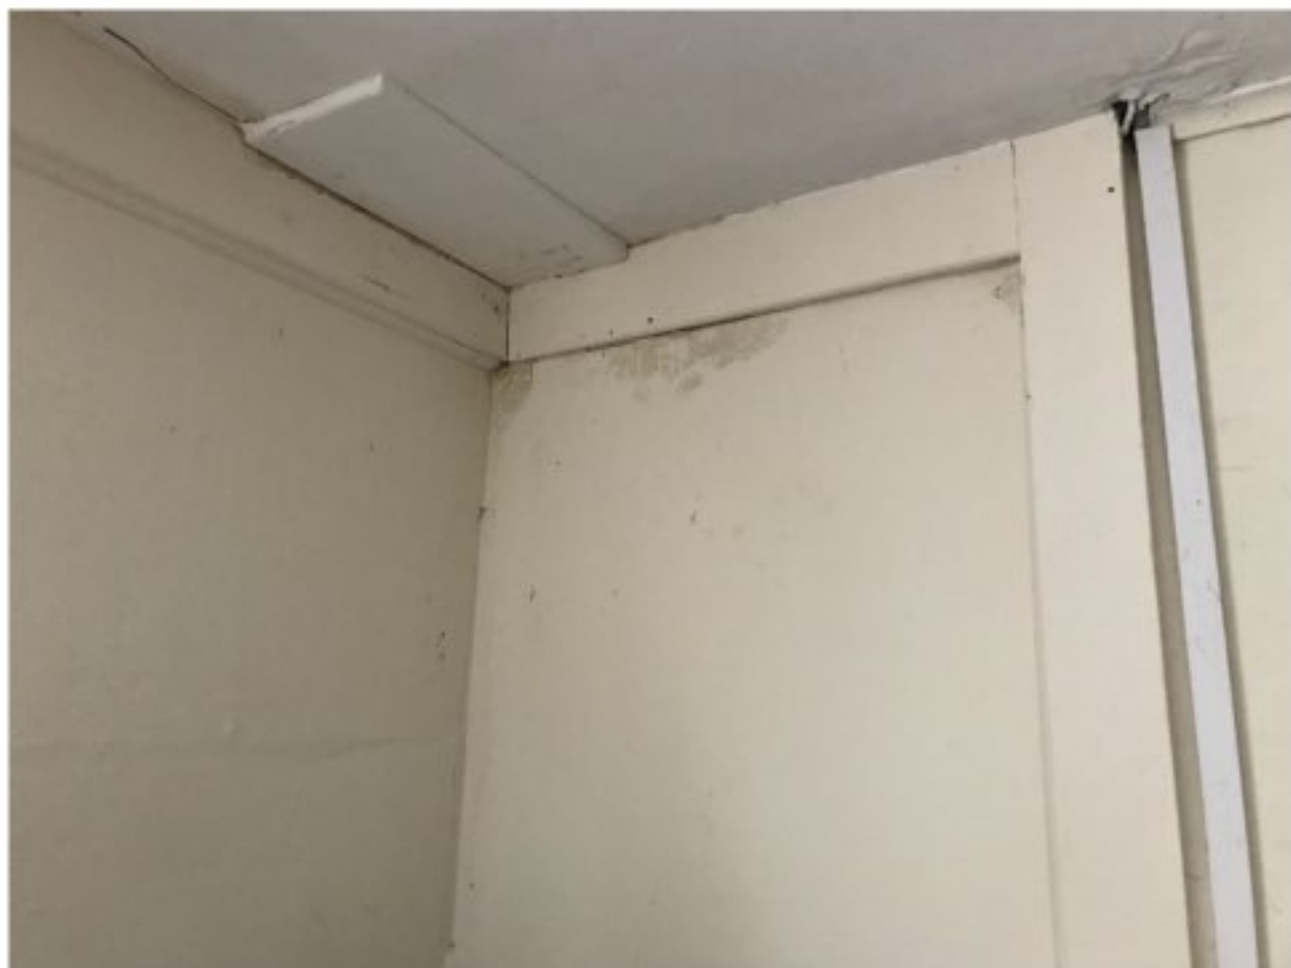
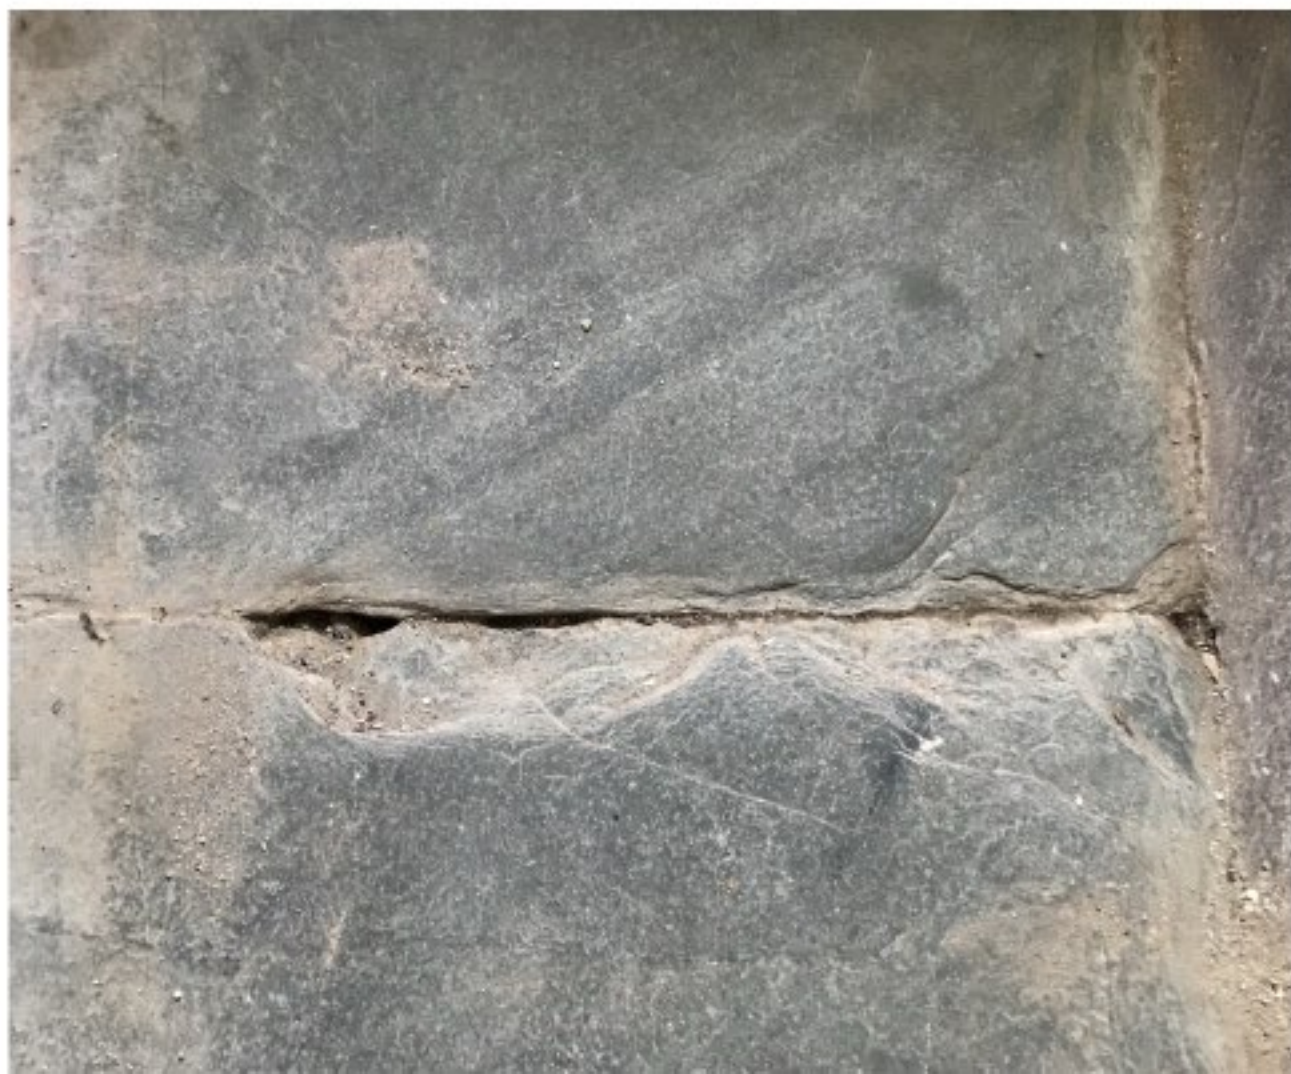
Detail views of current finishes:

This area of the house currently suffers from high levels of damp, alongside unsympathetic restoration work, possibly intended to hold back the moisture penetration through the external wall. The walls are generally lined with timber battens, polythene and a board facing. The existing slate floor has degraded joints and high levels of damp penetration are evident.

The proposed repair works consist of carefully numbering, taking out and setting aside the slate shelves for reuse, then removing all battens, polythene and fibreboard for disposal. The existing stone walls will then be carefully cleaned of any remaining fixings and other 20th century interventions. The walls will then be lined with Newton 803 or equivalent, fixed in accordance with the manufacturer's instructions, followed by lime plaster in three layers of diminishing strength. This is a similar proposal to the work previously undertaken in the lounge under approval reference PA16/5325. The slate floor will be numbered and carefully lifted in sections. The underlying shillet will be excavated to allow blinding, radon barrier and concrete to be placed. The slate will then be placed back in the same position and at the same levels as currently. The joints will be repaired in a lime based mortar.

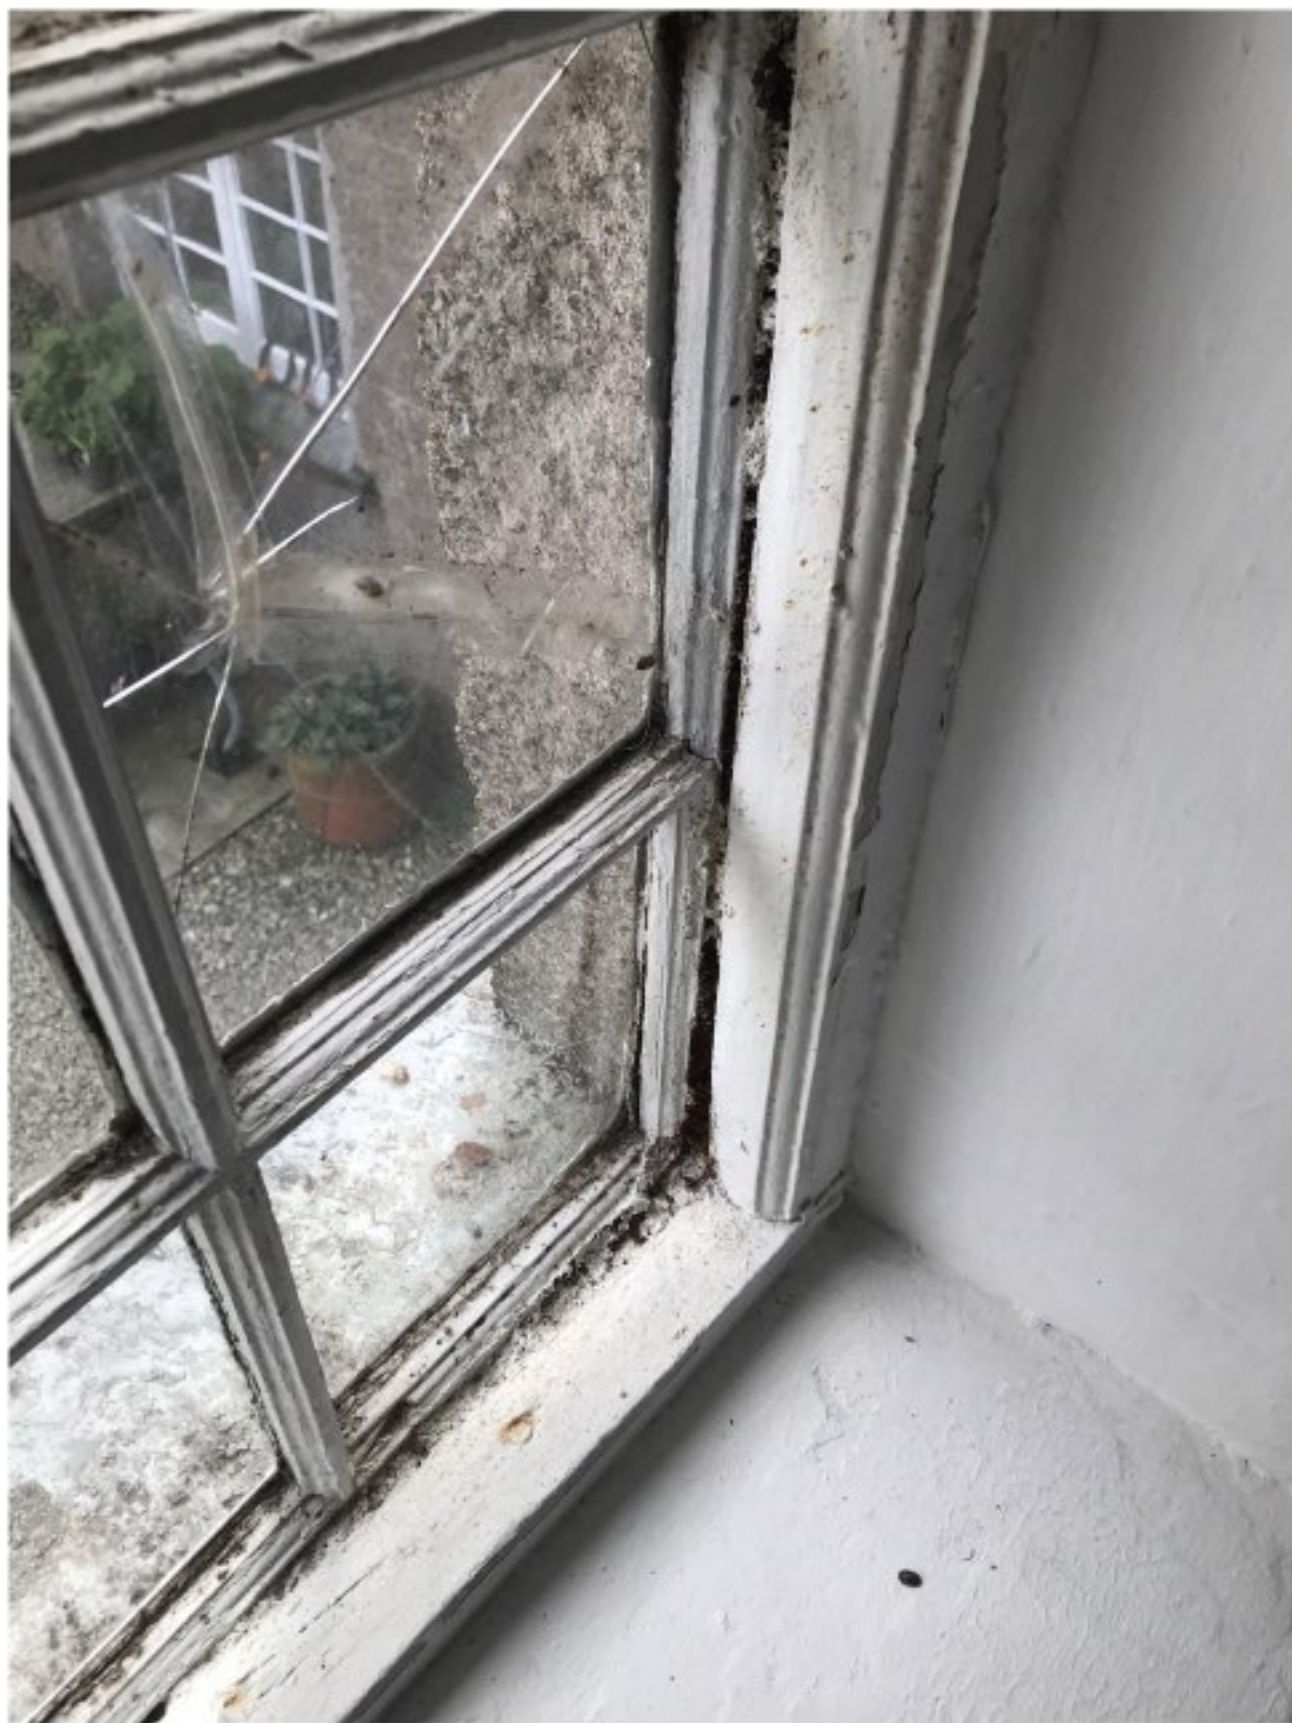
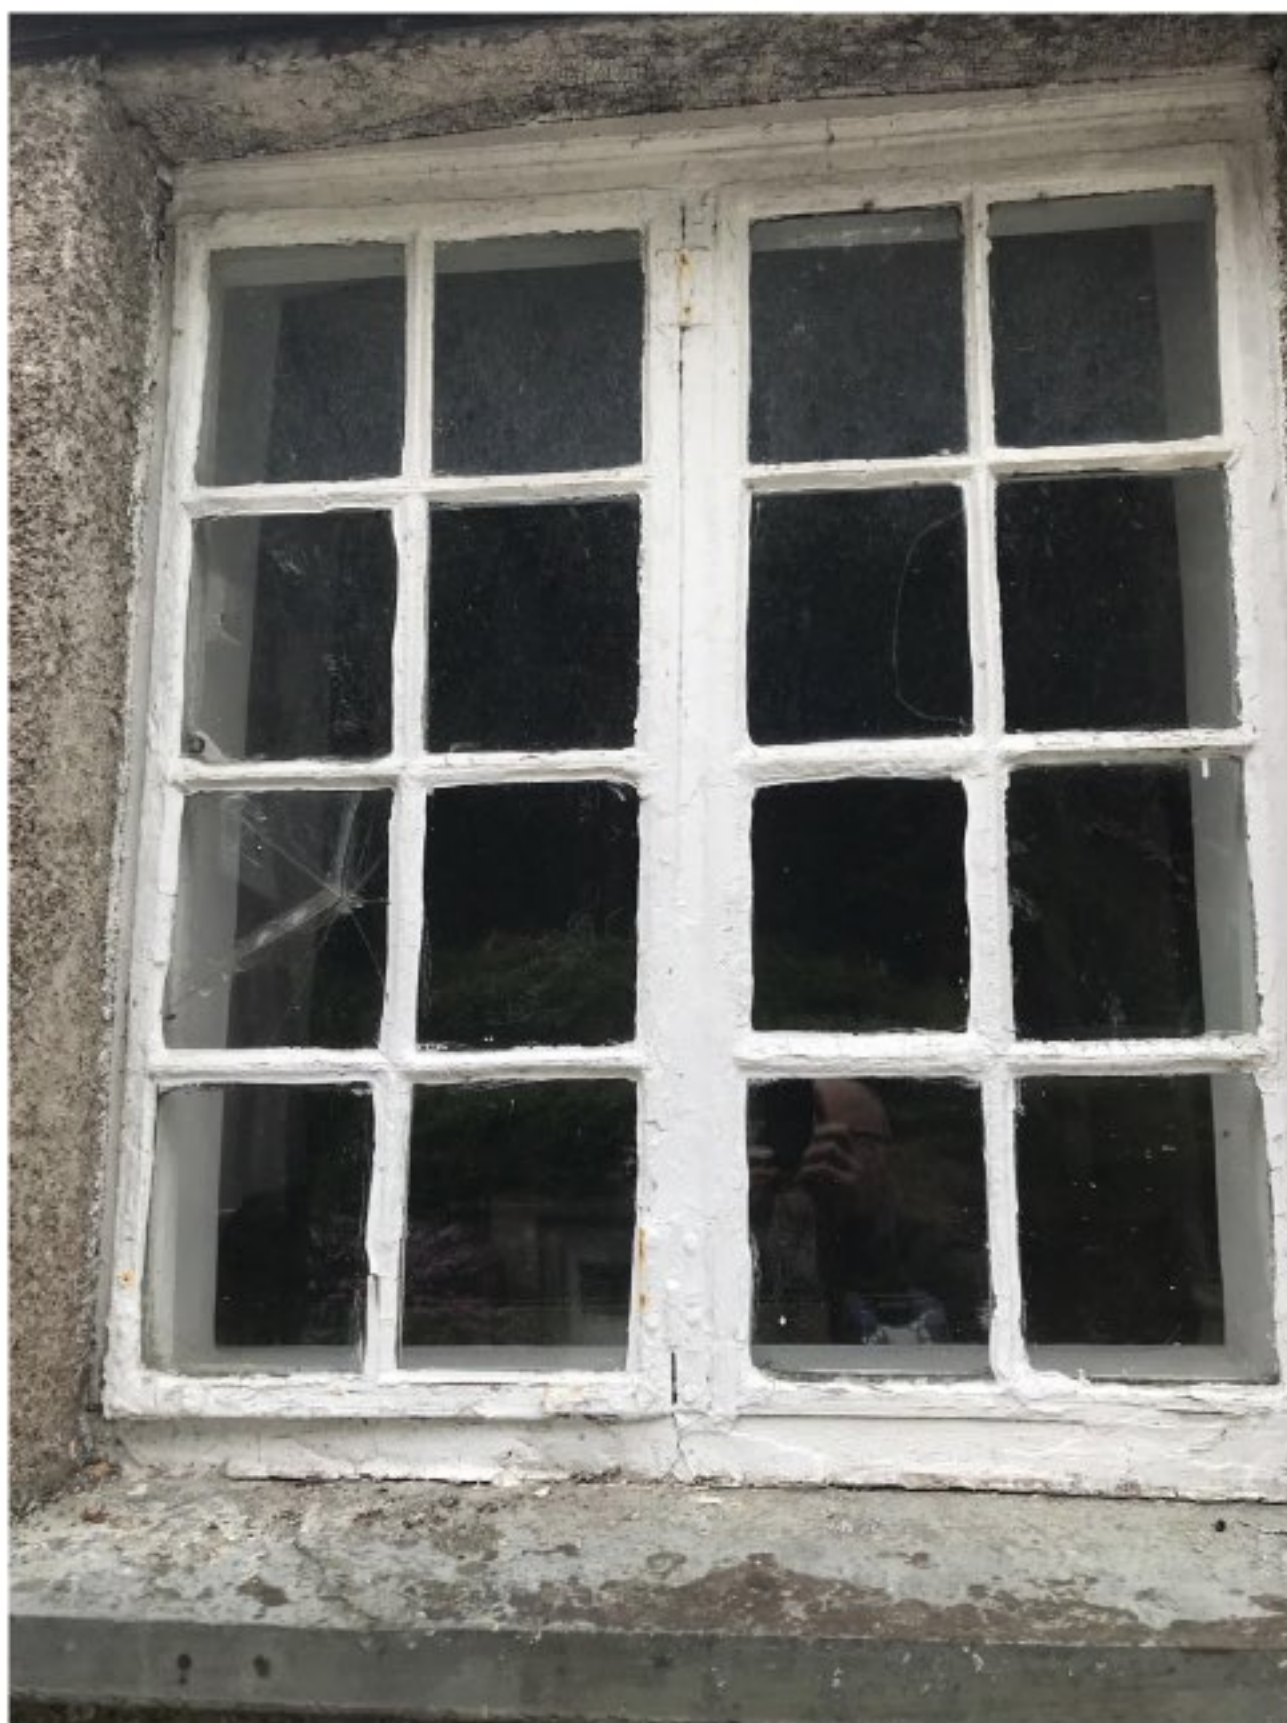
Images of window to bedroom 4 (location 4):

Since the last Listed Building Consent, UPVC windows have all now been removed and replaced with single glazed hardwood framed replacements, in keeping with the original reference points and the approval. In addition to replacements careful maintenance has also been undertaken to various timber windows to prevent further decay. There are however two original windows that are considered to be beyond the point of restoration or repair.

These windows are suffering from rot and have clearly not been openable for many years. The first serves the rear bathroom (rear north elevation) and the second the rear bedroom 4 window (east elevation). The location of both is marked on the submitted floor plans.

The proposed work is to install two new opening screen casements formed in Iroko hardwood and glazed in 4mm single clear float glass. Profile and elevation of replacements to be copied off originals and manufactured to match. The opening casements to bedroom 4 will be hinged off the centre mullion as the original does.
