Design and Access Statement and Heritage Impact Assessment for St Erney House, St Erney, Cornwall, PL12 5EZ

The proposed method to be used for further repair work and restoration of St Erney House.

Dated: August 2021

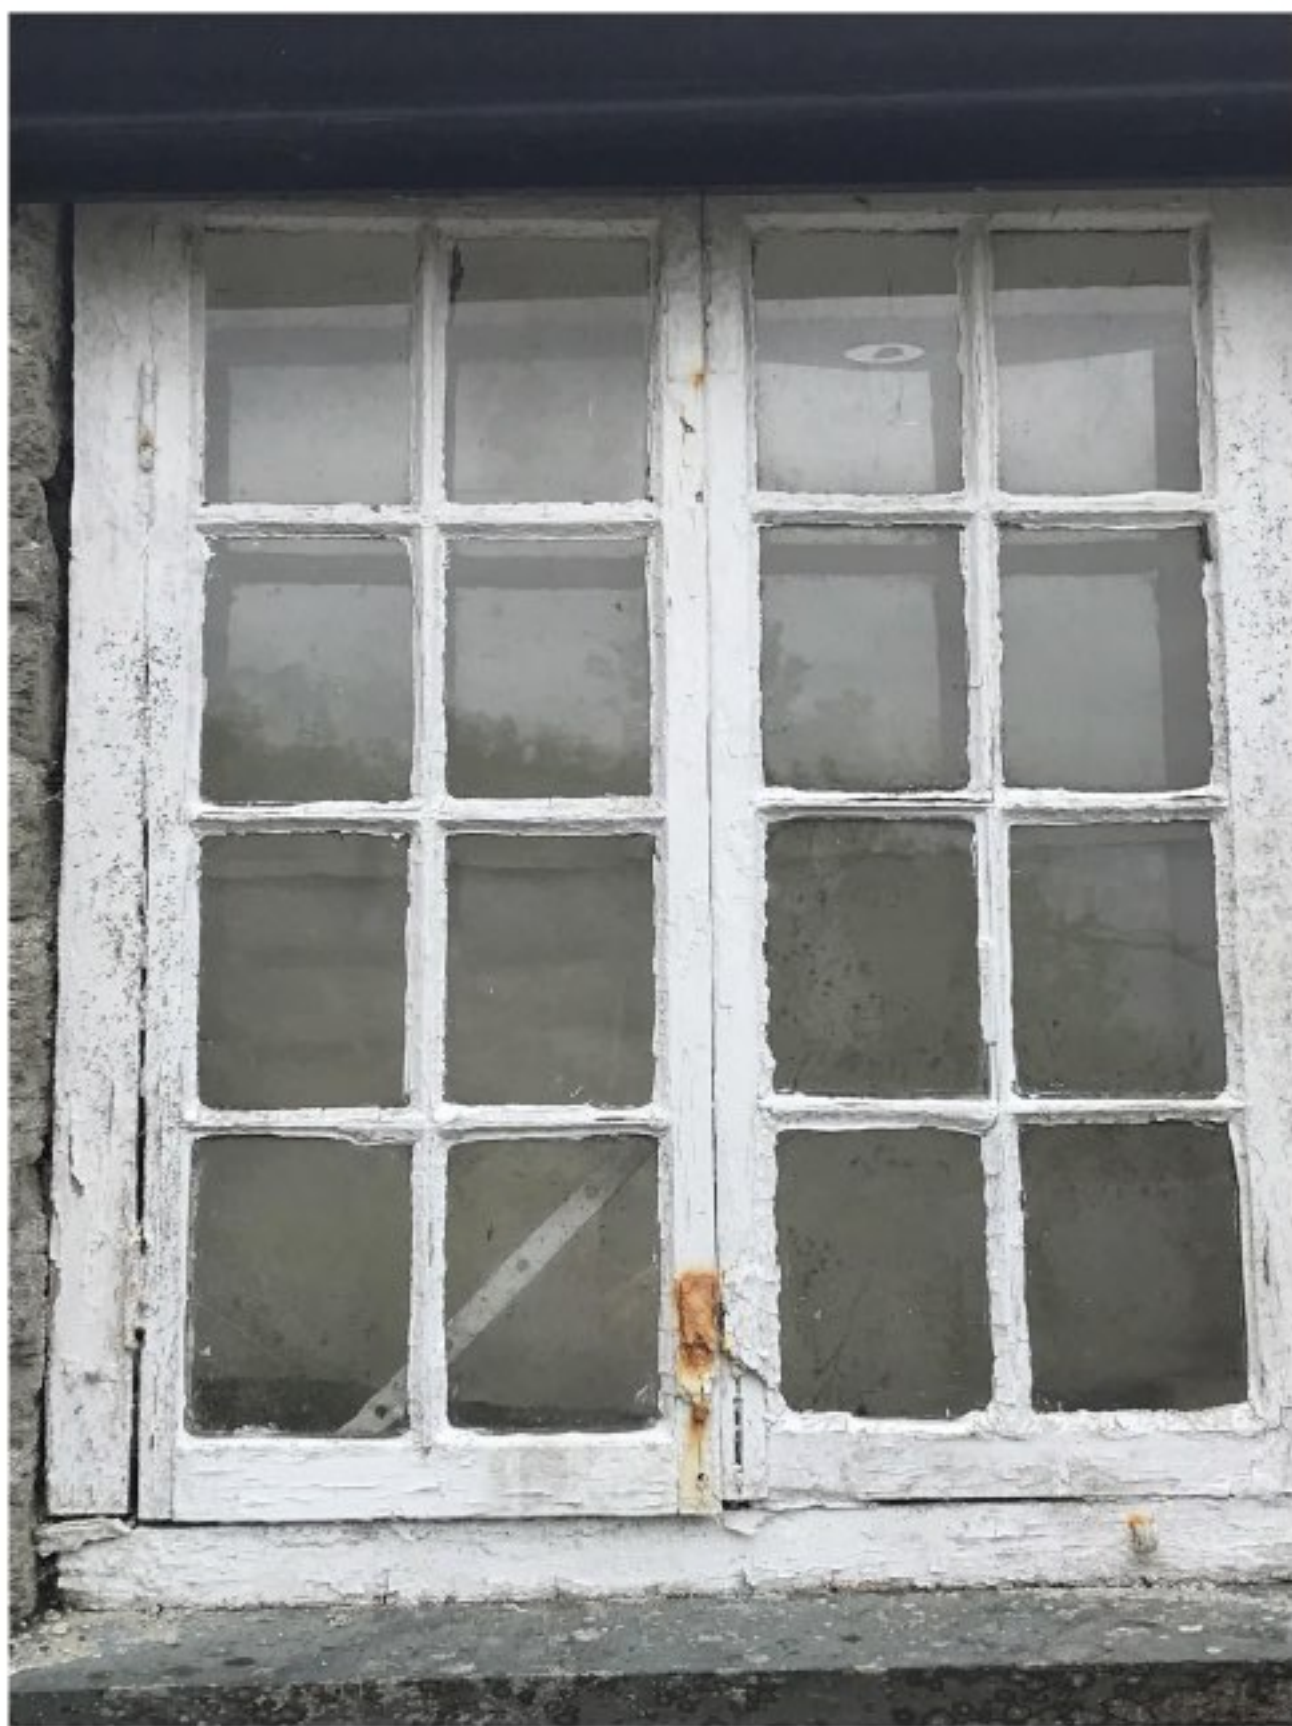
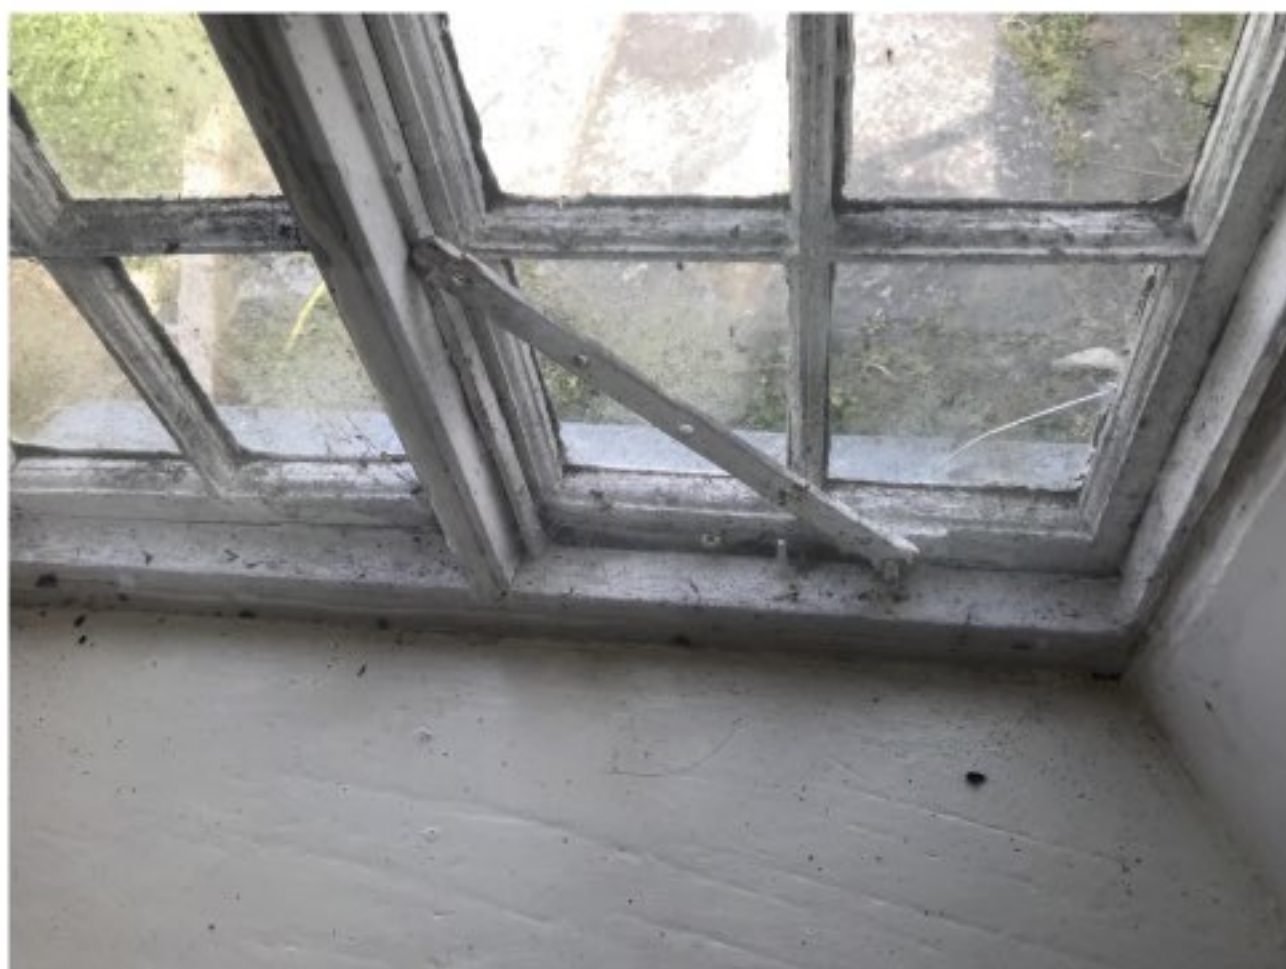
Images or rear bathroom window (location 4A):

Since the last Listed Building Consent, UPVC windows have all now been removed and replaced with single glazed hardwood framed replacements, in keeping with the original reference points and the approval. In addition to replacements careful maintenance has also been undertaken to various timber windows to prevent further decay. There are however two original windows that are considered to be beyond the point of restoration or repair.

These windows are suffering from rot and have clearly not been openable for many years. The first serves the rear bathroom (rear north elevation) and the second the rear bedroom 4 window (east elevation). The location of both is marked on the submitted floor plans.

The proposed work is to install two new opening screen casements formed in Iroko hardwood and glazed in 4mm single clear float glass. Profile and elevation of replacements to be copied off originals and manufactured to match. The opening casements to bedroom 4 will be hinged off the centre mullion as the original does.

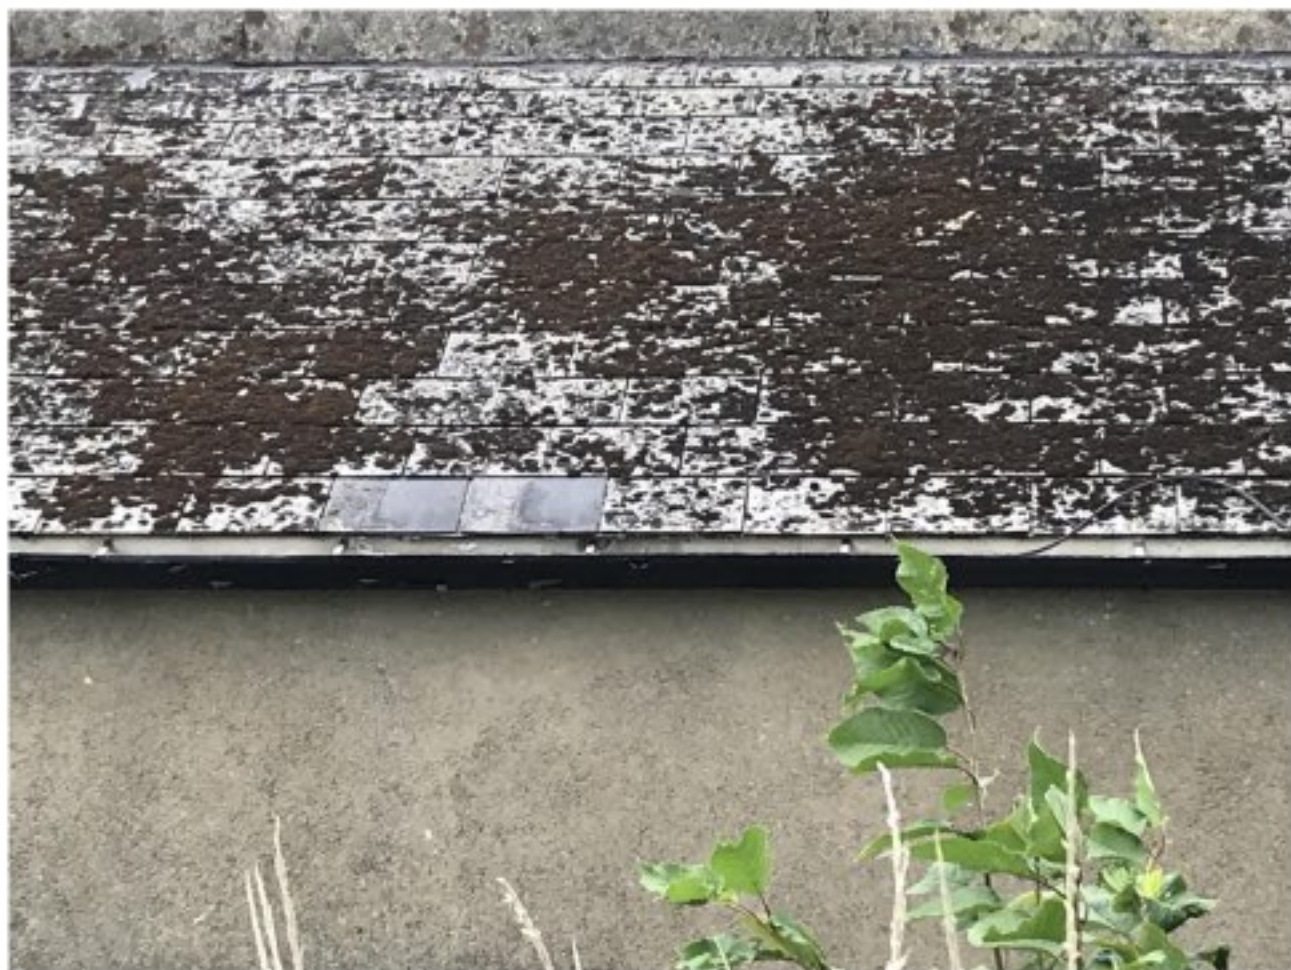
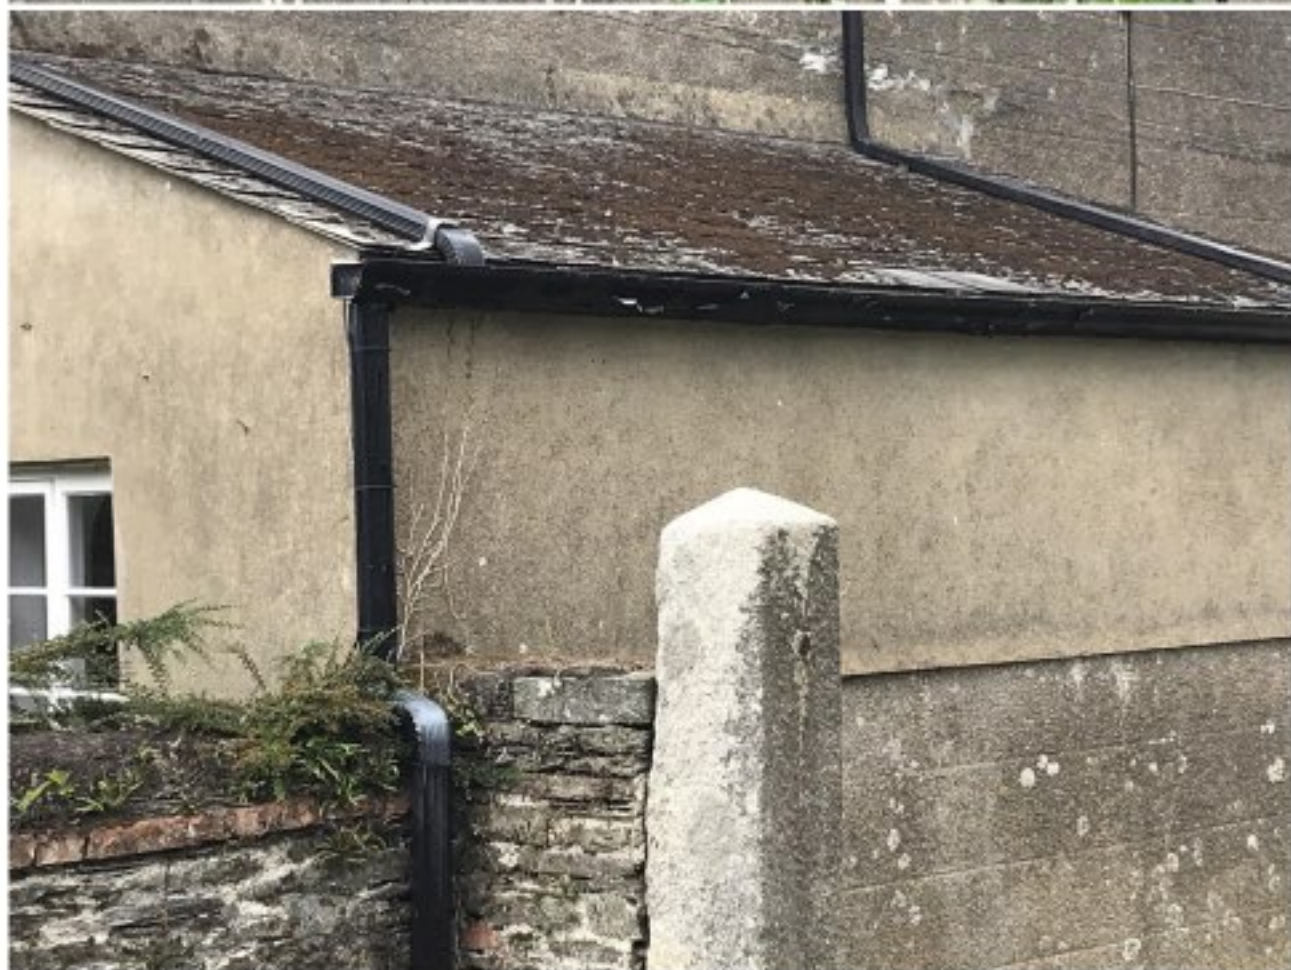
Images of current roof finish:

This lean to roof currently has a 20th artificial slate finish, with poor quality aluminium OG profile gutter and rectangular down pipes, with a wavy surface texture.

The proposed repair works will involve complete removal and replacement with Delabole slates on treated battens. A new code 4 lead flashing will be introduced at the junction with the main house wall, with a 150mm upstand.

Defective non-original gutters and down pipes will be replaced with new Marley Alutec traditional black aluminium half round profile guttering, down pipes and hoppers. There is clear evidence from render marks that the original downpipes discharged to the rear. The proposal is to restore this arrangement, please see photo below and submitted drawing.

Slates will be sized to match those of the main house roof and be fixed in accordance with BS:5534: Part 1; rev 1990, and BS:8000 Slating and Tiling Workmanship.

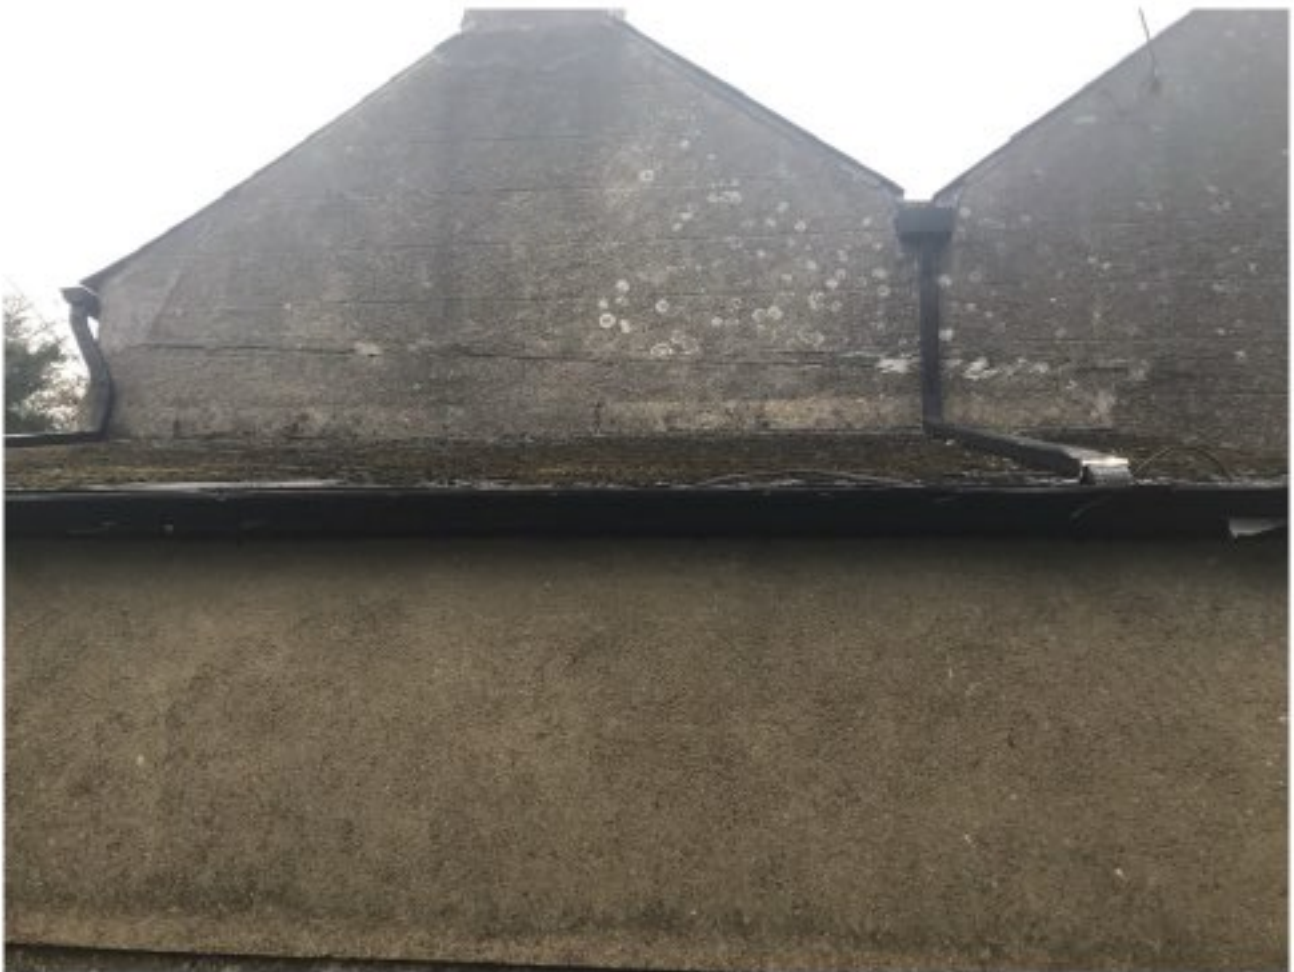
Above photo shows line of old rainwater discharge pipe marked on gable end render.
