Asbestos Survey Report 10/06/2021

Refurbishment Survey

nS8633
Specified areas of 104 Hythe St
104 Hythe St
Dartford
DA1 1BW

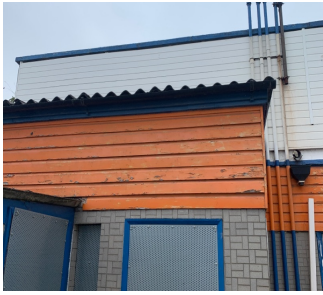
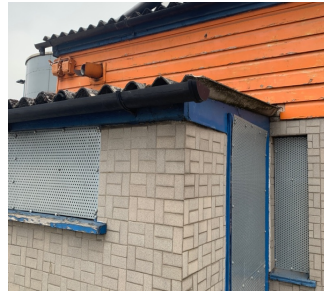
Item ID	001(OS)
Sample/link ID	001
Property Name	Specified areas of 104 Hythe St
Area/floor	002
Room/location	001
Specific location	Other Roof panels
Product/debris type	Cement Product(s) Corrugated Profile Sheet(s)
Asbestos type	Identified Chrysotile
Extent	12 m ²
Accessibility/vulnerability	Very low
Additional information	Not Sealed
Licensed/non-licensed	Non-licensed
R&D Element:	Yes
Air Test	-

Product Type (a)	1
Extent of Damage (b)	1
Surface Treatment (c)	1
Asbestos Fibre (d)	1
Total (a+b+c+d)	04
Material Risk Assessment	■ Very Low

Action/recommendations	Remove ACM before Refurb. Work under PCC by FLC
------------------------	-------------------------------------------------

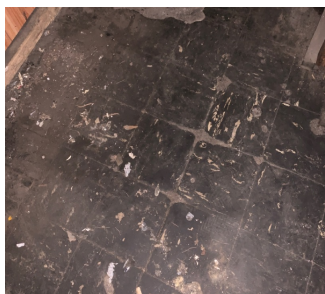
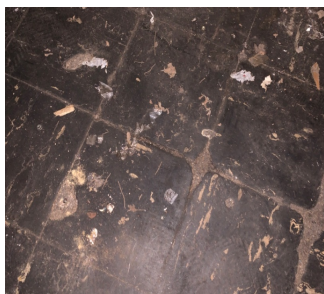
Item ID	002(OS)
Sample/link ID	002
Property Name	Specified areas of 104 Hythe St
Area/floor	001
Room/location	002
Specific location	Floor
Product/debris type	Flooring Floor Tile(s)
Asbestos type	Identified Chrysotile
Extent	20 m ²
Accessibility/vulnerability	High
Additional information	Sealed
Licensed/non-licensed	Non-licensed
R&D Element:	Yes
Air Test	-

Product Type (a)	1
Extent of Damage (b)	1
Surface Treatment (c)	0
Asbestos Fibre (d)	1
Total (a+b+c+d)	03
Material Risk Assessment	■ Very Low

Action/recommendations	Remove ACM before Refurb. Work under PCC by FLC
------------------------	-------------------------------------------------

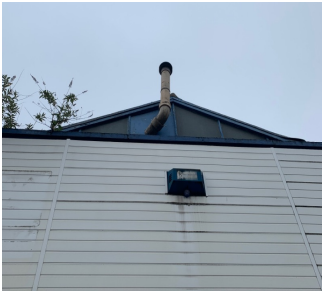
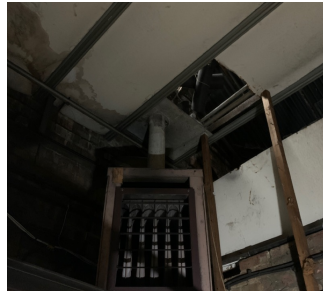
Item ID	005
Property Name	Specified areas of 104 Hythe St
Area/floor	001
Room/location	004
Specific location	Other Flue
Product/debris type	Cement Product(s) Flue Pipe
Extent	4 m
Accessibility/vulnerability	Very low
Additional information	Not Sealed

Product Type (a)	N/A
Extent of Damage (b)	N/A
Surface Treatment (c)	N/A
Asbestos Fibre (d)	N/A
Total (a+b+c+d)	12
Material Risk Assessment	■ High

Continues to outside of building

Action/recommendations Remove ACM before Refurb. Work under PCC by FLC

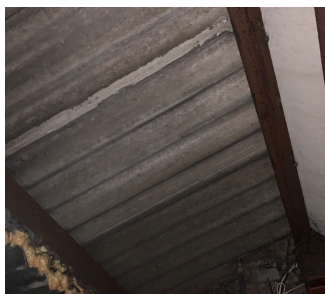
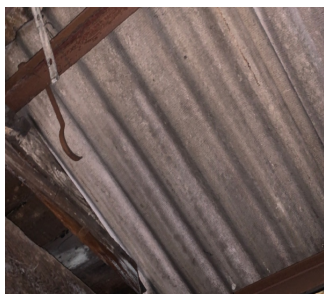
Item ID	003(VRS)
Sample/link ID	001
Property Name	Specified areas of 104 Hythe St
Area/floor	001
Room/location	004
Specific location	Other
Product/debris type	Cement Product(s) Corrugated Profile Sheet(s)
Asbestos type	Identified Chrysotile
Extent	6 m ²
Accessibility/vulnerability	Very low
Additional information	Not Sealed
Licensed/non-licensed	Non-licensed
R&D Element:	Yes
Air Test	-

Product Type (a)	1
Extent of Damage (b)	1
Surface Treatment (c)	1
Asbestos Fibre (d)	1
Total (a+b+c+d)	04
Material Risk Assessment	■ Very Low

Remove ACM before Refurb. Work under PCC by FLC

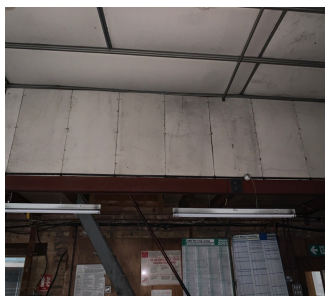
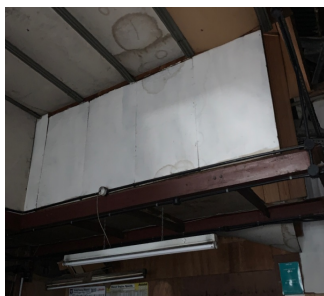
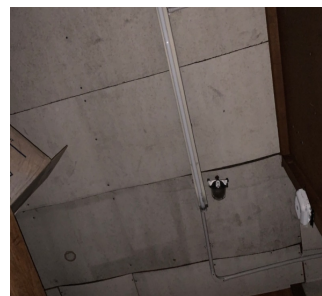
Item ID	004(OS)
Sample/link ID	003
Property Name	Specified areas of 104 Hythe St
Area/floor	001
Room/location	004
Specific location	Other Ceiling & wall panels to stairs and mezzanine floor
Product/debris type	Cement Product(s) Corrugated Profile Sheet(s)
Extent	20 m ²
	■ No Risk
