JP Chick & Partners Ltd
Consulting Civil & Structural Engineers

Fring Barn Complex

VISUAL STRUCTURAL INSPECTION REPORT FOR PLANNING

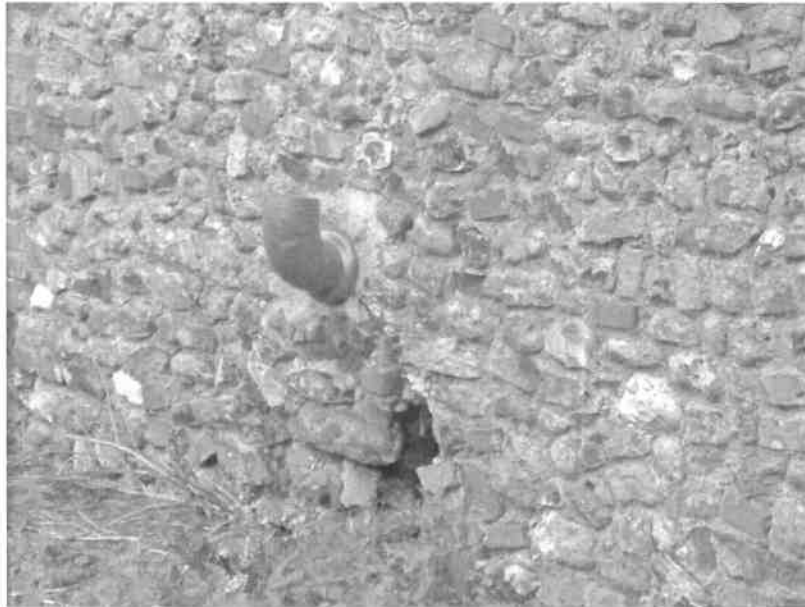
The walls generally appear fairly plumb along the entire length, with only some minor undulations recorded which is to be expected. At lower level there are a number of small voids caused by missing flint / bricks etc, and there is some minor weathering of joints between the flintwork and brick quoins surrounding the central entrance doorway. Further weathering of joints can be seen in the far internal southwest corner where rainwater pipes currently discharge to ground, as well as an additional small void adjacent to the penultimate pipe vent (see photograph 1).

P1: Southern single storey barn: Small void at low level to courtyard facing north elevation

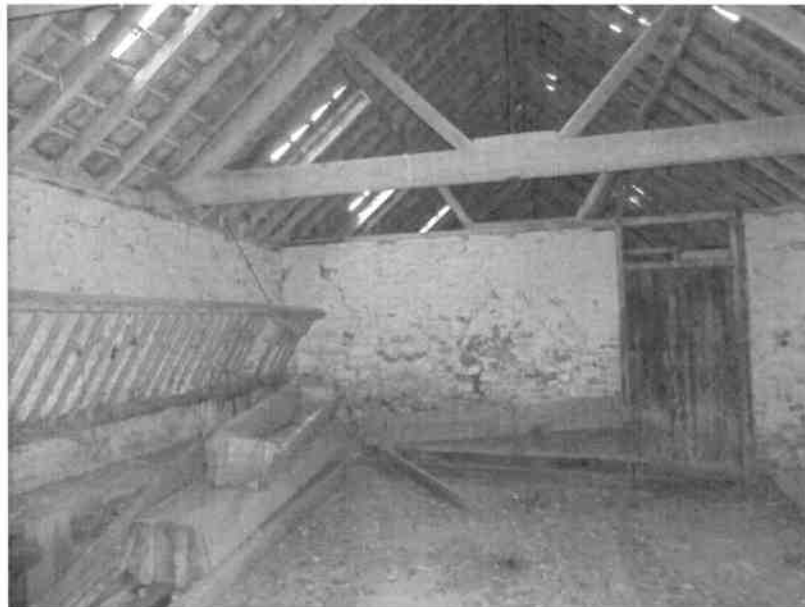
The internal walls again consist of a combination of brickwork, flintwork, and also chalk blocks generally between the vertical masonry quoins. The internal faces are generally well weathered. Of note is that along the barn are a number of lateral walls extending up to eaves level only, and at the junctions with the perimeter walls there is evidence of historic lateral movement whereby diagonal cracks vary between 5mm and 15mm in width are present to the majority of the lateral walls. A number of them also have localised minor cracking within the infill materials themselves. The internal materials are generally of a poorer standard than those used externally (see photograph 2).

P2: Southern single storey barn: Typical cracking due to lateral movement is evident to a number of cross walls at junction with perimeter walls

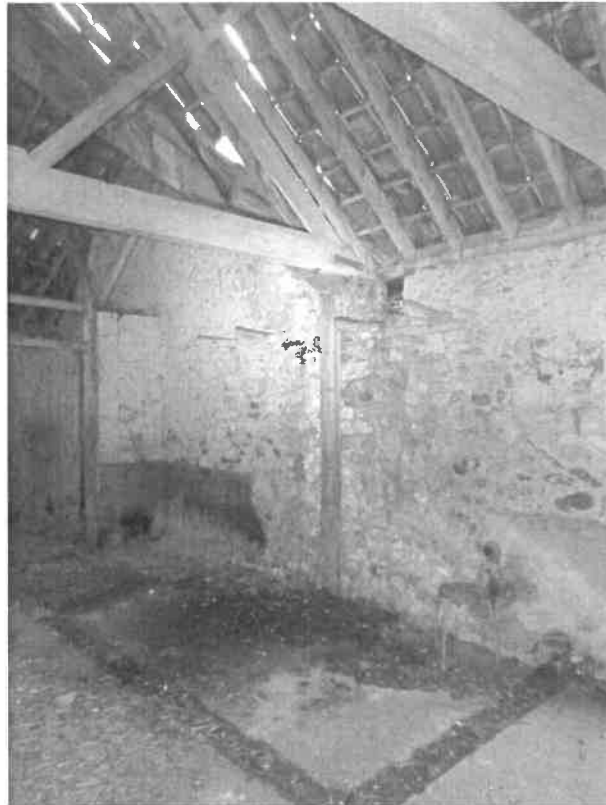
Towards the west corner there is more evidence of localised water ingress and this has caused some weathering of the infill panels immediately beneath. Some voiding and loss of section as a result is evident. Weathering is particularly poor at the bottom end of the internal valley (see photograph 3)

P3: Southern single storey barn: Leakage through roof at bottom of rotten valley member causing localised washout of mortar to walls

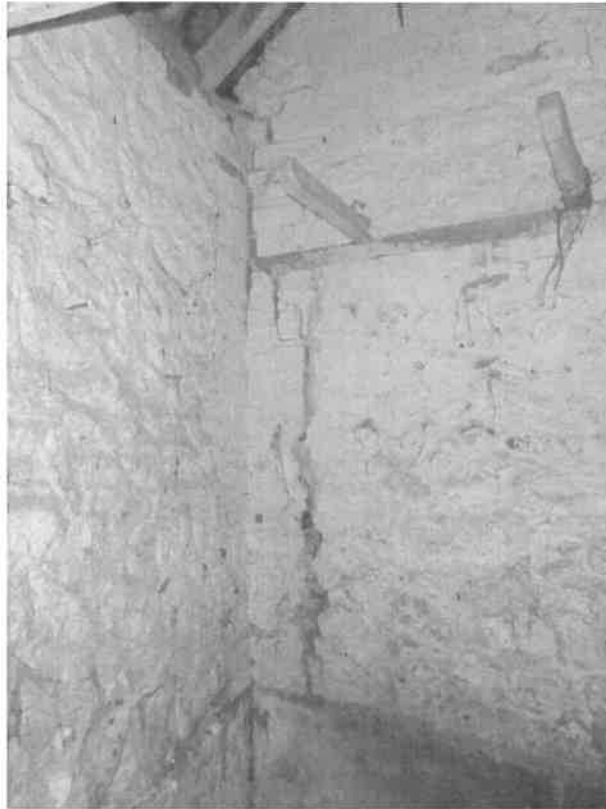
To the far south west corner, at the junction of the full height gable masonry of the West Wing there is evidence of more significant lateral movement of the eaves level wall, in the region of 30mm to 40mm. This does tie in with the distortions noted externally along this elevation (see photograph 4).

P4: Southern single storey barn: Lateral movement of between 30mm to 40mm evident to internal gable masonry at junction within west wing

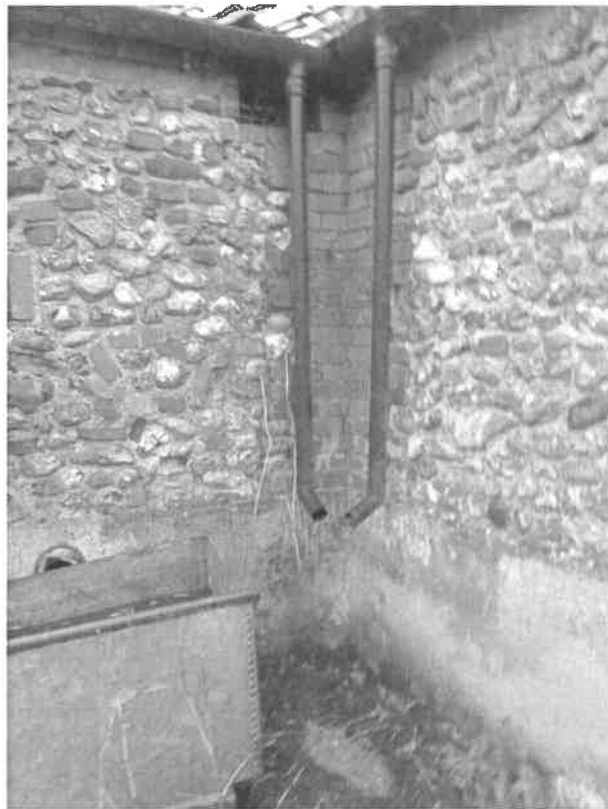
To the courtyard facing elevation there is localised displacement of tiles approximately $\frac{3}{4}$ of the way along its length towards the internal south west corner. The valley immediately above this corner is also in poor condition with slipped tiles and leakage through the filled in gutters generally. Of note is that the courtyard facing elevation does have guttering, but the downpipes can be seen to discharge direct to ground, or in overfilled galvanised troughs (see photograph 5).

P5: Southern single storey barn: Poor roof detailing to valley of courtyard facing return

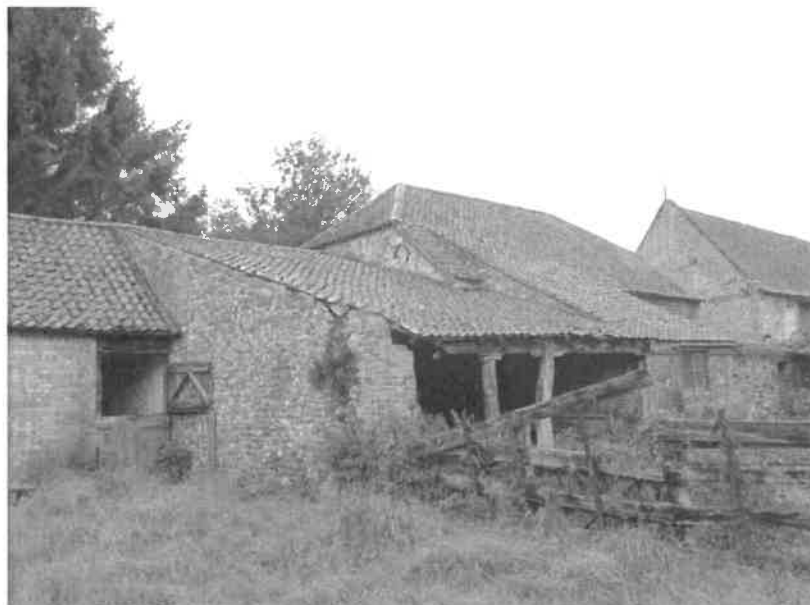
The central lean-to section is an open fronted cart lodge arrangement, whereby traditional timber posts bearing on plinths support eaves beams over. Of note is that the furthestmost beam has rotted away completely and this has led to localised deflections of the roof, and lateral movement of the eaves level masonry. Ingress of vegetation has also caused localised weathering (see photograph 6).

P6: West Wing: Rotten eaves beam to central lean-to section with localised cracking / voiding and vegetation growth

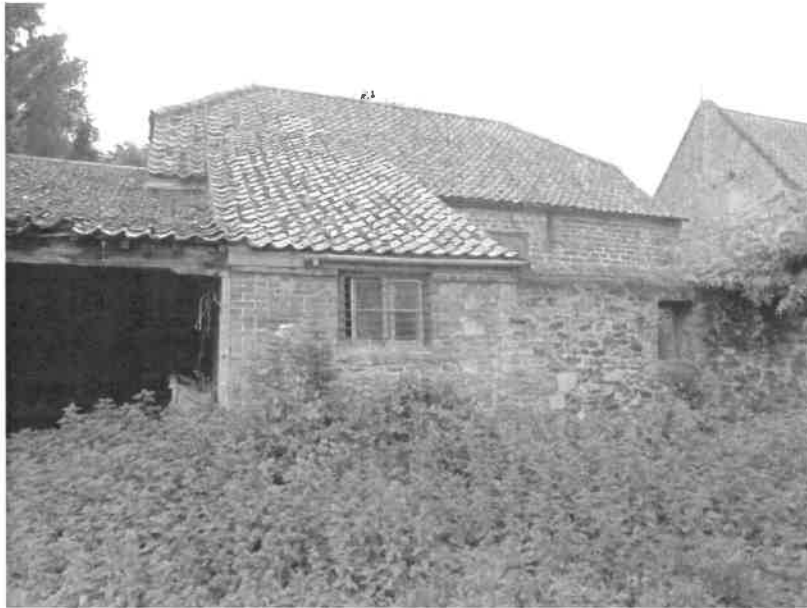
The two storey barn can be found to the furthest north west corner of the barn complex. There is a small single storey lean-to on the courtyard facing elevation, and this has particularly weathered masonry around the window openings. The wall then continues to form part of the main boundary wall of the courtyard. This is in similar condition, albeit obscured by vegetation at low level (see photograph 7).

P7: West Wing: Cracking and weathered masonry to courtyard facing lean-to

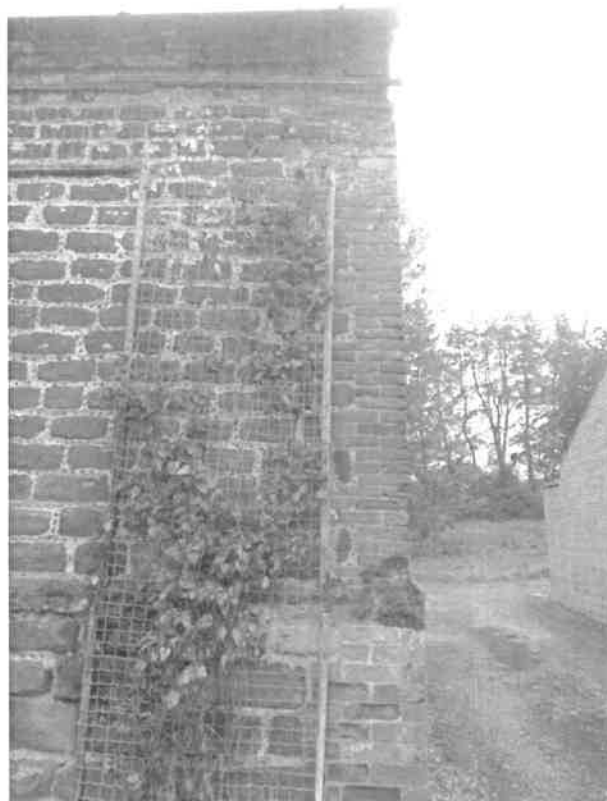
The remainder of the two storey section is constructed in part red brick masonry, part carrstone and flintwork infill. General weathering of the lime mortar to the infill panelling, as well as some minor cracks above the arched lintel were recorded, together with weathered / spalling of individual brick faces. There is a degree of lateral movement of the eaves level masonry outwards to the far north, courtyard facing elevation. Associated vertical cracking can also be seen at the east facing return and at the junction of the corner masonry quoin and the infill panel (see photograph 8).

P8: West Wing: Vertical cracking to north east corner of two storey barn

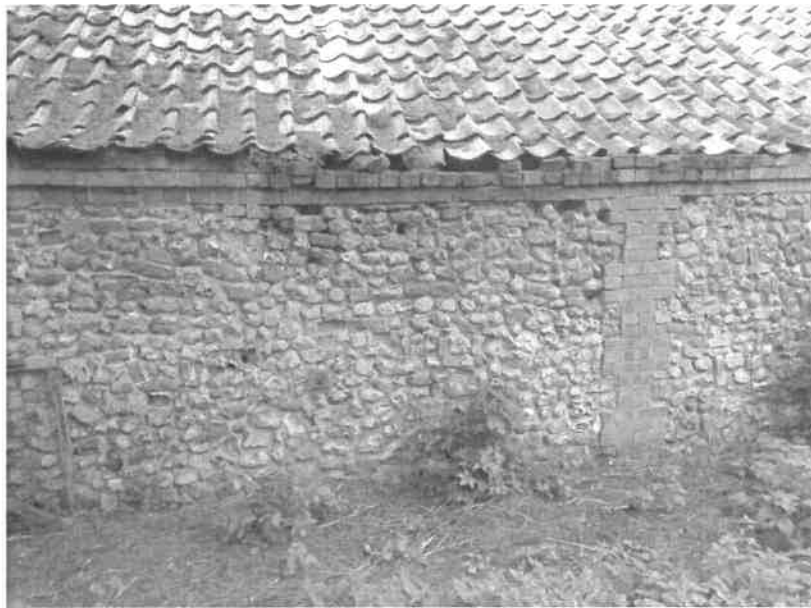
Of note is that ground levels are built up against the low level flint panels, and there is more obvious lateral movement outwards of the panels as a whole. At the worst point we consider lateral movement at eaves level is 50mm. Historic ties have been inserted towards the two storey element, and there is localised damage visible to the eaves level corbelled masonry too (see photograph 9).

P9: West wing: Lateral movement and localised damage to eaves level corbelled masonry

As stated previously the west facing wall of the west wing is suffering from lateral movement and whilst the recorded 50mm is not insignificant, it is not uncommon for this type of structure. It would be prudent to undertake some localised trial pitting to confirm or otherwise whether ground movement is a contributory factor. We suspect extra provision for lateral ties, and external buttressing along the west elevation would prevent further progressive lateral movement occurring in this area.

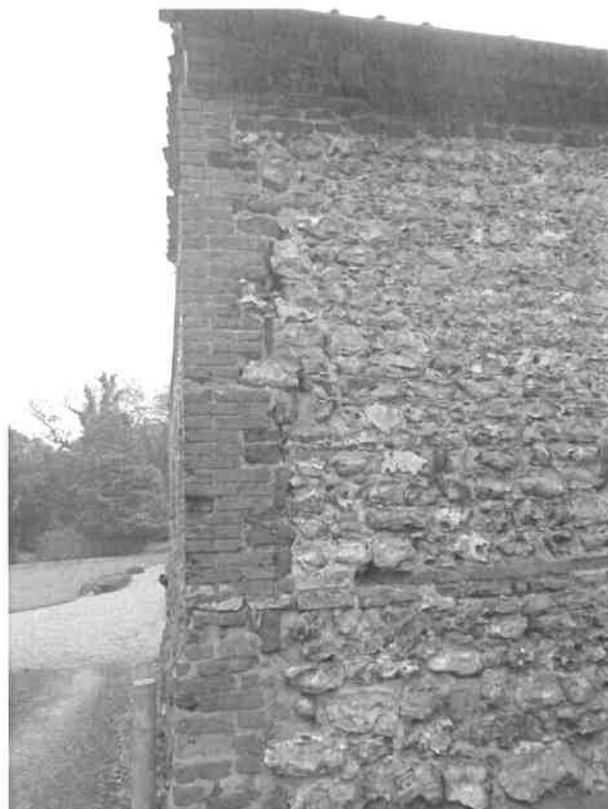
Immediately adjacent to the south west corner there is an historic 10mm wide vertical crack extending down from eaves level to approximately 1m above ground level. There is also evidence of previous repairs, i.e. cement fillet repairs having been undertaken, which is again evidence of historic damage (see photograph 10).

P10: West Wing: Washout of masonry and debonded historical cement fillet repairs at junction between single and two storey sections of west elevation

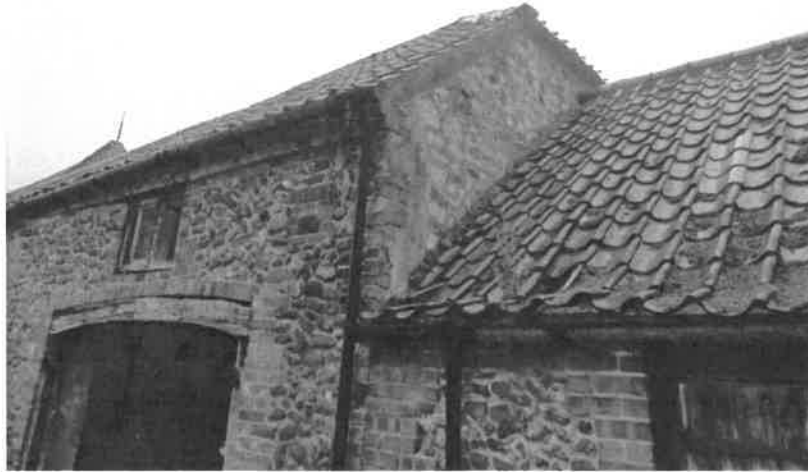
Immediately above the arched timber lintel forming the main opening into this elevation there are large diagonal cracks, maximum 30mm in width extending upwards from both corners. There is evidence of

decayed and rotten timber post ends which have been partially remediated in the past, but we suspect these have dropped causing the localised lintel movement above (see photograph 11).

P11: West Wing: Significant diagonal cracking above main arched opening into two storey barn section

Localised failure of individual lintels is easily remedied through either replacement of the rotten elements, or the provision of HeliBars and Cementies. The significant cracking adjacent to the arched opening to the workshop of the two storey element will require a replacement beam and likely localised reconstruction of the section of masonry above.

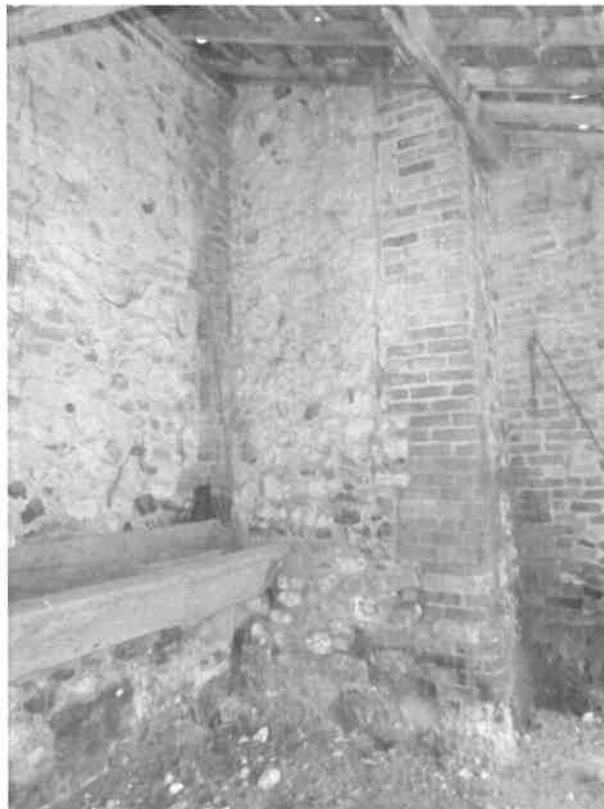
Within the open cart section there are a number of large vertical cracks in the region of 15mm to 20mm extending virtually full height within the infill panels themselves, as well as at the junction between the corner masonry quoins (see photograph 12). Weathering has also occurred, particularly at low level due to historic water ingress. There may be a degree of localised ground related movement occurring as a result of the significant water ingress currently occurring.

P12: West Wing: Vertically cracking within flintwork panels and corner quoins within lean-to section

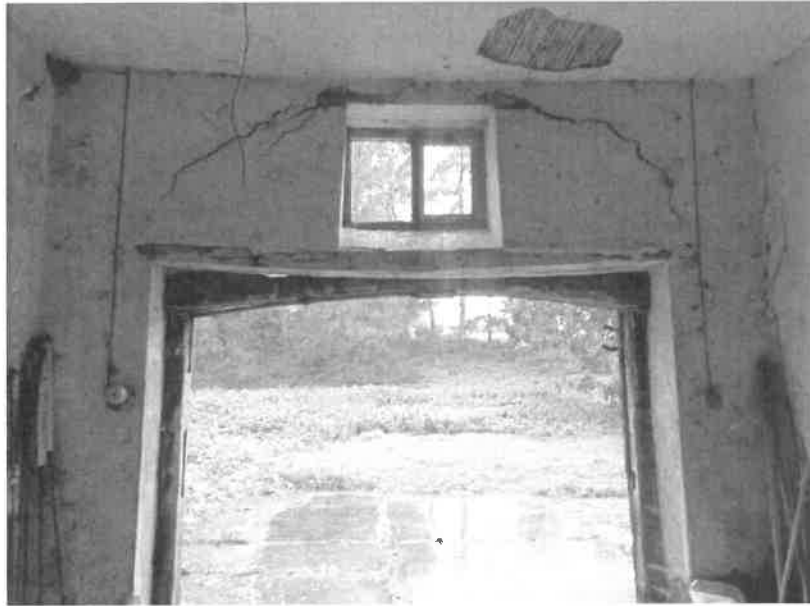
Above the rotten curved beam the large diagonal cracks recorded externally are visible (see photograph 13). The large vertical crack recorded to the south west corner of the workshop mirrors that recorded externally.

P13: West Wing: Diagonal cracking above arched timber lintel within workshop
