JP Chick & Partners Ltd
Consulting Civil & Structural Engineers

Fring Barn Complex

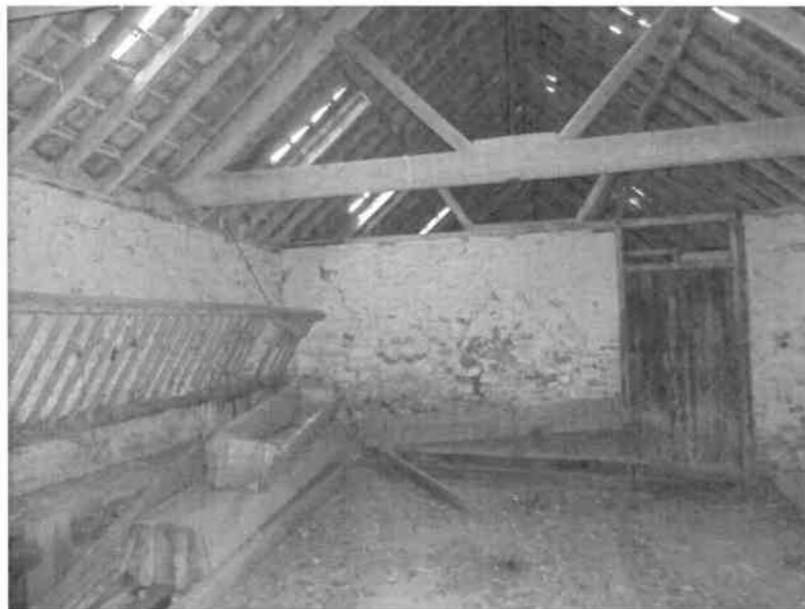
P2: Southern single storey barn: Typical cracking due to lateral movement is evident to a number of cross walls at junction with perimeter walls

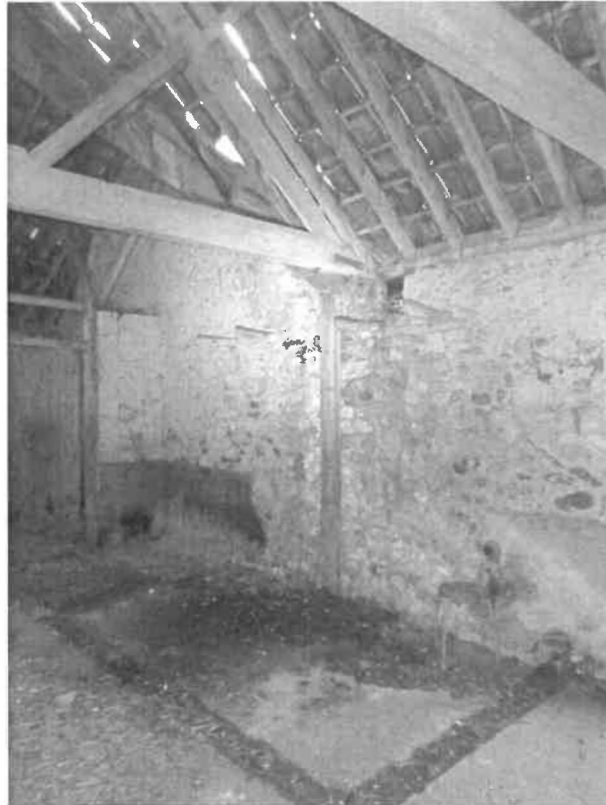
P3: Southern single storey barn: Leakage through roof at bottom of rotten valley member causing localised washout of mortar to walls

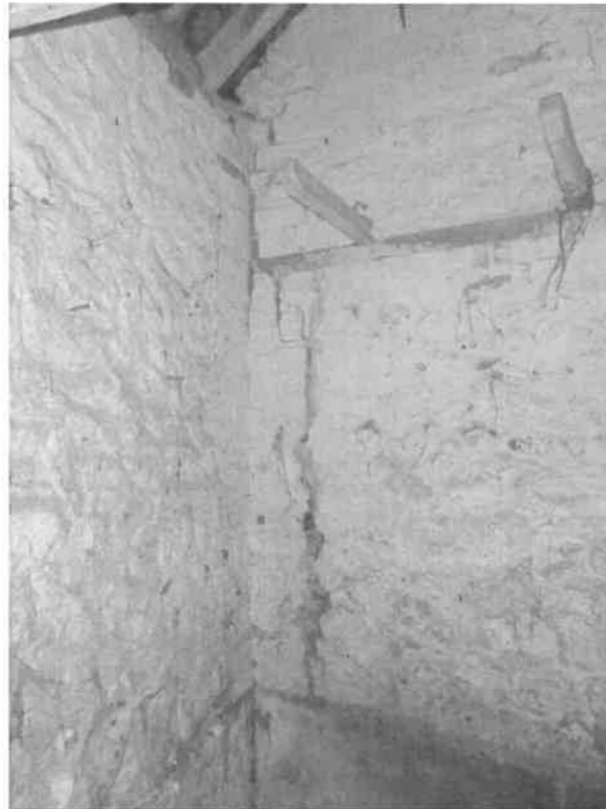
P4: Southern single storey barn: Lateral movement of between 30mm to 40mm evident to internal gable masonry at junction within west wing

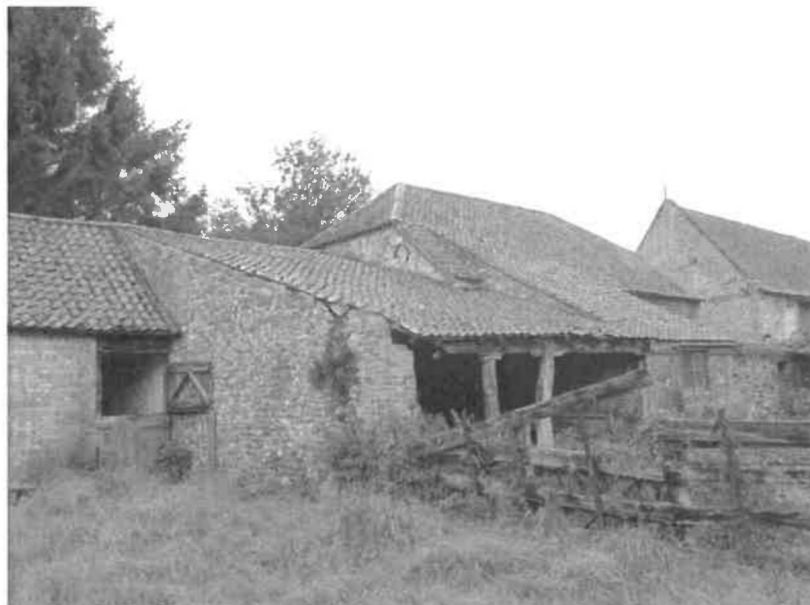
P6: West Wing: Rotten eaves beam to central lean-to section with localised cracking / voiding and vegetation growth

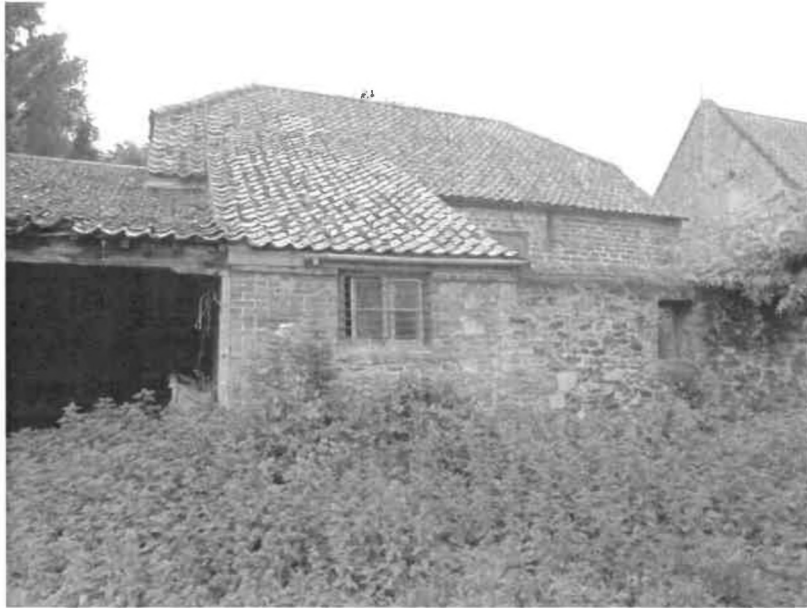
P7: West Wing: Cracking and weathered masonry to courtyard facing lean-to

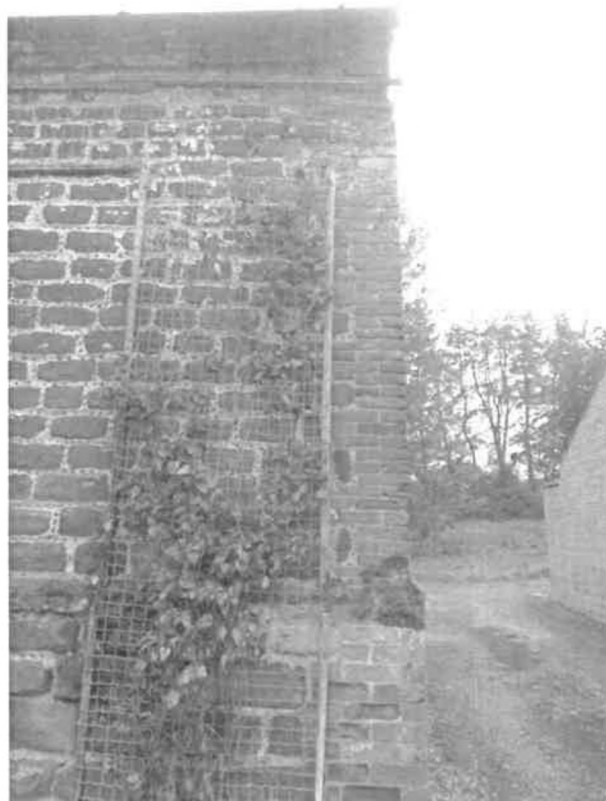
P8: West Wing: Vertical cracking to north east corner of two storey barn

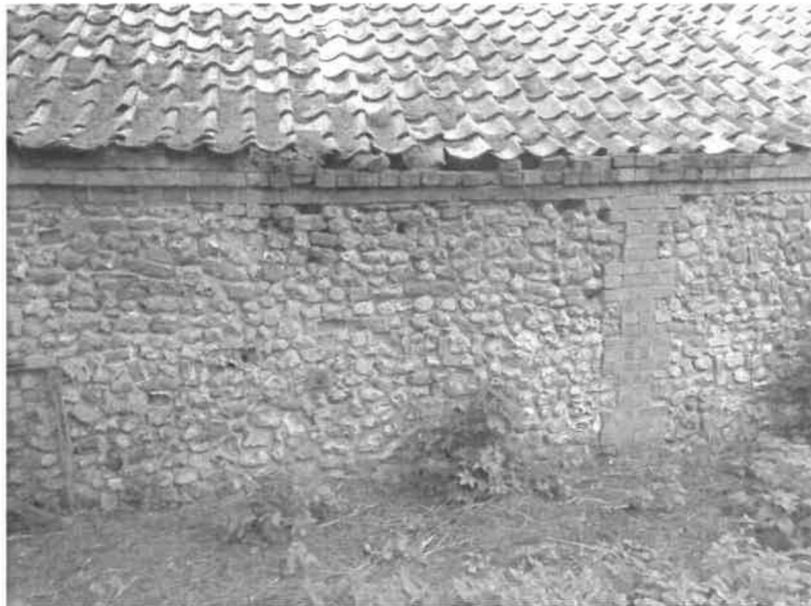
P9: West wing: Lateral movement and localised damage to eaves level corbelled masonry

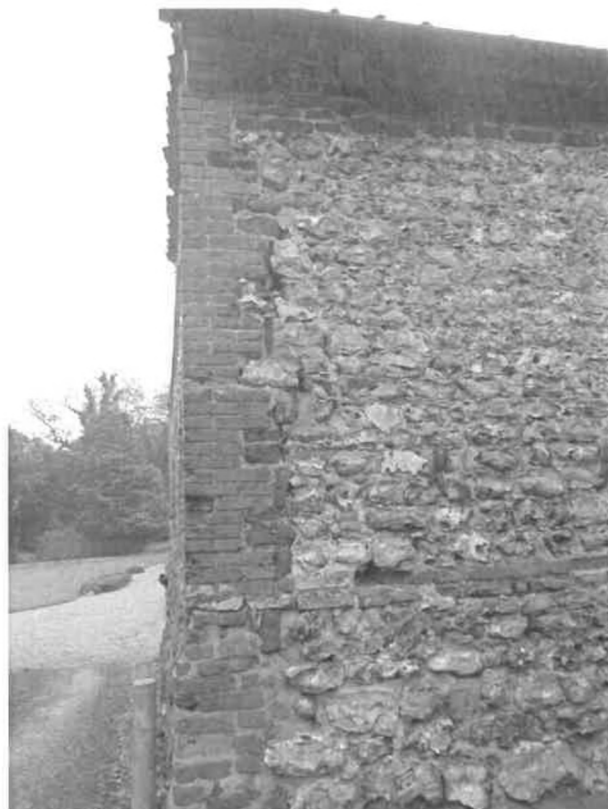
P10: West Wing: Washout of masonry and debonded historical cement fillet repairs at junction between single and two storey sections of west elevation

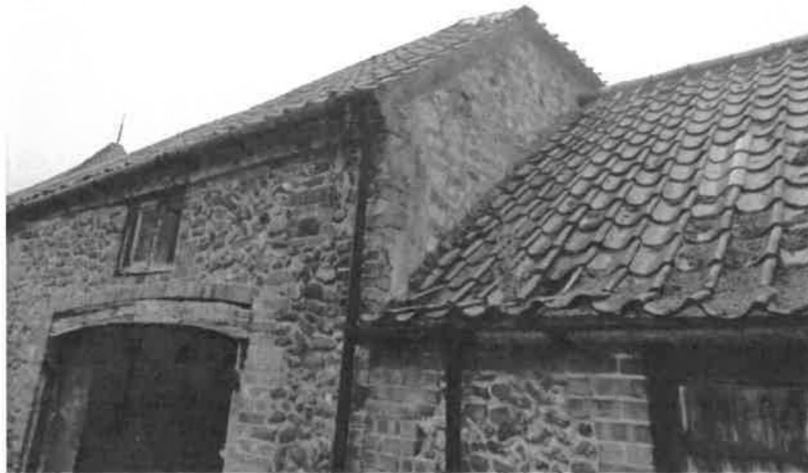
P11: West Wing: Significant diagonal cracking above main arched opening into two storey barn section

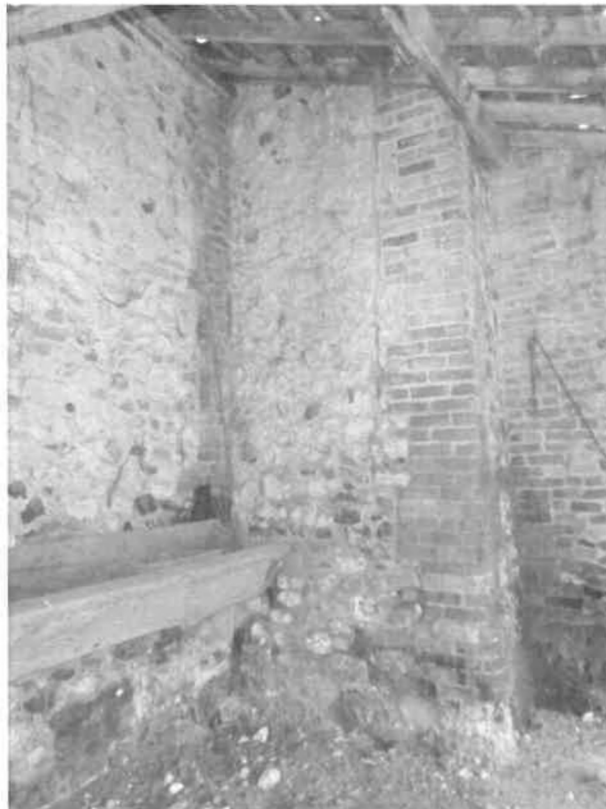
P12: West Wing: Vertically cracking within flintwork panels and corner quoins within lean-to section

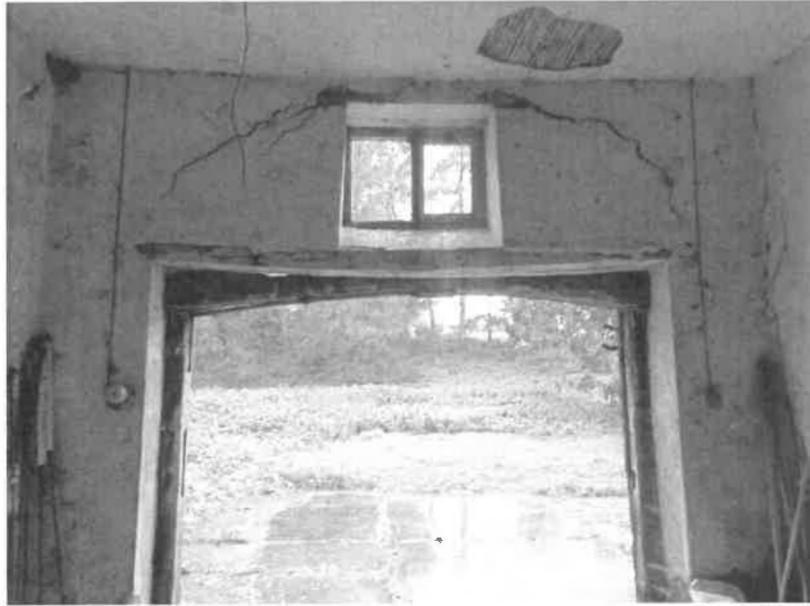
P13: West Wing: Diagonal cracking above arched timber lintel within workshop
