Old Arngrove Farm, Horton-cum-Studley, Buckinghamshire: An Historic Building Record Report

Planning Applications: 18/02901/APP & 18/02902/ALB

AOC Project No: 33927

Date: 9th December 2021

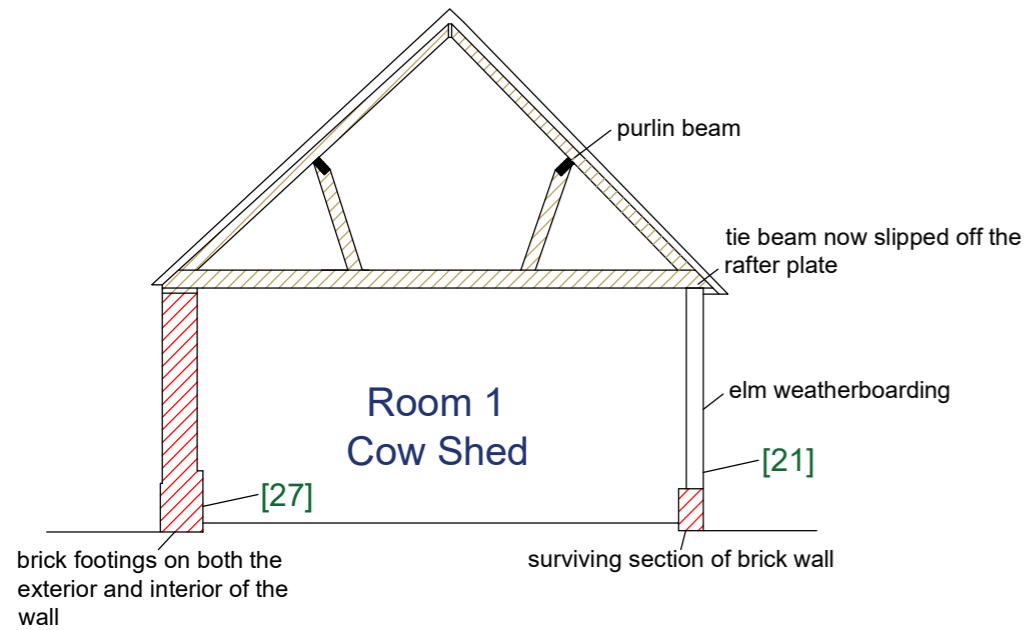
Figure 17: Section A-A, south-east facing section of Truss B

There are four roof trusses ([30]) in this building, Trusses A – D (**Figure 17**). As noted above, the south-west side of the tie beam is supported by the brick buttresses set within wall [27], although to the north-east side they are resting on the rafter plate (**Plates 85 – 87**). None of the tie beams are slotted into the wall structure, which has prevented them from potential further decay from potential damp (Floyd Consult 2018, 2). However the tie beams of Trusses A and B have slipped off the

- 6.4 Internally, the Cow Shed, Room 1, is in a very poor state with the four roof trusses, especially Trusses A and B, subject to slippage off the rafter plate removing its support for the roof. The trusses all appear to be contemporary and there is little evidence of re-use of the timbers which are joined via mortice slots. With the exception of the roof rafter on the south-west side (see [Plates 93 & 94](#)), the scratches noted on the tie beams in Rooms 1 and 2 may be simply scratch marks, or signs of working in the building. The deteriorating conditions of the timbers have required some additional strengthening and support, especially to the south-west wall, where additional timber blocks were placed between the tie beam and the rafter (see [Plate 78](#)). An additional post was also added to support the tie beam (see [Plates 88 & 89](#)). The trusses are all constructed of oak, although the weatherboarding is comprised of elm and birch with additional softwood and some oak elements (Floyd Consult 2018, 3:8).

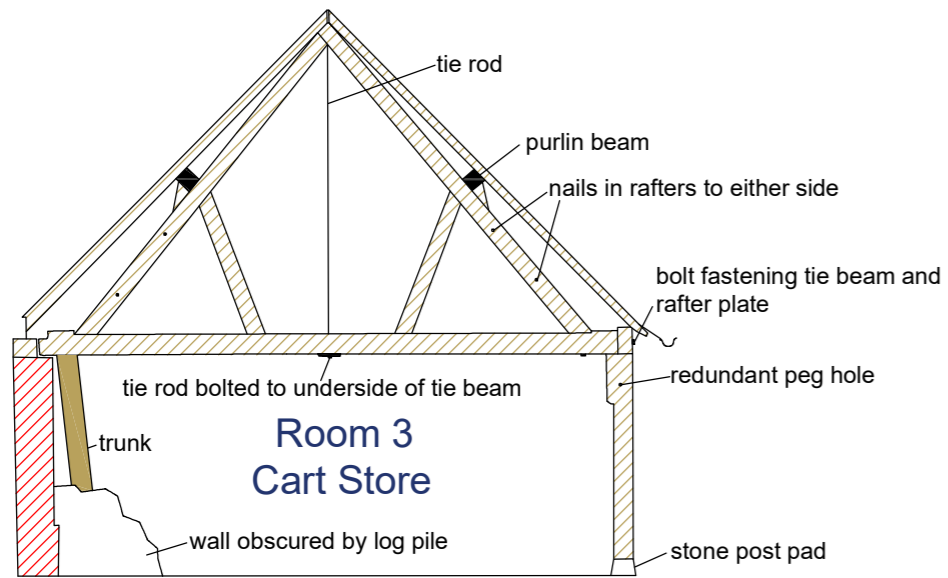
Figure 19: Section C-C, north-east facing section of Truss G

As noted above, there is one timber roof truss ([38]) in this room, Truss G (Figure 19; Plates 122 & 123). On the north-west side, the tie beam is supported on the aforementioned post and, to the south-east side, it is supported by the brick buttress in wall [36]. However, additional support is provided by a trunk which is set at an angle. It has two cross struts which support the outer rafters and an additional vertical tie rod which is attached to underside of the tie beam and where the rafters meet below the ridge beam (Plates 124 & 125). Where the outer rafters meet the purlin beam, there is further support added by a triangular timber wedge (Plate 126). The roof rafters rest over the purlin beam and there are no sarking boards here exposing the underside of the pantiles, which are all embossed with the manufactures mark, 'Steetley Acme' (Plate 127).
