Little Farm, Halsham
Structural Appraisal carried out by Griffin Toomes.

Structural REPORT

Outbuildings at

Little Farm, Halsham

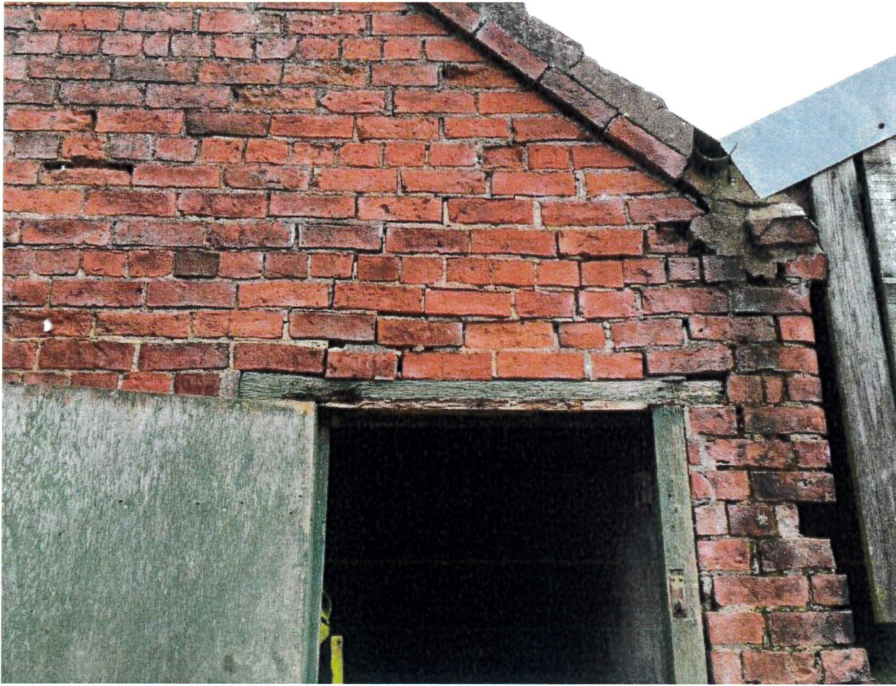
The western gable comprised a 225mm solid brick wall and had a single timber lintel door opening. The lintel had failed causing distortion of the brickwork above. This is now in an unstable condition.

Dislodge brickwork above door – South Elevation

All openings should be strengthened by the introduction of new lintels.

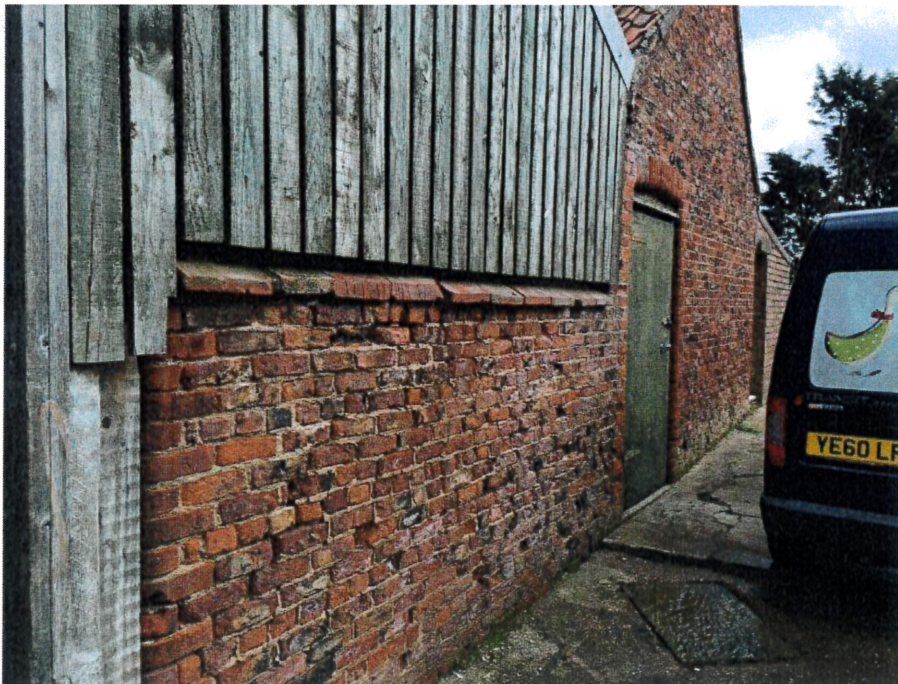
The external walls to the drying shed had significant weathering with loss of brickwork face in areas.

Weathered brickwork – South Elevation

All walls should be power washed and any defective bricks replaced. All joints should be re-pointed by an approved method.

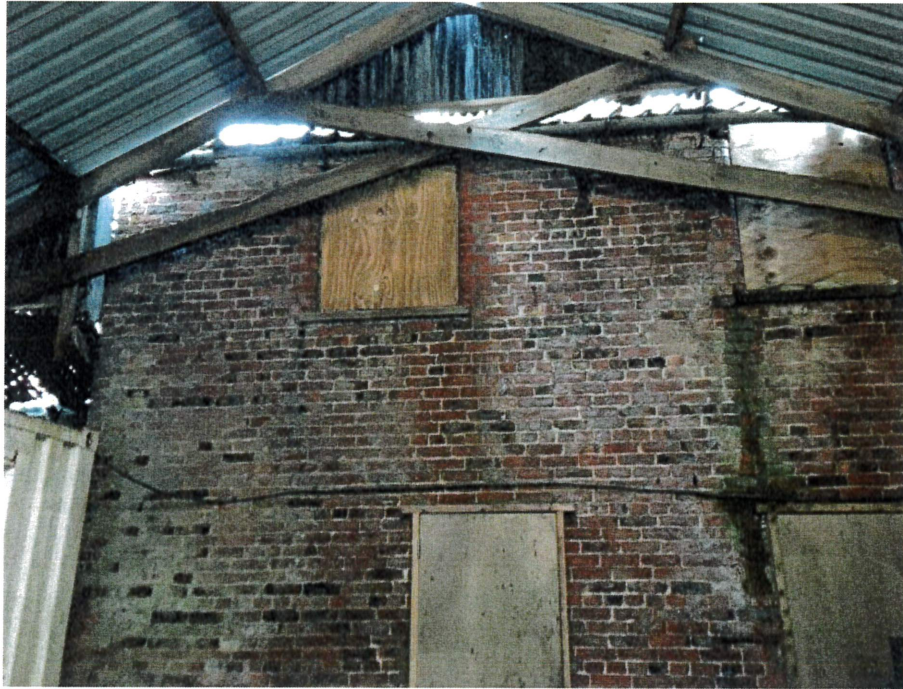
Rear Of Northern Barn Showing Infill Section

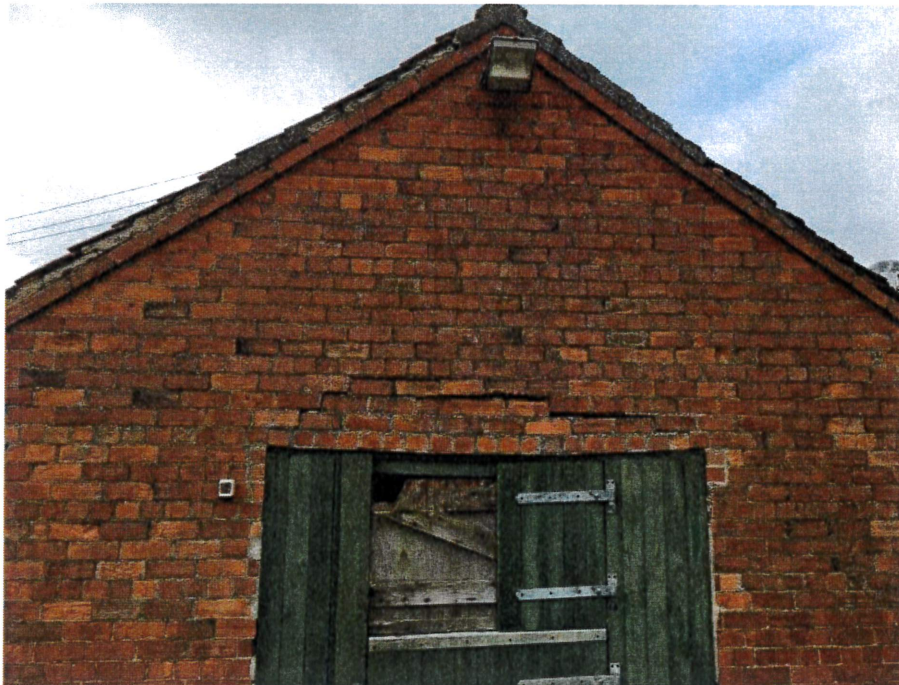
The timber lintel supports to the opening to the east has failed causing cracking and deformation to the supported brickwork above and it is now in an unstable condition.

Failed Lintel Above Door – East Elevation

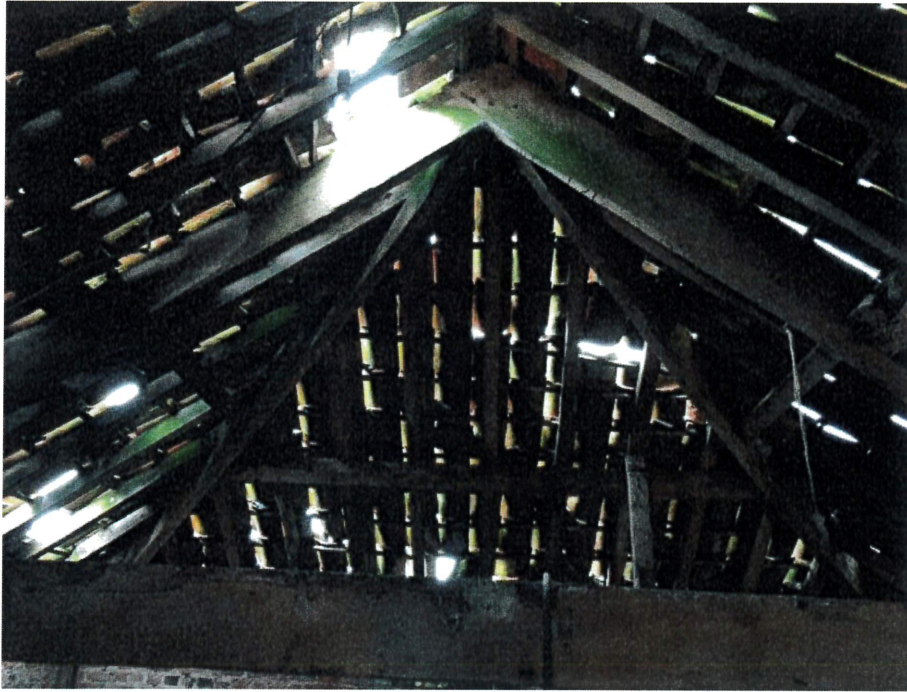
The roof remains original with no signs of refurbishment or repair. In areas there are signs of water ingress and the timbers are suffering decay with some areas indicating progressive failure.

Trusses and Roof Covering North Barn

All roofs should have the tiles removed and de-latted, The timber items can then be inspected for decay. In addition replacement and/or strengthening works will be required to some areas.

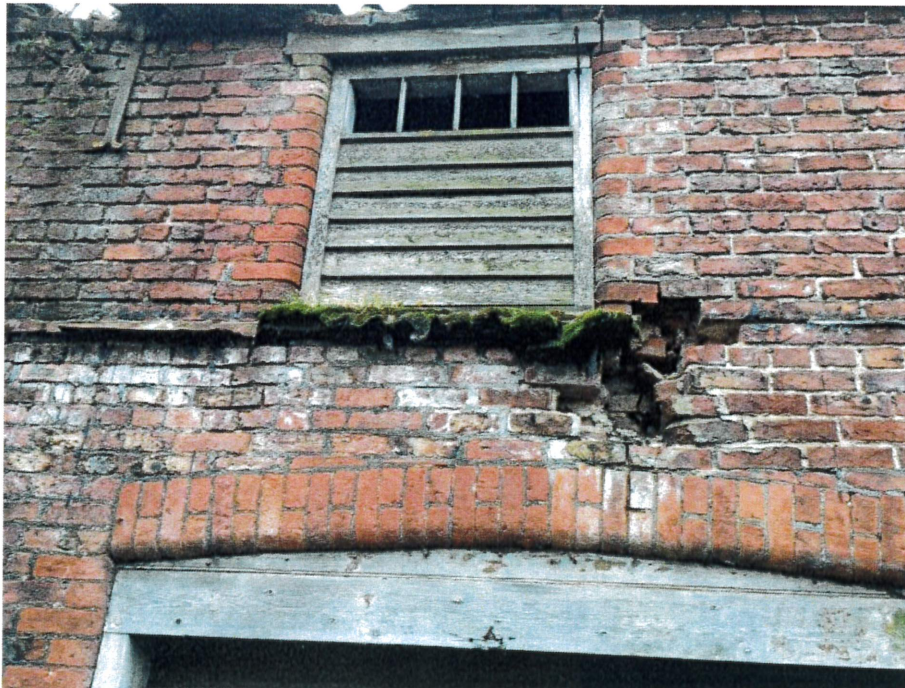
The brickwork on this elevation is badly weathered with a loss of brick section in areas and in one place a localised collapse. The corbelled eaves detail is missing in parts and generally in a poor condition.

Dislodged Brickwork In Wall Panel– North Elevation

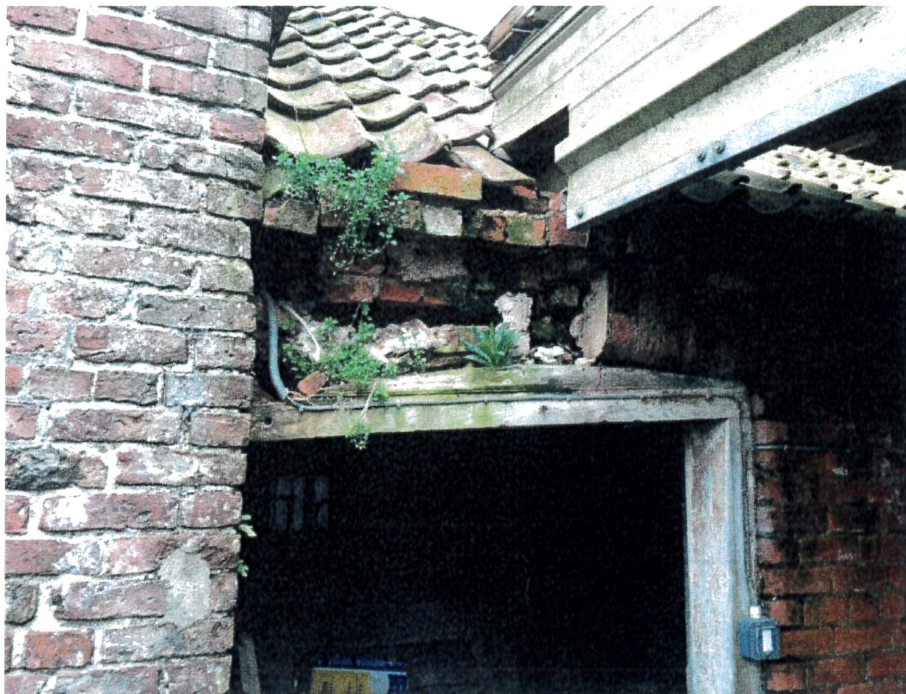
There was a single arched door opening to this section. The arch had failed with missing arch bricks. The structure above was supported by the remaining timber door frame.

Failed Arch Above Door– North Elevation

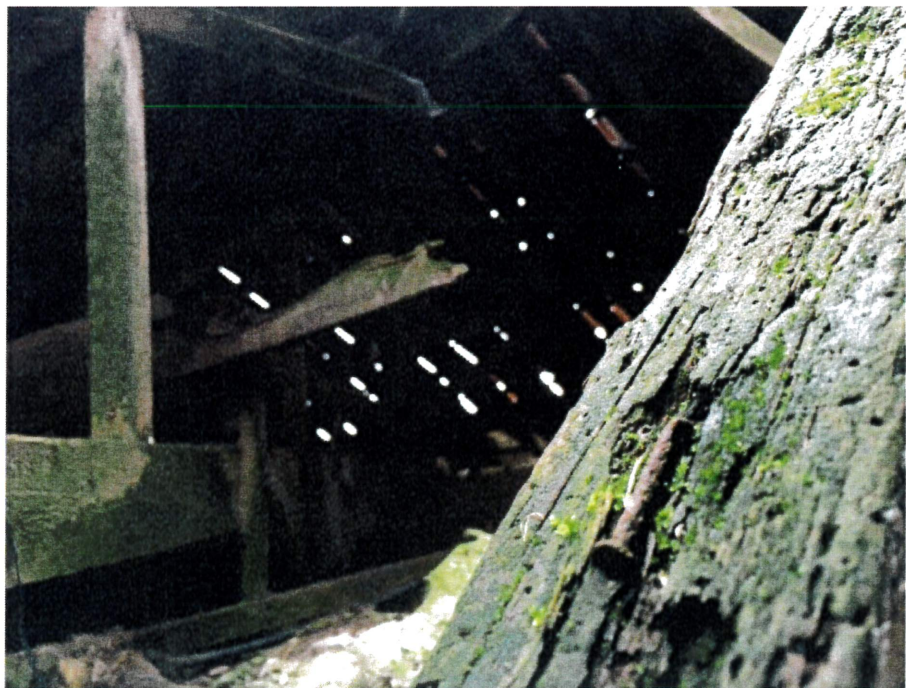
Condition Of Timber Elements Western Barn
Were Roof Covering Collapsed

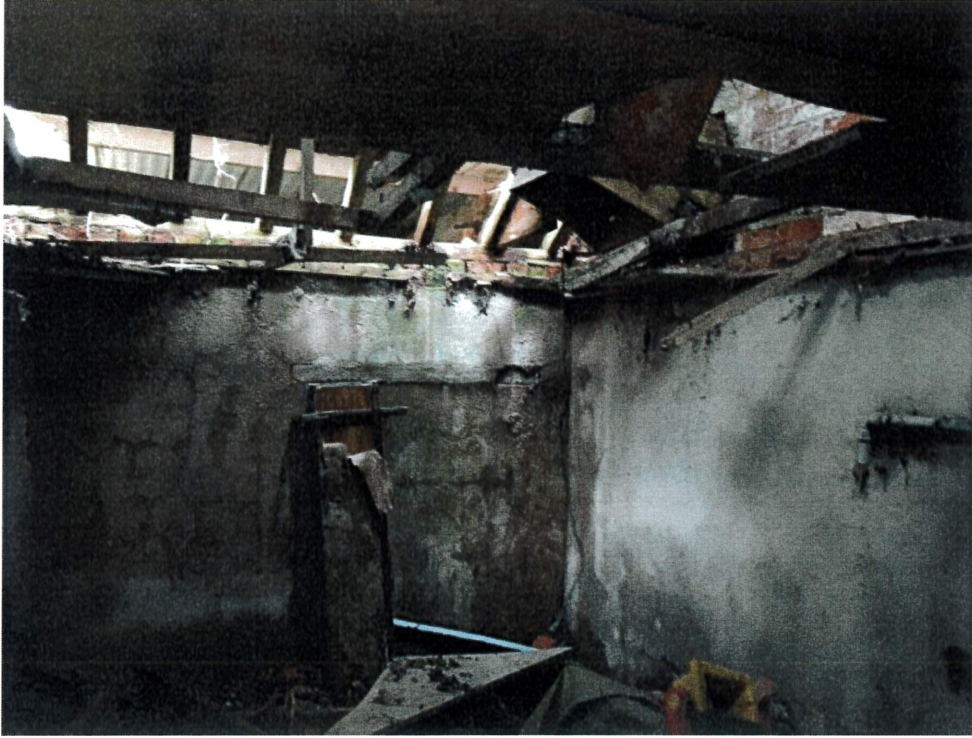
Roof Covering Collapsed - Western Barn
