The Old Cottages, Mellis Road, Thrandeston, Suffolk.

A schedule of potential repairs to the timber frame.

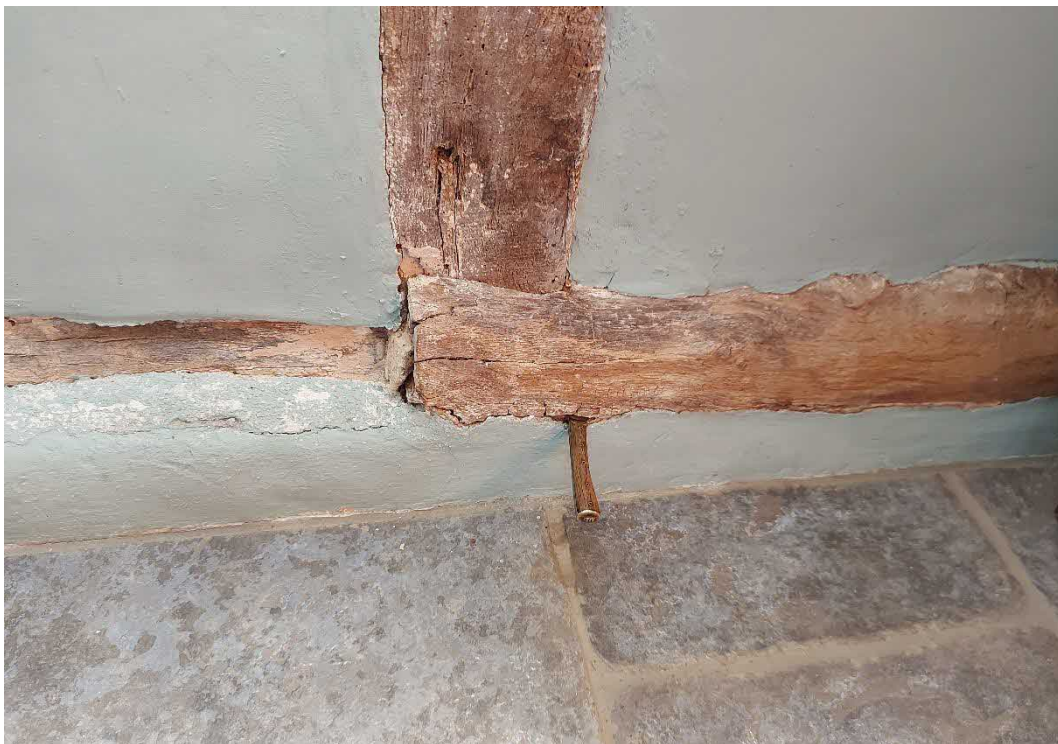
A section of sole plate on the south elevation (above) – two modest sections appear to be simply butted together with no obvious pegs which suggests a later replacement. Both are soft to the underside and outside, behind the cement render, they are likely to be in worse condition.

Where the decay is over a larger area we will use simple timber patches, to be fixed to the existing fabric with stainless steel fixings of a size appropriate to the repair.

However, where the plate is insubstantial to more than 50% of its section then it should probably be entirely replaced with new green oak.

Where possible, mortice and tenon joinery will be retained but where any stud/post tenons have decayed or broken then simple stainless steel L-brackets will be coach-screwed between the stud/post and the sole plate. These will be positioned within the infill area and not visible once the work is complete.

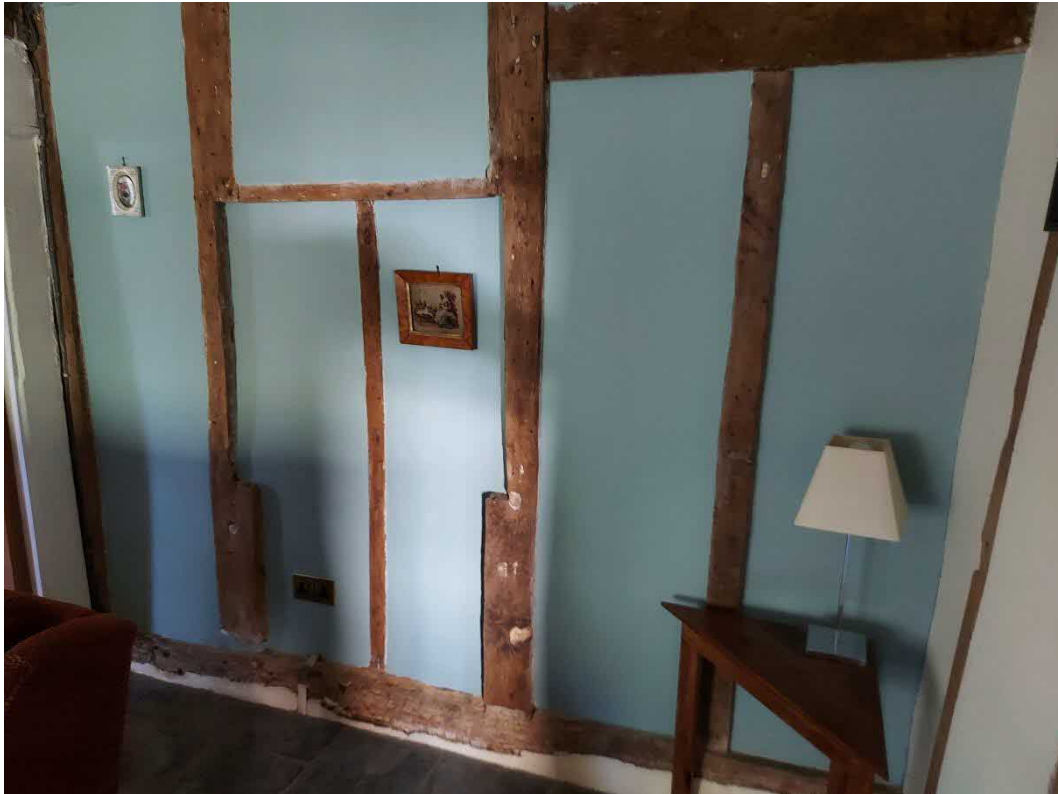
The rear wall shows much evidence of alteration and even where plates are of a larger section there is an absence of obvious pegged joinery. Many elements have been plastered over internally – presumably due to their irregular shape but also to perhaps mask their condition.

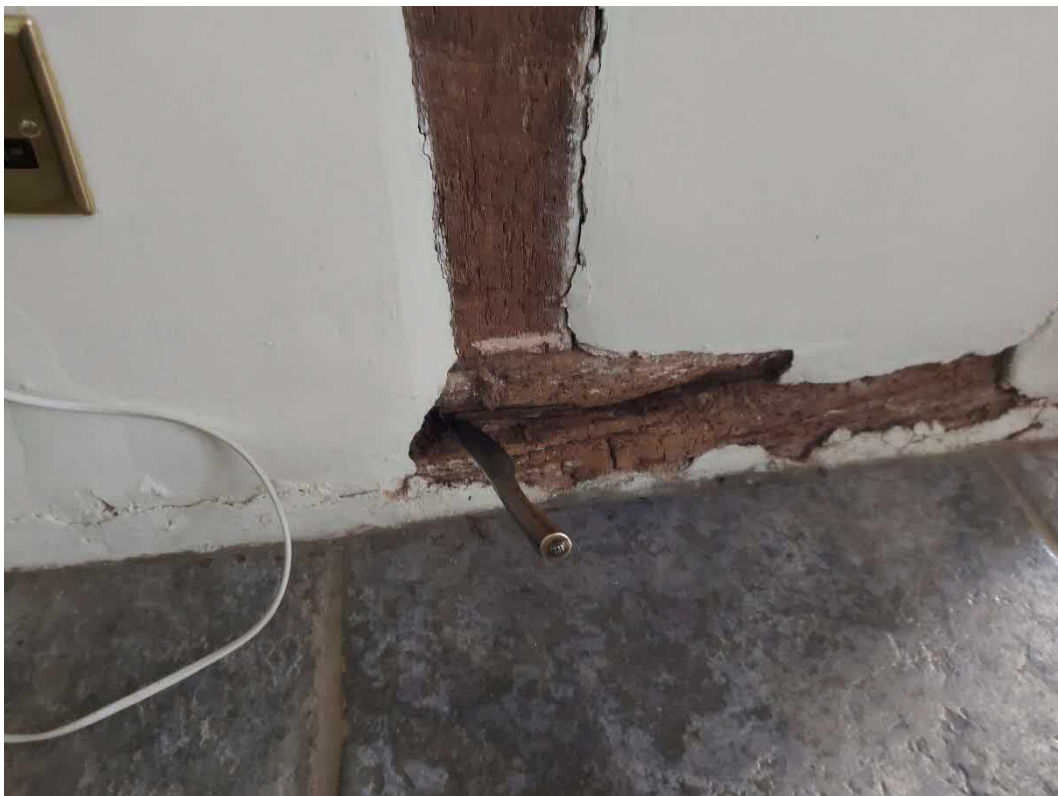
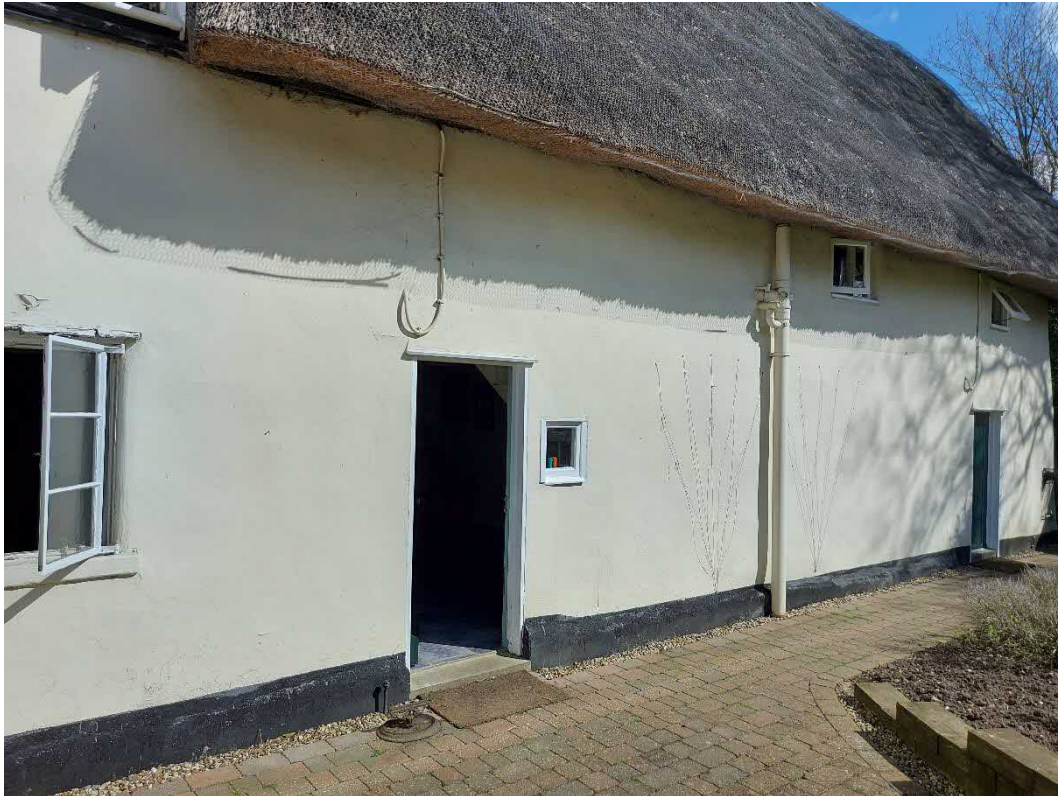
To the exterior (south), the brick plinth is rendered and painted black – some of which could be coal tar, applied as an attempt to stop dampness reaching the plate but invariably causing further permeability issues. The cement-based render is decorated with modern paint and there is some cracking evident in numerous locations, although none very large as yet.

Adjacent to the plinth is a strip of shingle which should allow better evaporation at the base of the building and the brick paviours are laid to a reasonable fall so we might assume the rain is adequately directed away from the building.

We propose to remove approximately 600-900mm of render in a neat, level line across the entire rear elevation and the adjacent east gable. We would carry out any appropriate repairs and then hand over to others for closing in.

Once the timber repairs are complete the plinth will be made good as necessary but much of it is below the ground levels so it should be fully retained with only minor repairs needed to the top course or two.

Damaged infill panels of wattle and daub will be repaired with reconstituted daub, laid onto new wattles if necessary.

Although the existing render is thick, hard and cement-based, the current programme of works doesn't call for replacement in entirety. However, all making good to the lower section where we have cut render to allow tool access and fitting of new timbers will be carried out by an experienced lime plastering contractor, see their separate comments regarding the makeup of the render.

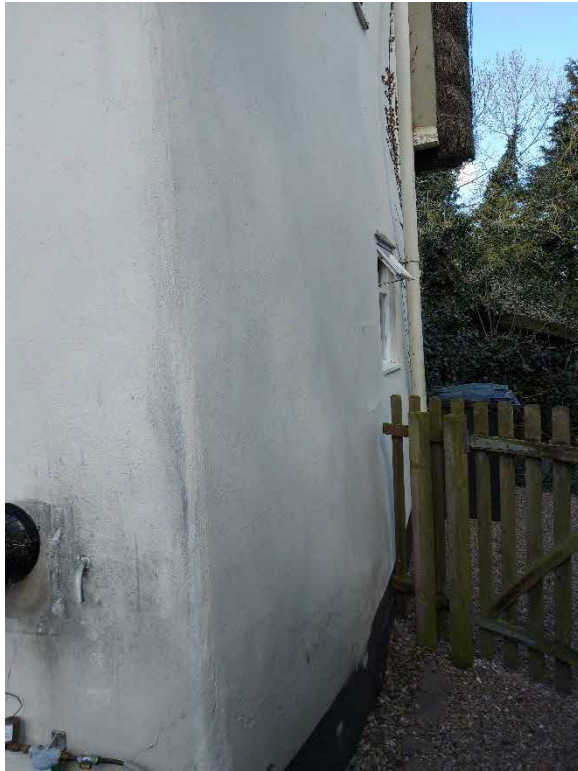
The eastern gable shows some sign of movement and here we might conclude that the sole plate and studs/posts above are in need of further inspection and probable repair. It is likely that the plate has decayed and compressed, which in turn allows the studs and posts above to push down into the insubstantial timber and cause distortions and misalignments.

This area may require the inspection and subsequent repairs to go higher – probably up to first floor level. The corner shows some evidence of recent filler and has cracked since that filling but the overall distortion appears to largely pre-date the rendering as this amount of movement under a cement render would not be tolerated by so brittle and rigid a material and we might expect to see far more cracking and separation.
