**J155475**  
**Management Survey (with MA only)**  
**13 Treyew Road**  
**Truro**  
**Cornwall**  
**TR1 2BY**

# 1.0 Executive summary:

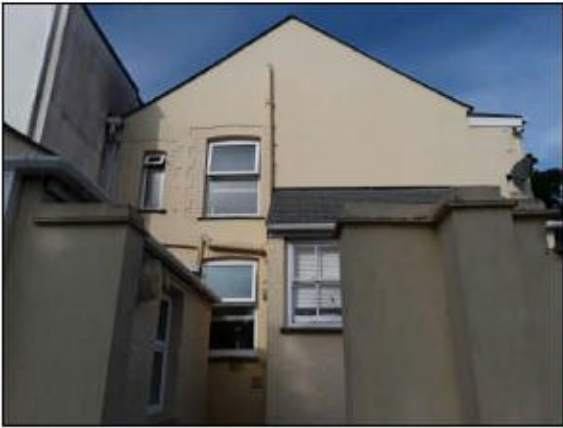
<b>Survey Date:</b>	<b>Lead Surveyor</b>	<b>Survey Type</b>	<b>Floor</b>	<b>Analysis</b>
	7 Jun 2021	Emma Gerry	Management Survey	External	N/A
	<b>Building</b>	<b>Room</b>	<b>Item</b>	<b>Quantity</b>	
	13 Treyew road	External E01	No suspect materials found	N/A	
	<b>Sample No (S,SP,P,As)</b>	<b>Product Type</b>	<b>Surface Treatment</b>	<b>Condition</b>	<b>Accessibility</b>
	Visual (P)	N/A	N/A	N/A	N/A
	<b>Material Risk Score</b>				
N/A					
<b>Recommended action</b>	No further action required				
<b>Surveyor comments</b>	N/A

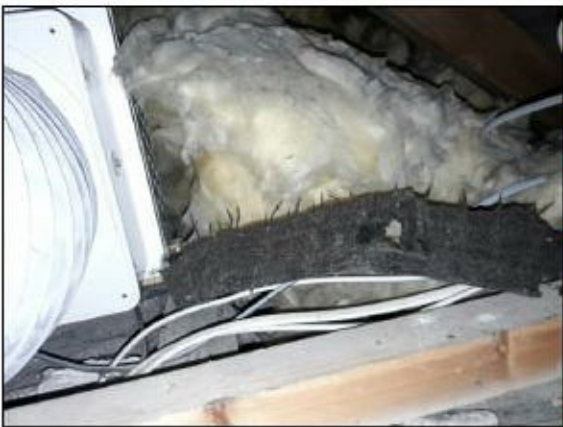
<b>Survey Date:</b>	<b>Lead Surveyor</b>	<b>Survey Type</b>	<b>Floor</b>	<b>Analysis</b>
	7 Jun 2021	Emma Gerry	Management Survey	Roof Void	No Asbestos Detected
	<b>Building</b>	<b>Room</b>	<b>Item</b>	<b>Quantity</b>	
	13 Treyew road	Roof void R01	Remains of bitumen felt To floor	<0.25m <sup>2</sup>	
	<b>Sample No (S,SP,P,As)</b>	<b>Product Type</b>	<b>Surface Treatment</b>	<b>Condition</b>	<b>Accessibility</b>
	EG000129 (S)	N/A	N/A	N/A	N/A
	<b>Material Risk Score</b>				
N/A					
<b>Recommended action</b>	No further action required				
<b>Surveyor comments</b>	N/A

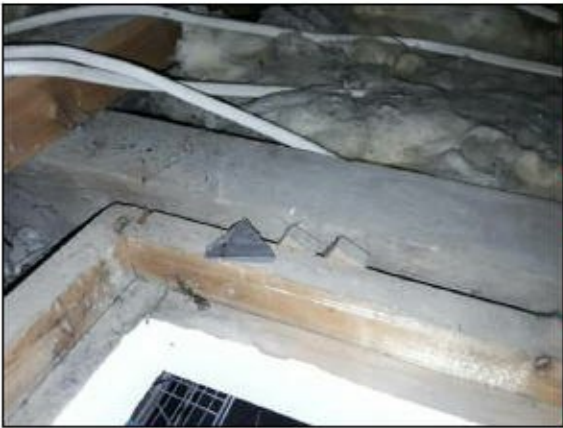
<b>Survey Date:</b>	<b>Lead Surveyor</b>	<b>Survey Type</b>	<b>Floor</b>	<b>Analysis</b>
	7 Jun 2021	Emma Gerry	Management Survey	Roof Void	Chrysotile (1)
	<b>Building</b>	<b>Room</b>	<b>Item</b>	<b>Quantity</b>	
	13 Treyew road	Roof void R01	Remains of roof tiles To floor	<0.25m <sup>2</sup>	
	<b>Sample No (S,SP,P,As)</b>	<b>Product Type</b>	<b>Surface Treatment</b>	<b>Condition</b>	<b>Accessibility</b>
	EG000130 (S)	Cement (1)	Surface Sealed (1)	Low Damage (1)	Usually inaccessible or unlikely to be disturbed
	<b>Material Risk Score</b>				
4					
<b>Recommended action</b>	C - Repair or Remove				
<b>Surveyor comments</b>	N/A

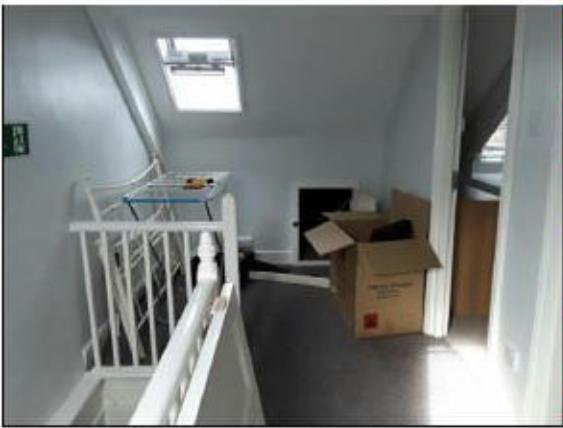
<b>Survey Date:</b>	<b>Lead Surveyor</b>	<b>Survey Type</b>	<b>Floor</b>	<b>Analysis</b>
	7 Jun 2021	Emma Gerry	Management Survey	2nd Floor	N/A
	<b>Building</b>	<b>Room</b>	<b>Item</b>	<b>Quantity</b>	
	13 Treyew road	Landing/stairs 201	No suspect materials found	N/A	
	<b>Sample No (S,SP,P,As)</b>	<b>Product Type</b>	<b>Surface Treatment</b>	<b>Condition</b>	<b>Accessibility</b>
	Visual (P)	N/A	N/A	N/A	N/A
	<b>Material Risk Score</b>				
N/A					
<b>Recommended action</b>	No further action required				
<b>Surveyor comments</b>	N/A

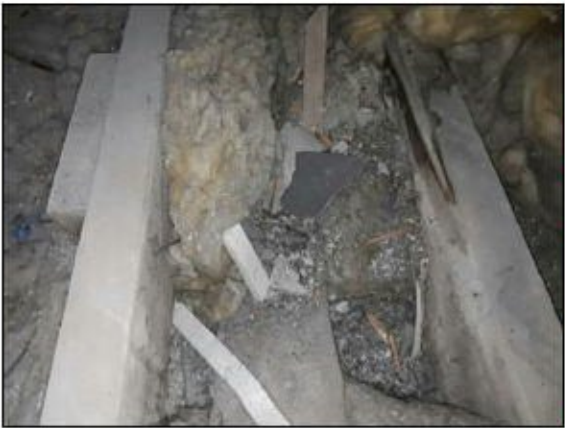
<b>Survey Date:</b>	<b>Lead Surveyor</b>	<b>Survey Type</b>	<b>Floor</b>	<b>Analysis</b>
	7 Jun 2021	Emma Gerry	Management Survey	2nd Floor	Chrysotile (1)
	<b>Building</b>	<b>Room</b>	<b>Item</b>	<b>Quantity</b>	
	13 Treyew road	Void 1 202	Cement/slate debris To floor	1m <sup>2</sup>	
	<b>Sample No (S,SP,P,As)</b>	<b>Product Type</b>	<b>Surface Treatment</b>	<b>Condition</b>	<b>Accessibility</b>
	EG000131 (S)	Cement (1)	Unsealed (2)	Medium Damage (2)	Usually inaccessible or unlikely to be disturbed
	<b>Material Risk Score</b>				
6					
<b>Recommended action</b>	C - Repair or Remove				
<b>Surveyor comments</b>	N/A

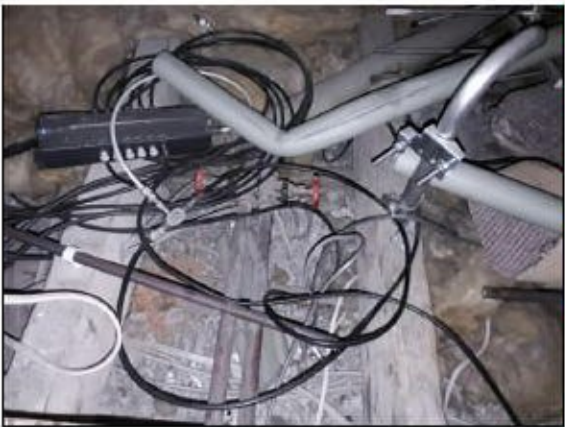
<b>Survey Date:</b>	<b>Lead Surveyor</b>	<b>Survey Type</b>	<b>Floor</b>	<b>Analysis</b>
	7 Jun 2021	Emma Gerry	Management Survey	2nd Floor	Chrysotile (1)
	<b>Building</b>	<b>Room</b>	<b>Item</b>	<b>Quantity</b>	
	13 Treyew road	Void 2 203	Cement/slate debris To floor	<1m <sup>2</sup>	
	<b>Sample No (S,SP,P,As)</b>	<b>Product Type</b>	<b>Surface Treatment</b>	<b>Condition</b>	<b>Accessibility</b>
	As EG000131 (SP)	Cement (1)	Unsealed (2)	Medium Damage (2)	Usually inaccessible or unlikely to be disturbed
	<b>Material Risk Score</b>				
6					
<b>Recommended action</b>	C - Repair or Remove				
<b>Surveyor comments</b>	N/A

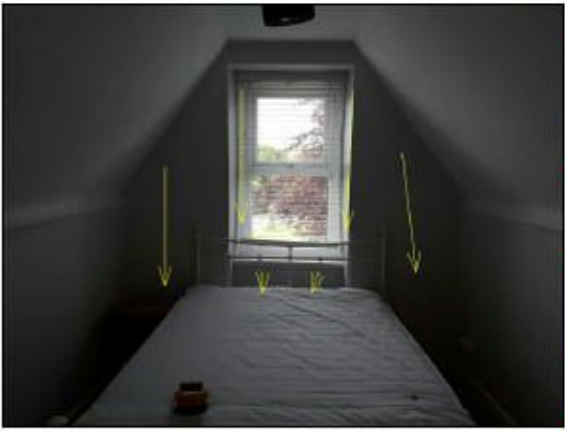
<b>Survey Date:</b>	<b>Lead Surveyor</b>	<b>Survey Type</b>	<b>Floor</b>	<b>Analysis</b>
	7 Jun 2021	Emma Gerry	Management Survey	2nd Floor	Chrysotile (1)
	<b>Building</b>	<b>Room</b>	<b>Item</b>	<b>Quantity</b>	
	13 Treyew road	Bedroom 204	Cement wall panels To window wall and returns	5m <sup>2</sup>	
	<b>Sample No (S,SP,P,As)</b>	<b>Product Type</b>	<b>Surface Treatment</b>	<b>Condition</b>	<b>Accessibility</b>
	EG000132 (S)	Cement (1)	Surface Sealed (1)	Good Condition (0)	Routinely disturbed
	<b>Material Risk Score</b>				
3					
<b>Recommended action</b>	D - Manage (Label and inspect at intervals)				
<b>Surveyor comments</b>	N/A

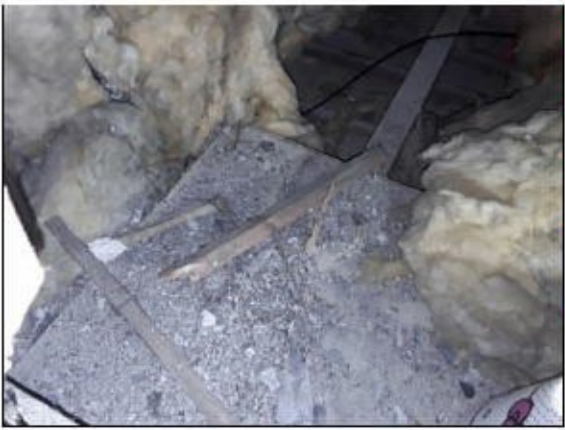
<b>Survey Date:</b>	<b>Lead Surveyor</b>	<b>Survey Type</b>	<b>Floor</b>	<b>Analysis</b>
	7 Jun 2021	Emma Gerry	Management Survey	2nd Floor	Chrysotile (1)
	<b>Building</b>	<b>Room</b>	<b>Item</b>	<b>Quantity</b>	
	13 Treyew road	Void 3 205	Cement/slate debris To floor	<2m <sup>2</sup>	
	<b>Sample No (S,SP,P,As)</b>	<b>Product Type</b>	<b>Surface Treatment</b>	<b>Condition</b>	<b>Accessibility</b>
	EG000133 (S)	Cement (1)	Unsealed (2)	Medium Damage (2)	Usually inaccessible or unlikely to be disturbed
	<b>Material Risk Score</b>				
6					
<b>Recommended action</b>	C - Repair or Remove				
<b>Surveyor comments</b>	N/A

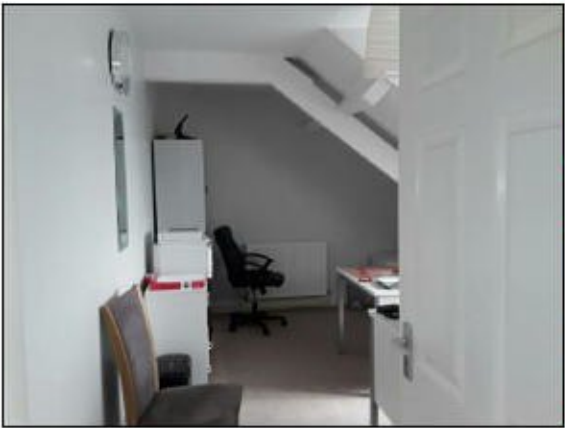
<b>Survey Date:</b>	<b>Lead Surveyor</b>	<b>Survey Type</b>	<b>Floor</b>	<b>Analysis</b>
	7 Jun 2021	Emma Gerry	Management Survey	2nd Floor	N/A
	<b>Building</b>	<b>Room</b>	<b>Item</b>	<b>Quantity</b>	
	13 Treyew road	Office 206	No suspect materials found	N/A	
	<b>Sample No (S,SP,P,As)</b>	<b>Product Type</b>	<b>Surface Treatment</b>	<b>Condition</b>	<b>Accessibility</b>
	Visual (P)	N/A	N/A	N/A	N/A
	<b>Material Risk Score</b>				
N/A					
<b>Recommended action</b>	No further action required				
<b>Surveyor comments</b>	N/A

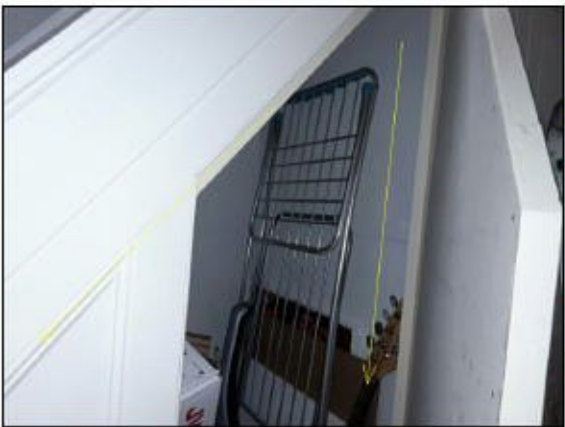
<b>Survey Date:</b>	<b>Lead Surveyor</b>	<b>Survey Type</b>	<b>Floor</b>	<b>Analysis</b>
	7 Jun 2021	Emma Gerry	Management Survey	1st Floor	No Asbestos Detected
	<b>Building</b>	<b>Room</b>	<b>Item</b>	<b>Quantity</b>	
	13 Treyew road	Cupboard Understairs 1 101	Insulating Board panels To underside of stairs and internal wall	5m <sup>2</sup>	
	<b>Sample No (S,SP,P,As)</b>	<b>Product Type</b>	<b>Surface Treatment</b>	<b>Condition</b>	<b>Accessibility</b>
	EG000134 (S)	N/A	N/A	N/A	N/A
	<b>Material Risk Score</b>				
N/A					
<b>Recommended action</b>	No further action required				
<b>Surveyor comments</b>	N/A

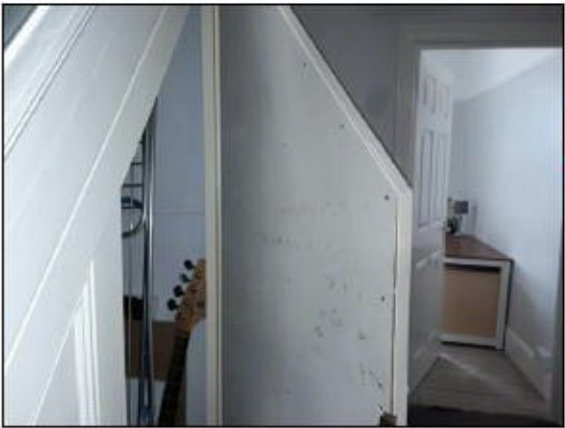
<b>Survey Date:</b>	<b>Lead Surveyor</b>	<b>Survey Type</b>	<b>Floor</b>	<b>Analysis</b>
	7 Jun 2021	Emma Gerry	Management Survey	1st Floor	
	<b>Building</b>	<b>Room</b>	<b>Item</b>	<b>Quantity</b>	
	13 Treyew road	Cupboard Understairs 1 101	Insulating Board lining To door	2m <sup>2</sup>	
	<b>Sample No (S,SP,P,As)</b>	<b>Product Type</b>	<b>Surface Treatment</b>	<b>Condition</b>	<b>Accessibility</b>
	EG000135 (S)	N/A	N/A	N/A	N/A
	<b>Material Risk Score</b>				
N/A					
<b>Recommended action</b>	No further action required				
<b>Surveyor comments</b>	N/A

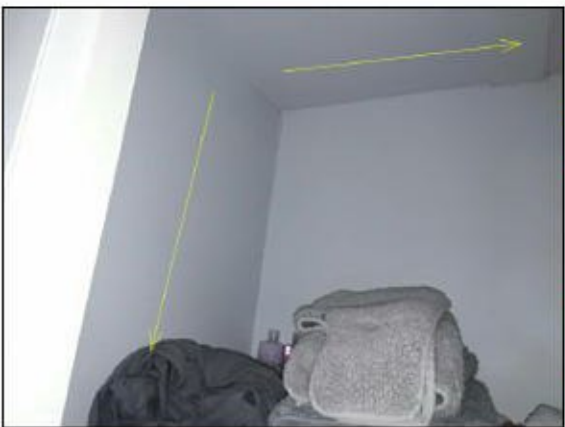
<b>Survey Date:</b>	<b>Lead Surveyor</b>	<b>Survey Type</b>	<b>Floor</b>	<b>Analysis</b>
	7 Jun 2021	Emma Gerry	Management Survey	1st Floor	
	<b>Building</b>	<b>Room</b>	<b>Item</b>	<b>Quantity</b>	
	13 Treyew road	Cupboard Understairs 2 102	Insulating Board panels To underside of stairs and internal walls	3m <sup>2</sup>	
	<b>Sample No (S,SP,P,As)</b>	<b>Product Type</b>	<b>Surface Treatment</b>	<b>Condition</b>	<b>Accessibility</b>
	As EG000134 (SP)	N/A	N/A	N/A	N/A
	<b>Material Risk Score</b>				
N/A					
<b>Recommended action</b>	No further action required				
<b>Surveyor comments</b>	N/A

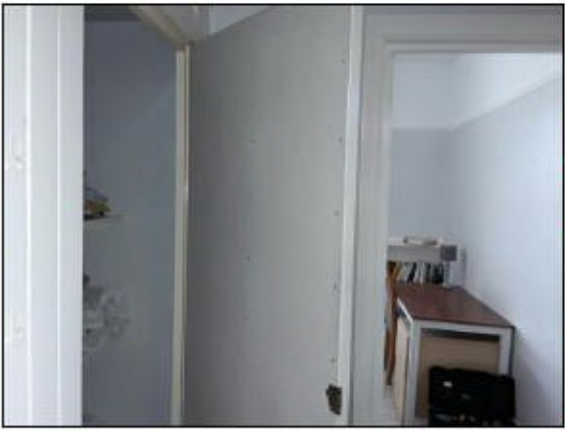
<b>Survey Date:</b>	<b>Lead Surveyor</b>	<b>Survey Type</b>	<b>Floor</b>	<b>Analysis</b>
	7 Jun 2021	Emma Gerry	Management Survey	1st Floor	No Asbestos Detected
	<b>Building</b>	<b>Room</b>	<b>Item</b>	<b>Quantity</b>	
	13 Treyew road	Cupboard Understairs 2 102	Insulating Board lining To door	2.5m <sup>2</sup>	
	<b>Sample No (S,SP,P,As)</b>	<b>Product Type</b>	<b>Surface Treatment</b>	<b>Condition</b>	<b>Accessibility</b>
	As EG000135 (SP)	N/A	N/A	N/A	N/A
	<b>Material Risk Score</b>				
N/A					
<b>Recommended action</b>	No further action required				
<b>Surveyor comments</b>	N/A

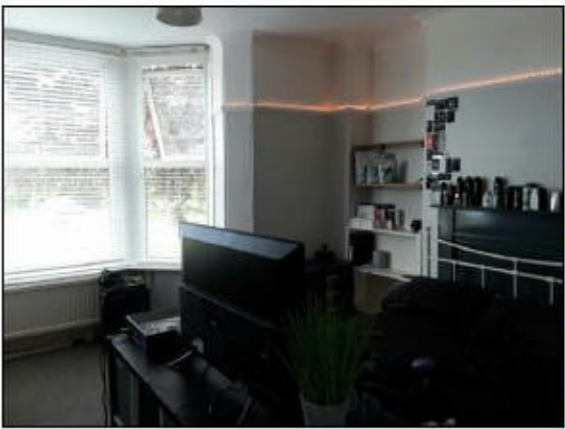
<b>Survey Date:</b>	<b>Lead Surveyor</b>	<b>Survey Type</b>	<b>Floor</b>	<b>Analysis</b>
	7 Jun 2021	Emma Gerry	Management Survey	1st Floor	N/A
	<b>Building</b>	<b>Room</b>	<b>Item</b>	<b>Quantity</b>	
	13 Treyew road	Bedroom 1 103	No suspect materials found	N/A	
	<b>Sample No (S,SP,P,As)</b>	<b>Product Type</b>	<b>Surface Treatment</b>	<b>Condition</b>	<b>Accessibility</b>
	Visual (P)	N/A	N/A	N/A	N/A
	<b>Material Risk Score</b>				
N/A					
<b>Recommended action</b>	No further action required				
<b>Surveyor comments</b>	N/A

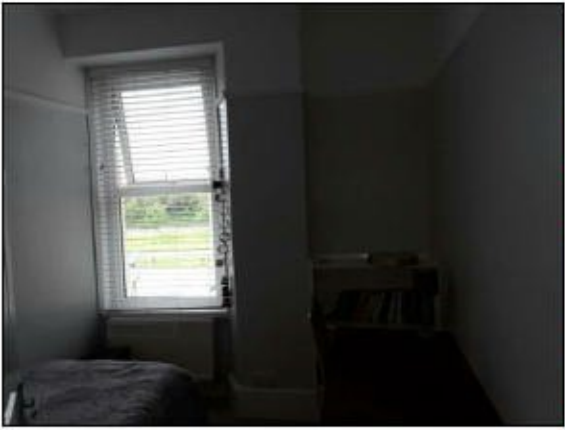
<b>Survey Date:</b>	<b>Lead Surveyor</b>	<b>Survey Type</b>	<b>Floor</b>	<b>Analysis</b>
	7 Jun 2021	Emma Gerry	Management Survey	1st Floor	N/A
	<b>Building</b>	<b>Room</b>	<b>Item</b>	<b>Quantity</b>	
	13 Treyew road	Bedroom 2 104	No suspect materials found	N/A	
	<b>Sample No (S,SP,P,As)</b>	<b>Product Type</b>	<b>Surface Treatment</b>	<b>Condition</b>	<b>Accessibility</b>
	Visual (P)	N/A	N/A	N/A	N/A
	<b>Material Risk Score</b>				
N/A					
<b>Recommended action</b>	No further action required				
<b>Surveyor comments</b>	N/A

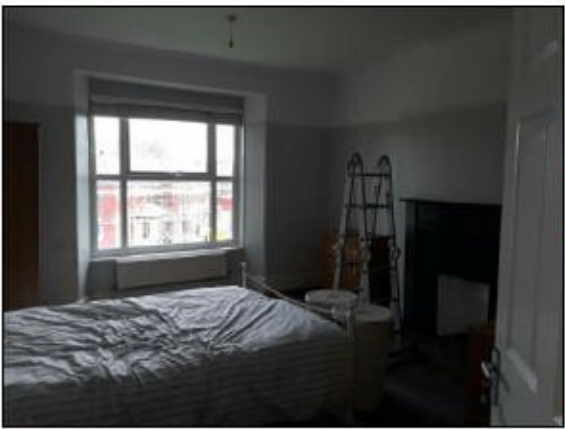
<b>Survey Date:</b>	<b>Lead Surveyor</b>	<b>Survey Type</b>	<b>Floor</b>	<b>Analysis</b>
	7 Jun 2021	Emma Gerry	Management Survey	1st Floor	N/A
	<b>Building</b>	<b>Room</b>	<b>Item</b>	<b>Quantity</b>	
	13 Treyew road	Bedroom 3 105	No suspect materials found	N/A	
	<b>Sample No (S,SP,P,As)</b>	<b>Product Type</b>	<b>Surface Treatment</b>	<b>Condition</b>	<b>Accessibility</b>
	Visual (P)	N/A	N/A	N/A	N/A
	<b>Material Risk Score</b>				
N/A					
<b>Recommended action</b>	No further action required				
<b>Surveyor comments</b>	N/A

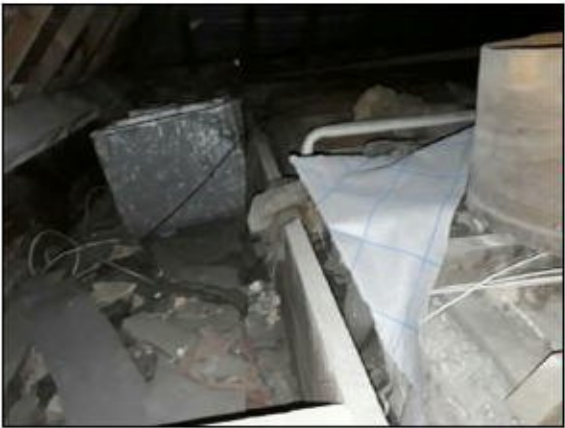
<b>Survey Date:</b>	<b>Lead Surveyor</b>	<b>Survey Type</b>	<b>Floor</b>	<b>Analysis</b>
	7 Jun 2021	Emma Gerry	Management Survey	2nd Floor	No Asbestos Detected
	<b>Building</b>	<b>Room</b>	<b>Item</b>	<b>Quantity</b>	
	13 Treyew road	Roof void 207	Remains of bitumen felt To floor	<3m <sup>2</sup>	
	<b>Sample No (S,SP,P,As)</b>	<b>Product Type</b>	<b>Surface Treatment</b>	<b>Condition</b>	<b>Accessibility</b>
	EG000136 (S)	N/A	N/A	N/A	N/A
<b>Material Risk Score</b>					
N/A					
<b>Recommended action</b>	No further action required				
<b>Surveyor comments</b>	N/A

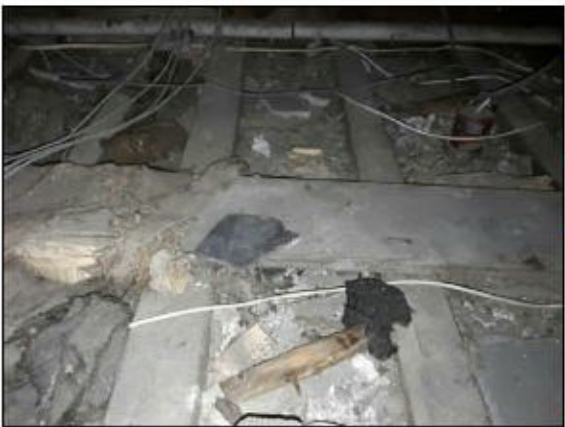
<b>Survey Date:</b>	<b>Lead Surveyor</b>	<b>Survey Type</b>	<b>Floor</b>	<b>Analysis</b>
	7 Jun 2021	Emma Gerry	Management Survey	2nd Floor	Chrysotile (1)
	<b>Building</b>	<b>Room</b>	<b>Item</b>	<b>Quantity</b>	
	13 Treyew road	Roof void 207	Slate/cement debris To floor	<2m <sup>2</sup>	
	<b>Sample No (S,SP,P,As)</b>	<b>Product Type</b>	<b>Surface Treatment</b>	<b>Condition</b>	<b>Accessibility</b>
	EG000137 (S)	Cement (1)	Surface Sealed (1)	Medium Damage (2)	Usually inaccessible or unlikely to be disturbed
<b>Material Risk Score</b>					
5					
<b>Recommended action</b>	C - Repair or Remove				
<b>Surveyor comments</b>	N/A

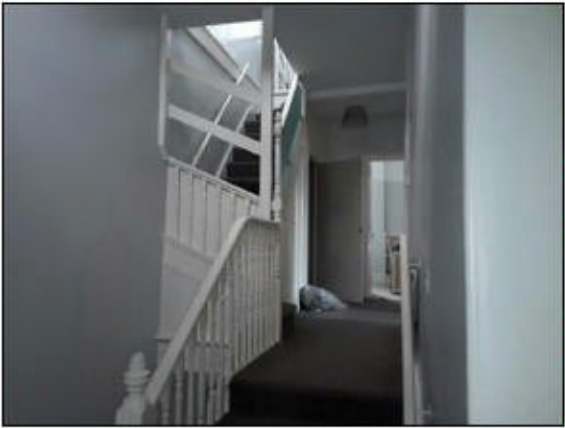
<b>Survey Date:</b>	<b>Lead Surveyor</b>	<b>Survey Type</b>	<b>Floor</b>	<b>Analysis</b>
	7 Jun 2021	Emma Gerry	Management Survey	1st Floor	N/A
	<b>Building</b>	<b>Room</b>	<b>Item</b>	<b>Quantity</b>	
	13 Treyew road	Landing/stairs 106	No suspect materials found	N/A	
	<b>Sample No (S,SP,P,As)</b>	<b>Product Type</b>	<b>Surface Treatment</b>	<b>Condition</b>	<b>Accessibility</b>
	Visual (P)	N/A	N/A	N/A	N/A
	<b>Material Risk Score</b>				
N/A					
<b>Recommended action</b>	No further action required				
<b>Surveyor comments</b>	N/A

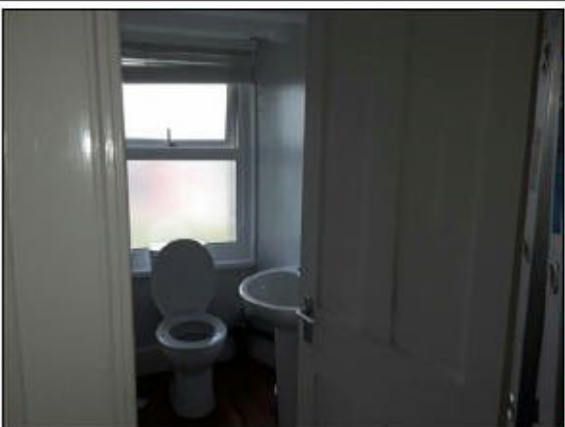
<b>Survey Date:</b>	<b>Lead Surveyor</b>	<b>Survey Type</b>	<b>Floor</b>	<b>Analysis</b>
	7 Jun 2021	Emma Gerry	Management Survey	1st Floor	N/A
	<b>Building</b>	<b>Room</b>	<b>Item</b>	<b>Quantity</b>	
	13 Treyew road	W.C. 107	No suspect materials found	N/A	
	<b>Sample No (S,SP,P,As)</b>	<b>Product Type</b>	<b>Surface Treatment</b>	<b>Condition</b>	<b>Accessibility</b>
	Visual (P)	N/A	N/A	N/A	N/A
	<b>Material Risk Score</b>				
N/A					
<b>Recommended action</b>	No further action required				
<b>Surveyor comments</b>	N/A

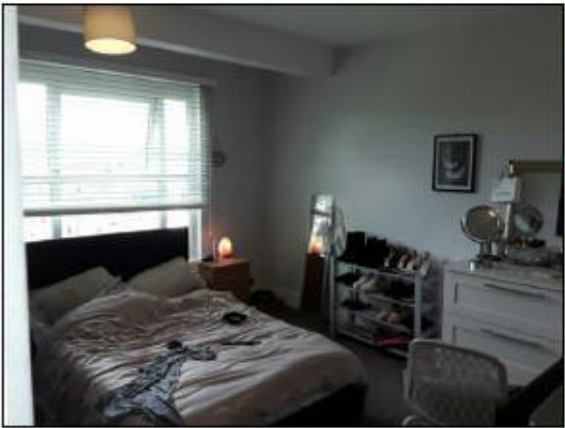
<b>Survey Date:</b>	<b>Lead Surveyor</b>	<b>Survey Type</b>	<b>Floor</b>	<b>Analysis</b>
	7 Jun 2021	Emma Gerry	Management Survey	1st Floor	N/A
	<b>Building</b>	<b>Room</b>	<b>Item</b>	<b>Quantity</b>	
	13 Treyew road	Bedroom 4 108	No suspect materials found	N/A	
	<b>Sample No (S,SP,P,As)</b>	<b>Product Type</b>	<b>Surface Treatment</b>	<b>Condition</b>	<b>Accessibility</b>
	Visual (P)	N/A	N/A	N/A	N/A
	<b>Material Risk Score</b>				
N/A					
<b>Recommended action</b>	No further action required				
<b>Surveyor comments</b>	N/A

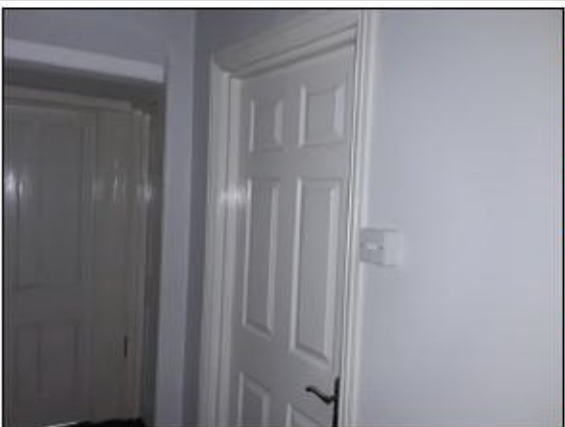
<b>Survey Date:</b>	<b>Lead Surveyor</b>	<b>Survey Type</b>	<b>Floor</b>	<b>Analysis</b>
	7 Jun 2021	Emma Gerry	Management Survey	1st Floor	N/A
	<b>Building</b>	<b>Room</b>	<b>Item</b>	<b>Quantity</b>	
	13 Treyew road	Bedroom 5 109	Inaccessible	N/A	
	<b>Sample No (S,SP,P,As)</b>	<b>Product Type</b>	<b>Surface Treatment</b>	<b>Condition</b>	<b>Accessibility</b>
	Visual (P)	N/A	N/A	N/A	N/A
	<b>Material Risk Score</b>				
N/A					
<b>Recommended action</b>	Inspection Required				
<b>Surveyor comments</b>	Occupied

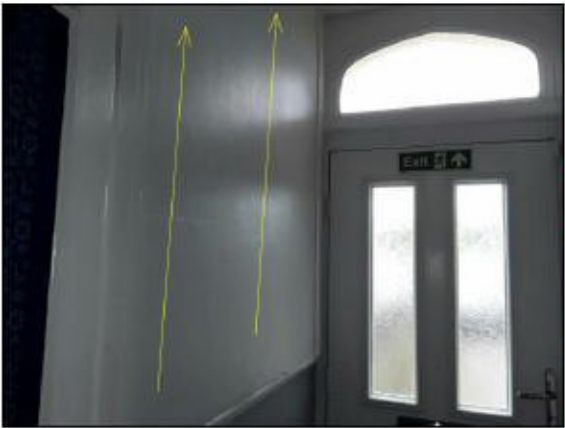
<b>Survey Date:</b>	<b>Lead Surveyor</b>	<b>Survey Type</b>	<b>Floor</b>	<b>Analysis</b>
	7 Jun 2021	Emma Gerry	Management Survey	Ground Floor	
	<b>Building</b>	<b>Room</b>	<b>Item</b>	<b>Quantity</b>	
	13 Treyew road	Porch G01	Cement lining To solid wall	3m <sup>2</sup>	
	<b>Sample No (S,SP,P,As)</b>	<b>Product Type</b>	<b>Surface Treatment</b>	<b>Condition</b>	<b>Accessibility</b>
	EG000139 (S)	N/A	N/A	N/A	N/A
	<b>Material Risk Score</b>				
N/A					
<b>Recommended action</b>	No further action required				
<b>Surveyor comments</b>	One side, top only (see photo)

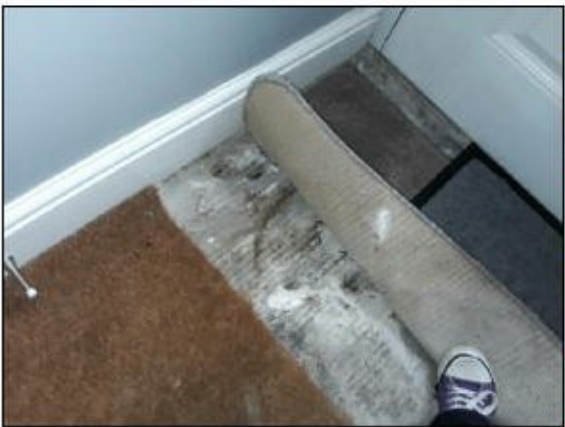
<b>Survey Date:</b>	<b>Lead Surveyor</b>	<b>Survey Type</b>	<b>Floor</b>	<b>Analysis</b>
	7 Jun 2021	Emma Gerry	Management Survey	Ground Floor	
	<b>Building</b>	<b>Room</b>	<b>Item</b>	<b>Quantity</b>	
	13 Treyew road	Porch G01	Bitumen Adhesive Under carpet to concrete floor	Small amounts	
	<b>Sample No (S,SP,P,As)</b>	<b>Product Type</b>	<b>Surface Treatment</b>	<b>Condition</b>	<b>Accessibility</b>
	EG000140 (S)	N/A	N/A	N/A	N/A
	<b>Material Risk Score</b>				
N/A					
<b>Recommended action</b>	No further action required				
<b>Surveyor comments</b>	N/A

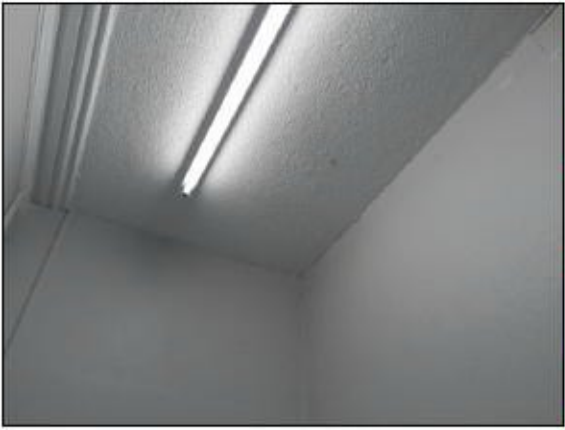
<b>Survey Date:</b>	<b>Lead Surveyor</b>	<b>Survey Type</b>	<b>Floor</b>	<b>Analysis</b>
	7 Jun 2021	Emma Gerry	Management Survey	Ground Floor	No Asbestos Detected
	<b>Building</b>	<b>Room</b>	<b>Item</b>	<b>Quantity</b>	
	13 Treyew road	Boiler room G05	Textured Coating To lath and plaster ceiling	3m <sup>2</sup>	
	<b>Sample No (S,SP,P,As)</b>	<b>Product Type</b>	<b>Surface Treatment</b>	<b>Condition</b>	<b>Accessibility</b>
	EG000141 (S)	N/A	N/A	N/A	N/A
	<b>Material Risk Score</b>				
N/A					
<b>Recommended action</b>	No further action required				
<b>Surveyor comments</b>	N/A

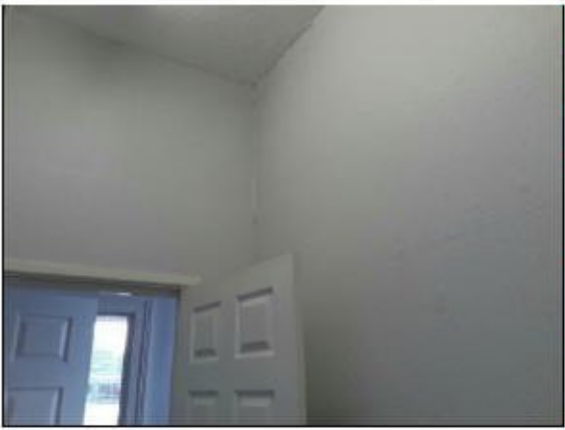
<b>Survey Date:</b>	<b>Lead Surveyor</b>	<b>Survey Type</b>	<b>Floor</b>	<b>Analysis</b>
	7 Jun 2021	Emma Gerry	Management Survey	Ground Floor	No Asbestos Detected
	<b>Building</b>	<b>Room</b>	<b>Item</b>	<b>Quantity</b>	
	13 Treyew road	Boiler room G05	Fibreboard panels To walls, adjacent meeting room only	8m <sup>2</sup>	
	<b>Sample No (S,SP,P,As)</b>	<b>Product Type</b>	<b>Surface Treatment</b>	<b>Condition</b>	<b>Accessibility</b>
	EG000142 (S)	N/A	N/A	N/A	N/A
	<b>Material Risk Score</b>				
N/A					
<b>Recommended action</b>	No further action required				
<b>Surveyor comments</b>	N/A

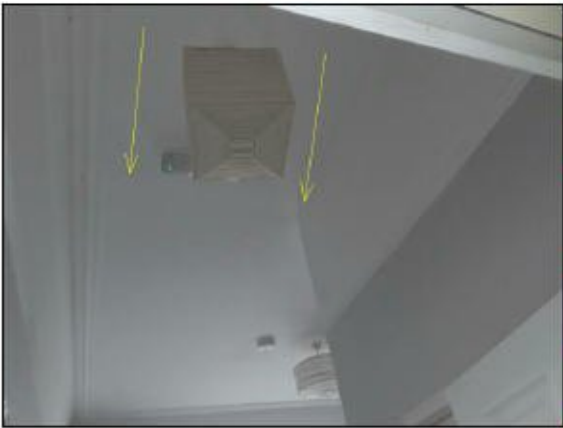
<b>Survey Date:</b>	<b>Lead Surveyor</b>	<b>Survey Type</b>	<b>Floor</b>	<b>Analysis</b>
	7 Jun 2021	Emma Gerry	Management Survey	Ground Floor	
	<b>Building</b>	<b>Room</b>	<b>Item</b>	<b>Quantity</b>	
	13 Treyew road	Meeting room G04	Textured Coating To lath and plaster ceiling	14m <sup>2</sup>	
	<b>Sample No (S,SP,P,As)</b>	<b>Product Type</b>	<b>Surface Treatment</b>	<b>Condition</b>	<b>Accessibility</b>
	As EG000141 (SP)	N/A	N/A	N/A	N/A
	<b>Material Risk Score</b>				
N/A					
<b>Recommended action</b>	No further action required				
<b>Surveyor comments</b>	Majority of Textured Coating plastered over, presumed to be over entire ceiling.

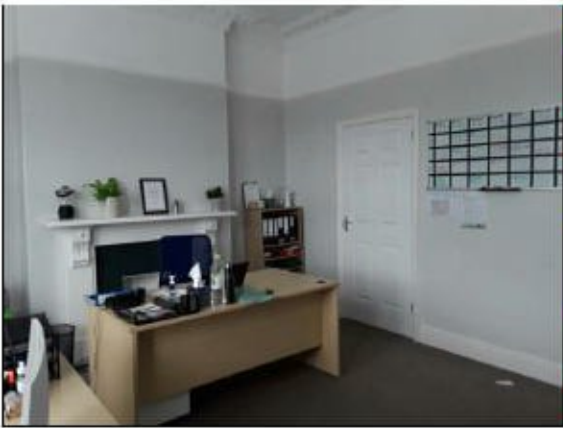
<b>Survey Date:</b>	<b>Lead Surveyor</b>	<b>Survey Type</b>	<b>Floor</b>	<b>Analysis</b>
	7 Jun 2021	Emma Gerry	Management Survey	Ground Floor	
	<b>Building</b>	<b>Room</b>	<b>Item</b>	<b>Quantity</b>	
	13 Treyew road	Reception G03	No suspect materials found	N/A	
	<b>Sample No (S,SP,P,As)</b>	<b>Product Type</b>	<b>Surface Treatment</b>	<b>Condition</b>	<b>Accessibility</b>
	Visual (P)	N/A	N/A	N/A	N/A
	<b>Material Risk Score</b>				
N/A					
<b>Recommended action</b>	No further action required				
<b>Surveyor comments</b>	N/A

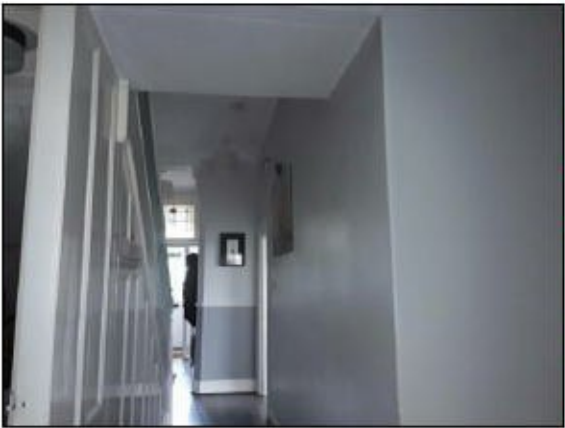
<b>Survey Date:</b>	<b>Lead Surveyor</b>	<b>Survey Type</b>	<b>Floor</b>	<b>Analysis</b>
	7 Jun 2021	Emma Gerry	Management Survey	Ground Floor	N/A
	<b>Building</b>	<b>Room</b>	<b>Item</b>	<b>Quantity</b>	
	13 Treyew road	Hall G02	No suspect materials found	N/A	
	<b>Sample No (S,SP,P,As)</b>	<b>Product Type</b>	<b>Surface Treatment</b>	<b>Condition</b>	<b>Accessibility</b>
	Visual (P)	N/A	N/A	N/A	N/A
	<b>Material Risk Score</b>				
N/A					
<b>Recommended action</b>	No further action required				
<b>Surveyor comments</b>	N/A

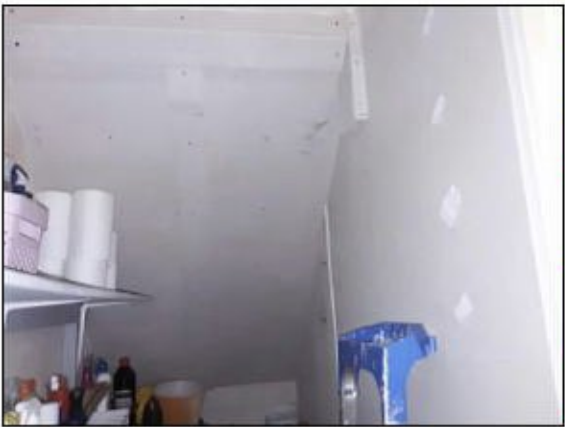
<b>Survey Date:</b>	<b>Lead Surveyor</b>	<b>Survey Type</b>	<b>Floor</b>	<b>Analysis</b>
	7 Jun 2021	Emma Gerry	Management Survey	Ground Floor	No Asbestos Detected
	<b>Building</b>	<b>Room</b>	<b>Item</b>	<b>Quantity</b>	
	13 Treyew road	Understair Cupboard G06	Insulating Board panels To internal walls and under stairs	12m <sup>2</sup>	
	<b>Sample No (S,SP,P,As)</b>	<b>Product Type</b>	<b>Surface Treatment</b>	<b>Condition</b>	<b>Accessibility</b>
	EG000143 (S)	N/A	N/A	N/A	N/A
	<b>Material Risk Score</b>				
N/A					
<b>Recommended action</b>	No further action required				
<b>Surveyor comments</b>	N/A

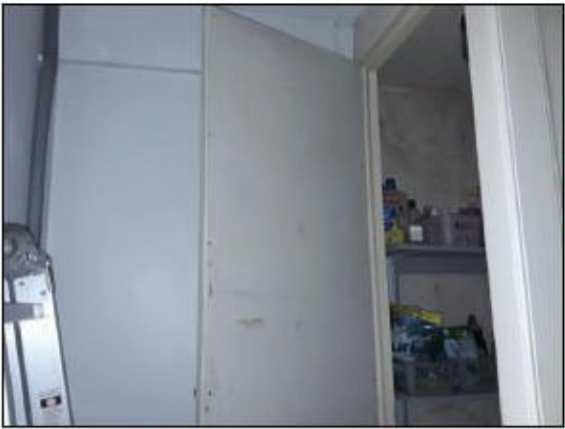
<b>Survey Date:</b>	<b>Lead Surveyor</b>	<b>Survey Type</b>	<b>Floor</b>	<b>Analysis</b>
	7 Jun 2021	Emma Gerry	Management Survey	Ground Floor	No Asbestos Detected
	<b>Building</b>	<b>Room</b>	<b>Item</b>	<b>Quantity</b>	
	13 Treyew road	Understair Cupboard G06	Insulating Board panel To door	2.5m <sup>2</sup>	
	<b>Sample No (S,SP,P,As)</b>	<b>Product Type</b>	<b>Surface Treatment</b>	<b>Condition</b>	<b>Accessibility</b>
	EG000144 (S)	N/A	N/A	N/A	N/A
	<b>Material Risk Score</b>				
N/A					
<b>Recommended action</b>	No further action required				
<b>Surveyor comments</b>	N/A

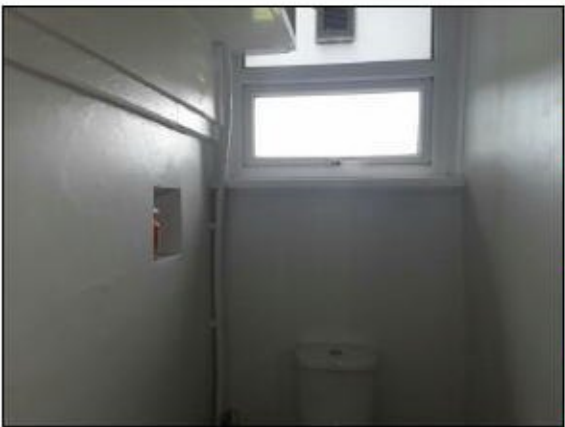
<b>Survey Date:</b>	<b>Lead Surveyor</b>	<b>Survey Type</b>	<b>Floor</b>	<b>Analysis</b>
	7 Jun 2021	Emma Gerry	Management Survey	Ground Floor	N/A
	<b>Building</b>	<b>Room</b>	<b>Item</b>	<b>Quantity</b>	
	13 Treyew road	W.C. G07	Live painted bitumen mains cable To timber boxing	3lm	
	<b>Sample No (S,SP,P,As)</b>	<b>Product Type</b>	<b>Surface Treatment</b>	<b>Condition</b>	<b>Accessibility</b>
	Visual (P)	N/A	N/A	N/A	N/A
	<b>Material Risk Score</b>				
N/A					
<b>Recommended action</b>	Inspection Required				
<b>Surveyor comments</b>	Live

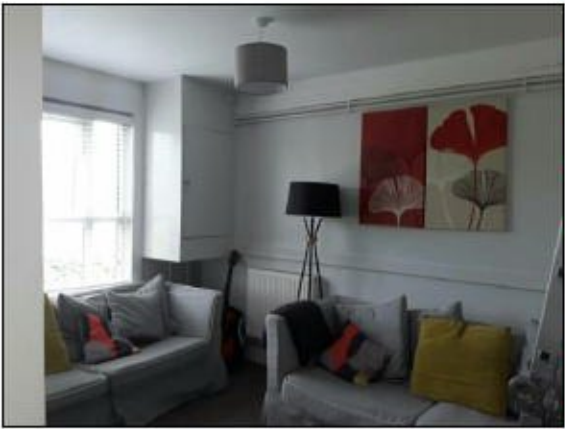
<b>Survey Date:</b>	<b>Lead Surveyor</b>	<b>Survey Type</b>	<b>Floor</b>	<b>Analysis</b>
	7 Jun 2021	Emma Gerry	Management Survey	Ground Floor	N/A
	<b>Building</b>	<b>Room</b>	<b>Item</b>	<b>Quantity</b>	
	13 Treyew road	Lounge G08	No suspect materials found	N/A	
	<b>Sample No (S,SP,P,As)</b>	<b>Product Type</b>	<b>Surface Treatment</b>	<b>Condition</b>	<b>Accessibility</b>
	Visual (P)	N/A	N/A	N/A	N/A
	<b>Material Risk Score</b>				
N/A					
<b>Recommended action</b>	No further action required				
<b>Surveyor comments</b>	N/A

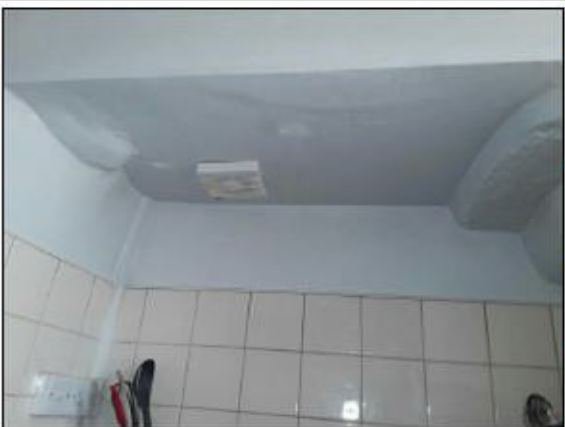
<b>Survey Date:</b>	<b>Lead Surveyor</b>	<b>Survey Type</b>	<b>Floor</b>	<b>Analysis</b>
	7 Jun 2021	Emma Gerry	Management Survey	Ground Floor	No Asbestos Detected
	<b>Building</b>	<b>Room</b>	<b>Item</b>	<b>Quantity</b>	
	13 Treyew road	Kitchen G09	Insulating Board closure panels Over cooker	1m <sup>2</sup>	
	<b>Sample No (S,SP,P,As)</b>	<b>Product Type</b>	<b>Surface Treatment</b>	<b>Condition</b>	<b>Accessibility</b>
	EG000145 (S)	N/A	N/A	N/A	N/A
	<b>Material Risk Score</b>				
N/A					
<b>Recommended action</b>	No further action required				
<b>Surveyor comments</b>	N/A

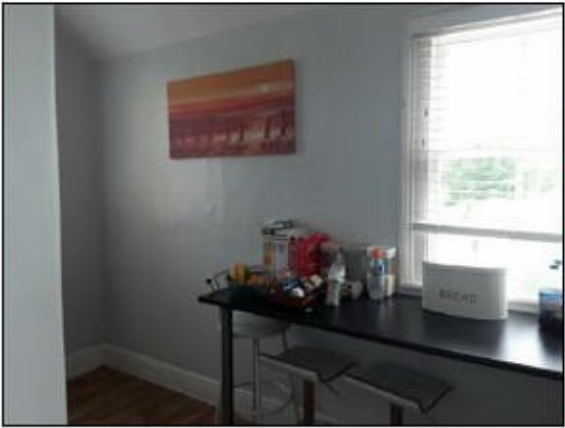
<b>Survey Date:</b>	<b>Lead Surveyor</b>	<b>Survey Type</b>	<b>Floor</b>	<b>Analysis</b>
	7 Jun 2021	Emma Gerry	Management Survey	Ground Floor	N/A
	<b>Building</b>	<b>Room</b>	<b>Item</b>	<b>Quantity</b>	
	13 Treyew road	Breakfast room G10	No suspect materials found	N/A	
	<b>Sample No (S,SP,P,As)</b>	<b>Product Type</b>	<b>Surface Treatment</b>	<b>Condition</b>	<b>Accessibility</b>
	Visual (P)	N/A	N/A	N/A	N/A
	<b>Material Risk Score</b>				
N/A					
<b>Recommended action</b>	No further action required				
<b>Surveyor comments</b>	N/A

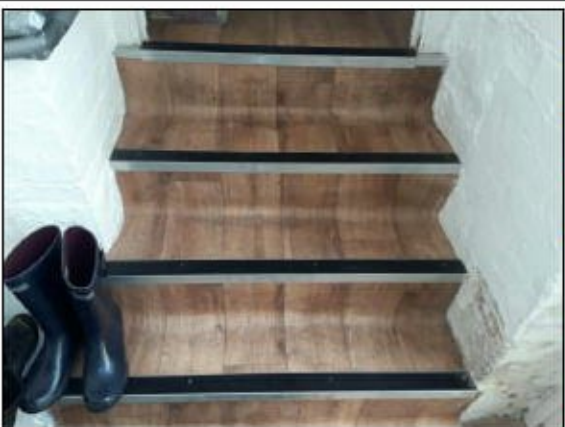
<b>Survey Date:</b>	<b>Lead Surveyor</b>	<b>Survey Type</b>	<b>Floor</b>	<b>Analysis</b>
	7 Jun 2021	Emma Gerry	Management Survey	Ground Floor	No Asbestos Detected
	<b>Building</b>	<b>Room</b>	<b>Item</b>	<b>Quantity</b>	
	13 Treyew road	Kitchen G09	Stair nosing Down to laundry	4lm	
	<b>Sample No (S,SP,P,As)</b>	<b>Product Type</b>	<b>Surface Treatment</b>	<b>Condition</b>	<b>Accessibility</b>
	EG000146 (S)	N/A	N/A	N/A	N/A
	<b>Material Risk Score</b>				
N/A					
<b>Recommended action</b>	No further action required				
<b>Surveyor comments</b>	N/A

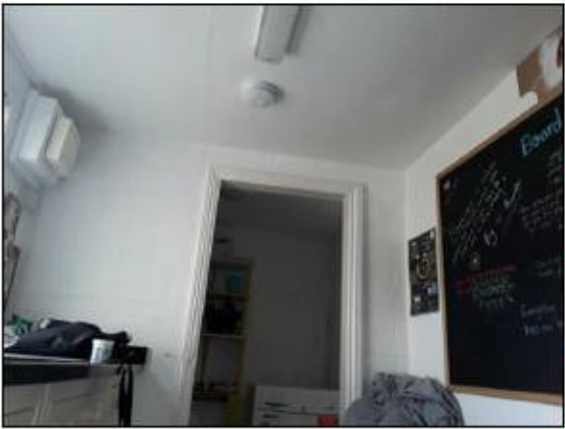
<b>Survey Date:</b>	<b>Lead Surveyor</b>	<b>Survey Type</b>	<b>Floor</b>	<b>Analysis</b>
	7 Jun 2021	Emma Gerry	Management Survey	Ground Floor	No Asbestos Detected
	<b>Building</b>	<b>Room</b>	<b>Item</b>	<b>Quantity</b>	
	13 Treyew road	Laundry G11	Fibreboard ceiling panels Throughout	10m <sup>2</sup>	
	<b>Sample No (S,SP,P,As)</b>	<b>Product Type</b>	<b>Surface Treatment</b>	<b>Condition</b>	<b>Accessibility</b>
	EG000147 (S)	N/A	N/A	N/A	N/A
	<b>Material Risk Score</b>				
N/A					
<b>Recommended action</b>	No further action required				
<b>Surveyor comments</b>	N/A
