OAKFIELD
ARBORICULTURAL SERVICES

Arboricultural Impact Assessment

for
Flint Cottage, Alby Hill,
Aldborough

OAS 21-092-AR01

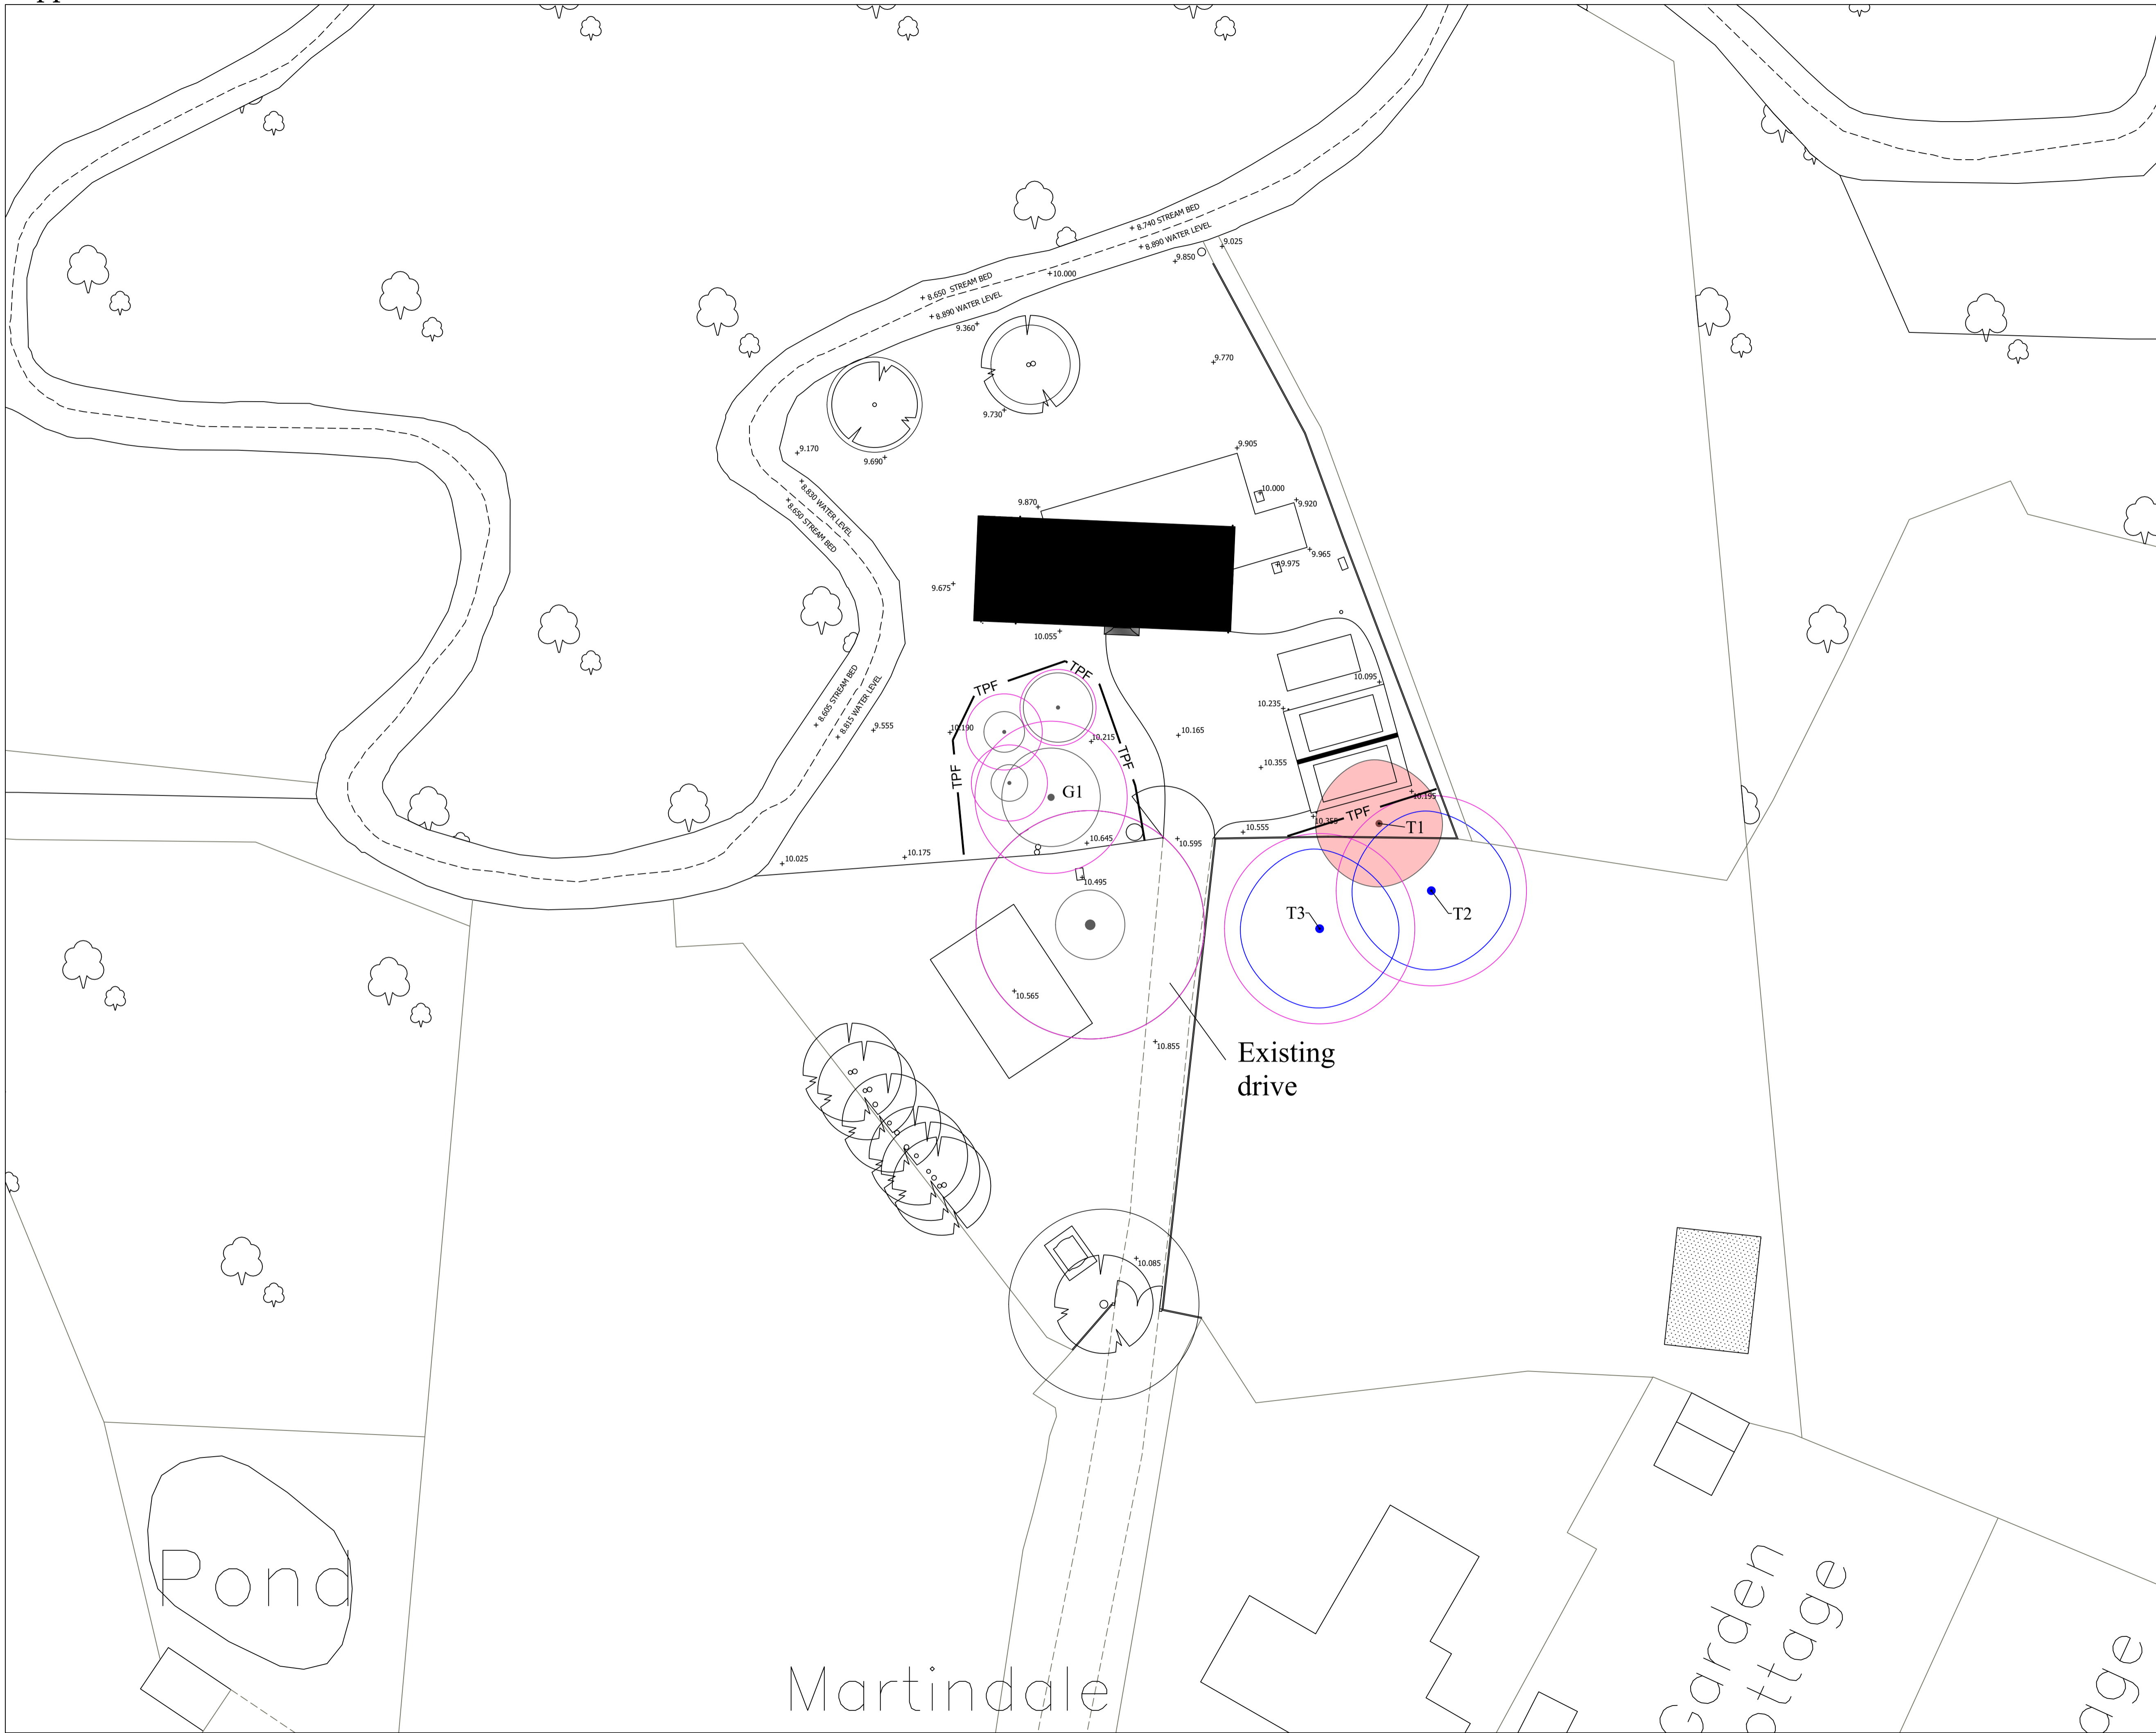
Appendix 3 Tree Constraints/ Protection Plan

3.1.2 The proposal will require the removal of T1 to accommodate the car port. The tree, Ash, is in relatively poor condition and its removal should not be seen as a constraint to the proposal, mitigation can come in the form of replacement planting elsewhere within the site.

3.7.1 Tree protection fencing will be required to be installed as shown on the Tree Protection Plan OAS 21-092-TS01. Fit for its purpose fencing must be installed post any tree works and before construction begins on site and will remain in situ throughout the construction phase.
