Conversion of  
**Carrycoats Coach House**  
To Dwelling House  
2023

DESIGN & ACCESS STATEMENT

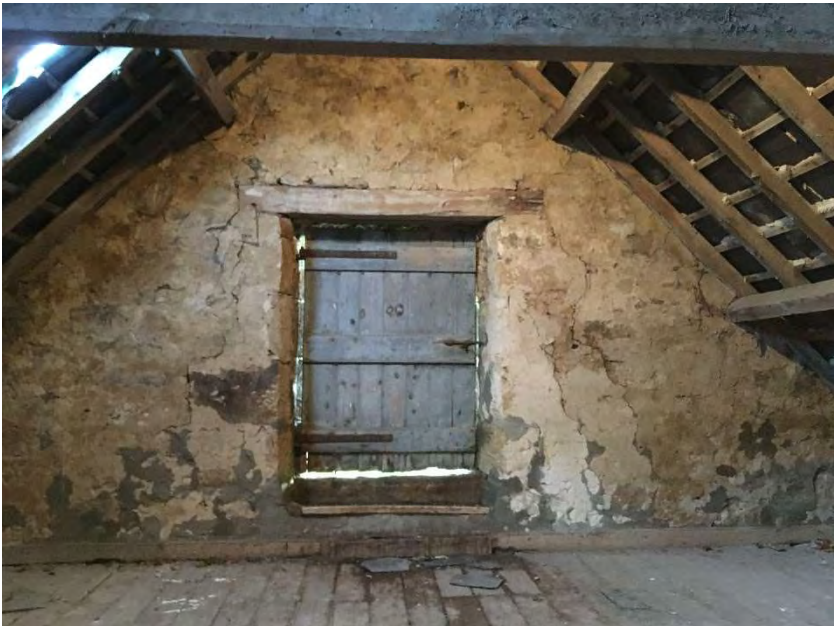
Photo 13  
Internal view of hayloft with cracked masonry and wet floor after recent water ingress through slates.

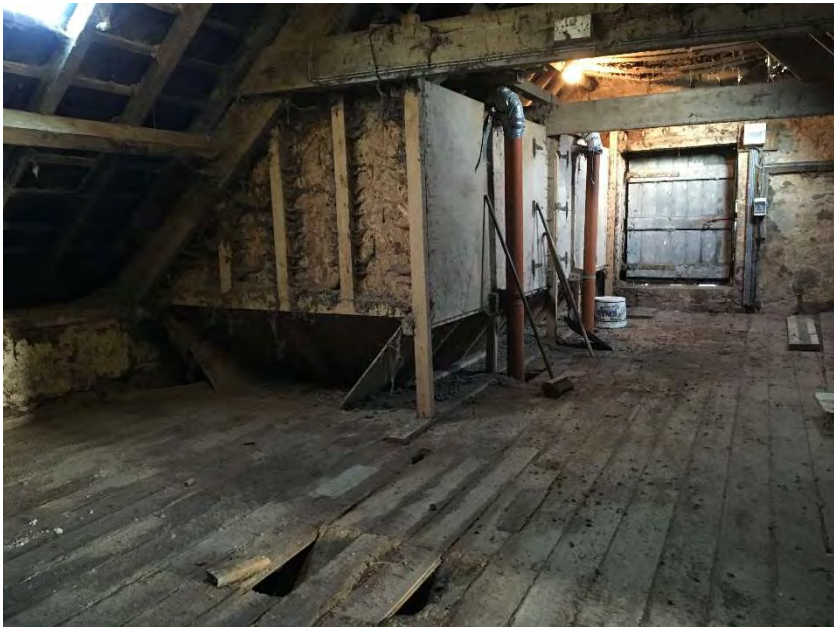
Photo 14  
Internal view of former hayloft with 1960s feed hoppers and weak floor saturated after recent water ingress through slates.

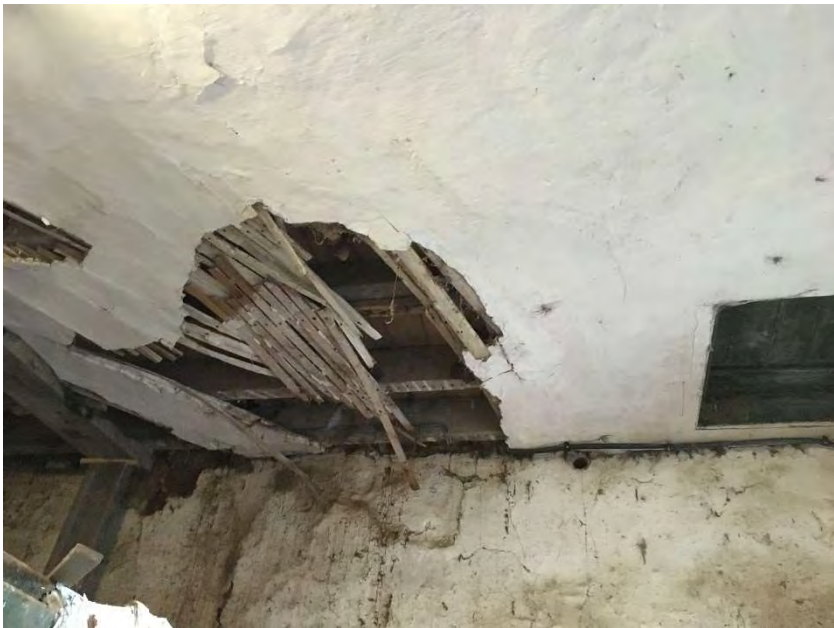
Photo 15  
Internal view of damaged lath and plaster caused by water ingress through roof.

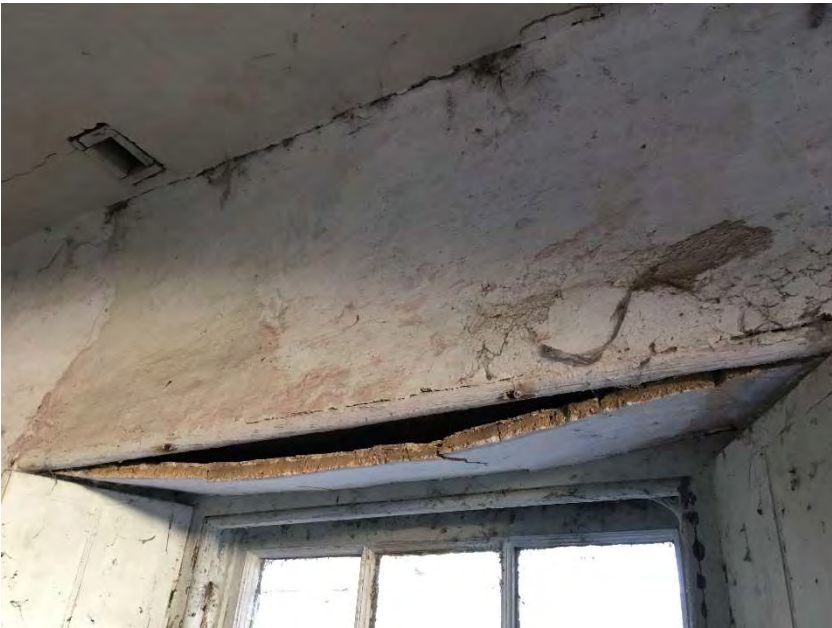
Photo 16  
Internal view of damaged lath and plaster caused by water ingress over window.

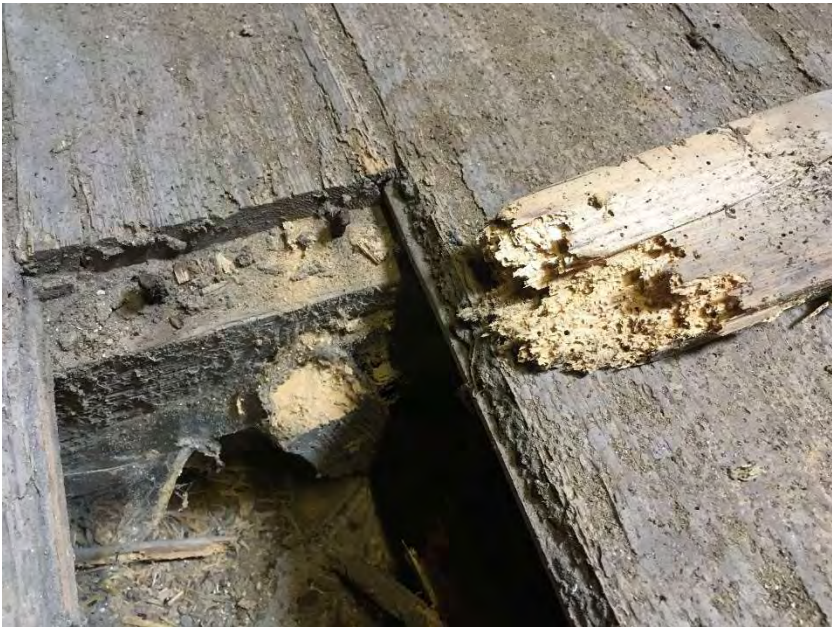
Photo 17  
Close up of floor boards in former hayloft in fragile condition owing to woodworm infestation.

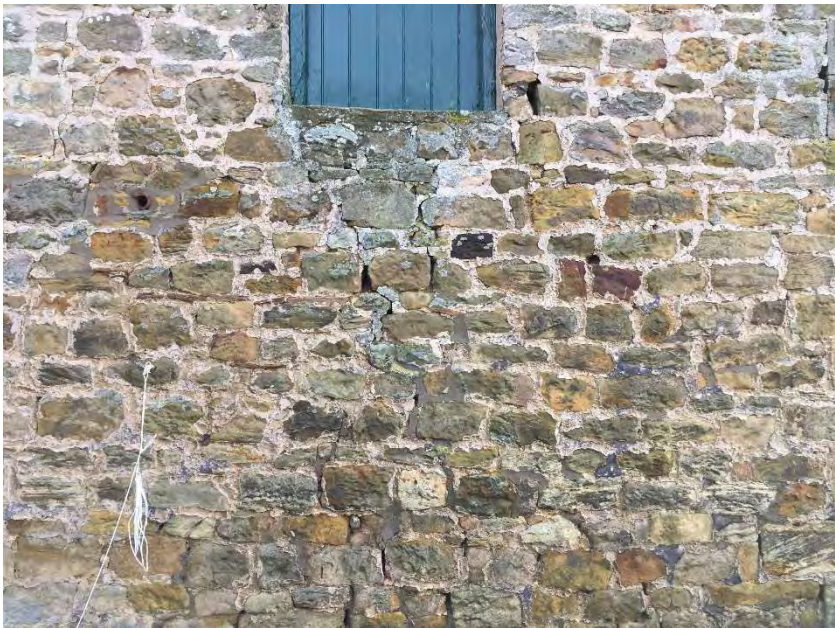
Photo 18  
Close up of cracked masonry on east gable.

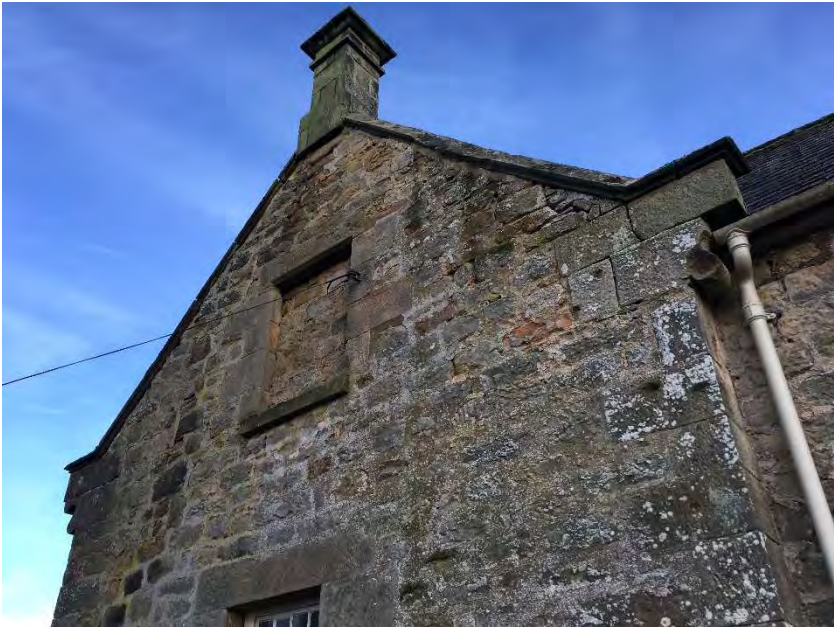
Photo 19  
Close up of cracked and broken kneeler stone to west.

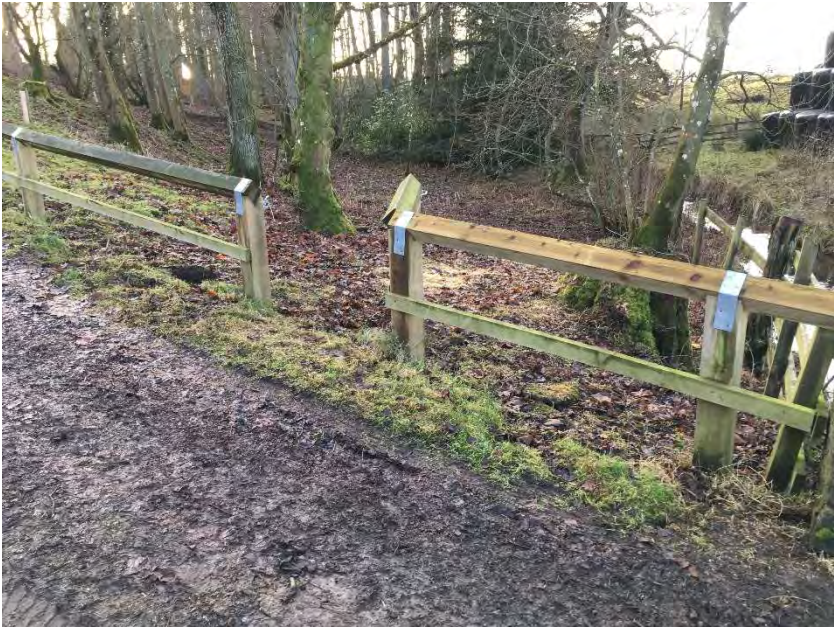
Photo 20  
Existing birds-mouth fencing to west.

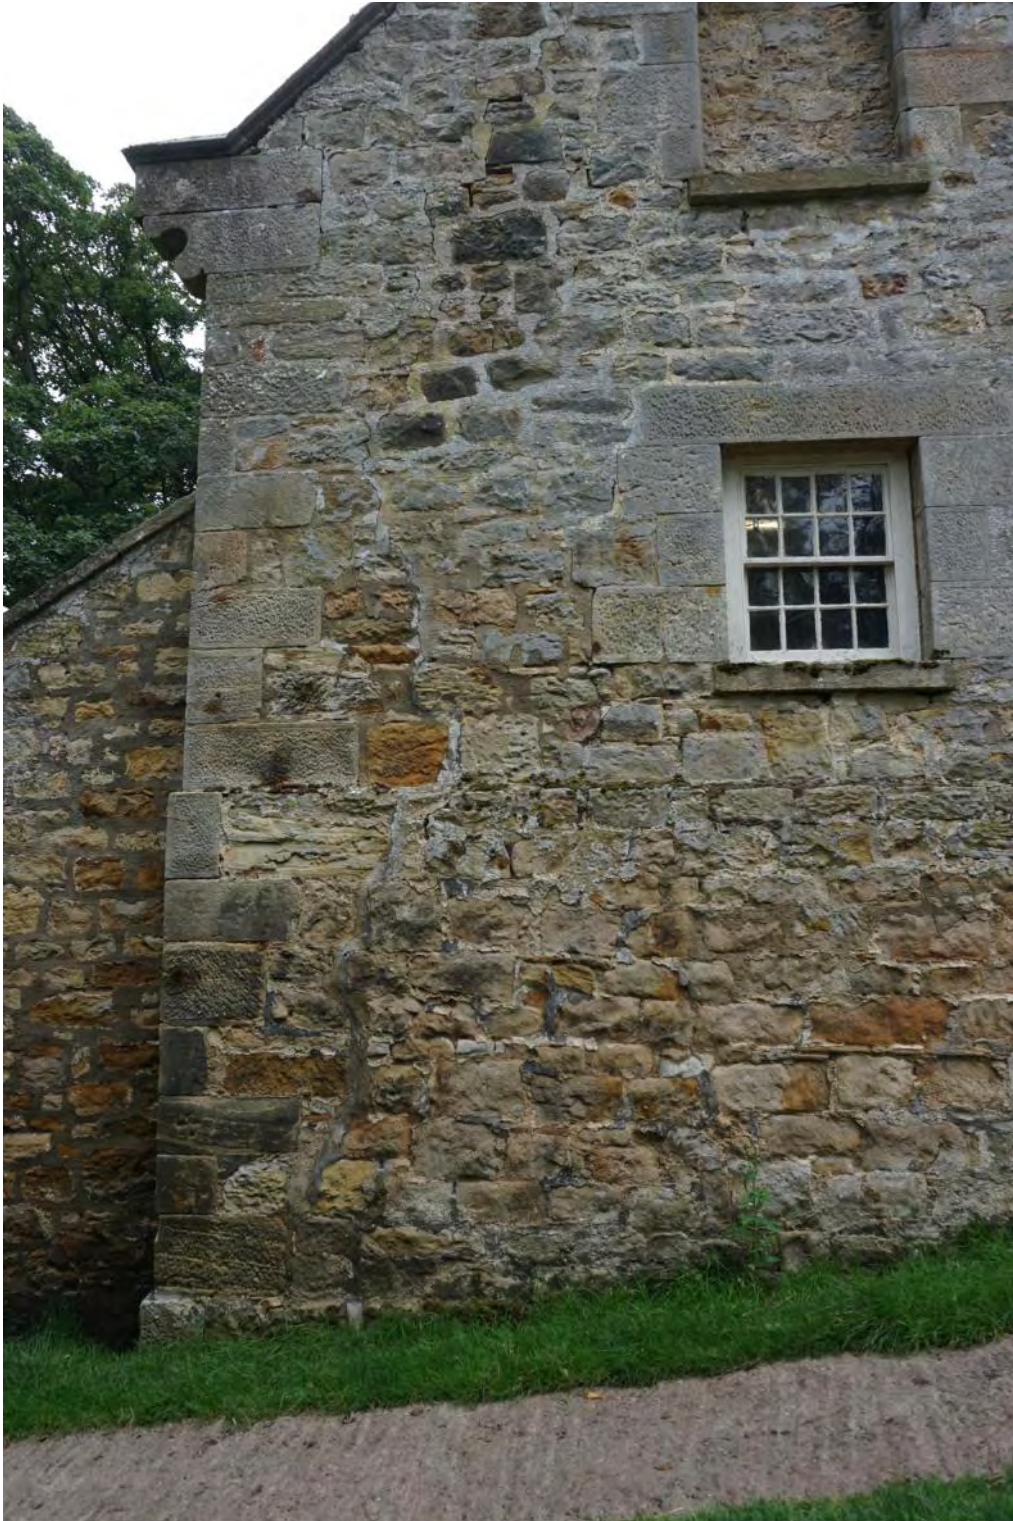
PHOTO 5 – Crack to northwest wall of main building (showing past repairs)

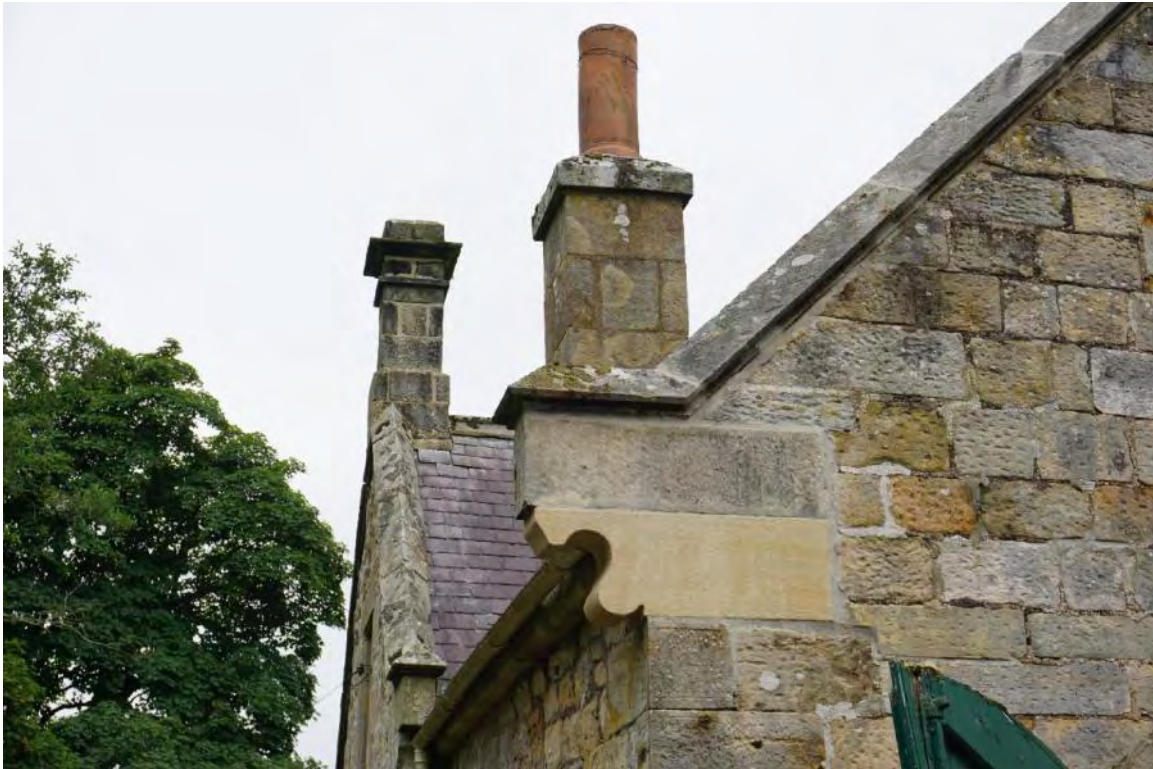
**PHOTO 6 – Replaced Kneeler to southeast gable**

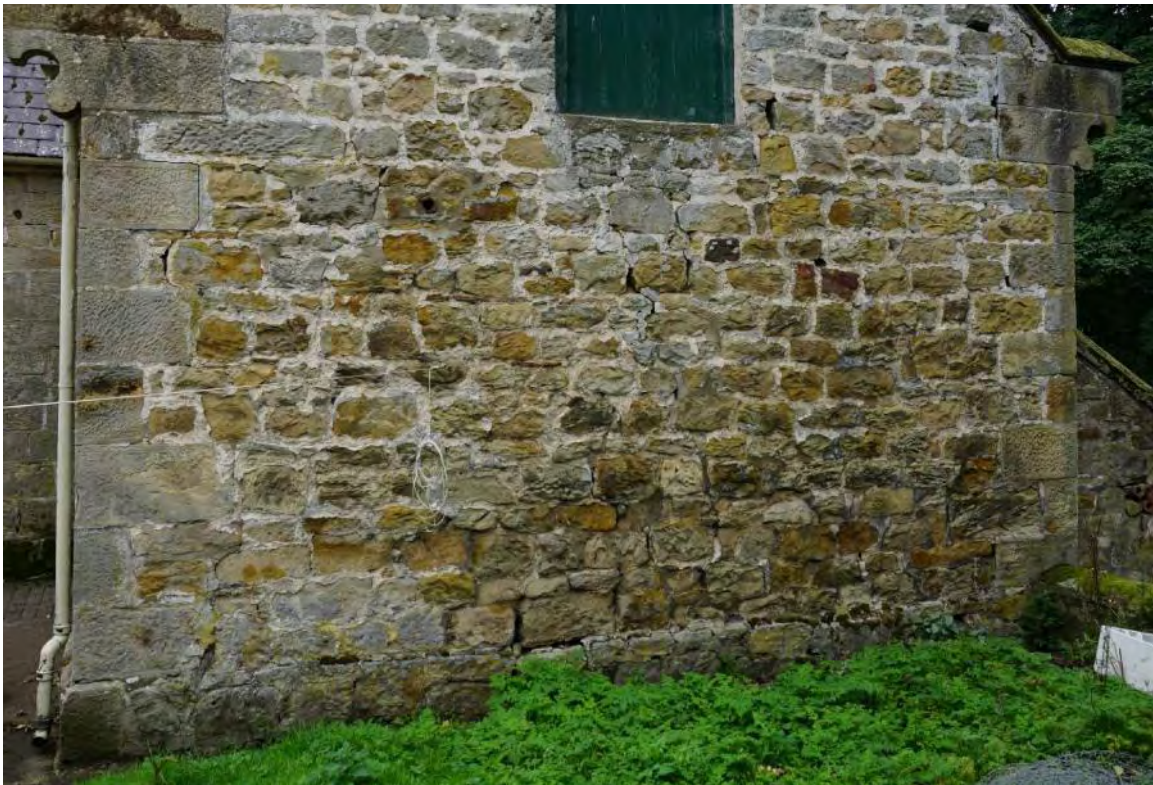
**PHOTO 7 – Cracks to east gable – below hayloft door**

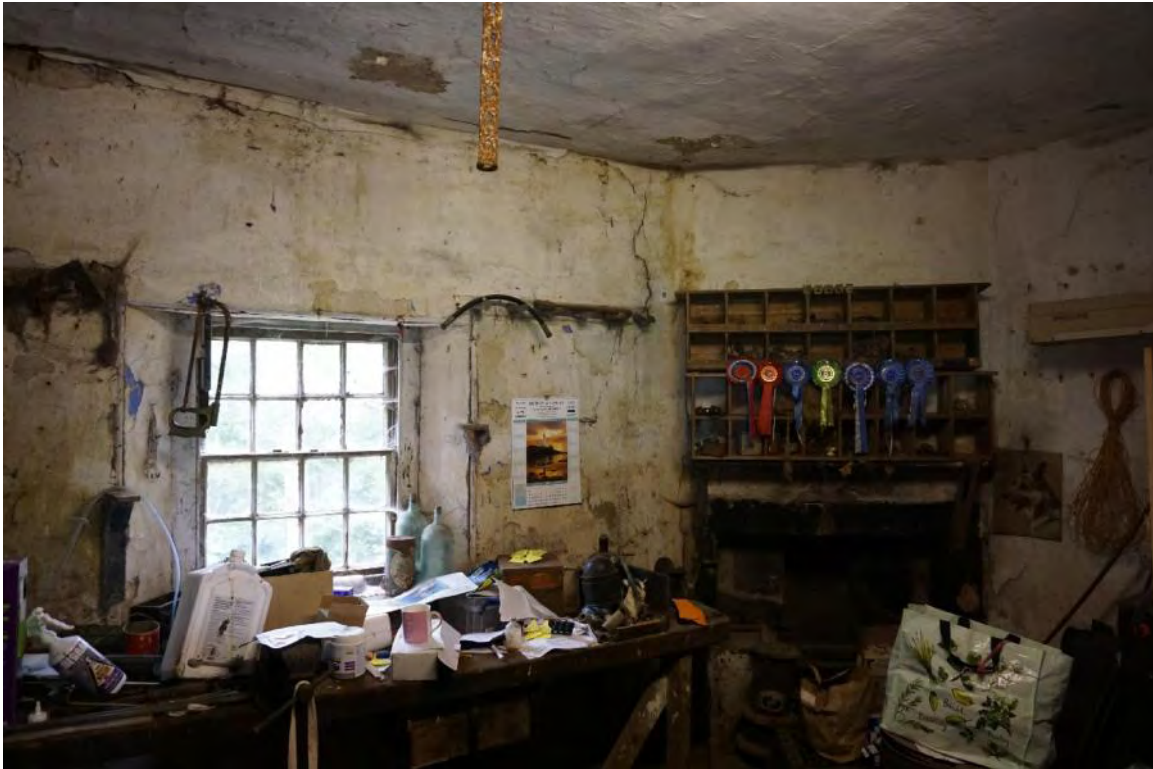
**PHOTO 8 – Workroom between coachhouse and stable. – cracks to northwest corner**

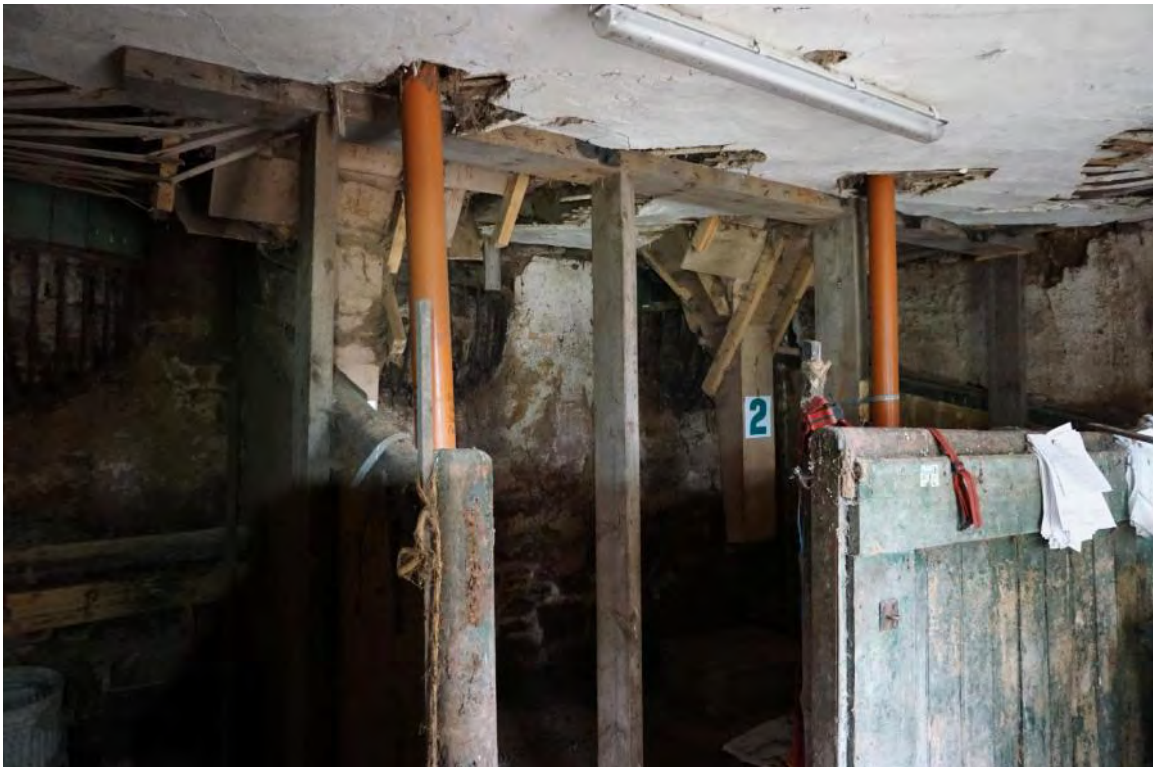
**PHOTO 9 – Timber Props to Joists in Stables – joists cut to accommodate hoppers**

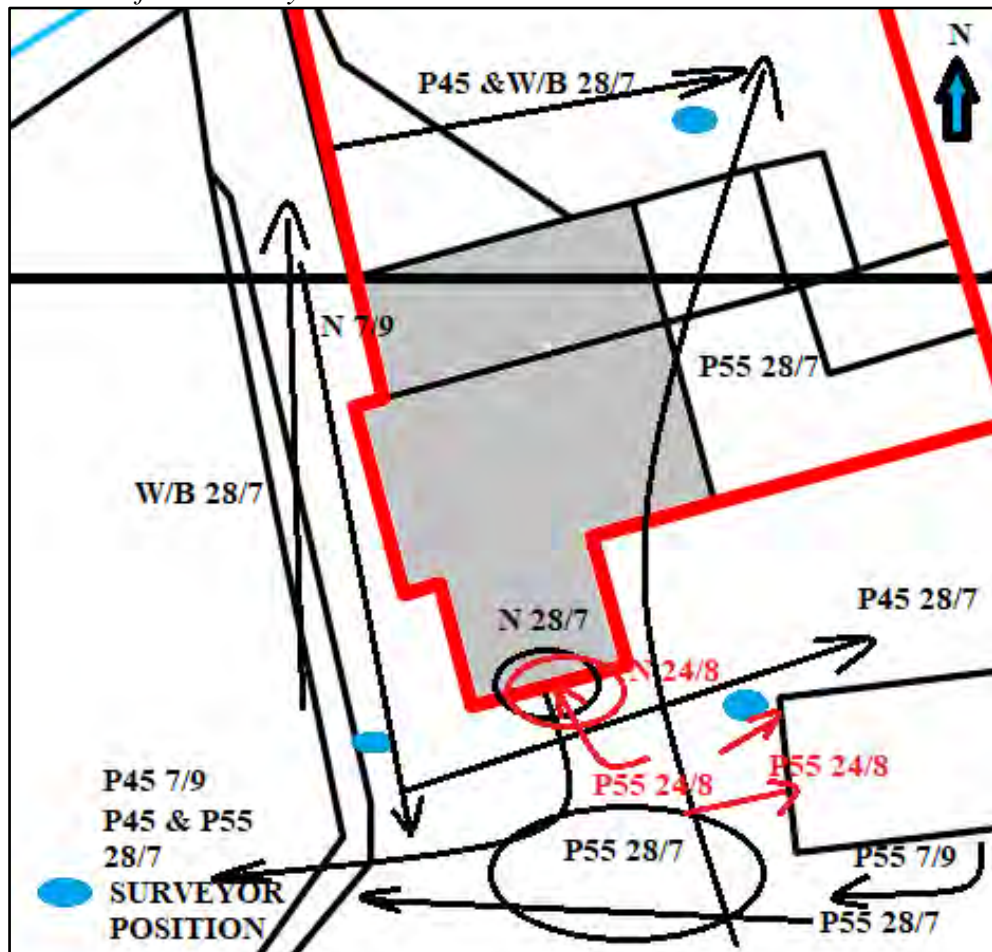
#### 4.4.4 Great Crested Newts

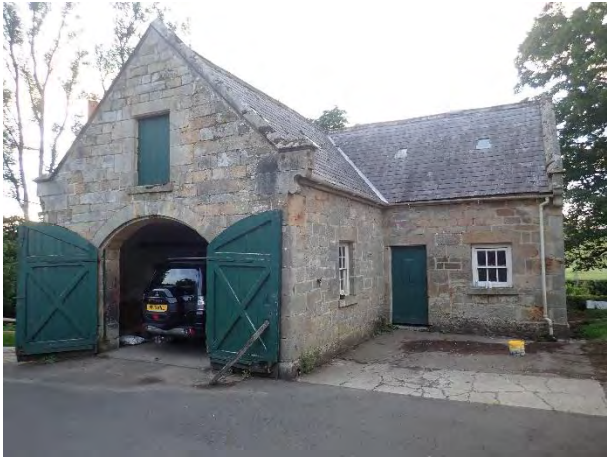
**The coach house from the south**

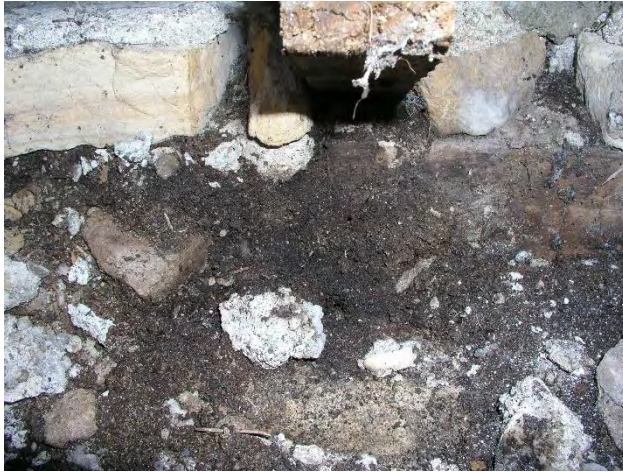
**Photo showing disintegrated bat droppings beneath coping stones. If examined carefully, in the black dust exoskeletons of insects can be seen shining.**

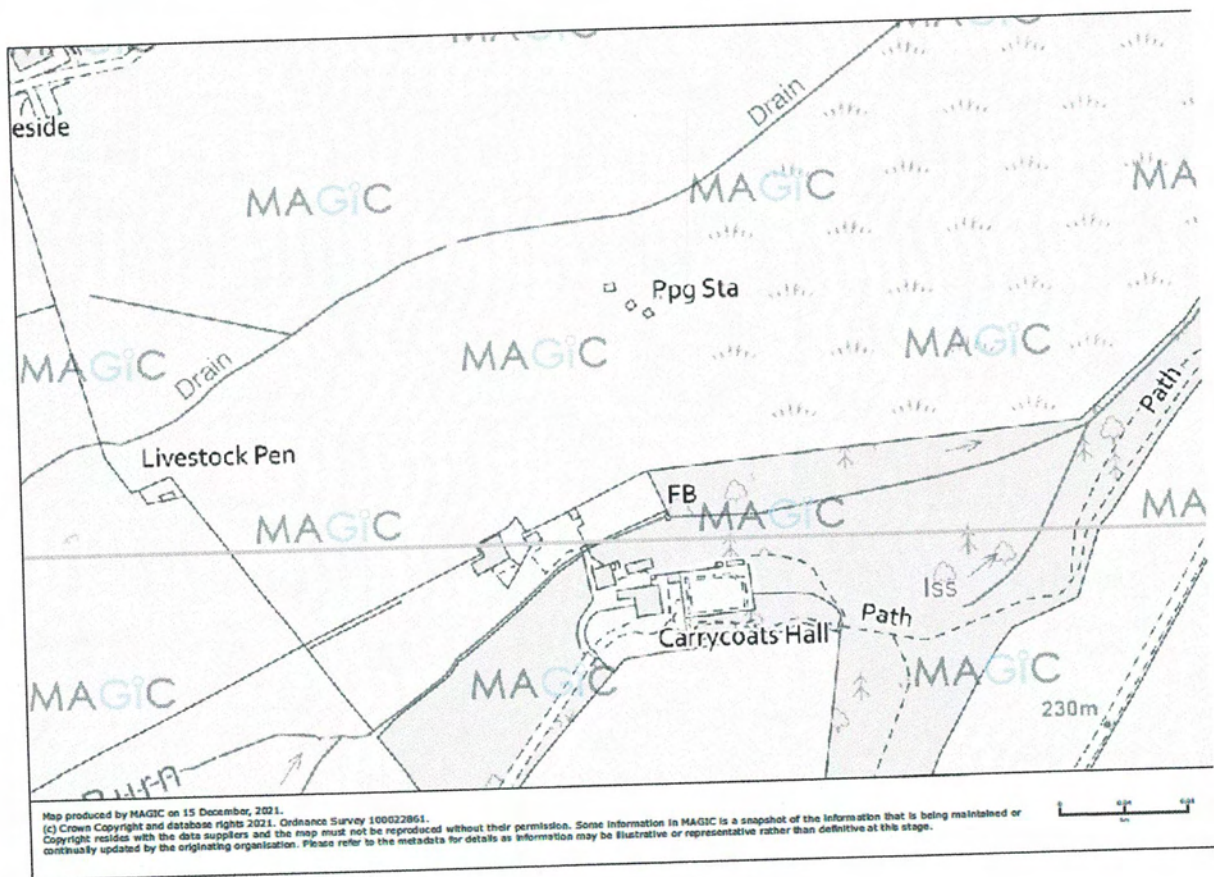
The supply therefore has ample capacity to serve the additional development proposed.
