Tree Safety and Condition Survey

West Lodge

**November 26<sup>th</sup> ,2021**

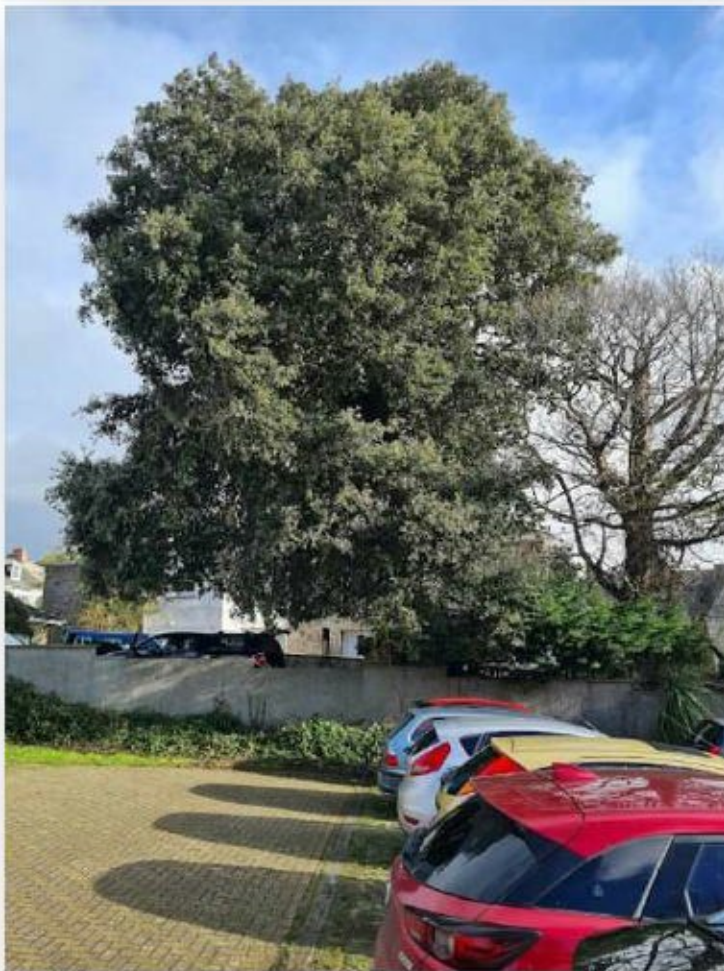
Image 1- Holm Oak (*Quercus ilex*)

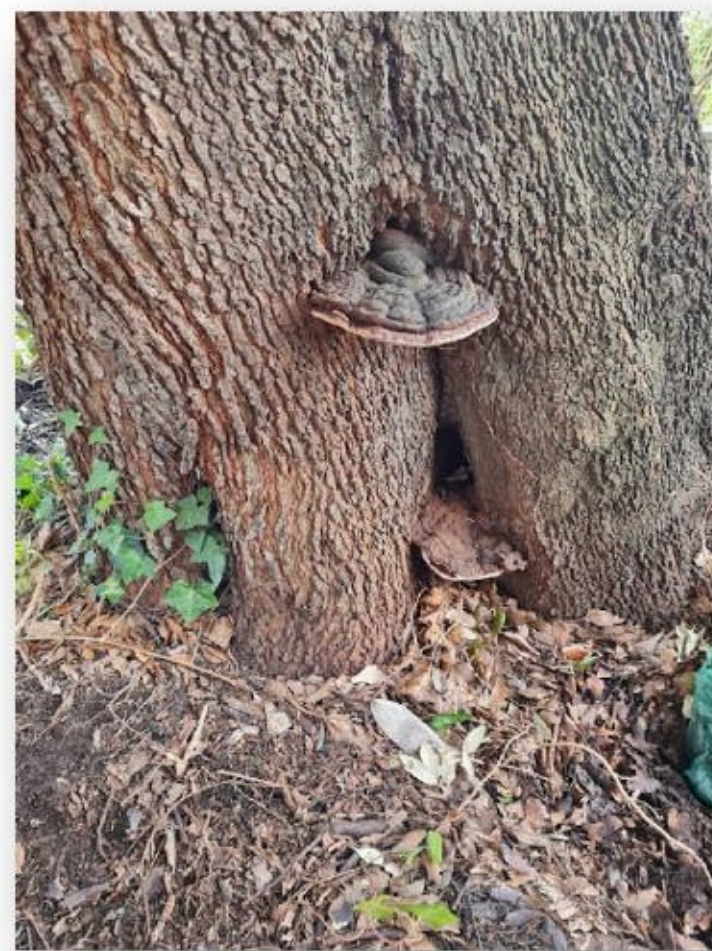
- 4.2 **Root System Assessment** – The tree has grown with restricted rooting volume due to raised bed. The tarmac drive has risen in places due to the root system exploiting the substrate below and pressure from root expansion/incremental growth.
- 4.3 **Buttress/root collar Assessment** – Two brackets of *Ganoderma applanatum* identified at base and 0.4m on western quarter (image 2). Sounding (resonance test) indicated internal decay. As it was difficult to assess the advancement of the decay using VTA methods, a further investigation using a Tomograph was carried out (see Appendix 4).
- 4.4 **Main Stem Assessment** – leaning 25 degrees from upright Northwest. Sounding (resonance test) indicated no internal decay above 1m. No fungal fruiting bodies observed on upper stem.

Image 2 – Shows *Ganoderma applanatum* brackets

- 5.2 Bracket fungus *Ganoderma applanatum* is a heartwood decay pathogen and frequently found on Holm Oak of this age class. Characteristically, the fungus produces a woody bracket forming a single bracket or overlapping in tiers, generally dark matt brown with a white underside. When the action of this fungus reaches an advanced stage an excessive amount of decay can result in the failure of the stem. However, the rate of decay can be slow and take many years to advance leaving the strength of the residual wall within acceptable tolerances for many years.

- 5.6 I recommend that a Tomograph Assessment of the stem (T1) should be carried out again in five years to assess the progression of the decay.

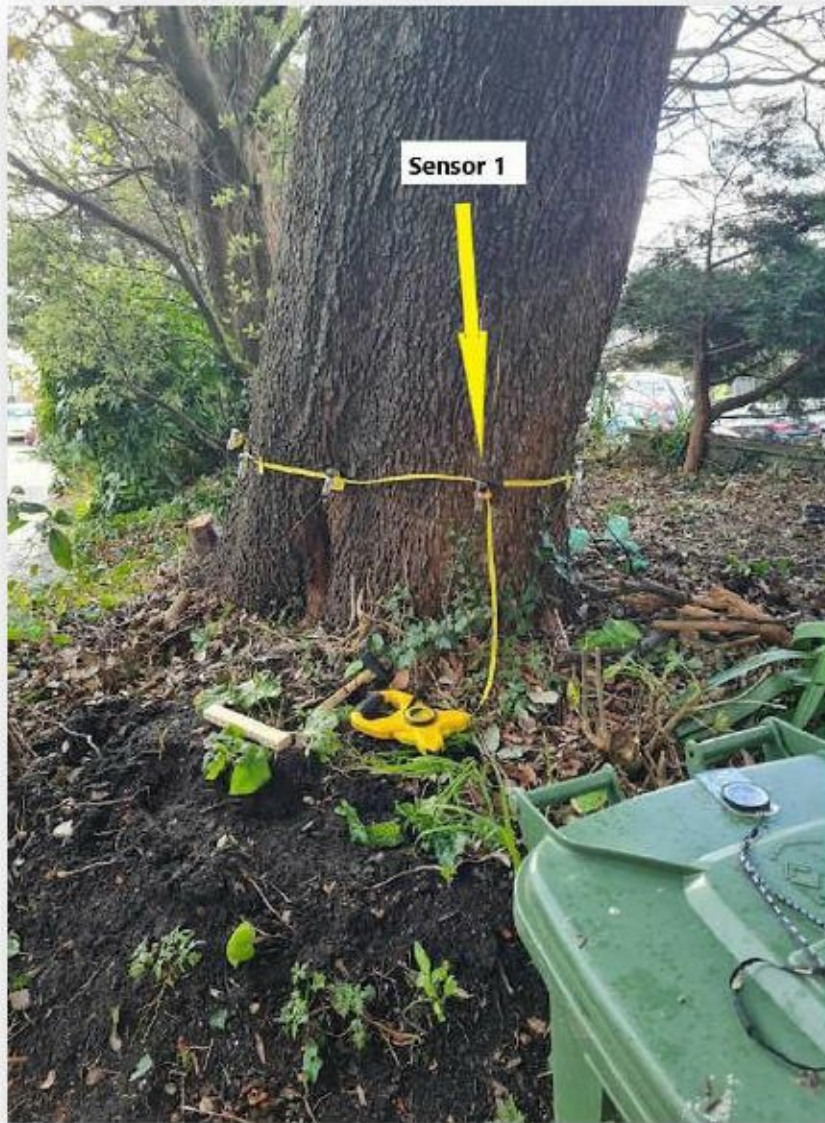
*Arborsonic set up looking South (Sensors @ 3500mm)*

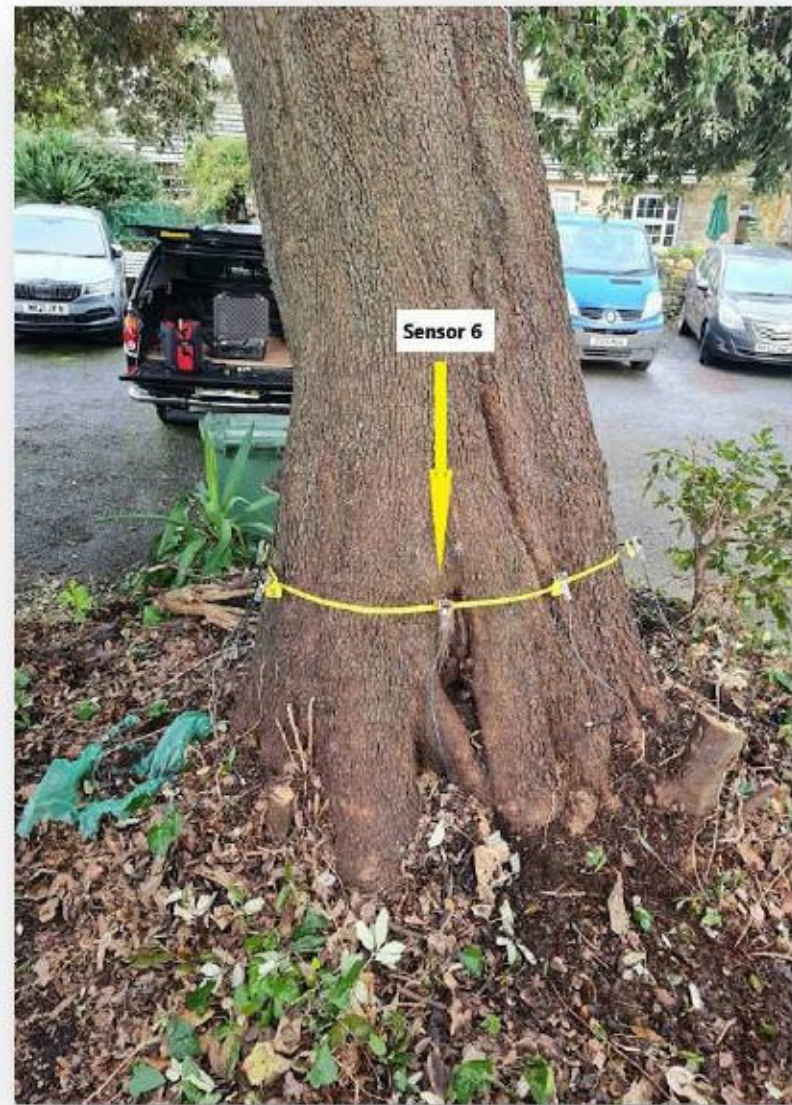
*Arborsonic set up looking North (Sensors @ 3500mm)*

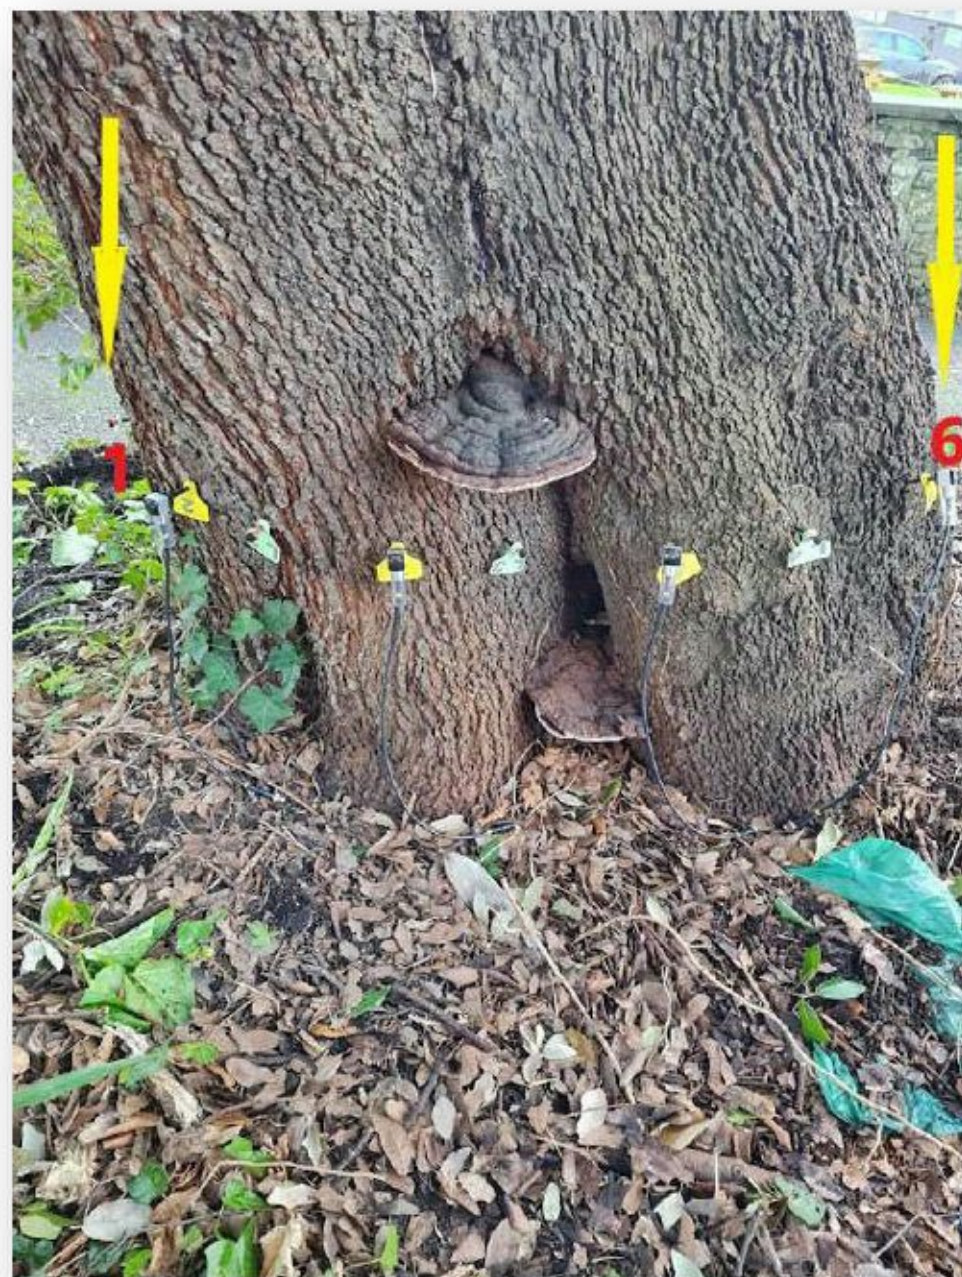
*Arborsonic set up between fruiting bodies @ 3500mm- Sensors 1&6 indicated*

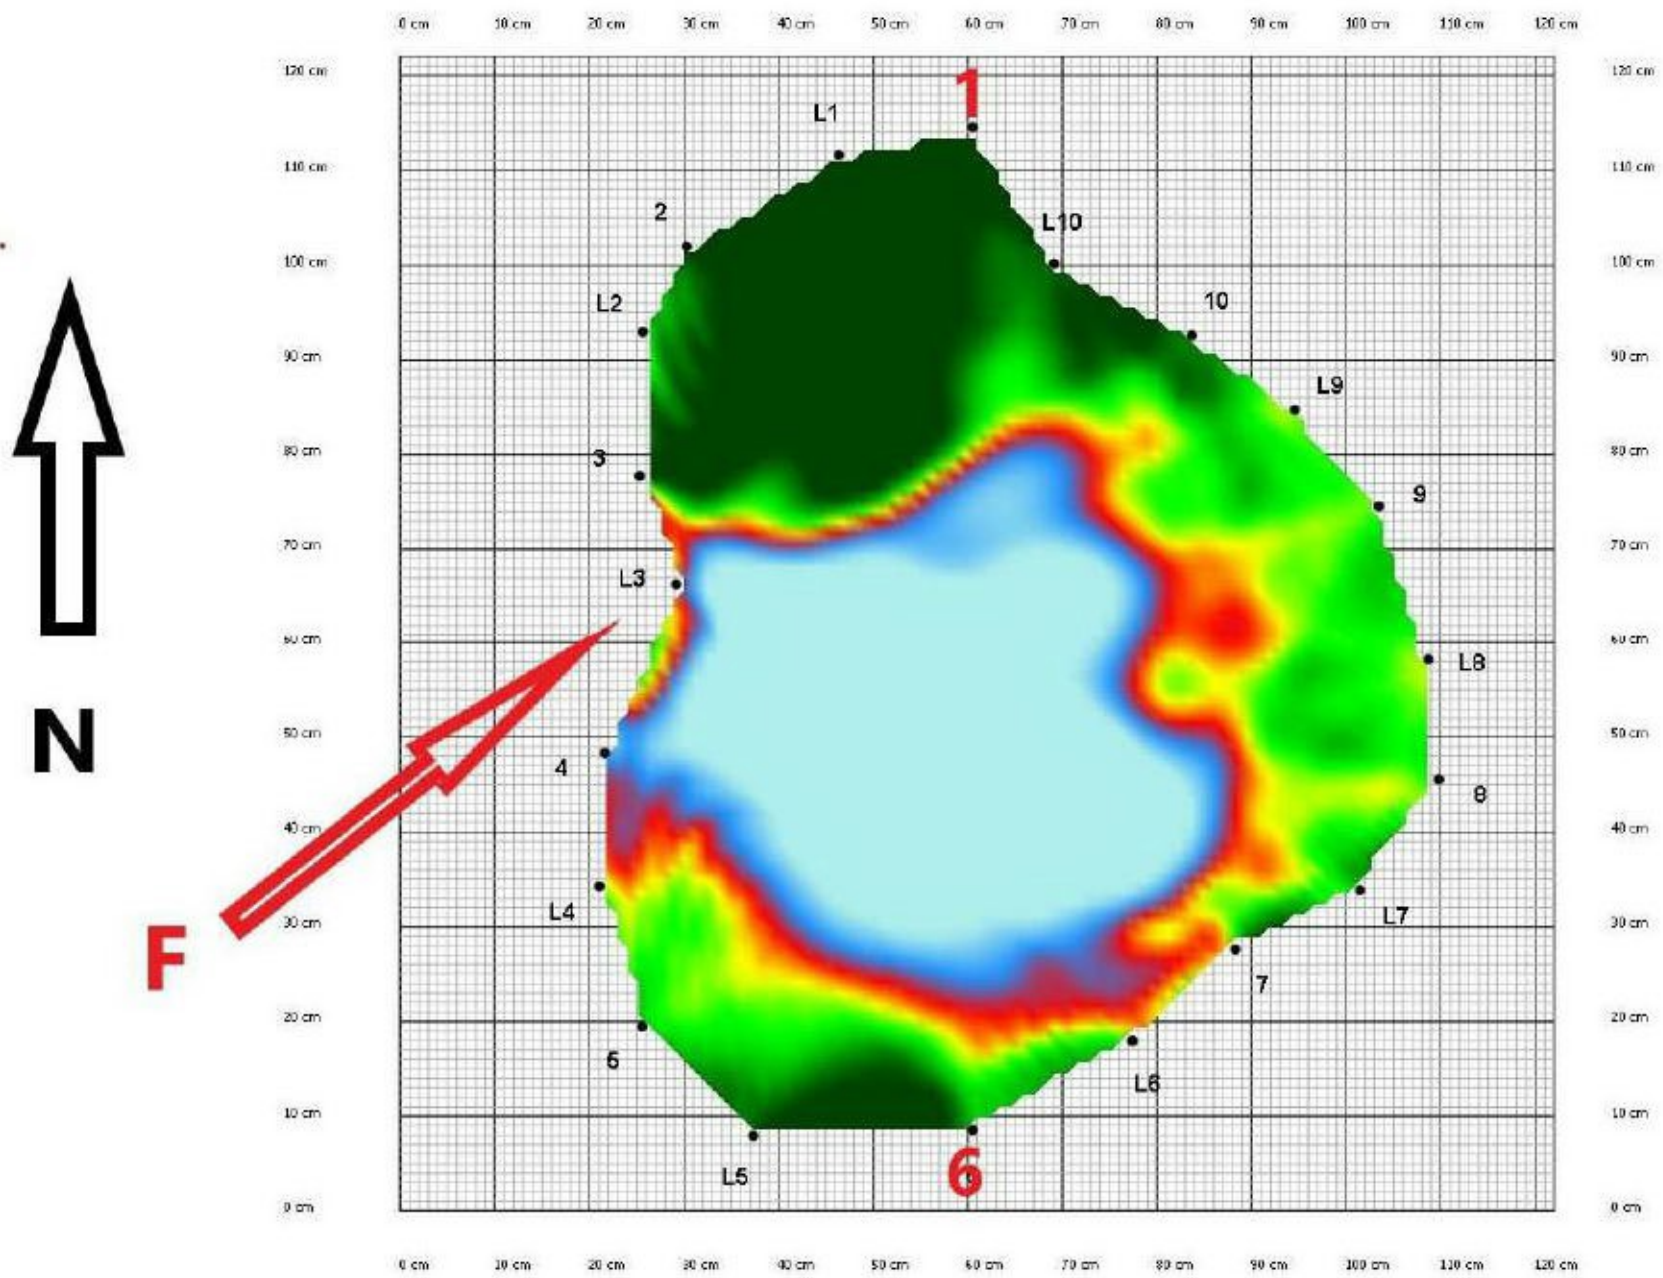
Sonic Tomogram image-Layer @350mm . 'F' – indicates position of fruiting bodies

Safety factor: 408 %  
 Risk rating: Low risk  
 Decayed area: 51 %  
 Avg. TR: 0.29  
 Tree weight above layer: 8462 kg  
 M: 232498 Nm

**Conclusions** - Based upon this assessment the tree has a basic safety factor of 408% which is above the minimal requirement of 150%, as such the tree is assumed to offer a **low risk of stem failure** at 0.35 m, assuming an upper wind speed of 33m/s (118.8 km/h or 73.8 mph or Beaufort Force 12) are likely to be experienced on site in the next year. The decay has the potential to overcome the remaining stem section in the longterm and will require periodic appraisal to enable comparison with this baseline information. Ideally the stem should be reassessed in this way in 5 years. The tree as a whole should be visually inspected every 12 months.

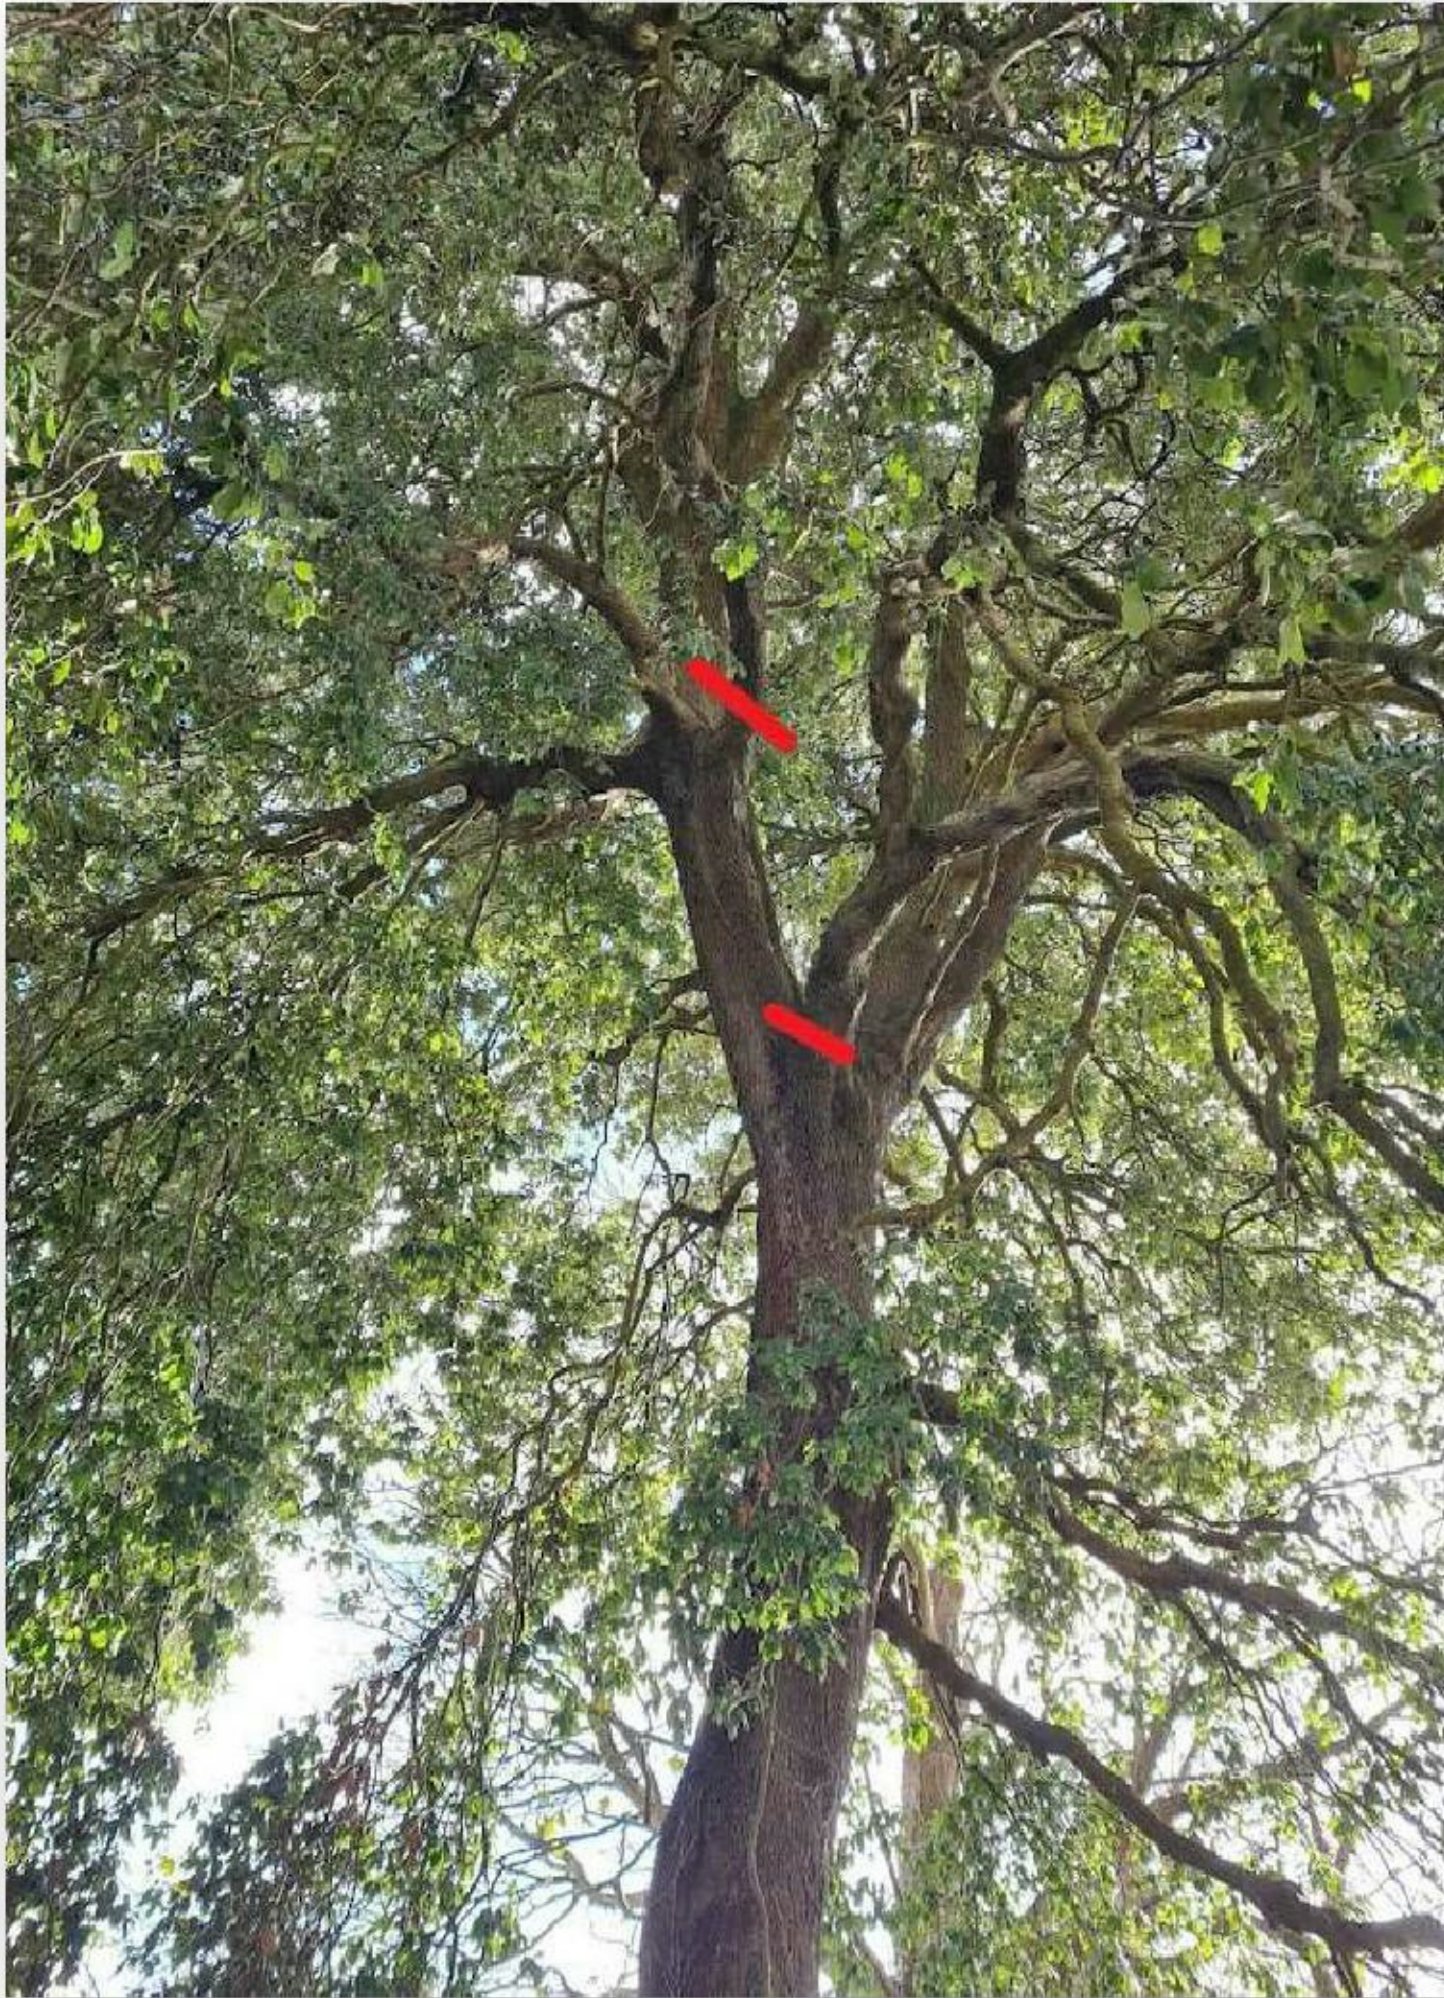
*Image 1- Red line shows removal of first primary branch and branch above*

Tree Surgery work : Remove first primary branch to North west back to main stem then remove second order branch to left 1.5m up (looking south) back to main stem (*see Image 1*). Crown lift remaining low branches to achieve 5m clearance over drive and car park. (*see Images 2 and 3*) .Reduce crown height by 3m to leave 14m and radial crown spread to northwest by 2m to leave 5m radial crown spread (*Image 4*).

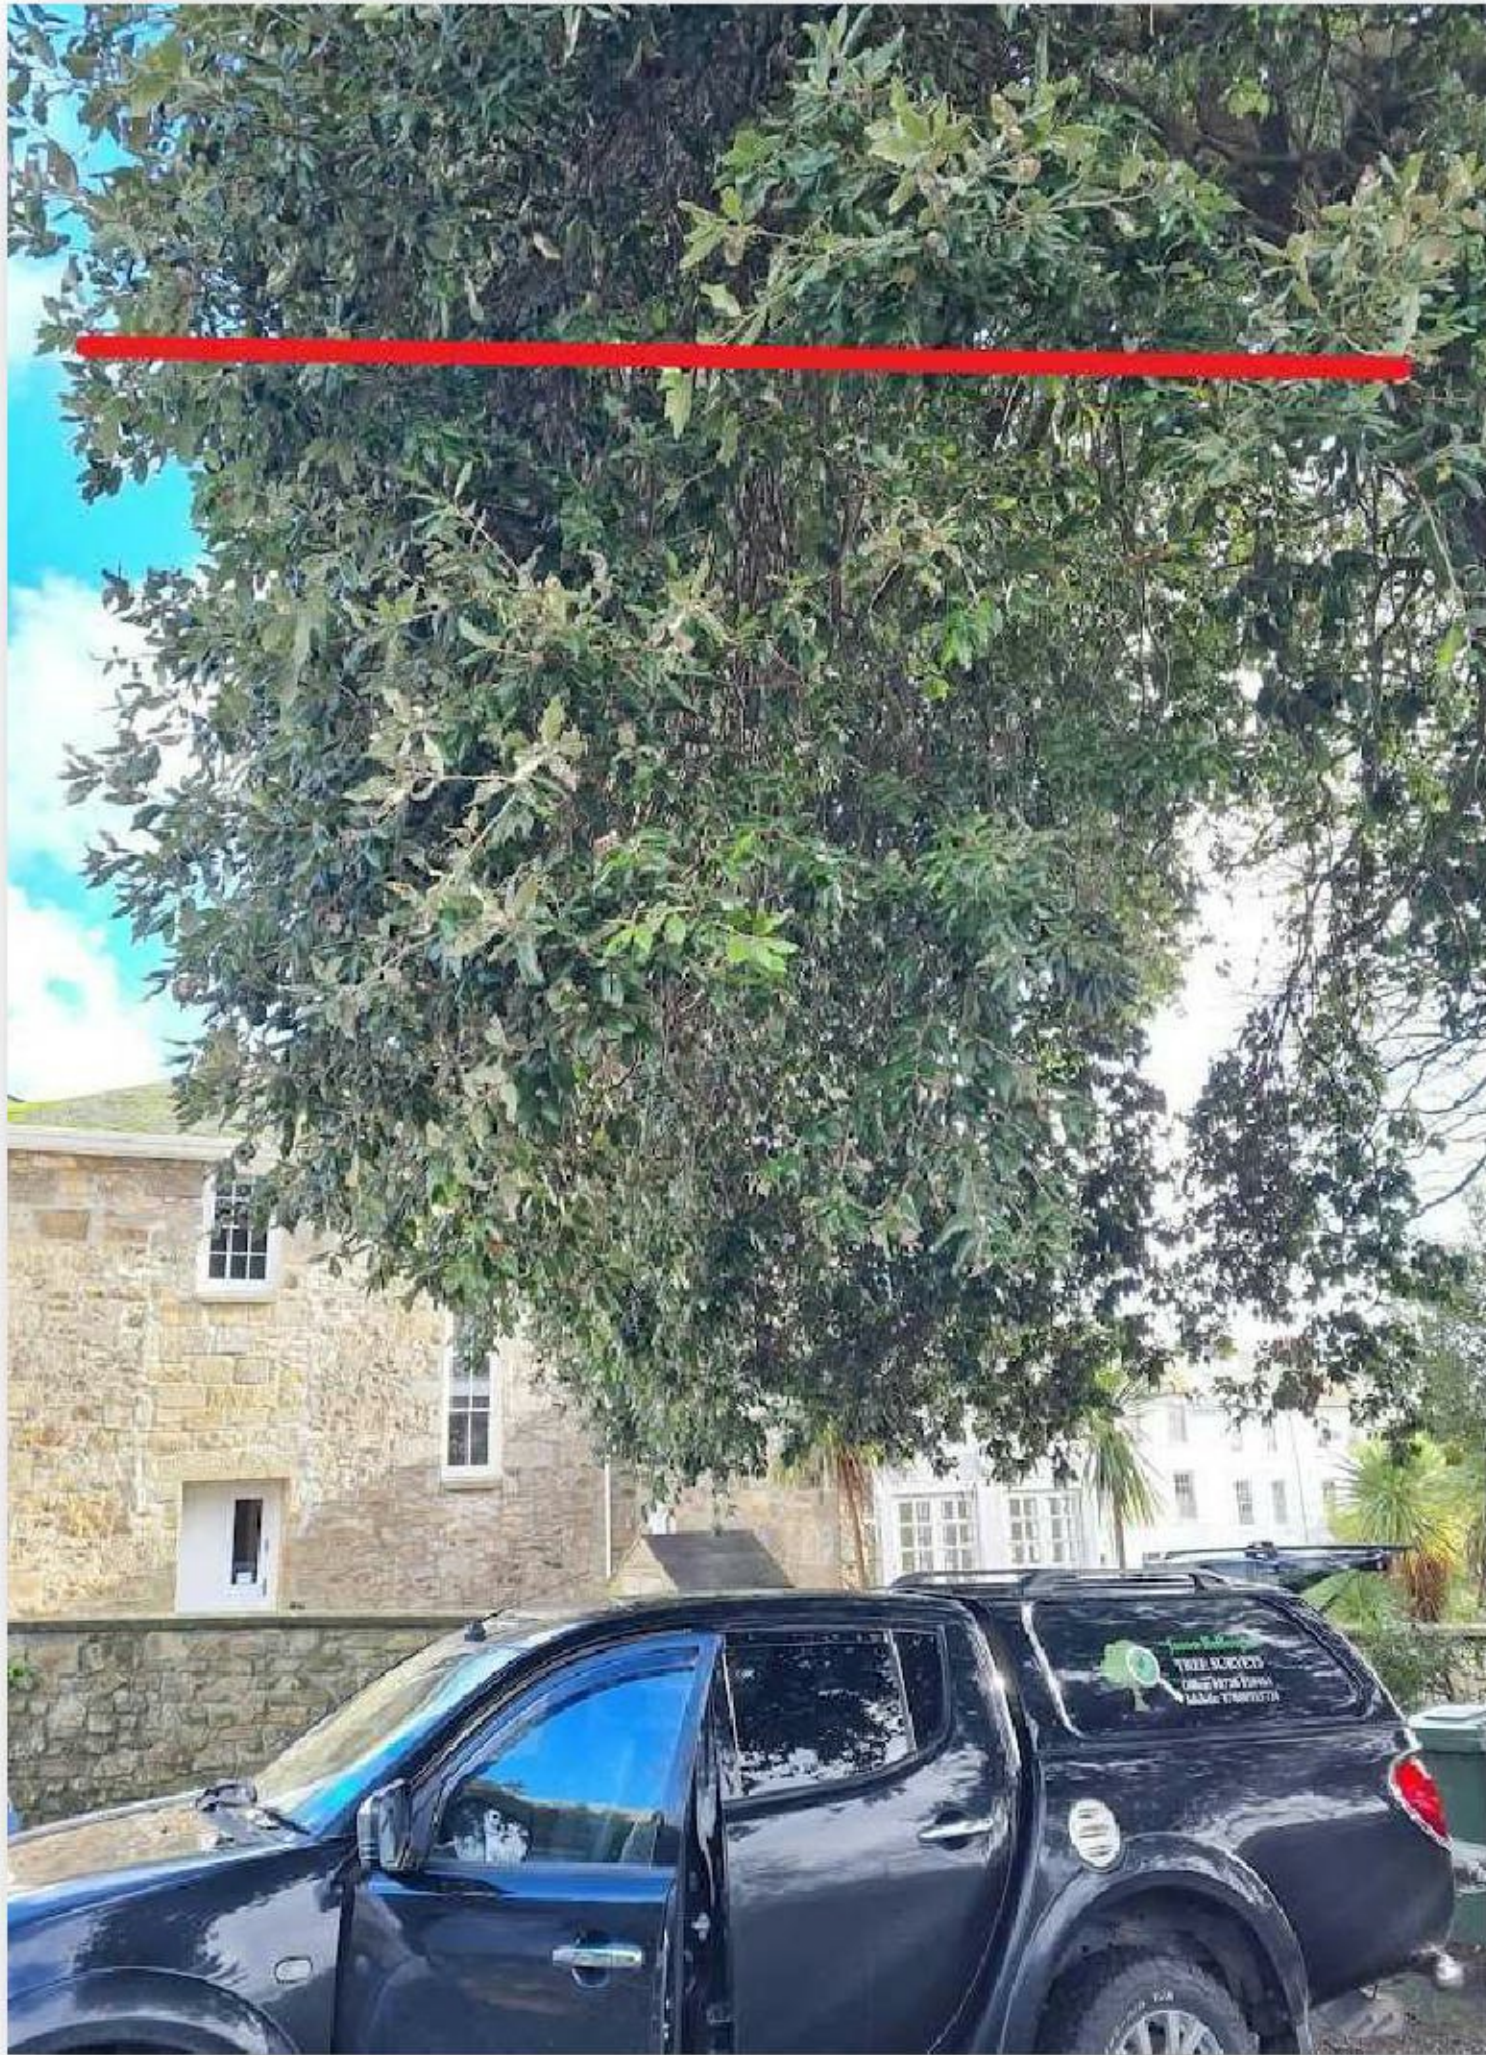
***Image 2- Red line shows crown lift over drive by 5m***

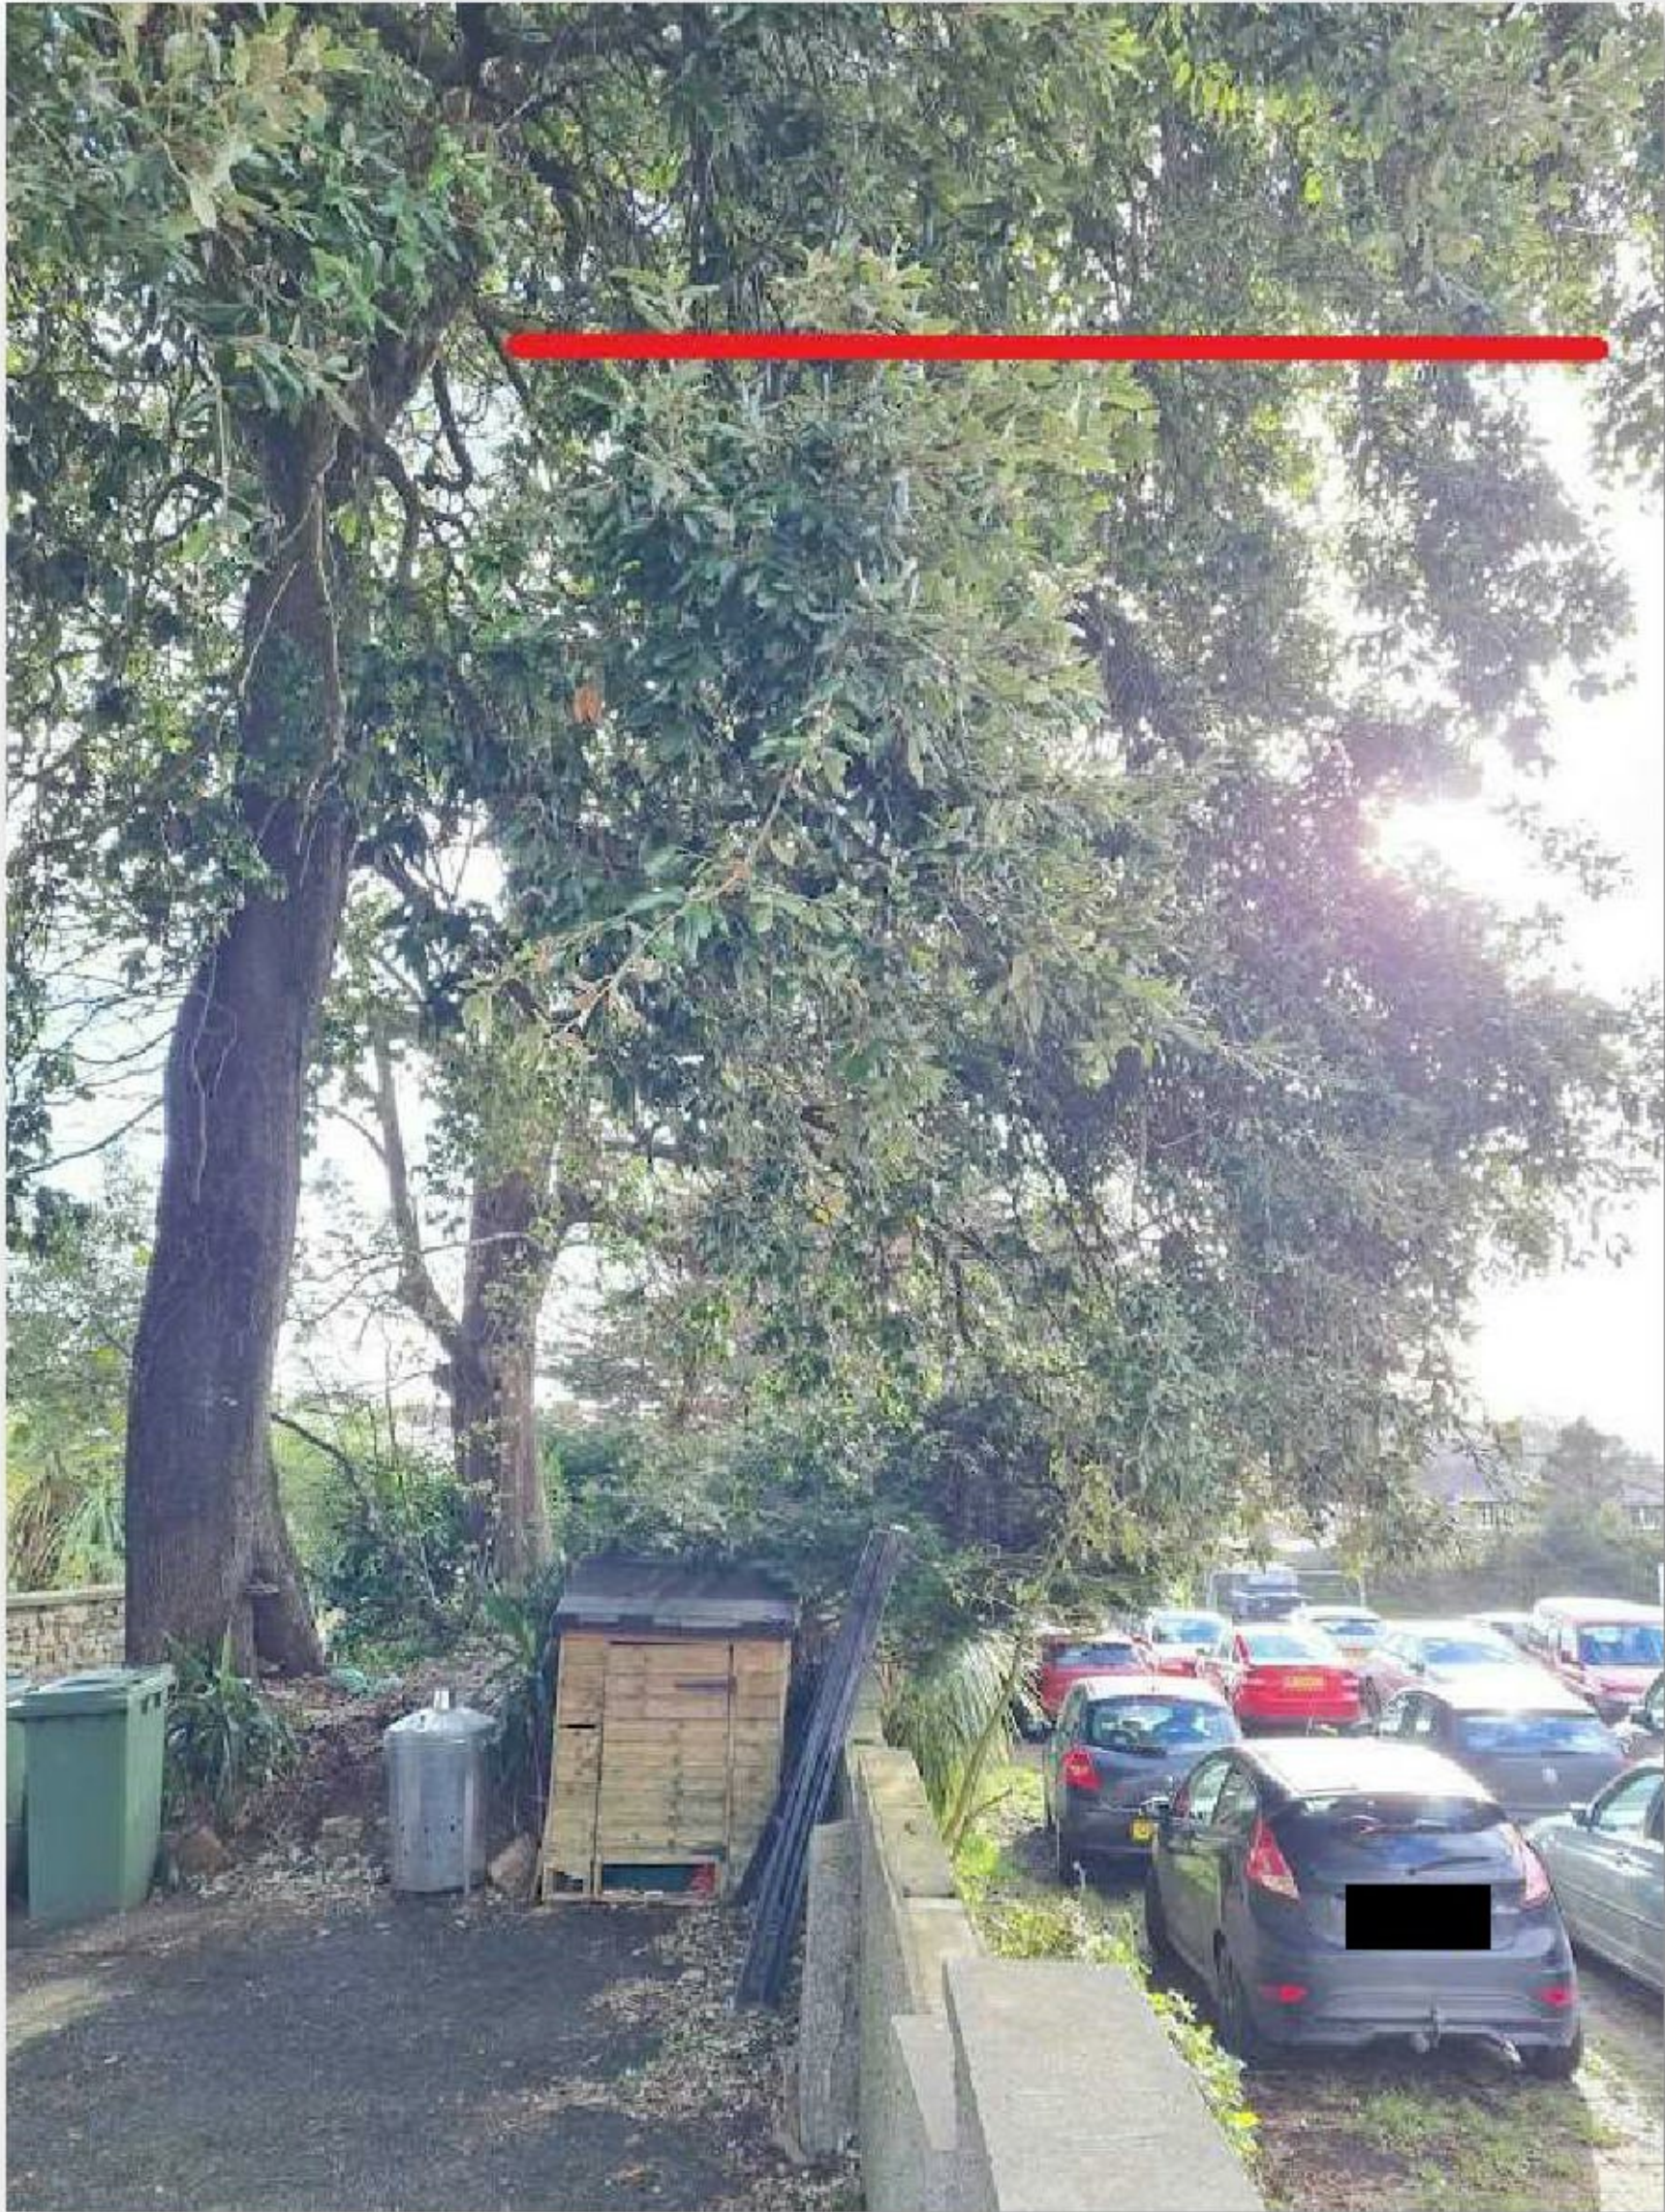
***Image 3- - Red line shows crown lift over drive/car park by 5m***

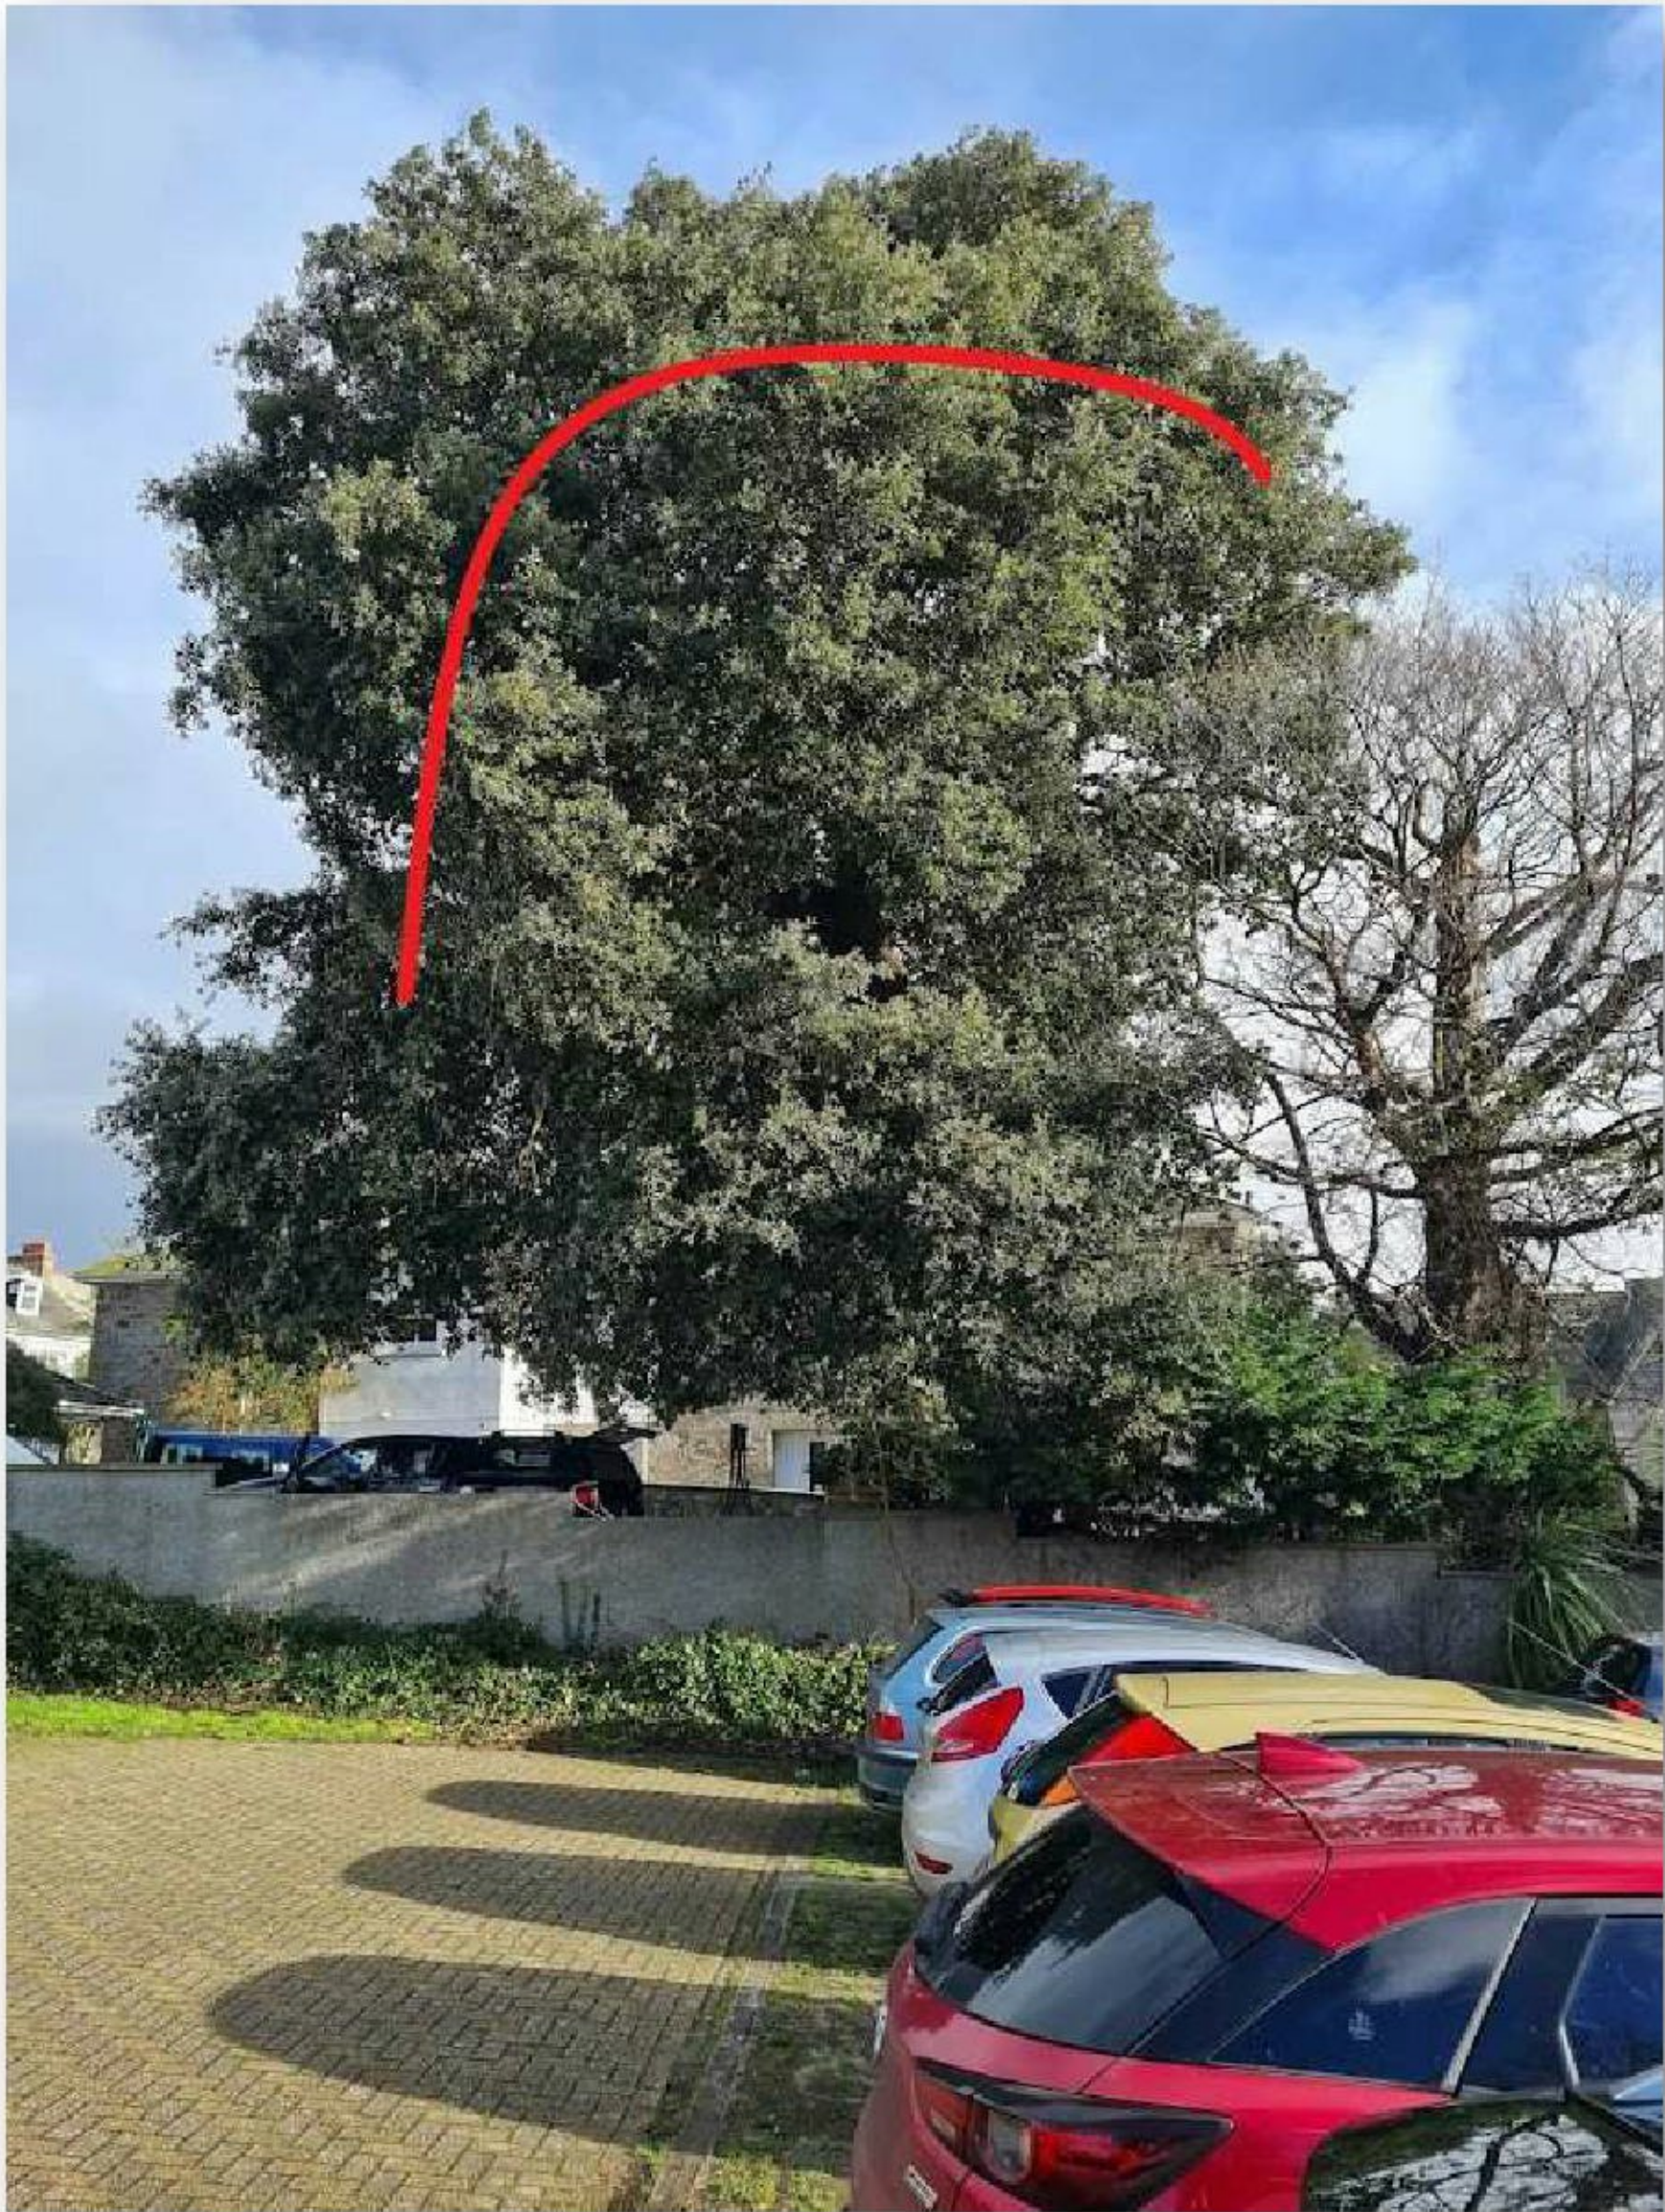
***Image 4- Red line indicates crown height reduction by 3m to leave 14m and radial crown spread by 2m to leave 5m radial crown spread (Northwest side).***
