ARBORICULTURAL ASSESSMENT REPORT

For:	Client:	Sedgwick International UK
	Insurer:	
Site:	Policyholder:	
	Risk Address:	The Old Vicarage, Church Hill, Ramsey, Harwich, CO12 5EU
Refs:	PRI Ref:	179784
	Client Ref:	9170697
	Insurer Ref:

Arborist Name:	Will Hinde	Date:	15/02/2021
QC:	Margaret MacQueen	Date:	17/02/2021

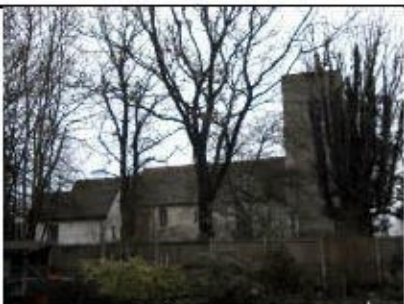
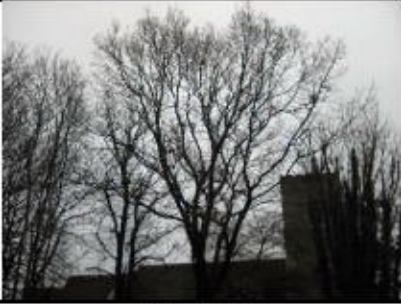
T6 - Oak

Tree No	Common Name	Age Class	Condition	Height (m)	Crown Spread (m)	Stem diam. (mm)	Dist to bldg. (m)	Roots Implicated	Pruning history	Recommendation	Tree work constraints	Notes	Owner address	Owner
T4	Oak	Mature	Good	13.5	8	520	15	N	Subject to past reduction management	No work required.		No site plan of where test holes were dug was provided, pattern of cracks appears to show more movement to RHS than rear.	The Old Vicarage Church Hill Ramsey Harwich CO12 5EU	PH
T5	Sycamore	Mature	Good	15.8	7.0	300*	20.5	N	Subject to past management.	No work required.			St Michaels Church Church Hill Ramsey Harwich CO12 5EU	P3P
T6	Oak	Mature	Good	17.5	10	600*	17	Y	Subject to past management.	Fell and treat stump (deciduous).			District land registry search required	UKN
T7	Maple (Field)	Early Mature	Good	9	6	250*	20.5	N	Subject to past management.	No work required.			District land registry search required	UKN
T8	Sycamore	Mature	Good	13	6	350*	15	Y	Subject to past reduction management	Fell and treat stump (deciduous).		Twin stem.	District land registry search required	UKN

Tree No:	Species	Works Required
T6	Oak	Fell and treat stump (deciduous).
T8	Sycamore	Fell and treat stump (deciduous).
