PROJECT: SIDCUP

ADDRESS: 131 STATION ROAD, SIDCUP, KENT, DA15 7AA

EXISTING GROUND FLOOR GENERAL ARRANGEMENT

DATE: 03/08/2021
 SCALE: 1:50@A2
 DRAWN BY: rds

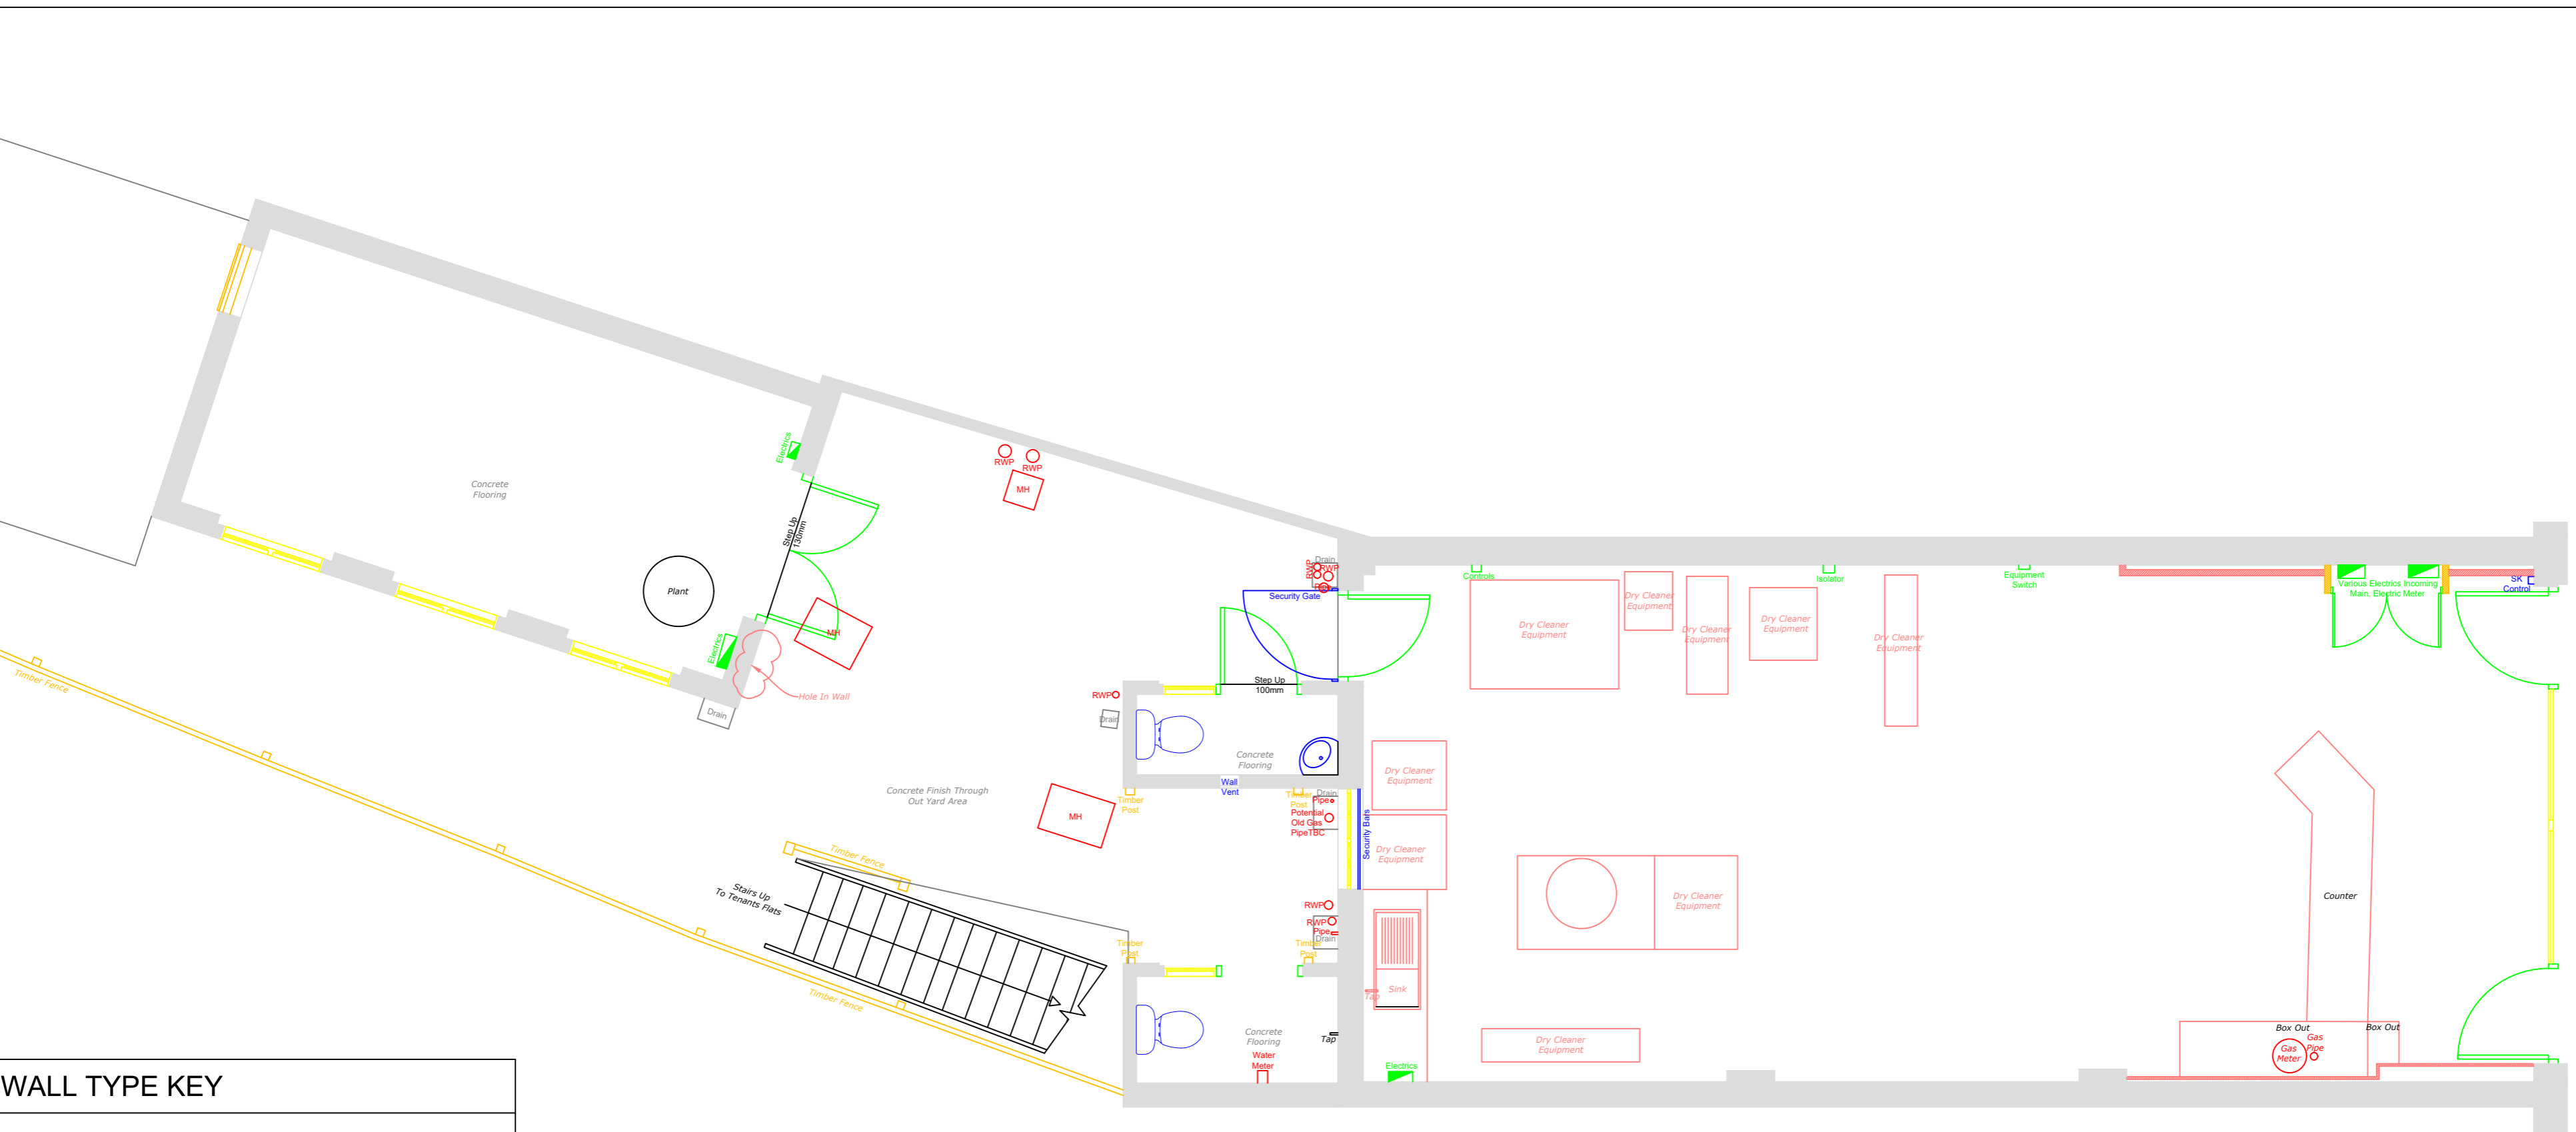
- Shop Front**
- Timber stepped threshold on shop front entrance does not meet DDA regulations
- Flooring**
- Uneven flooring throughout unit, needs addressing
 - Concrete flooring throughout unit with wood vinyl and carpet laid on top
- Walls**
- Over board cladding to be stripped back to structural walls
 - Rear left hand wall of the unit has signs of water damage
 - Rear right hand wall next to rear door has low level damage, needs addressing
- Rear Window**
- Rear window has damage, needs addressing
 - Signs of water damage
 - Damage from installation of security bars
 - Missing window panes
- Back Door**
- Back door needs to be replaced due to not being secure

- Equipment**
- Gas meter located in store
 - Gas meter is located in box out around counter
 - Appointed contractor required to ensure gas meter is suitable for Pizza Hut requirements

- Potential additional gas pipes in box out, TBC
 - Main electrics needs to be checked by appointed electrical contractor to confirm if the electrics are suitable for Pizza Hut requirements

- Water meter is located outside the unit in out building
- Rear Yard**
- Rear yard is in urgent need of repair
 - Two out buildings have major damp issues and are in disrepair

- Canopy area is in major disrepair
 - Canopy roof is falling down and being held up by timber posts
 - Potential old gas pipe located in canopy area TBC

- Rubbish located in canopy area
 - Left hand out building needs attention, ceiling is falling down, damp, piles of rubbish. In addition the water meter is located in out building which is leaking

- Rear yard is shared with above flats and not secure due to access required for tenants.
 - Confirmation required for ownership of rear unit
 - Rear yard flooring is uneven and falling towards rear door
