**BROWNFIELD SOLUTIONS GEO-ENVIRONMENTAL ASSESSMENT**

**ALDI STORES LTD**  
WESTGATE, SKELMERSDALE

Geo-Environmental Assessment Report

JM/C3788/7517 Rev A

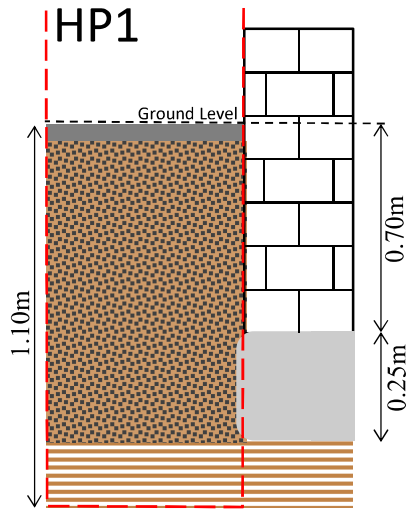
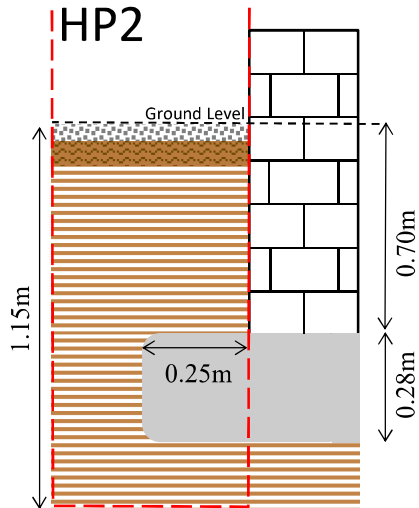
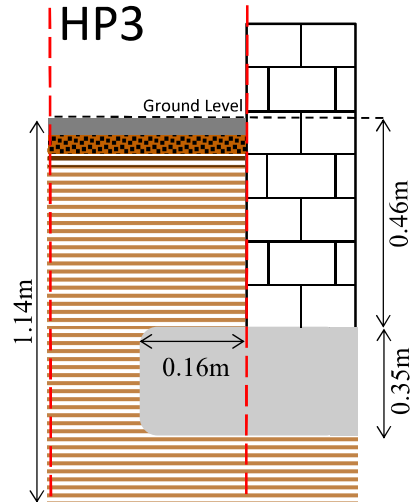
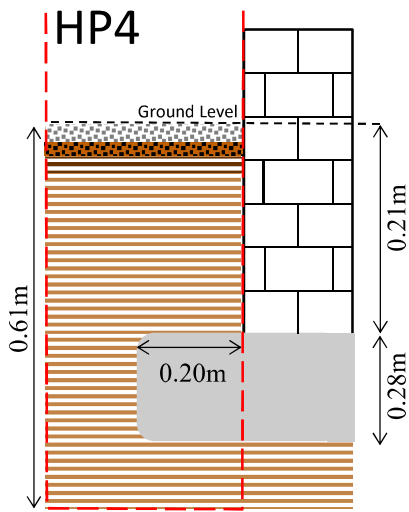
<b>BROWNFIELD SOLUTIONS LTD</b> <small>GEO ENVIRONMENTAL ENGINEERING EXCELLENCE</small>	
ALDI	
Westgate, Skelmersdale	
Existing Foundations	
Drawing Number C3788/05	
Scale: NTS	
Drawn By: JM	Checked By: AJS

5.4.1 The current foundations beneath the existing building onsite appear to be concrete strip foundations, based on the foundation inspection pits excavated. All four hand excavated trial pits proved thickness of the foundations to be 0.25-0.35m thick, and depth from ground level to foundations to be between 0.21m and 0.70m bgl. A diagram of the foundations is presented in drawings, reference C3788/05.
