737/03

Lockskimmers Farm

We attach photos taken during a visit on 19 November 2021 to look at the areas of proposed works to the east end of the house, together with marked-up extracts of your proposed plans. These note initial comments on the structural implications of the proposals and the investigations required to progress the structural design.

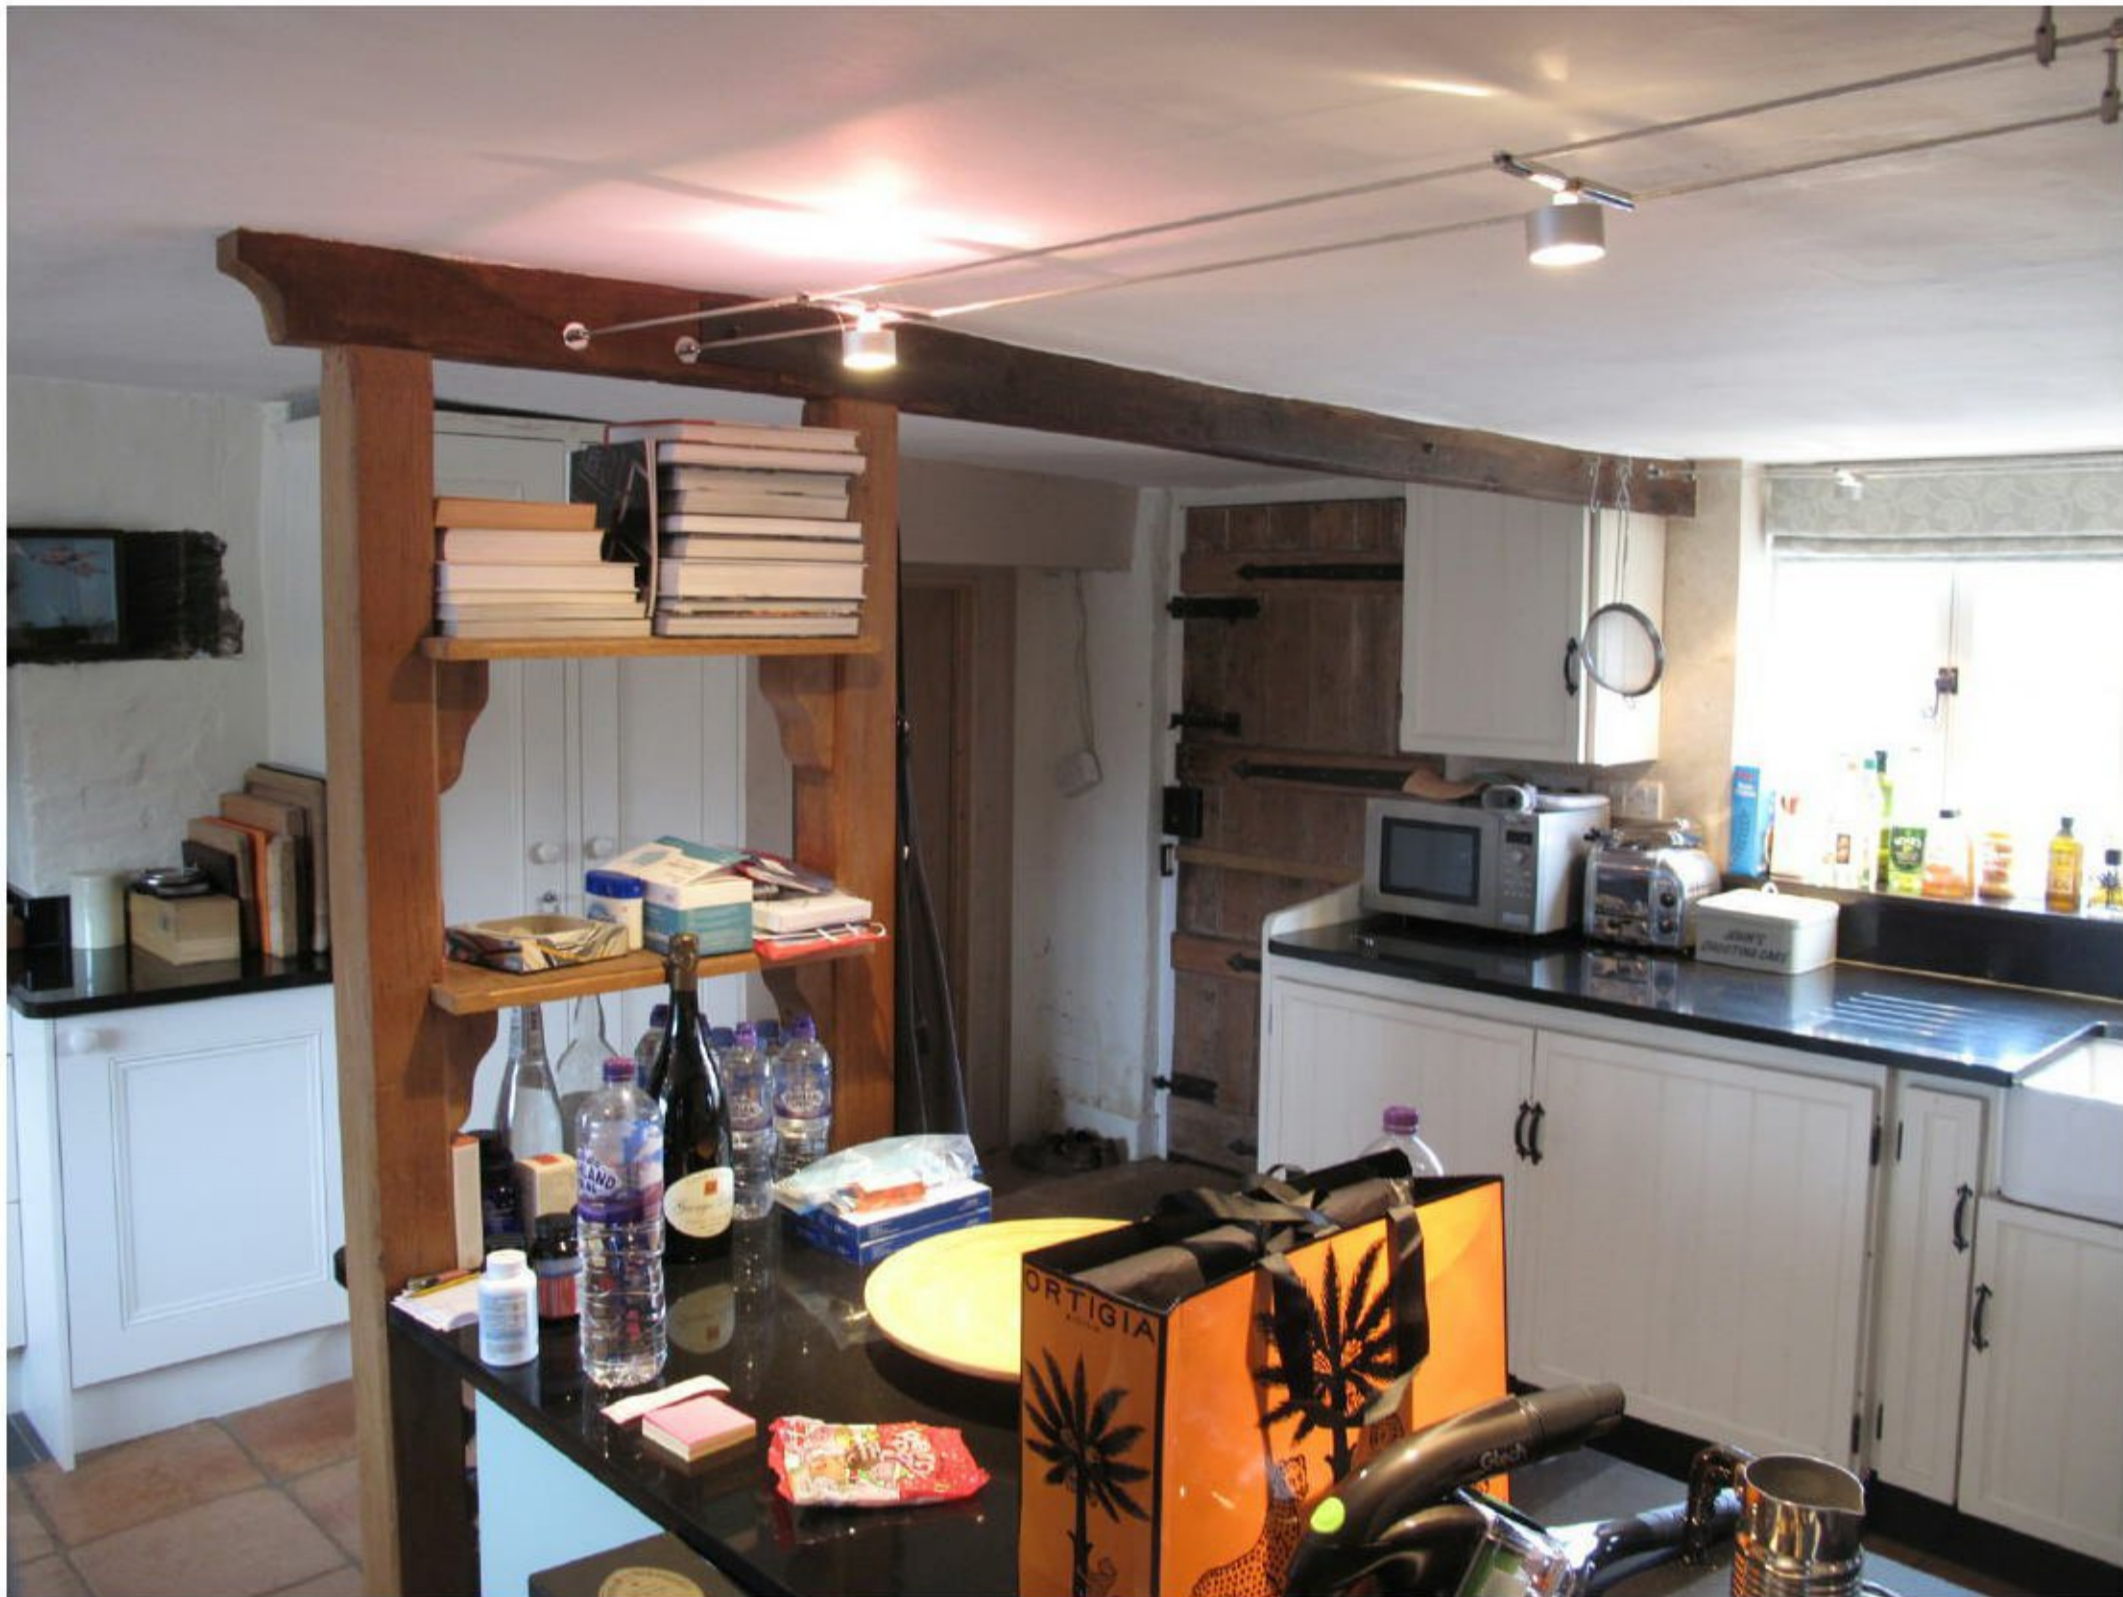
1. Investigate if posts and beam provide support to floor above

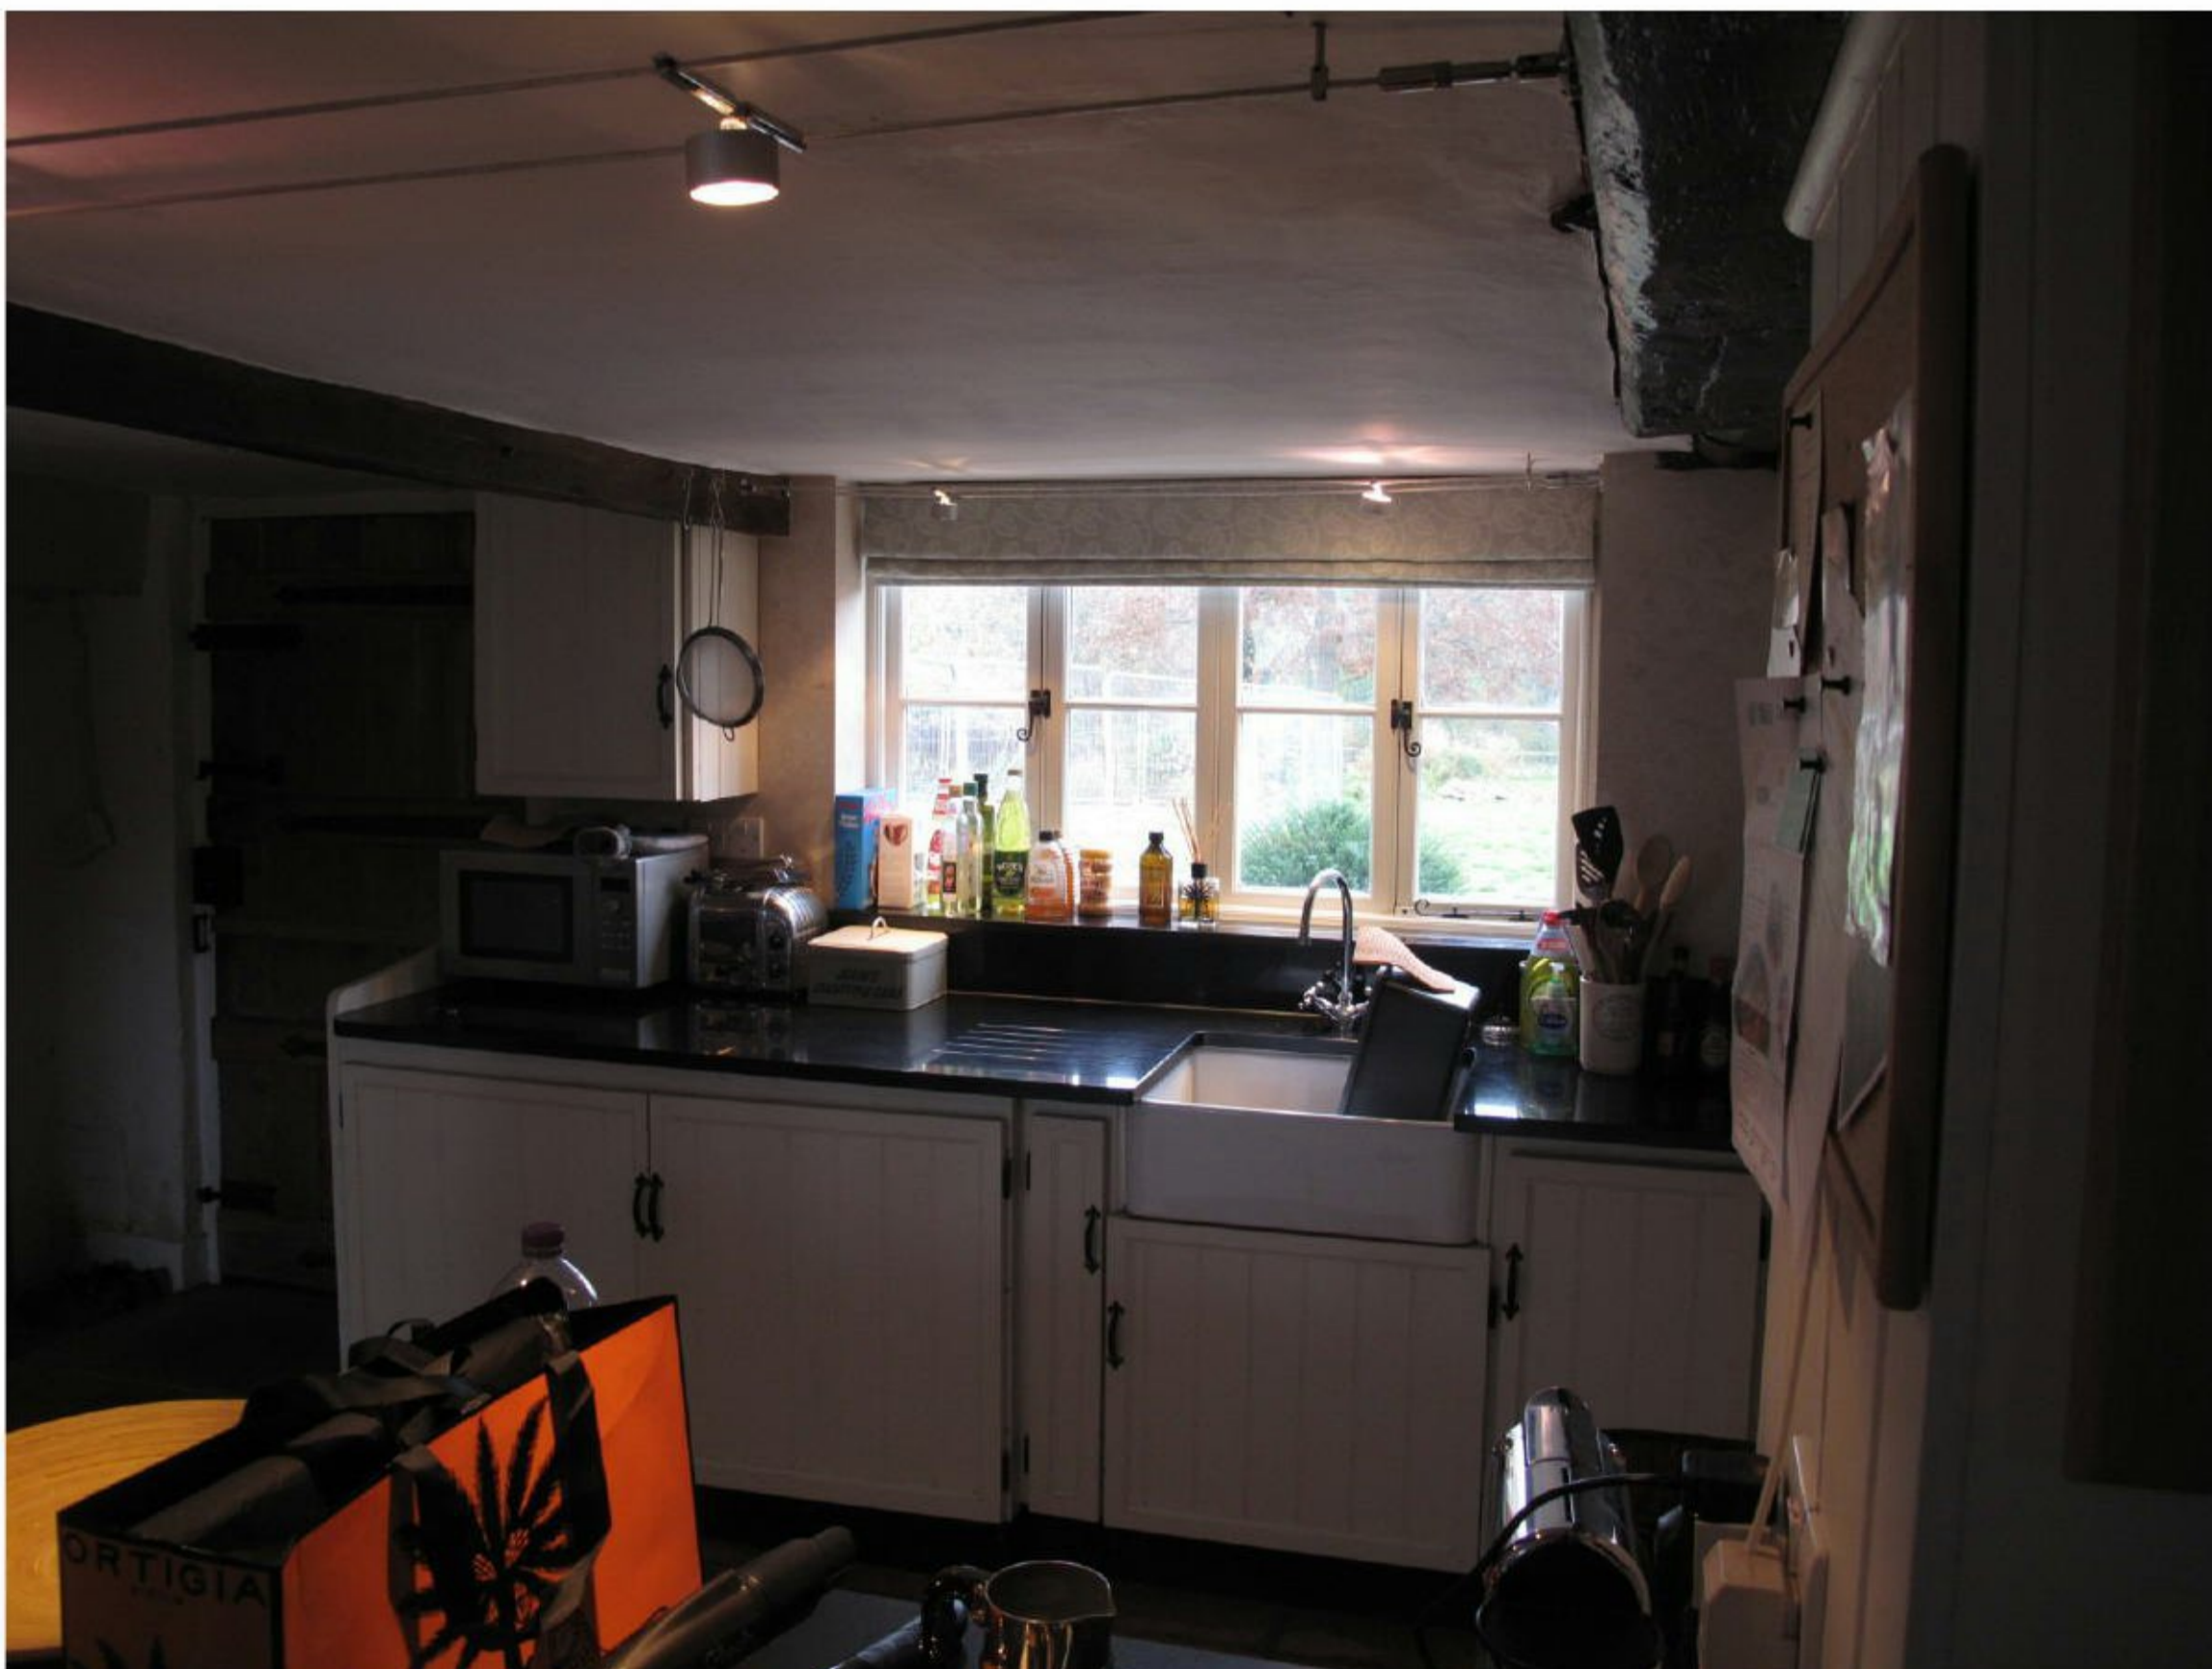
2. Proposed door in existing window opening

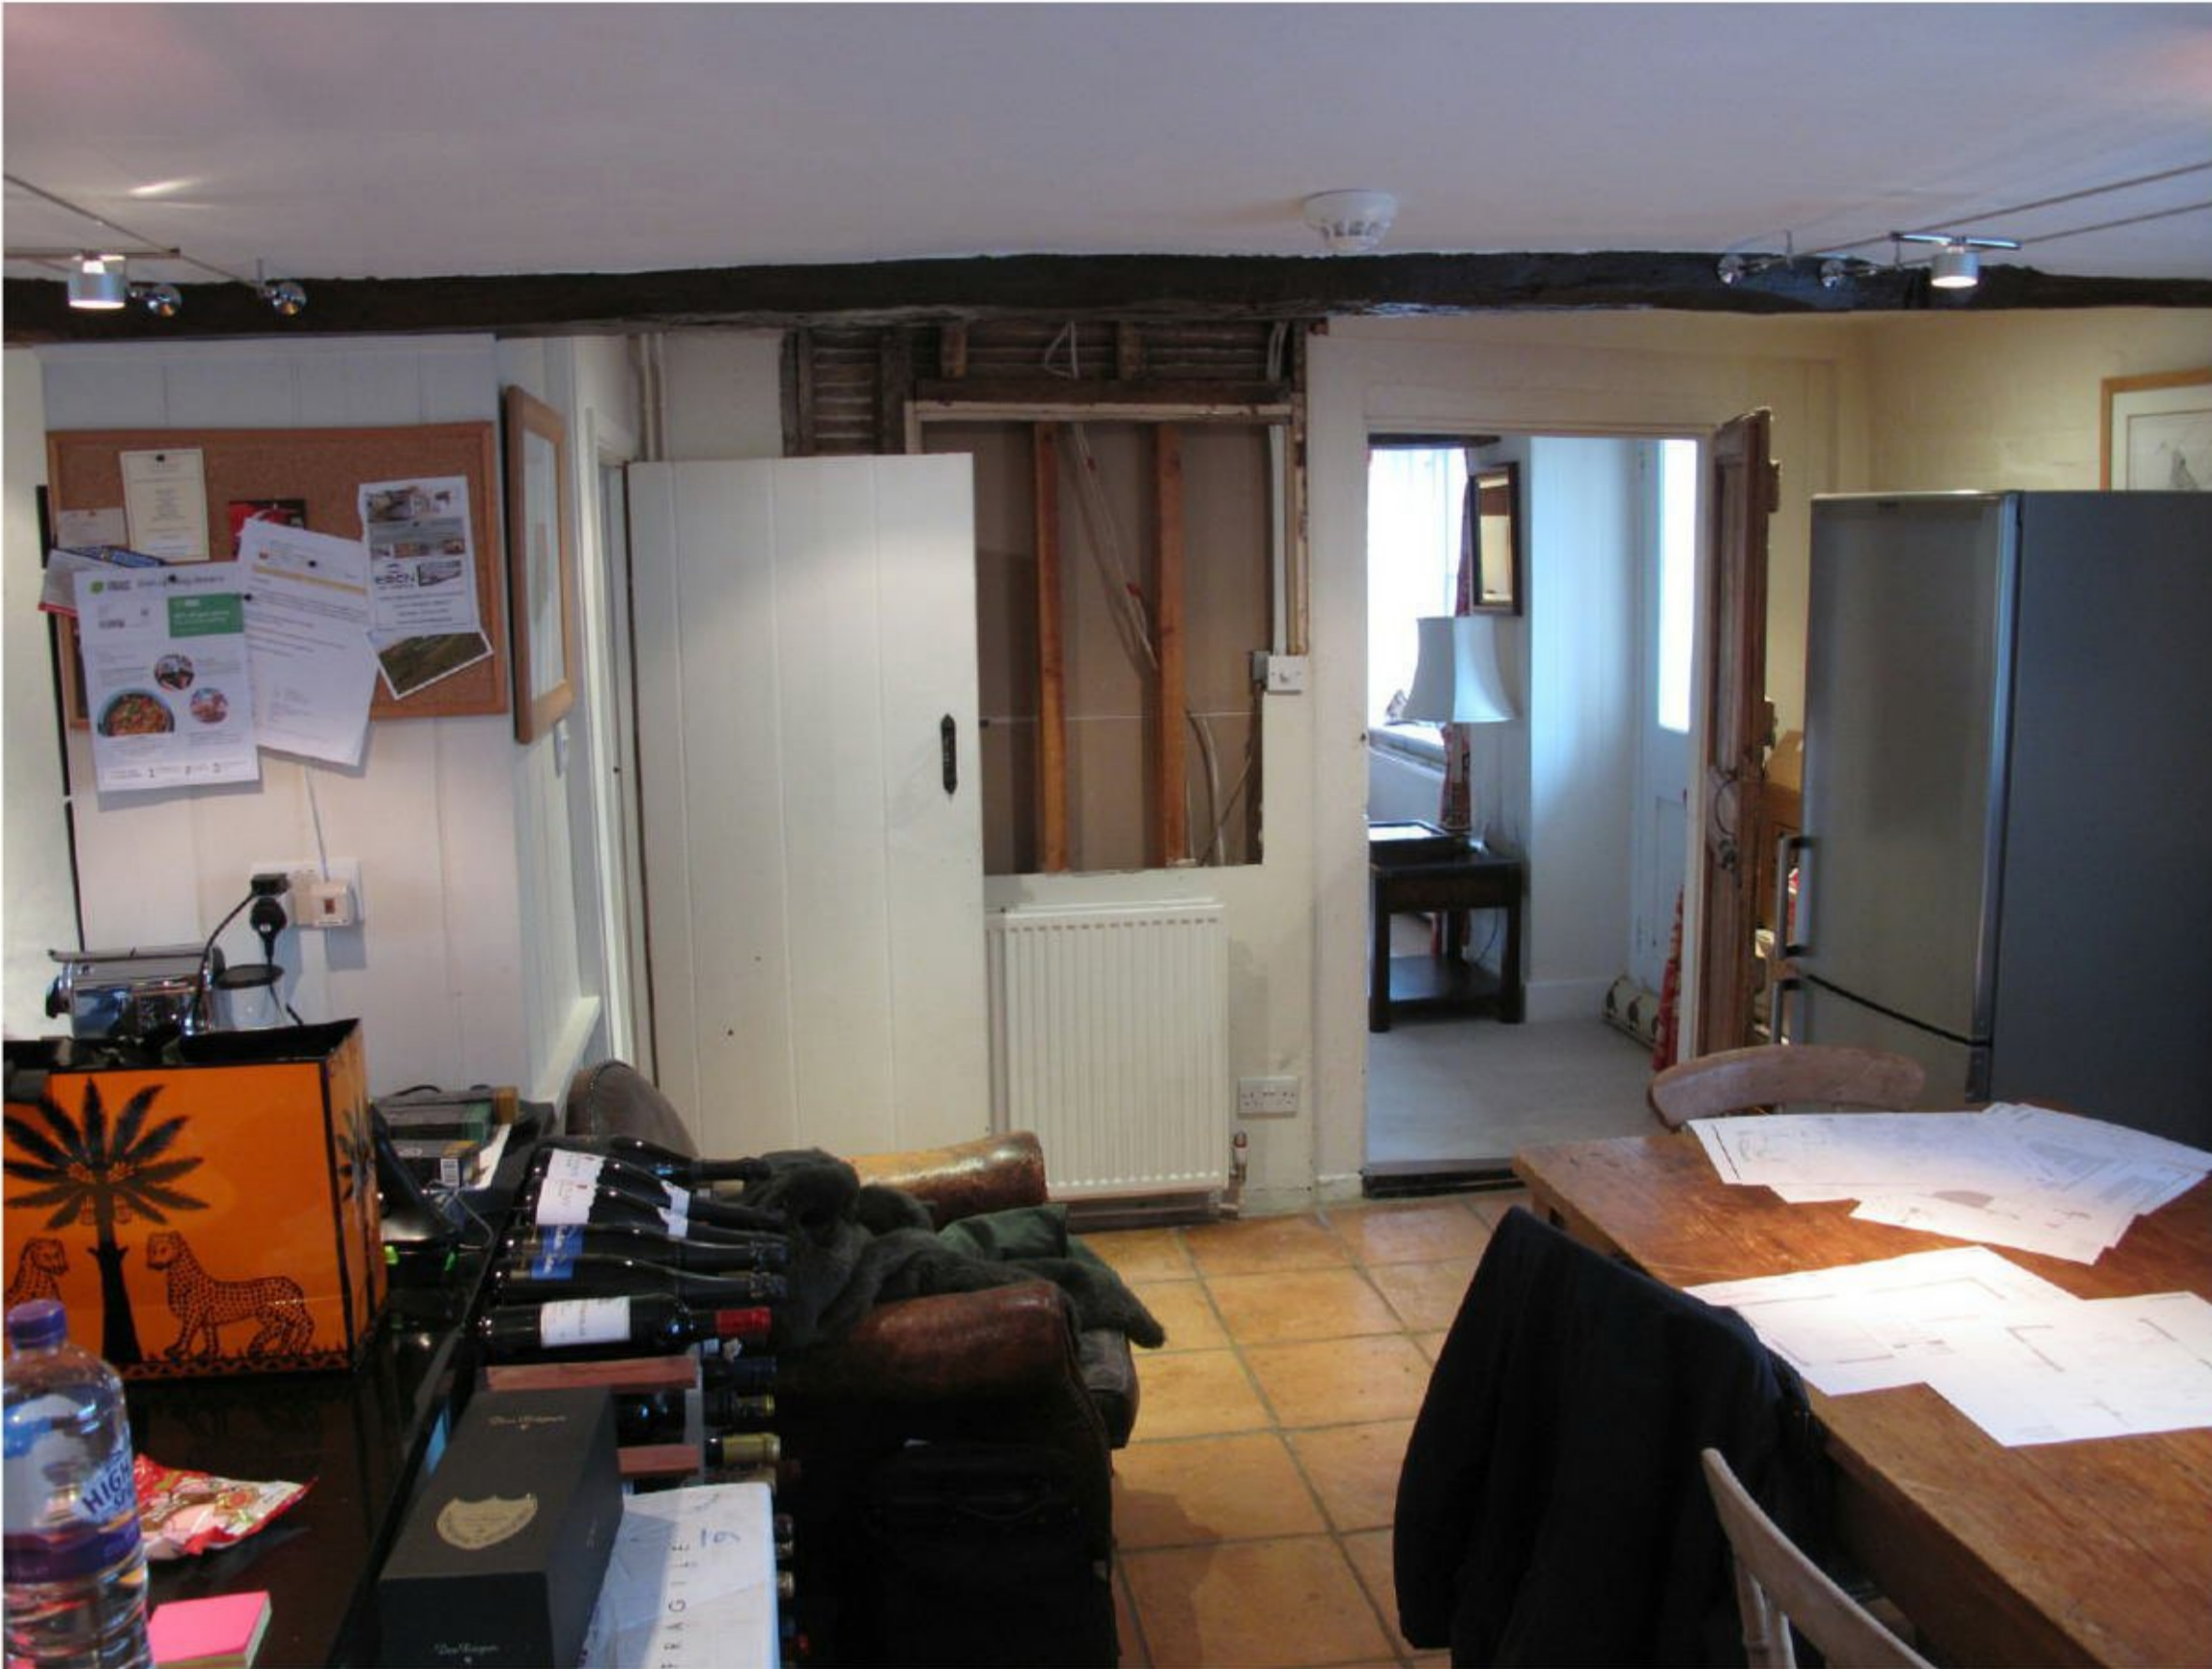
3. Stair enclosure and finishes to stud wall to be removed

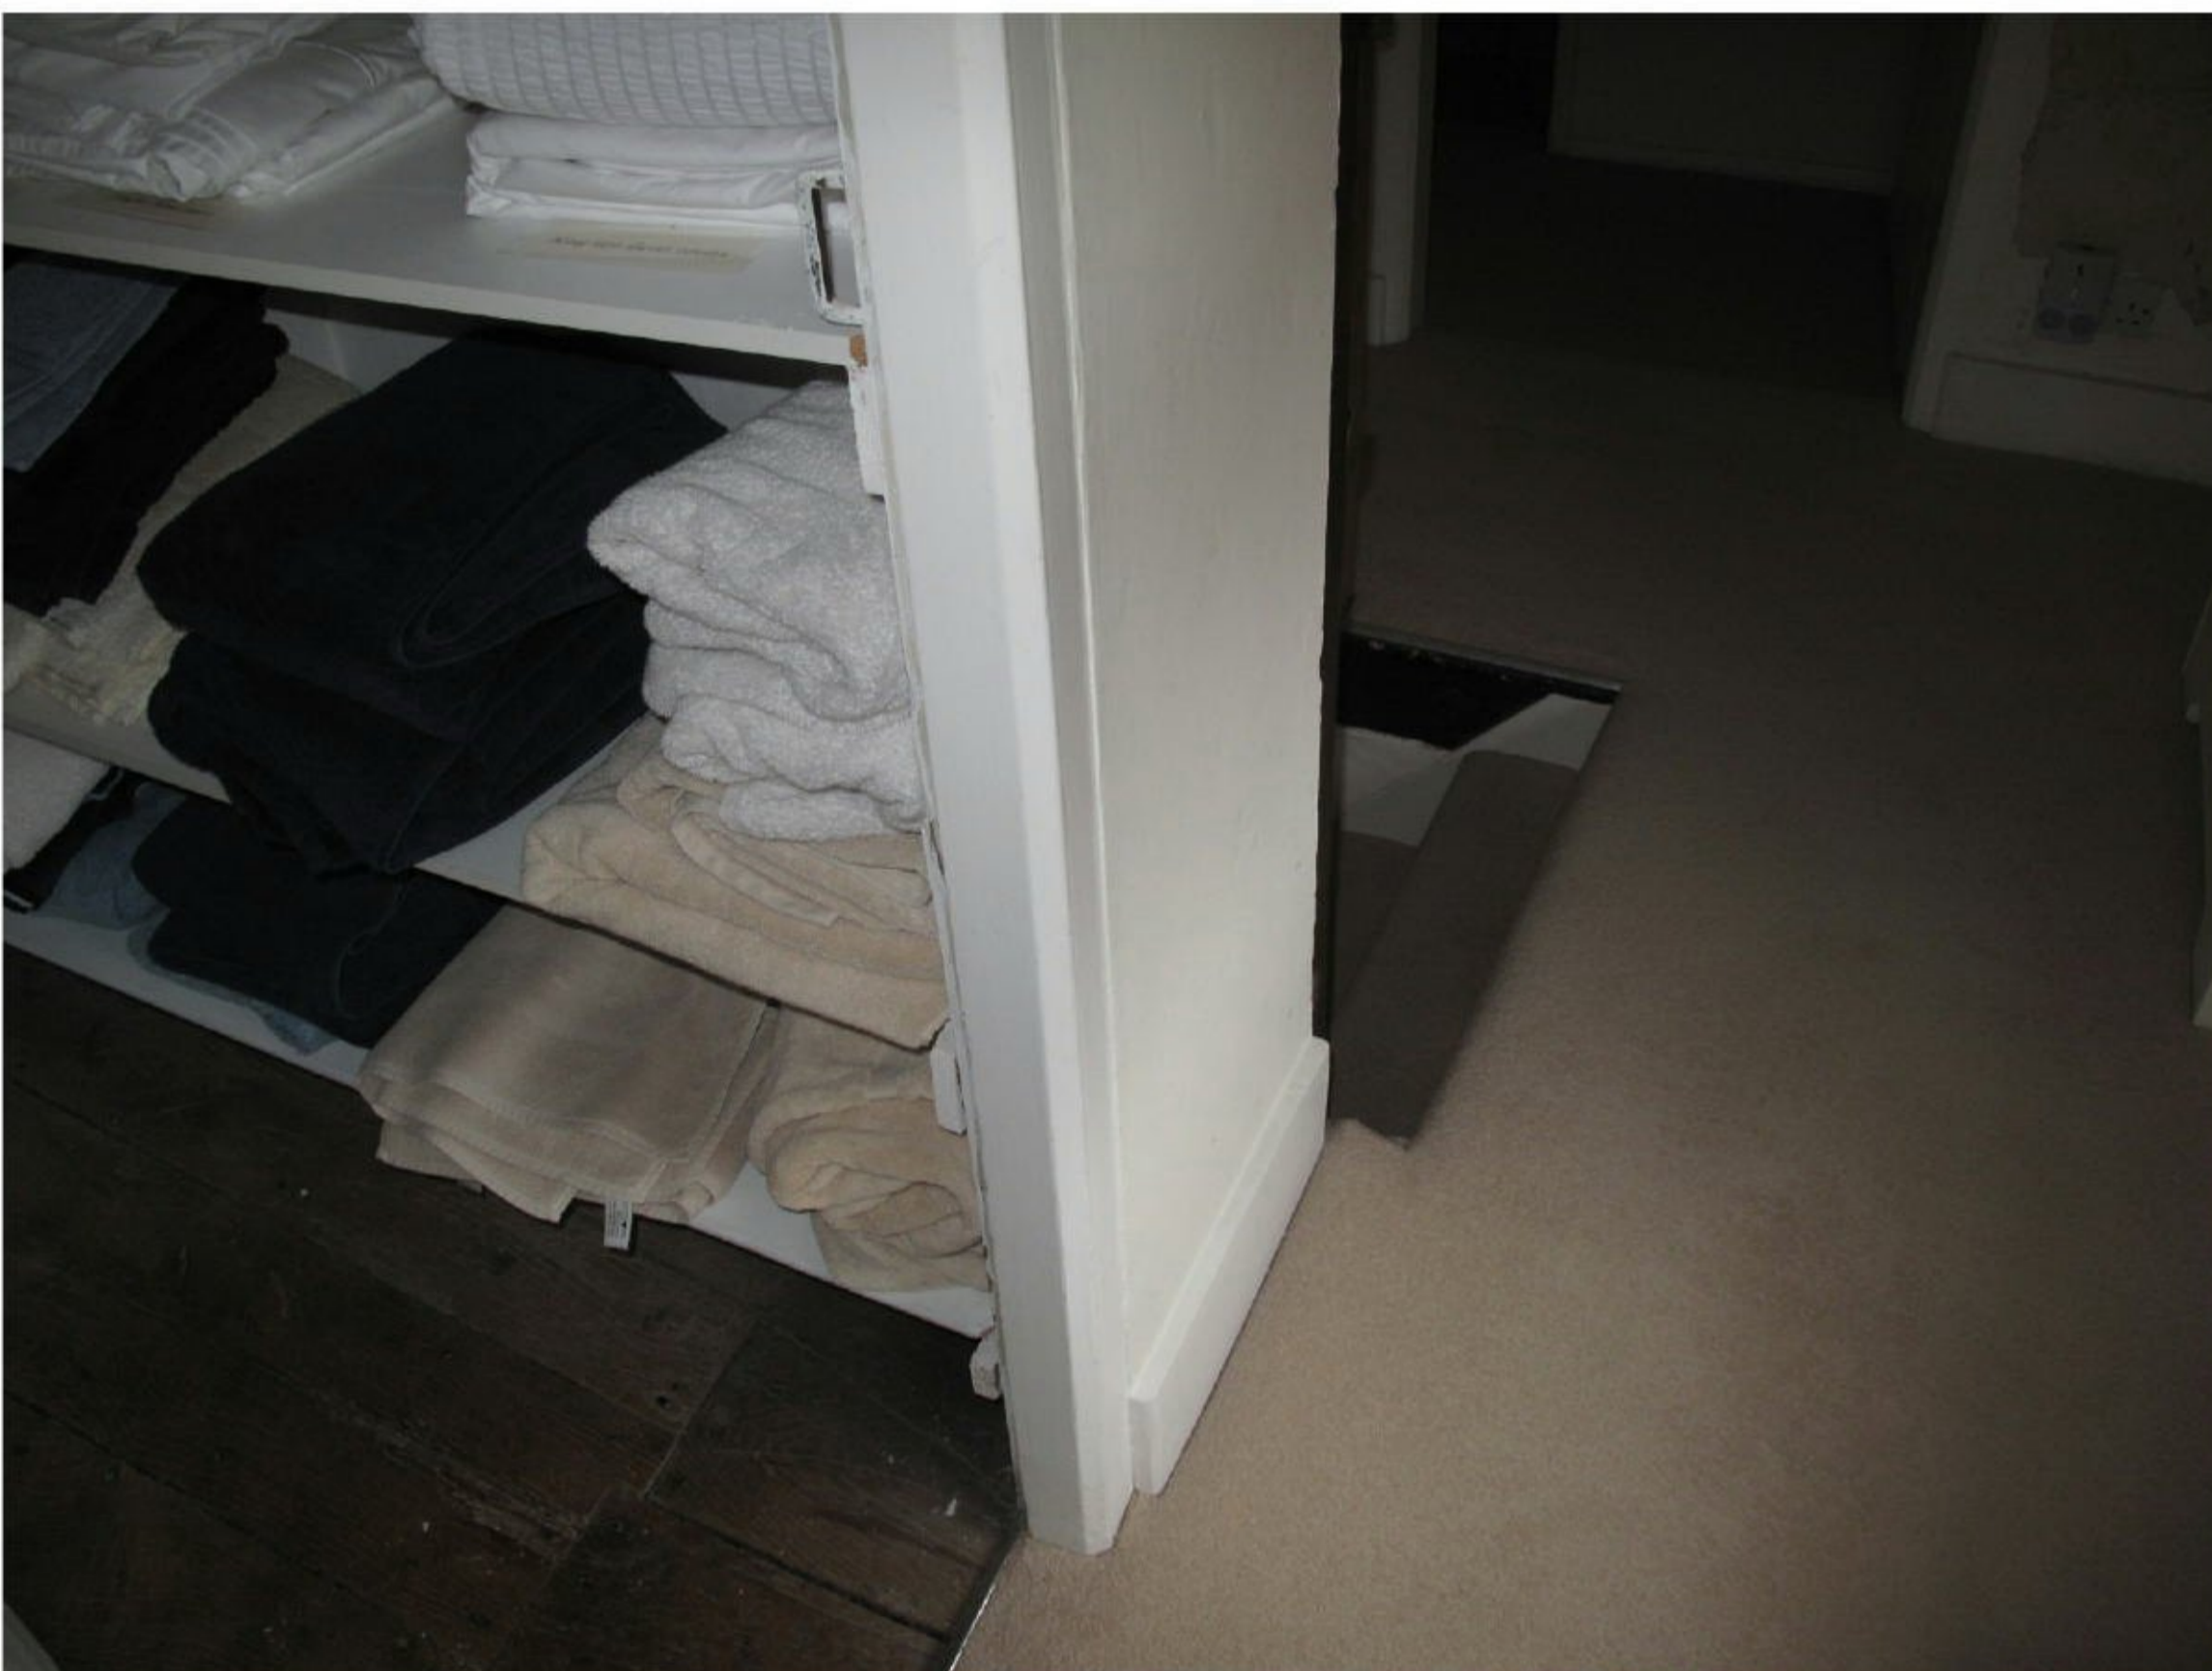
4. Stud wall removed and infill to floor where stair removed

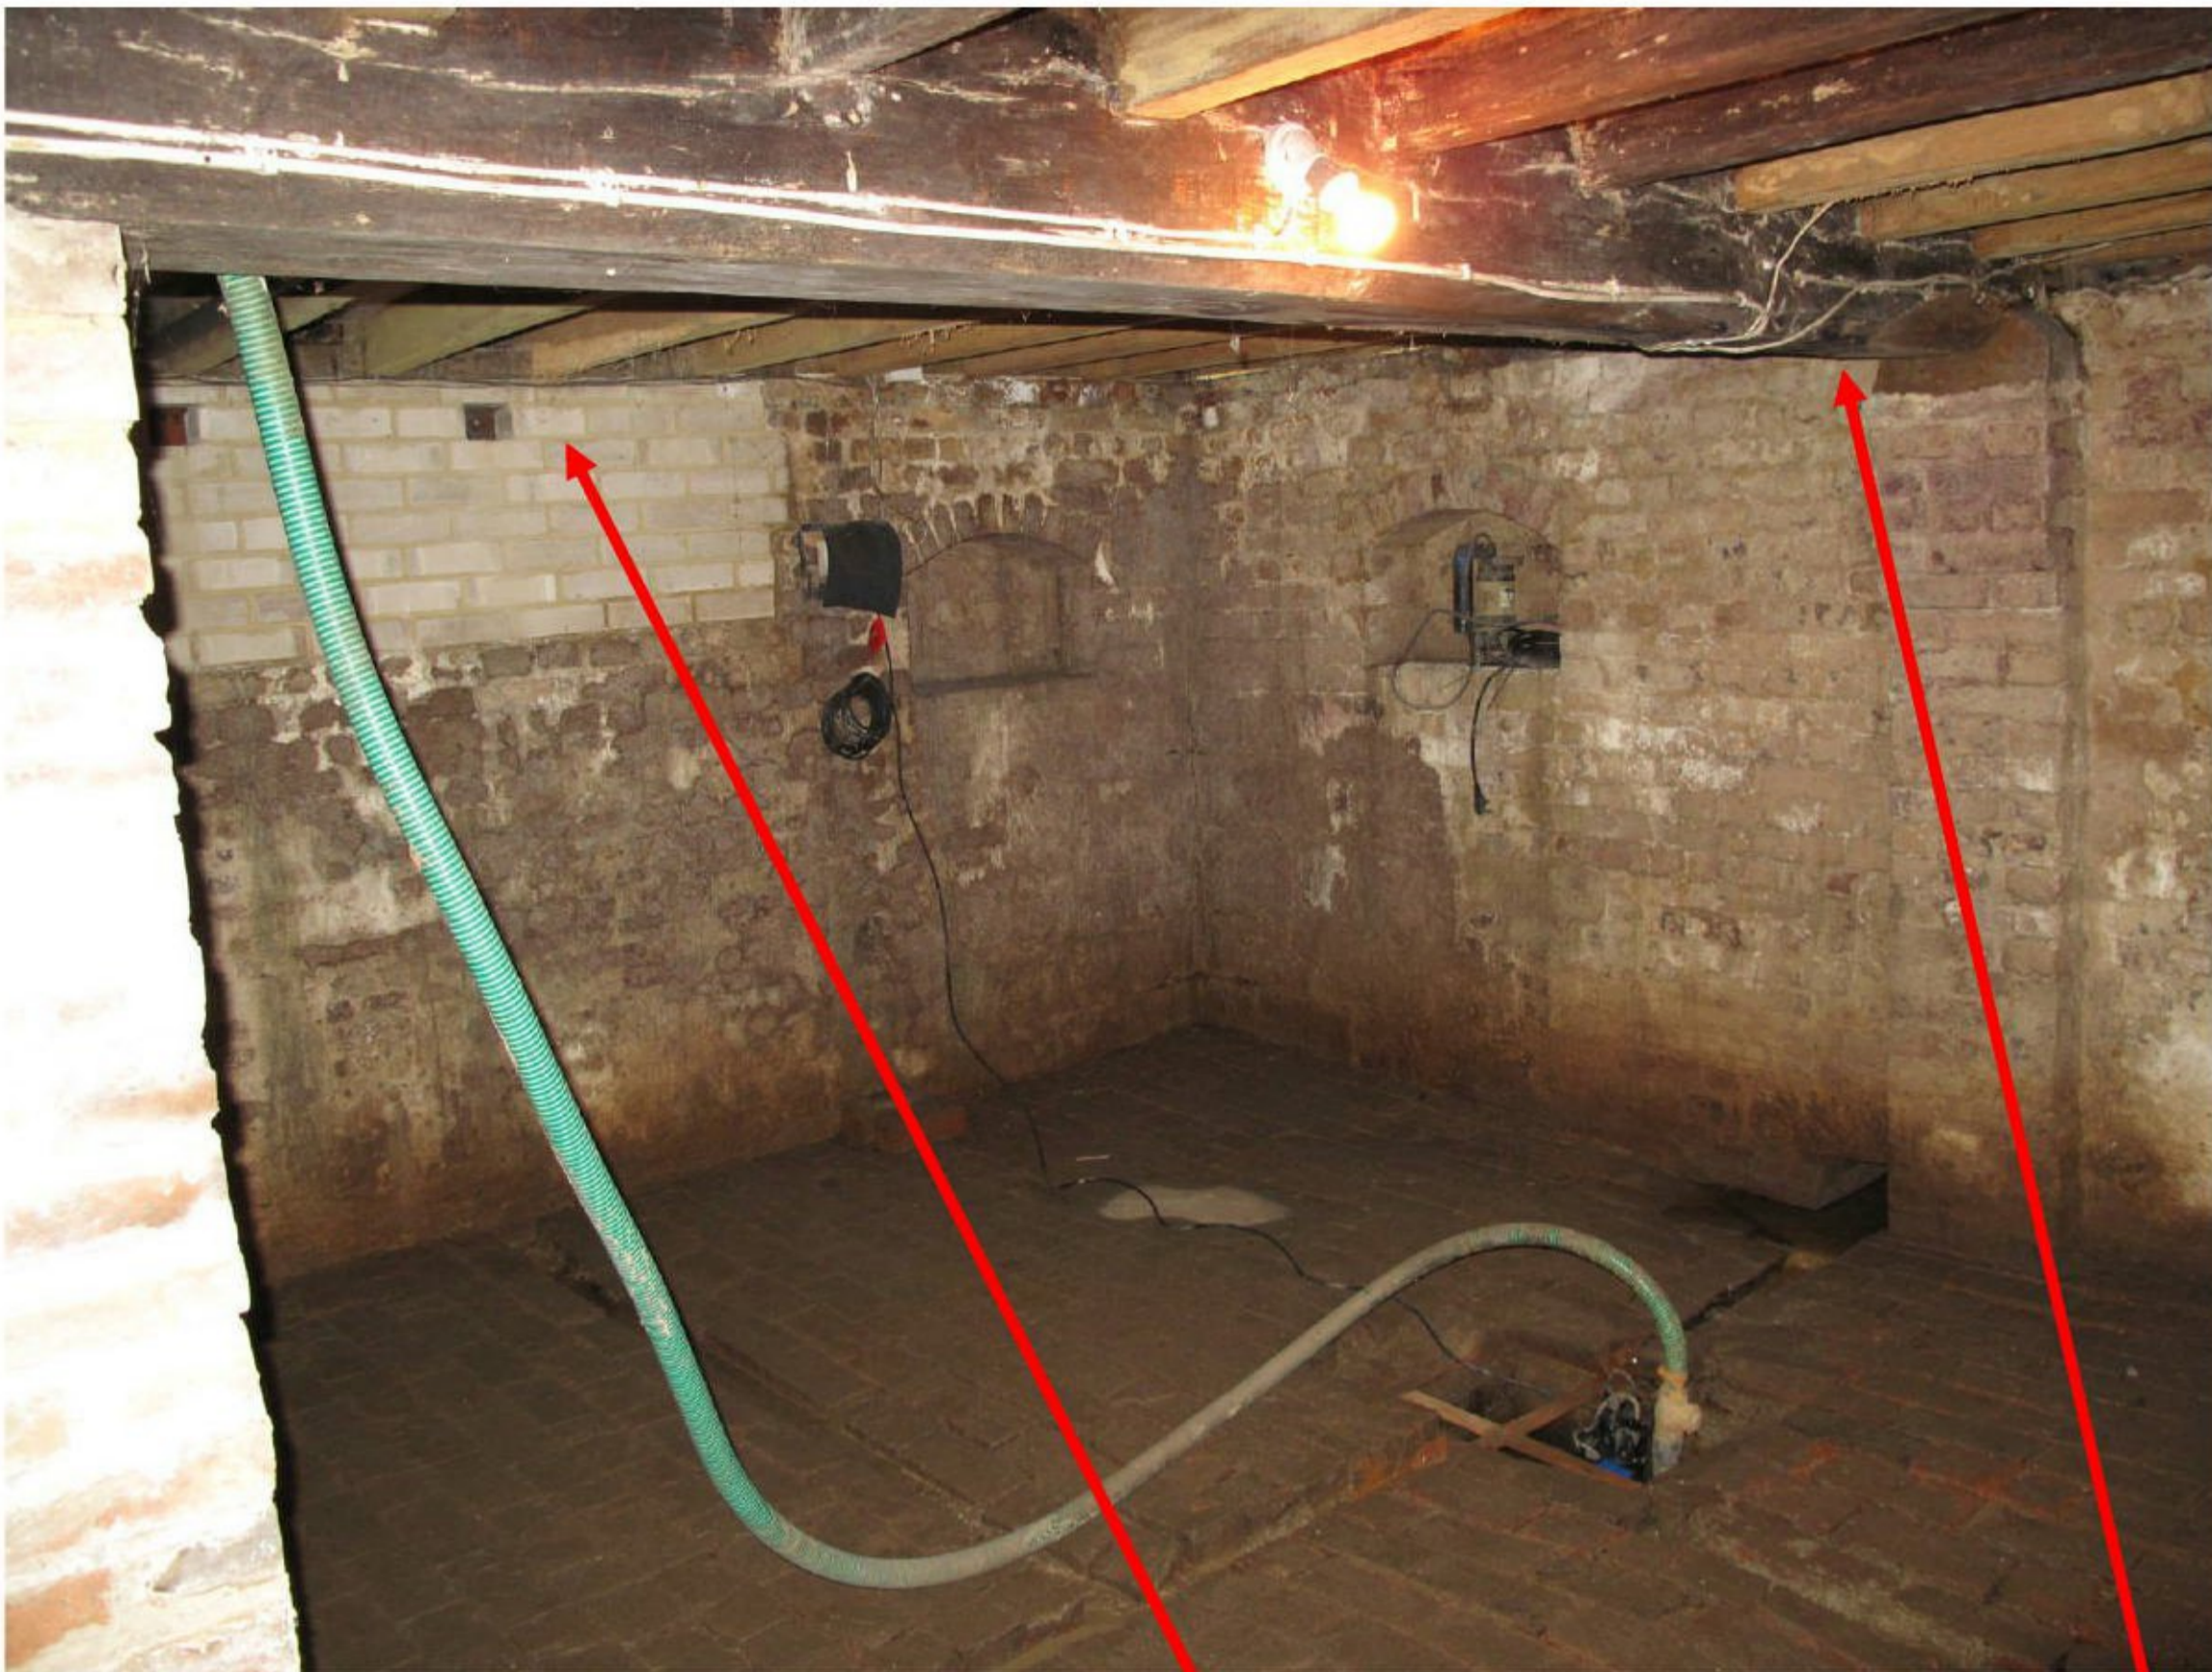
5. New lintel where brickwork to be removed and support to decayed end of beam

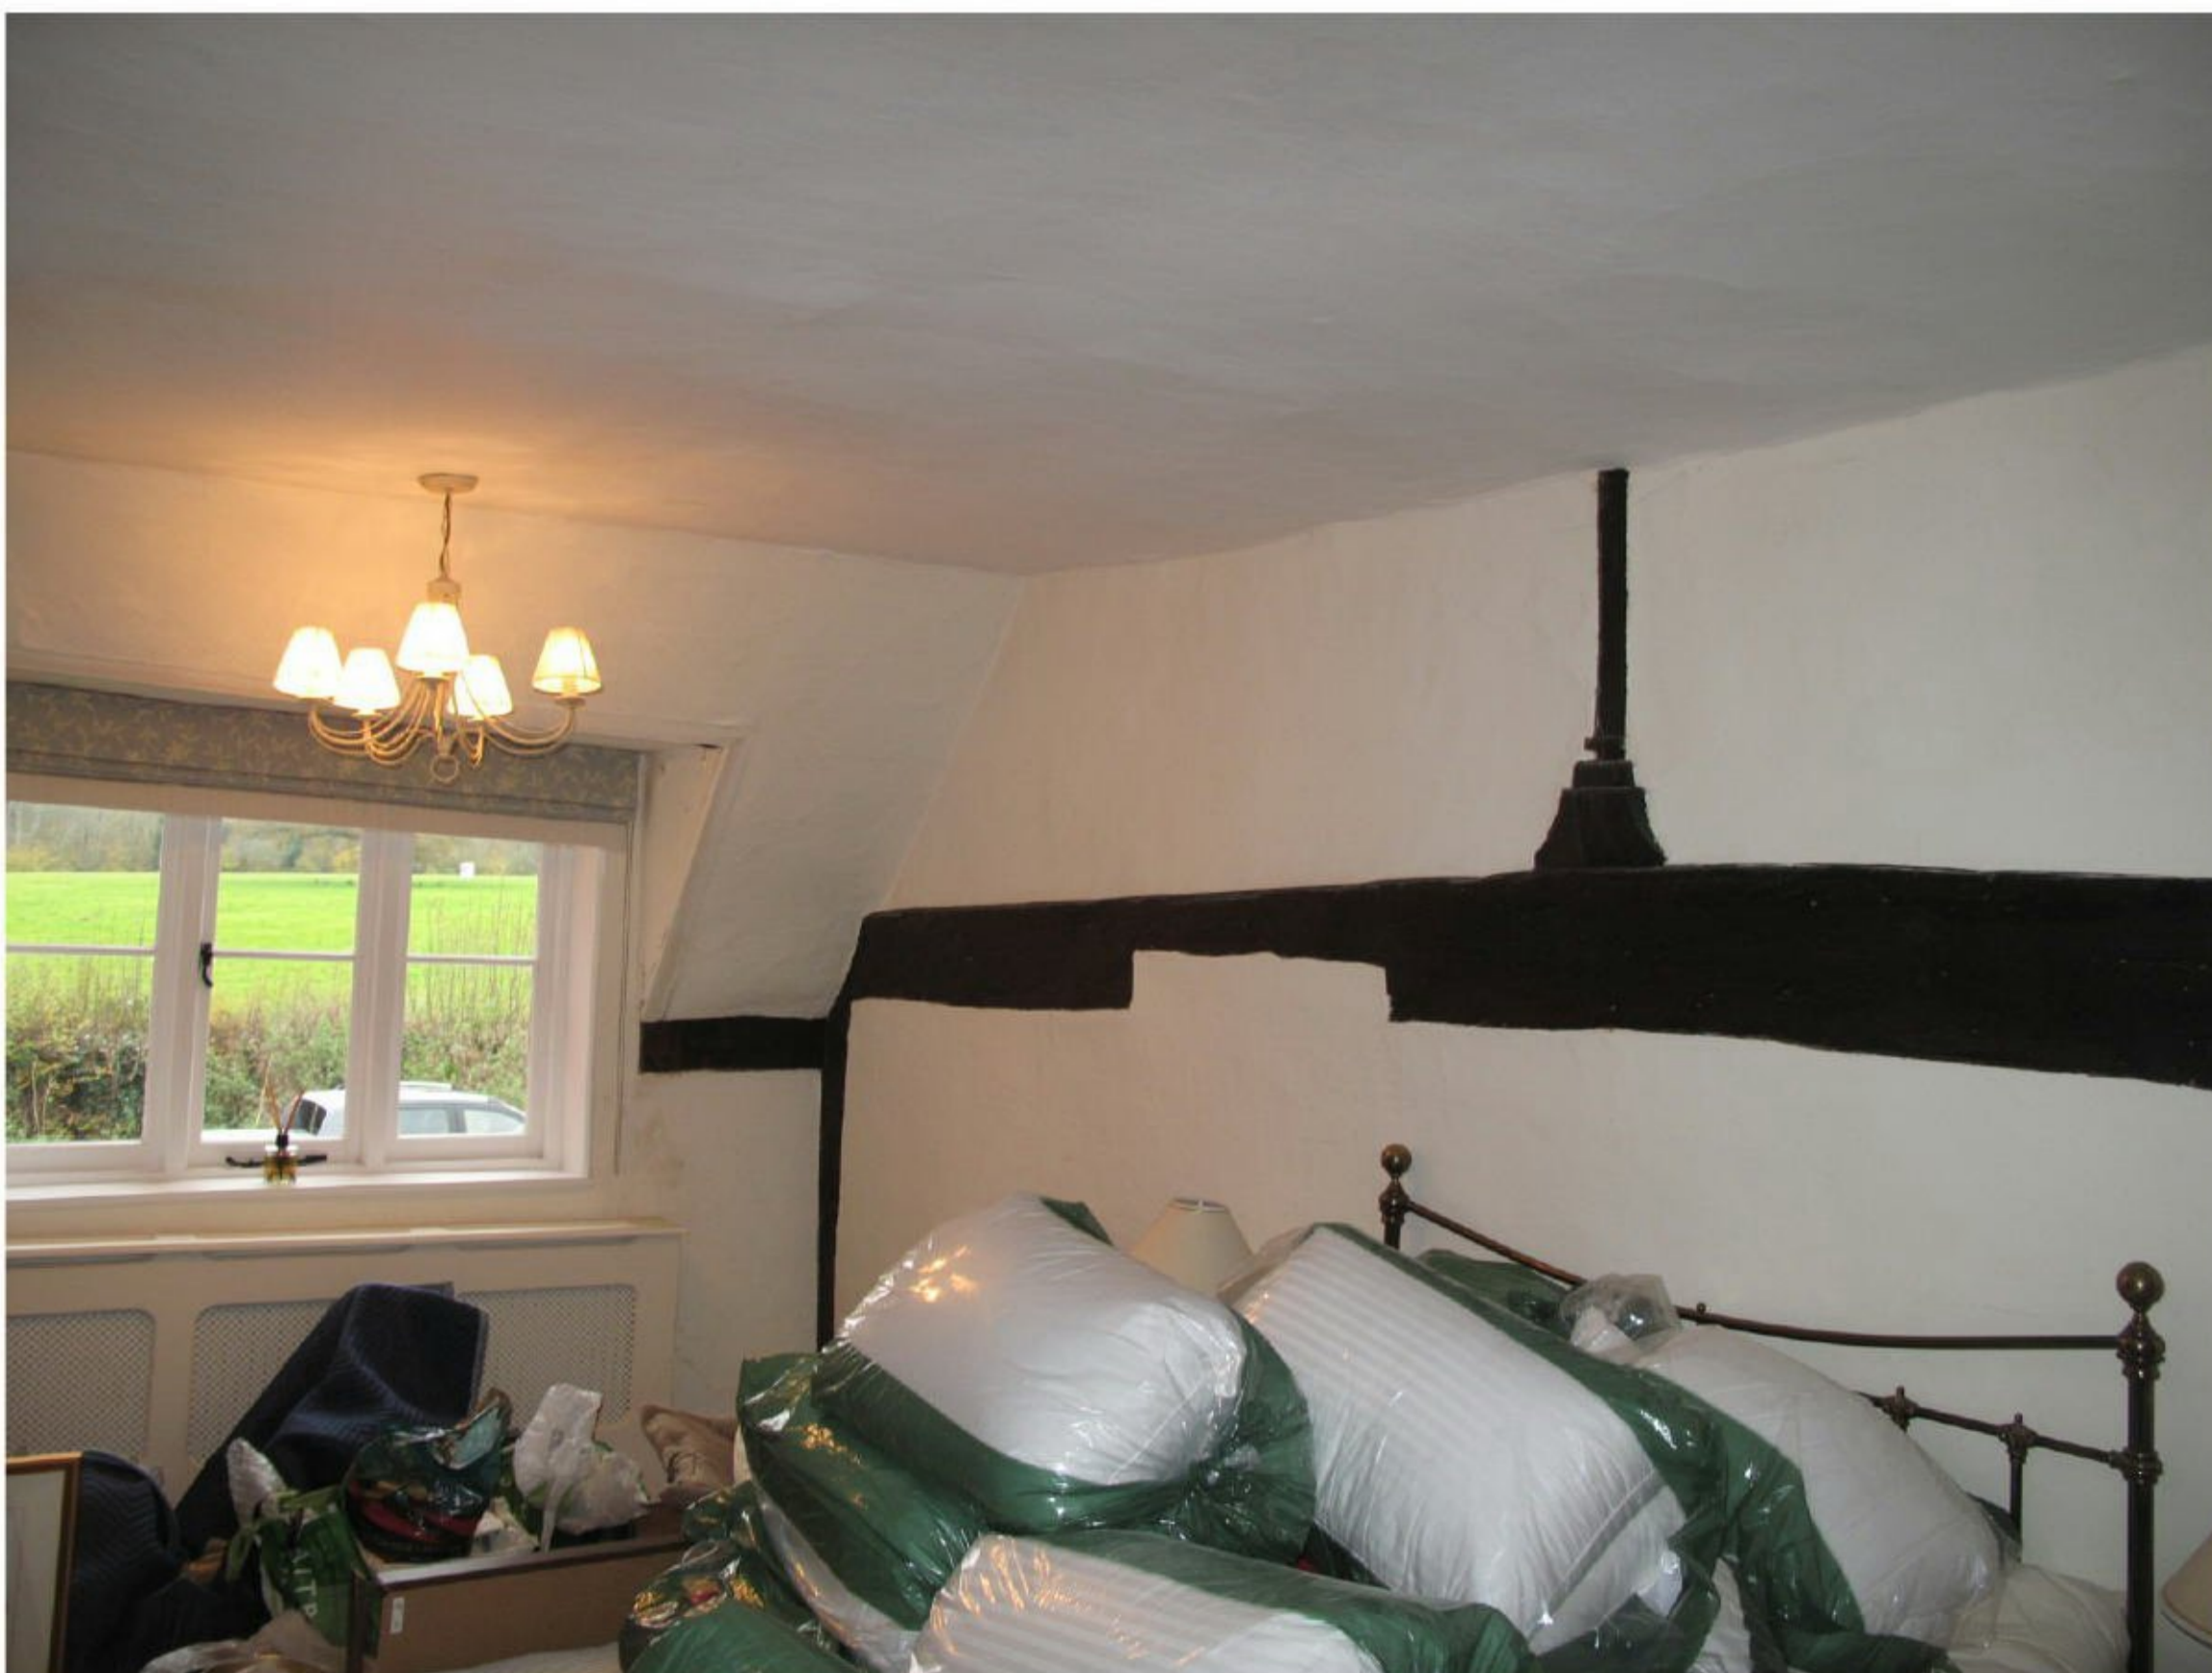
6. Ceiling finishes to be removed to investigate structure above
