737/03

Lockskimmers Farm

We attach photos taken during a visit on 19 November 2021 to look at the areas of proposed works to the east end of the house, together with marked-up extracts of your proposed plans. These note initial comments on the structural implications of the proposals and the investigations required to progress the structural design.

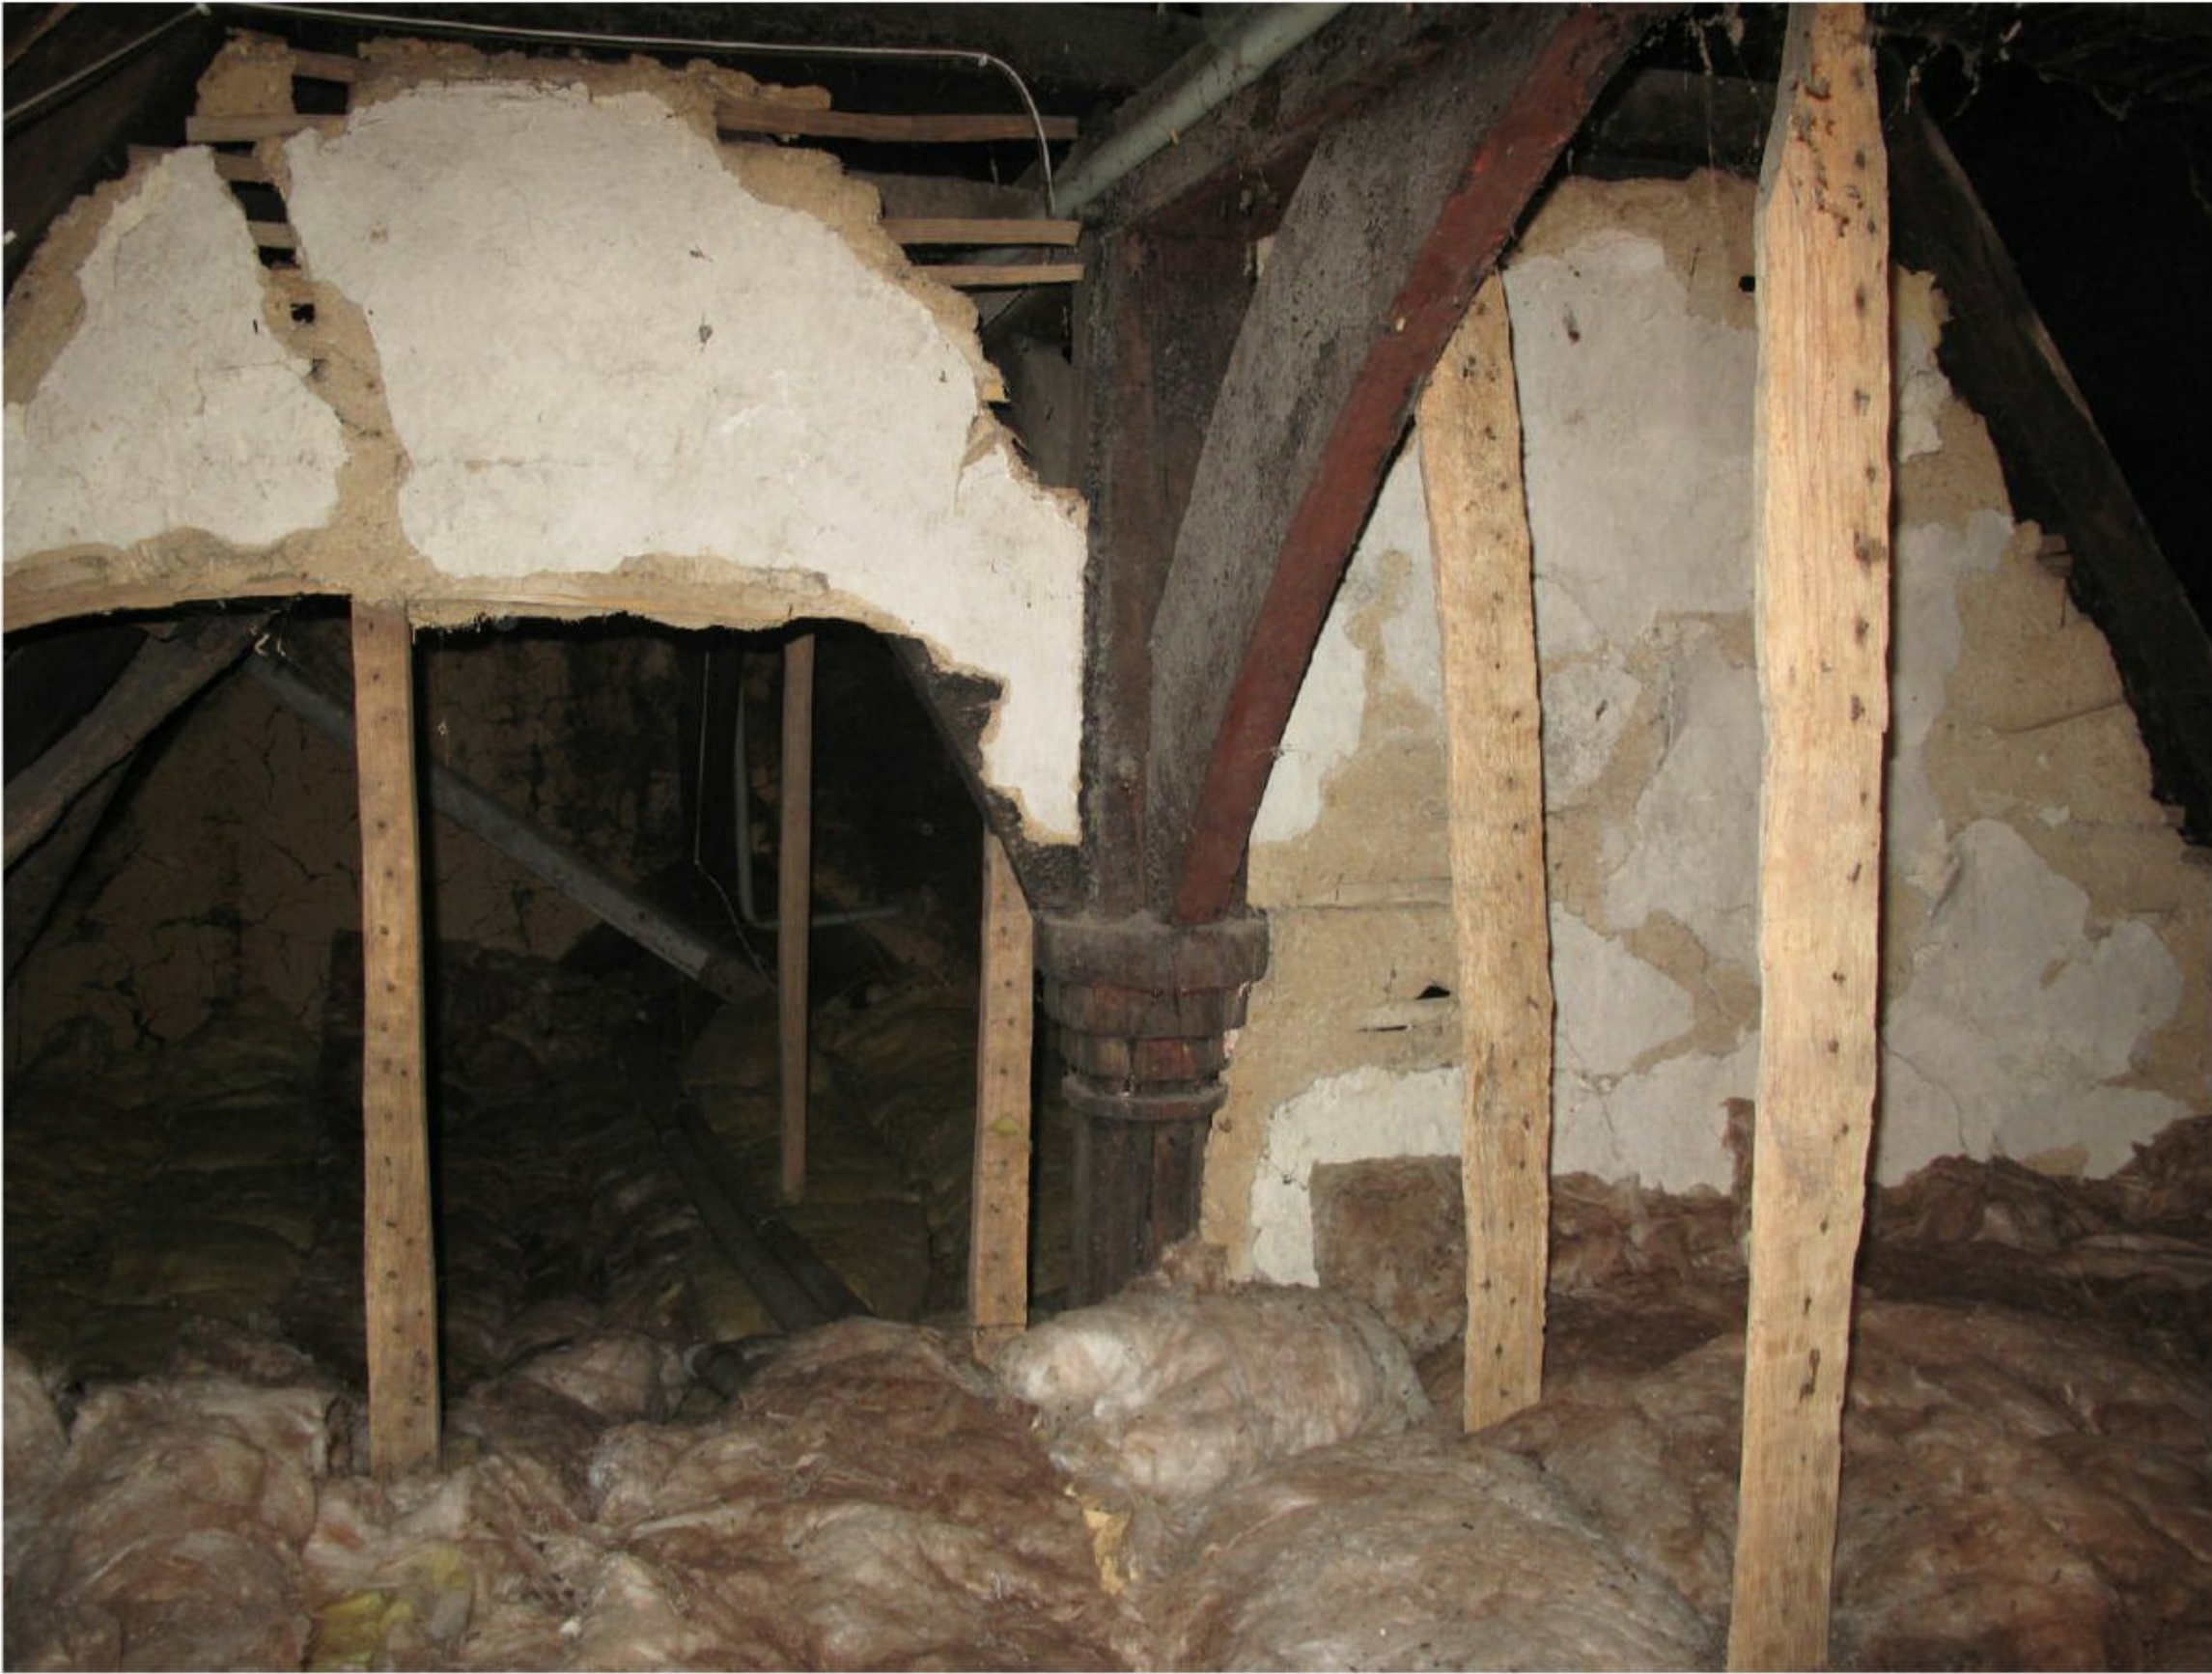
7. Roof structure to be repaired to allow props to be removed.
Details to follow access after removal of insulation and ceiling finishes

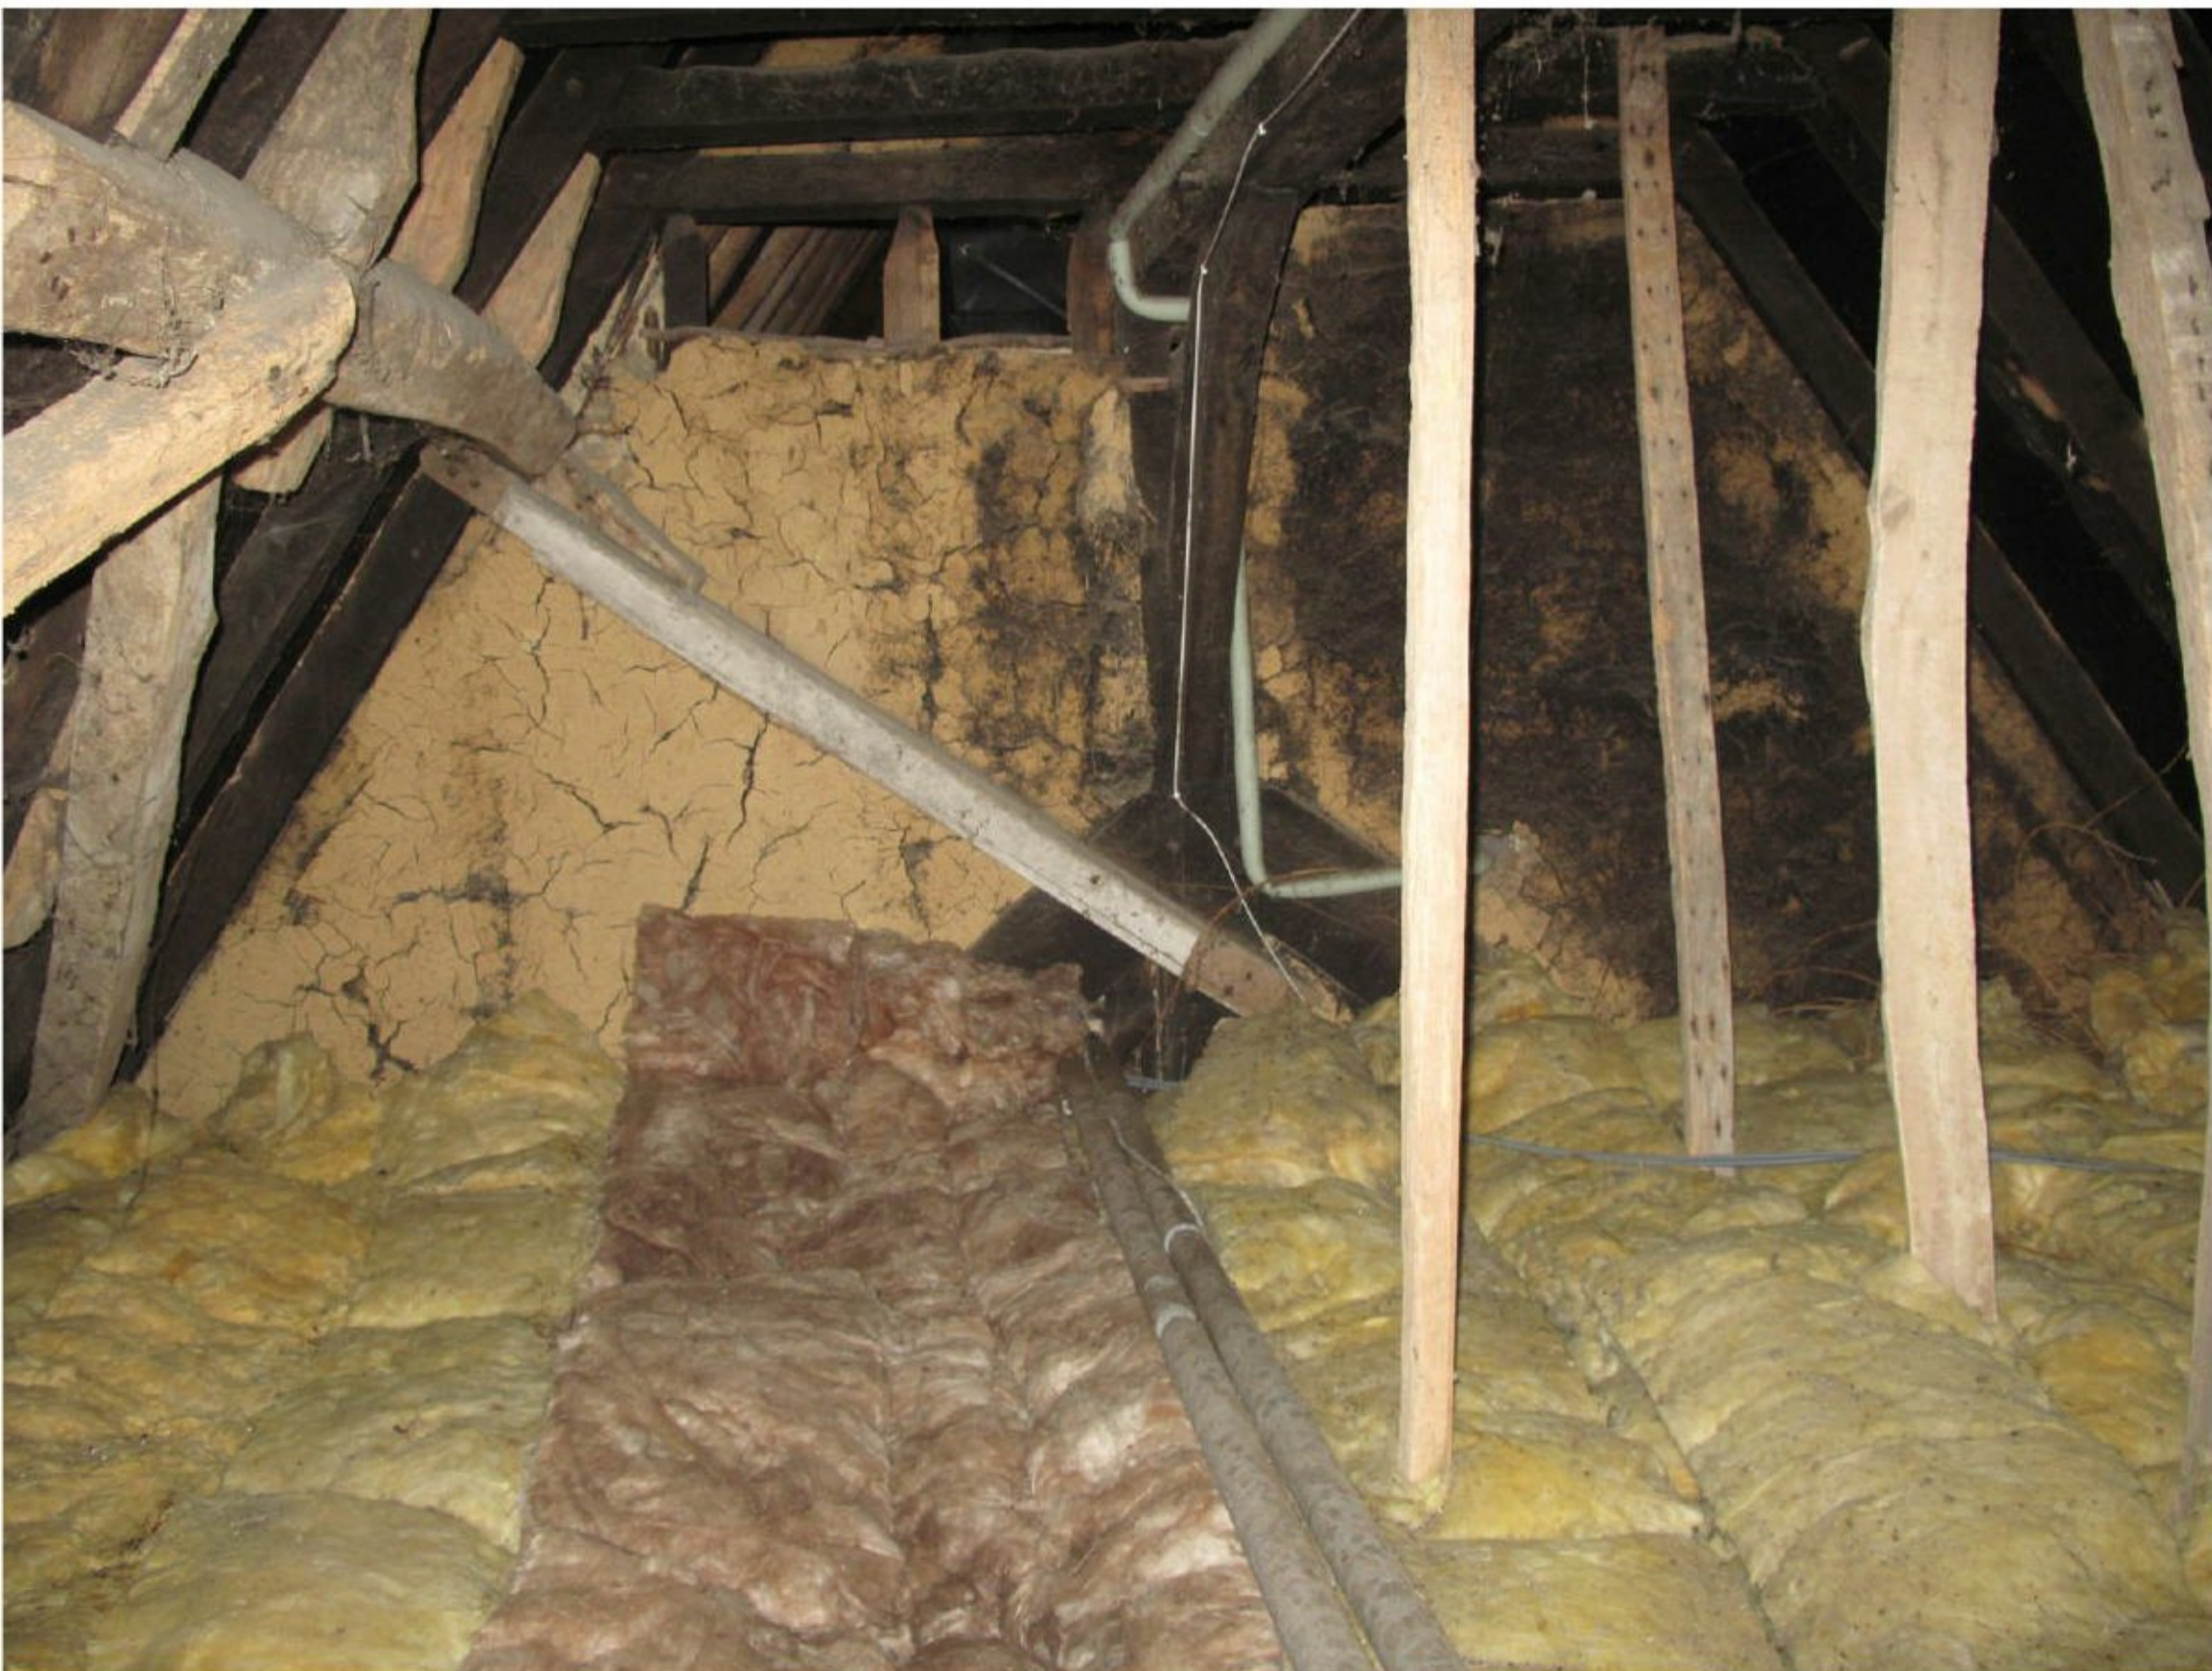
8. Roof void above

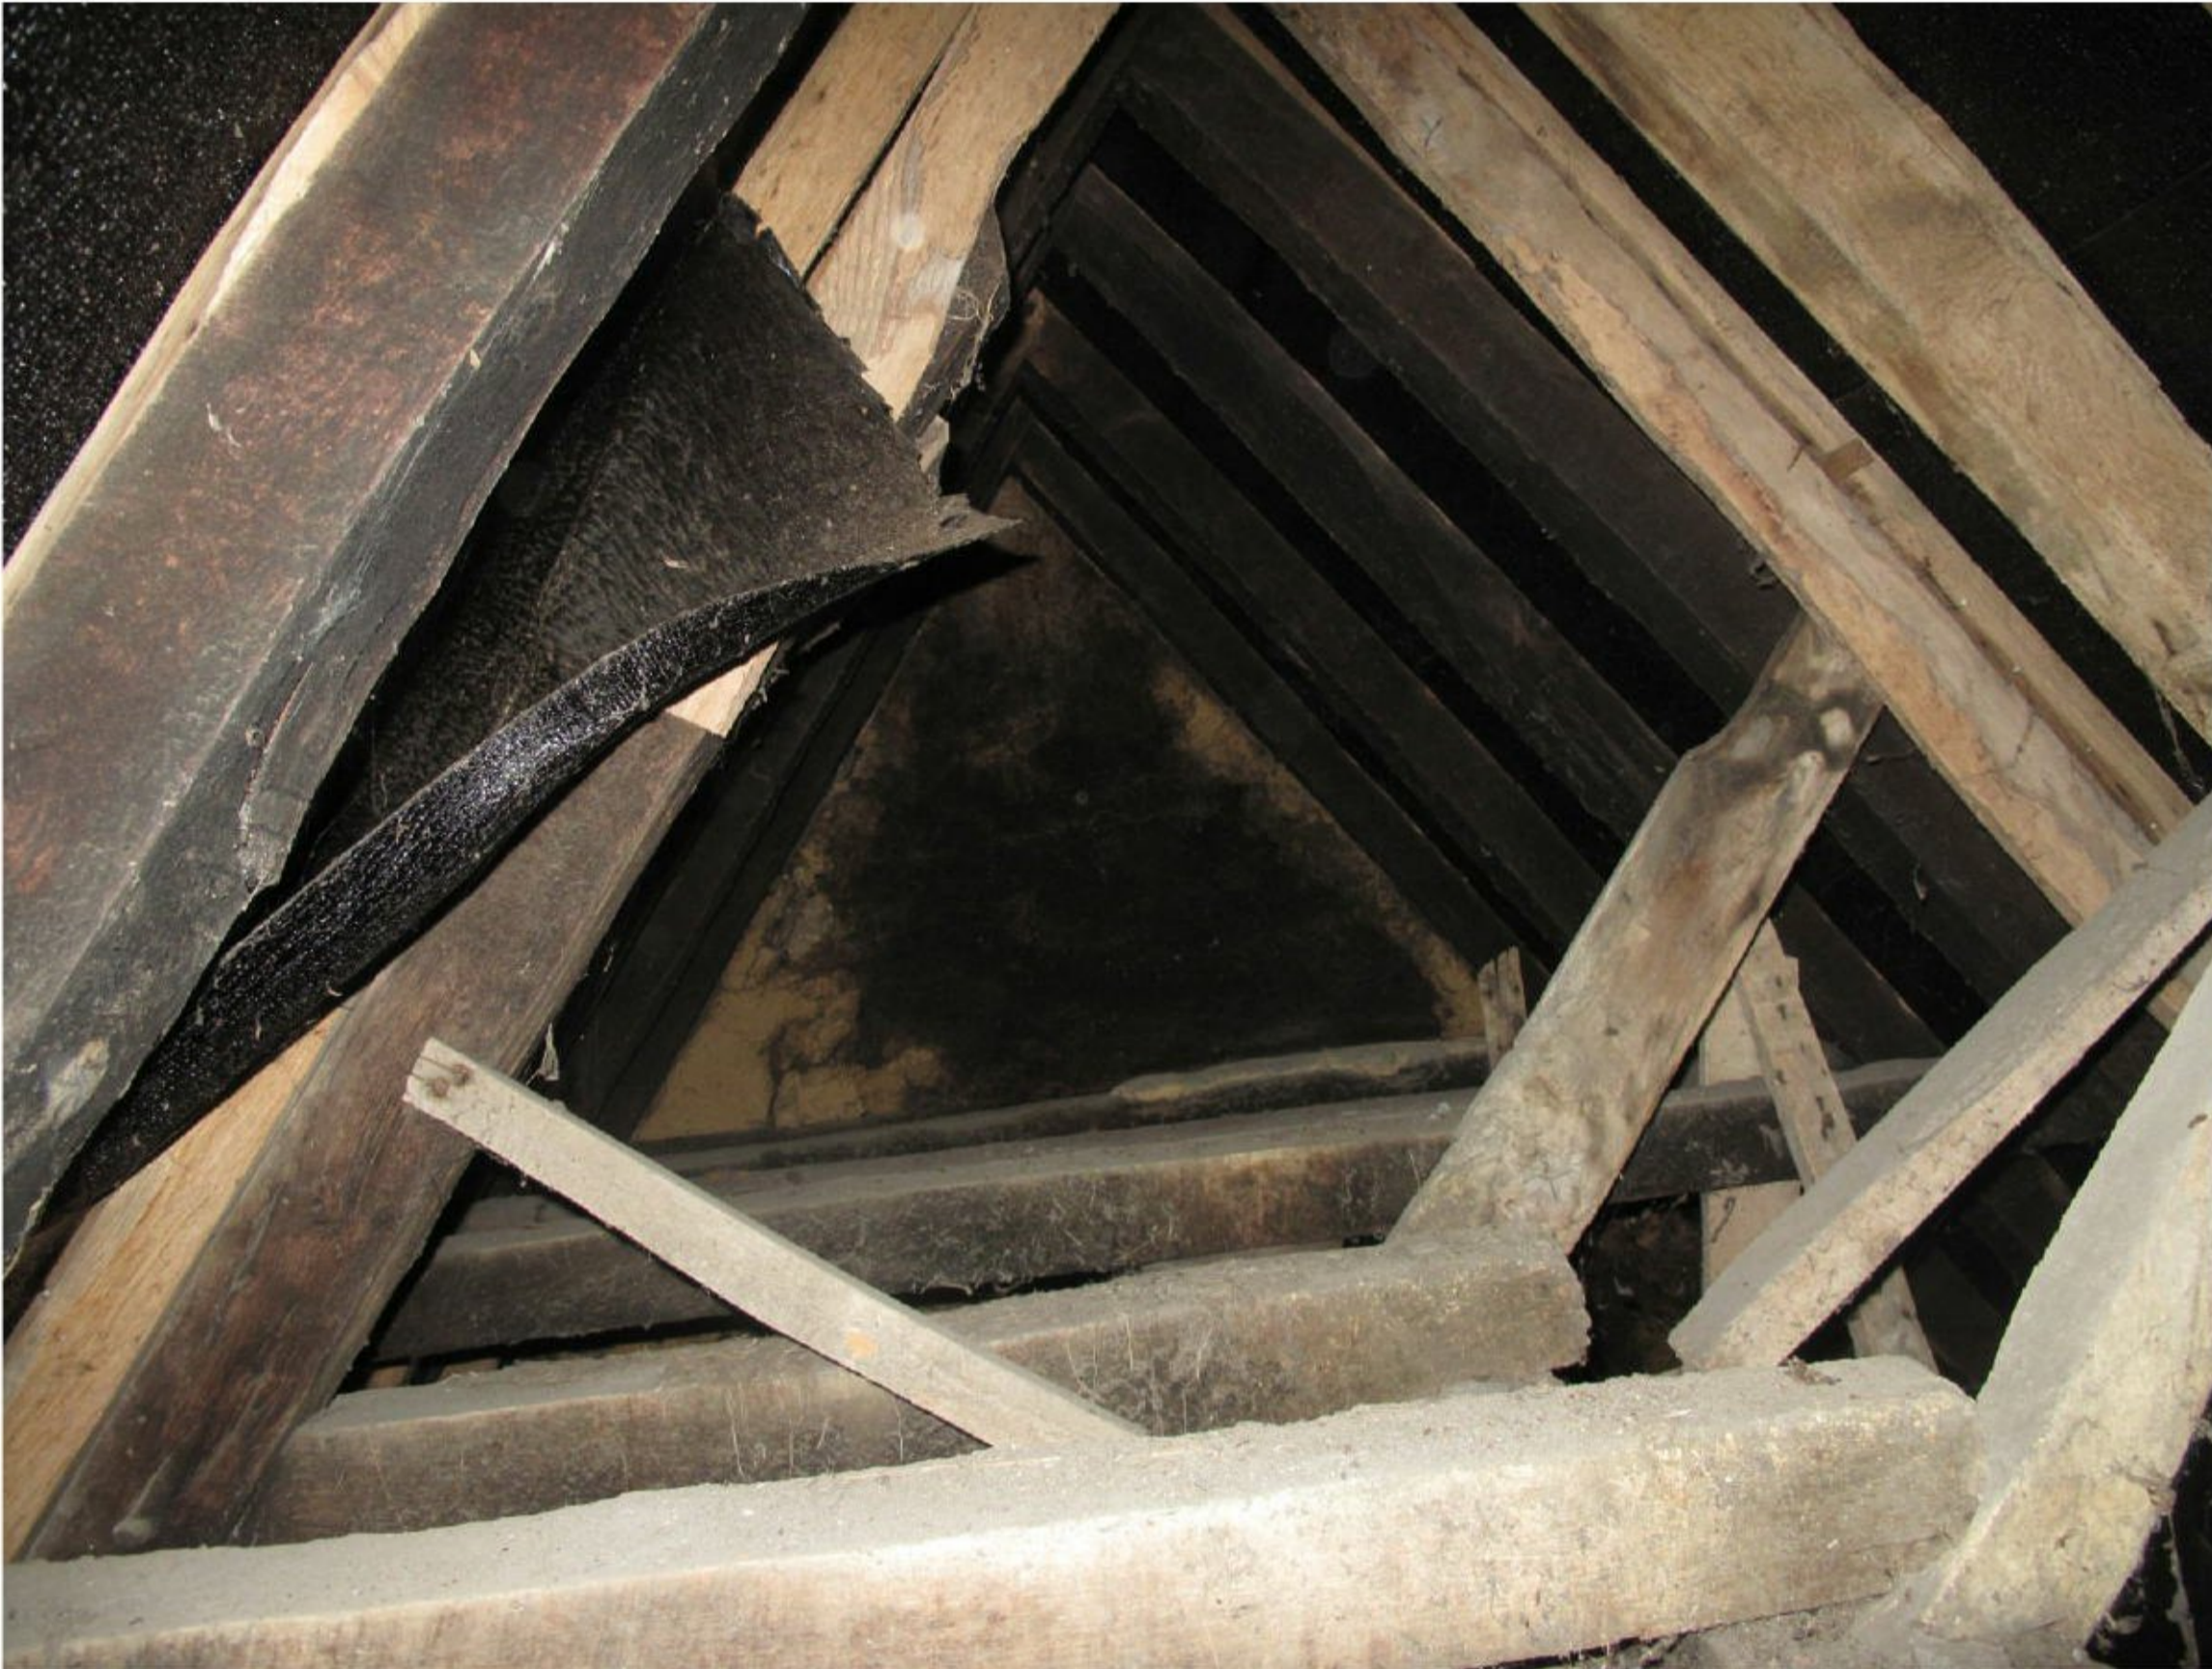
9. Extensive repairs needed to roof structure

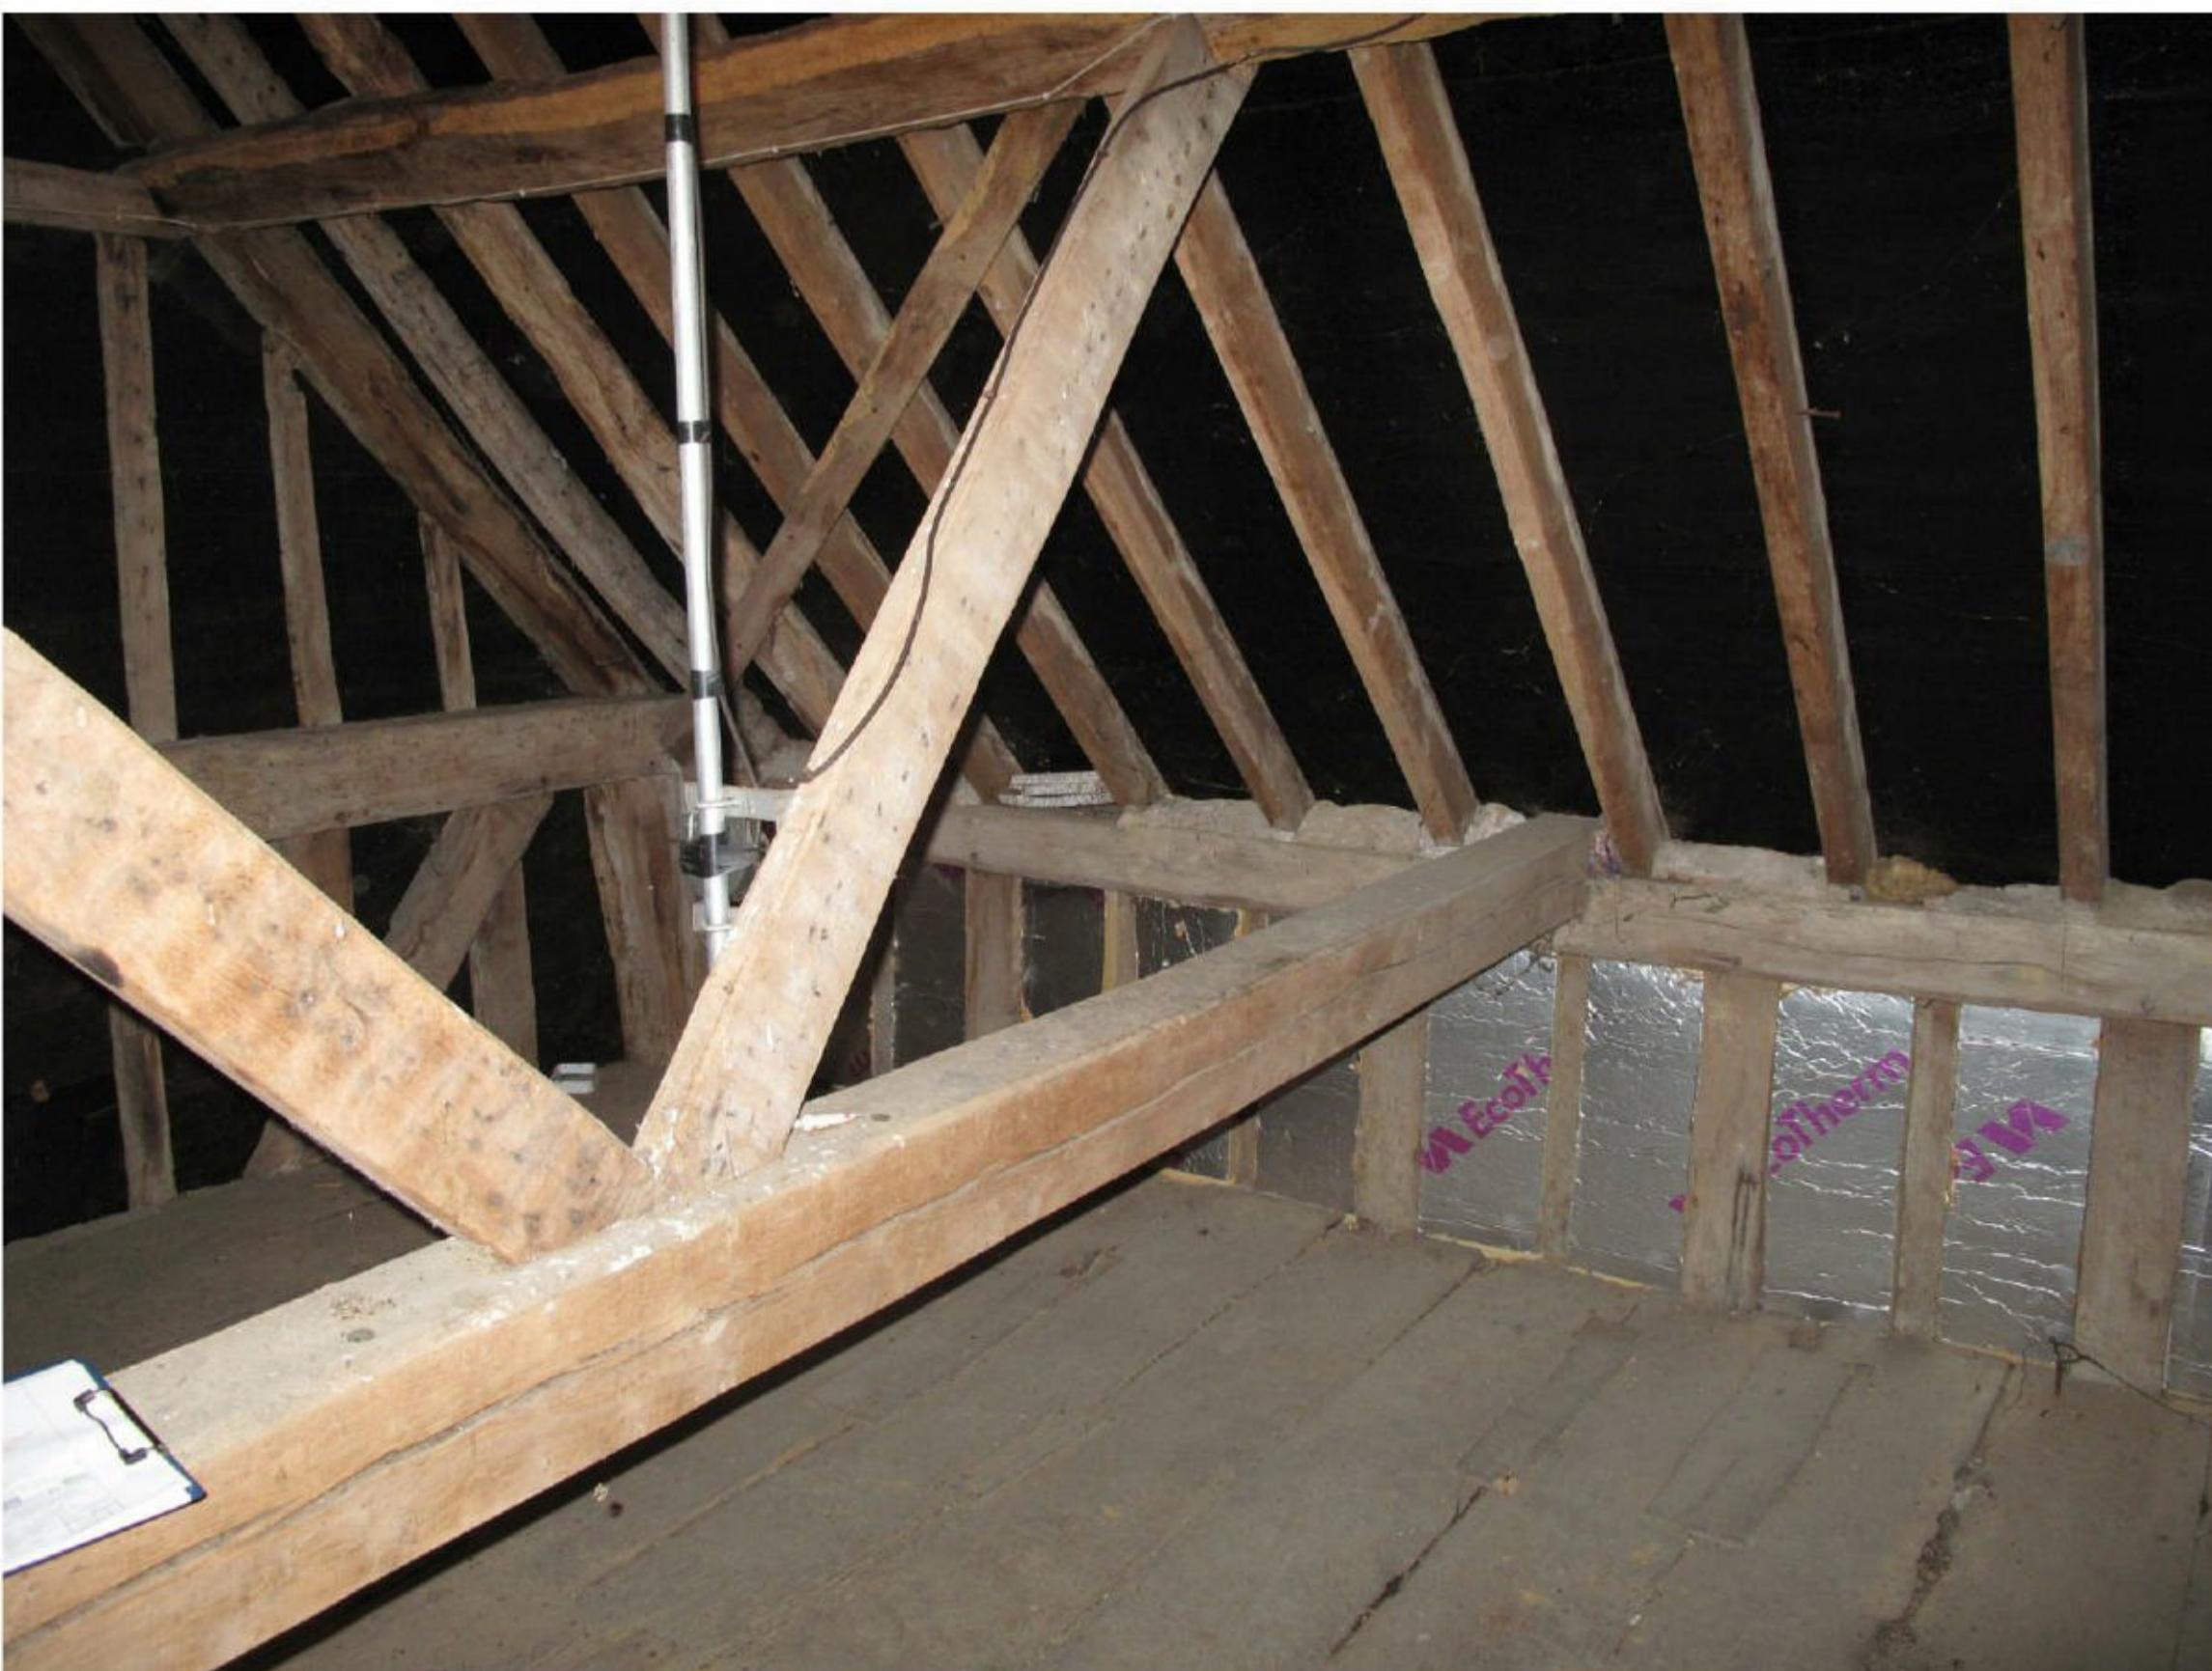
10. Room S2. Tie beam and raking props to purlins to be replaced with new structure

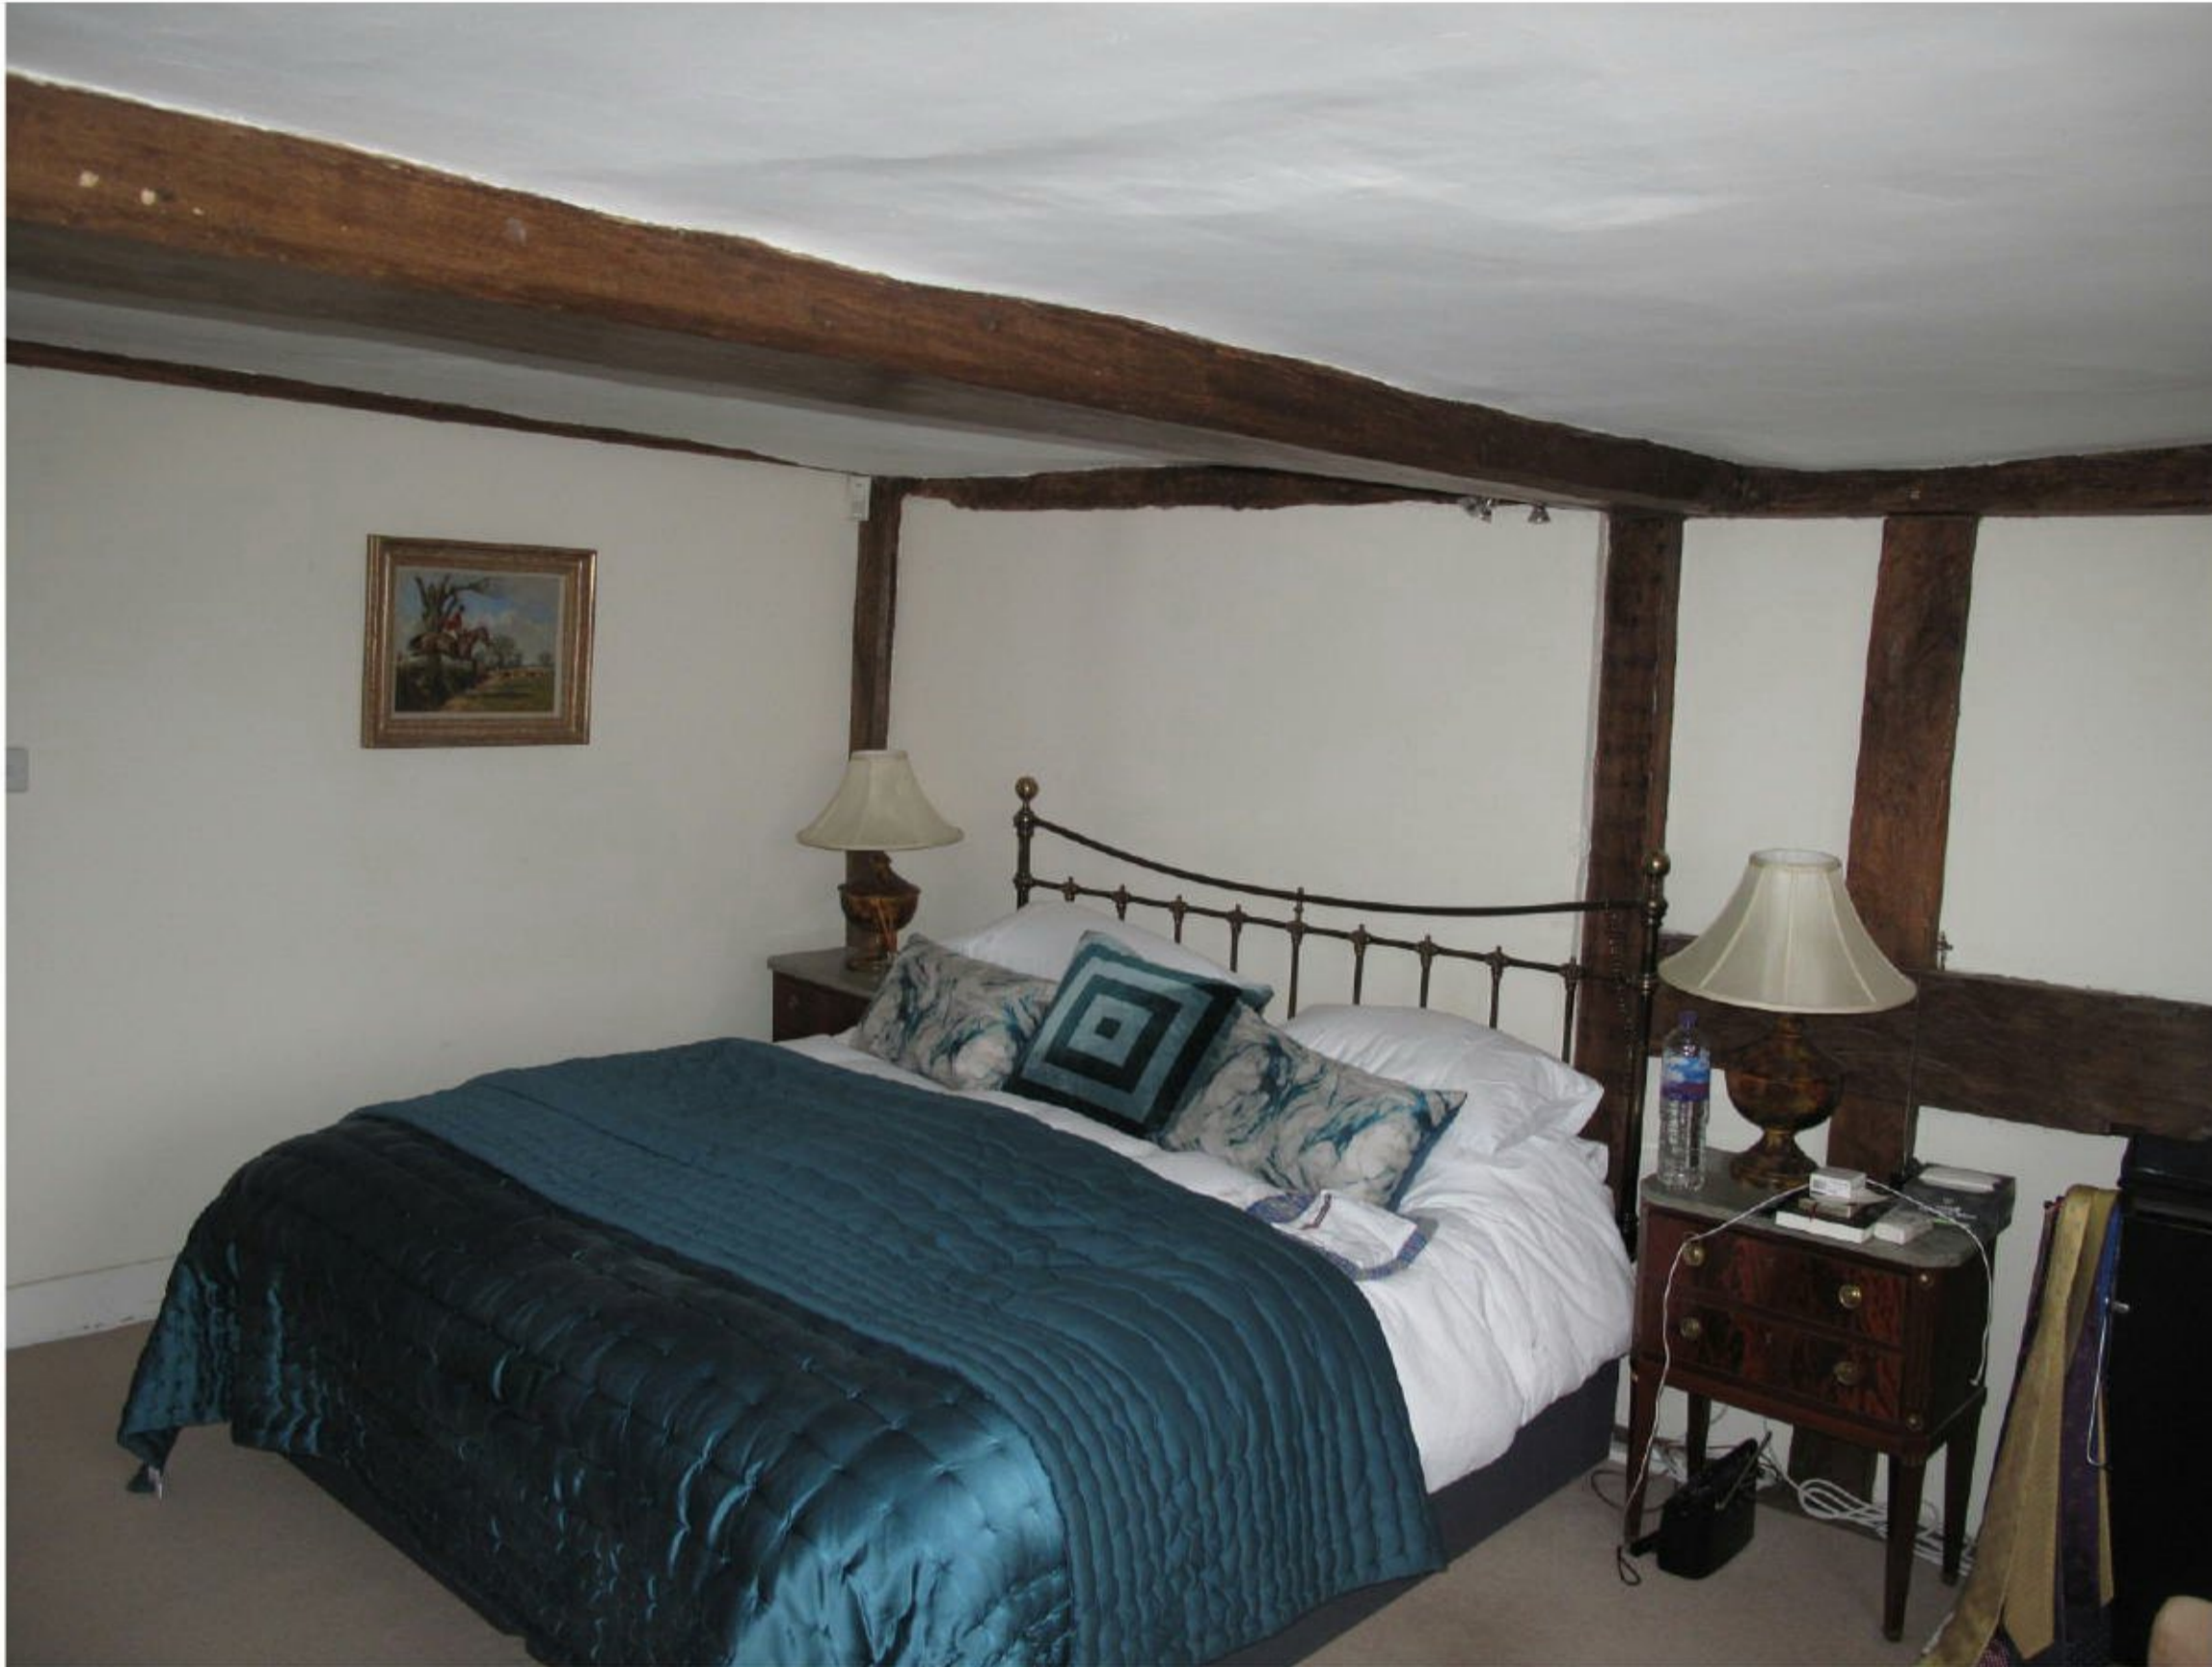
11. Timber beam in ceiling in line with truss in room S2, above, to be removed

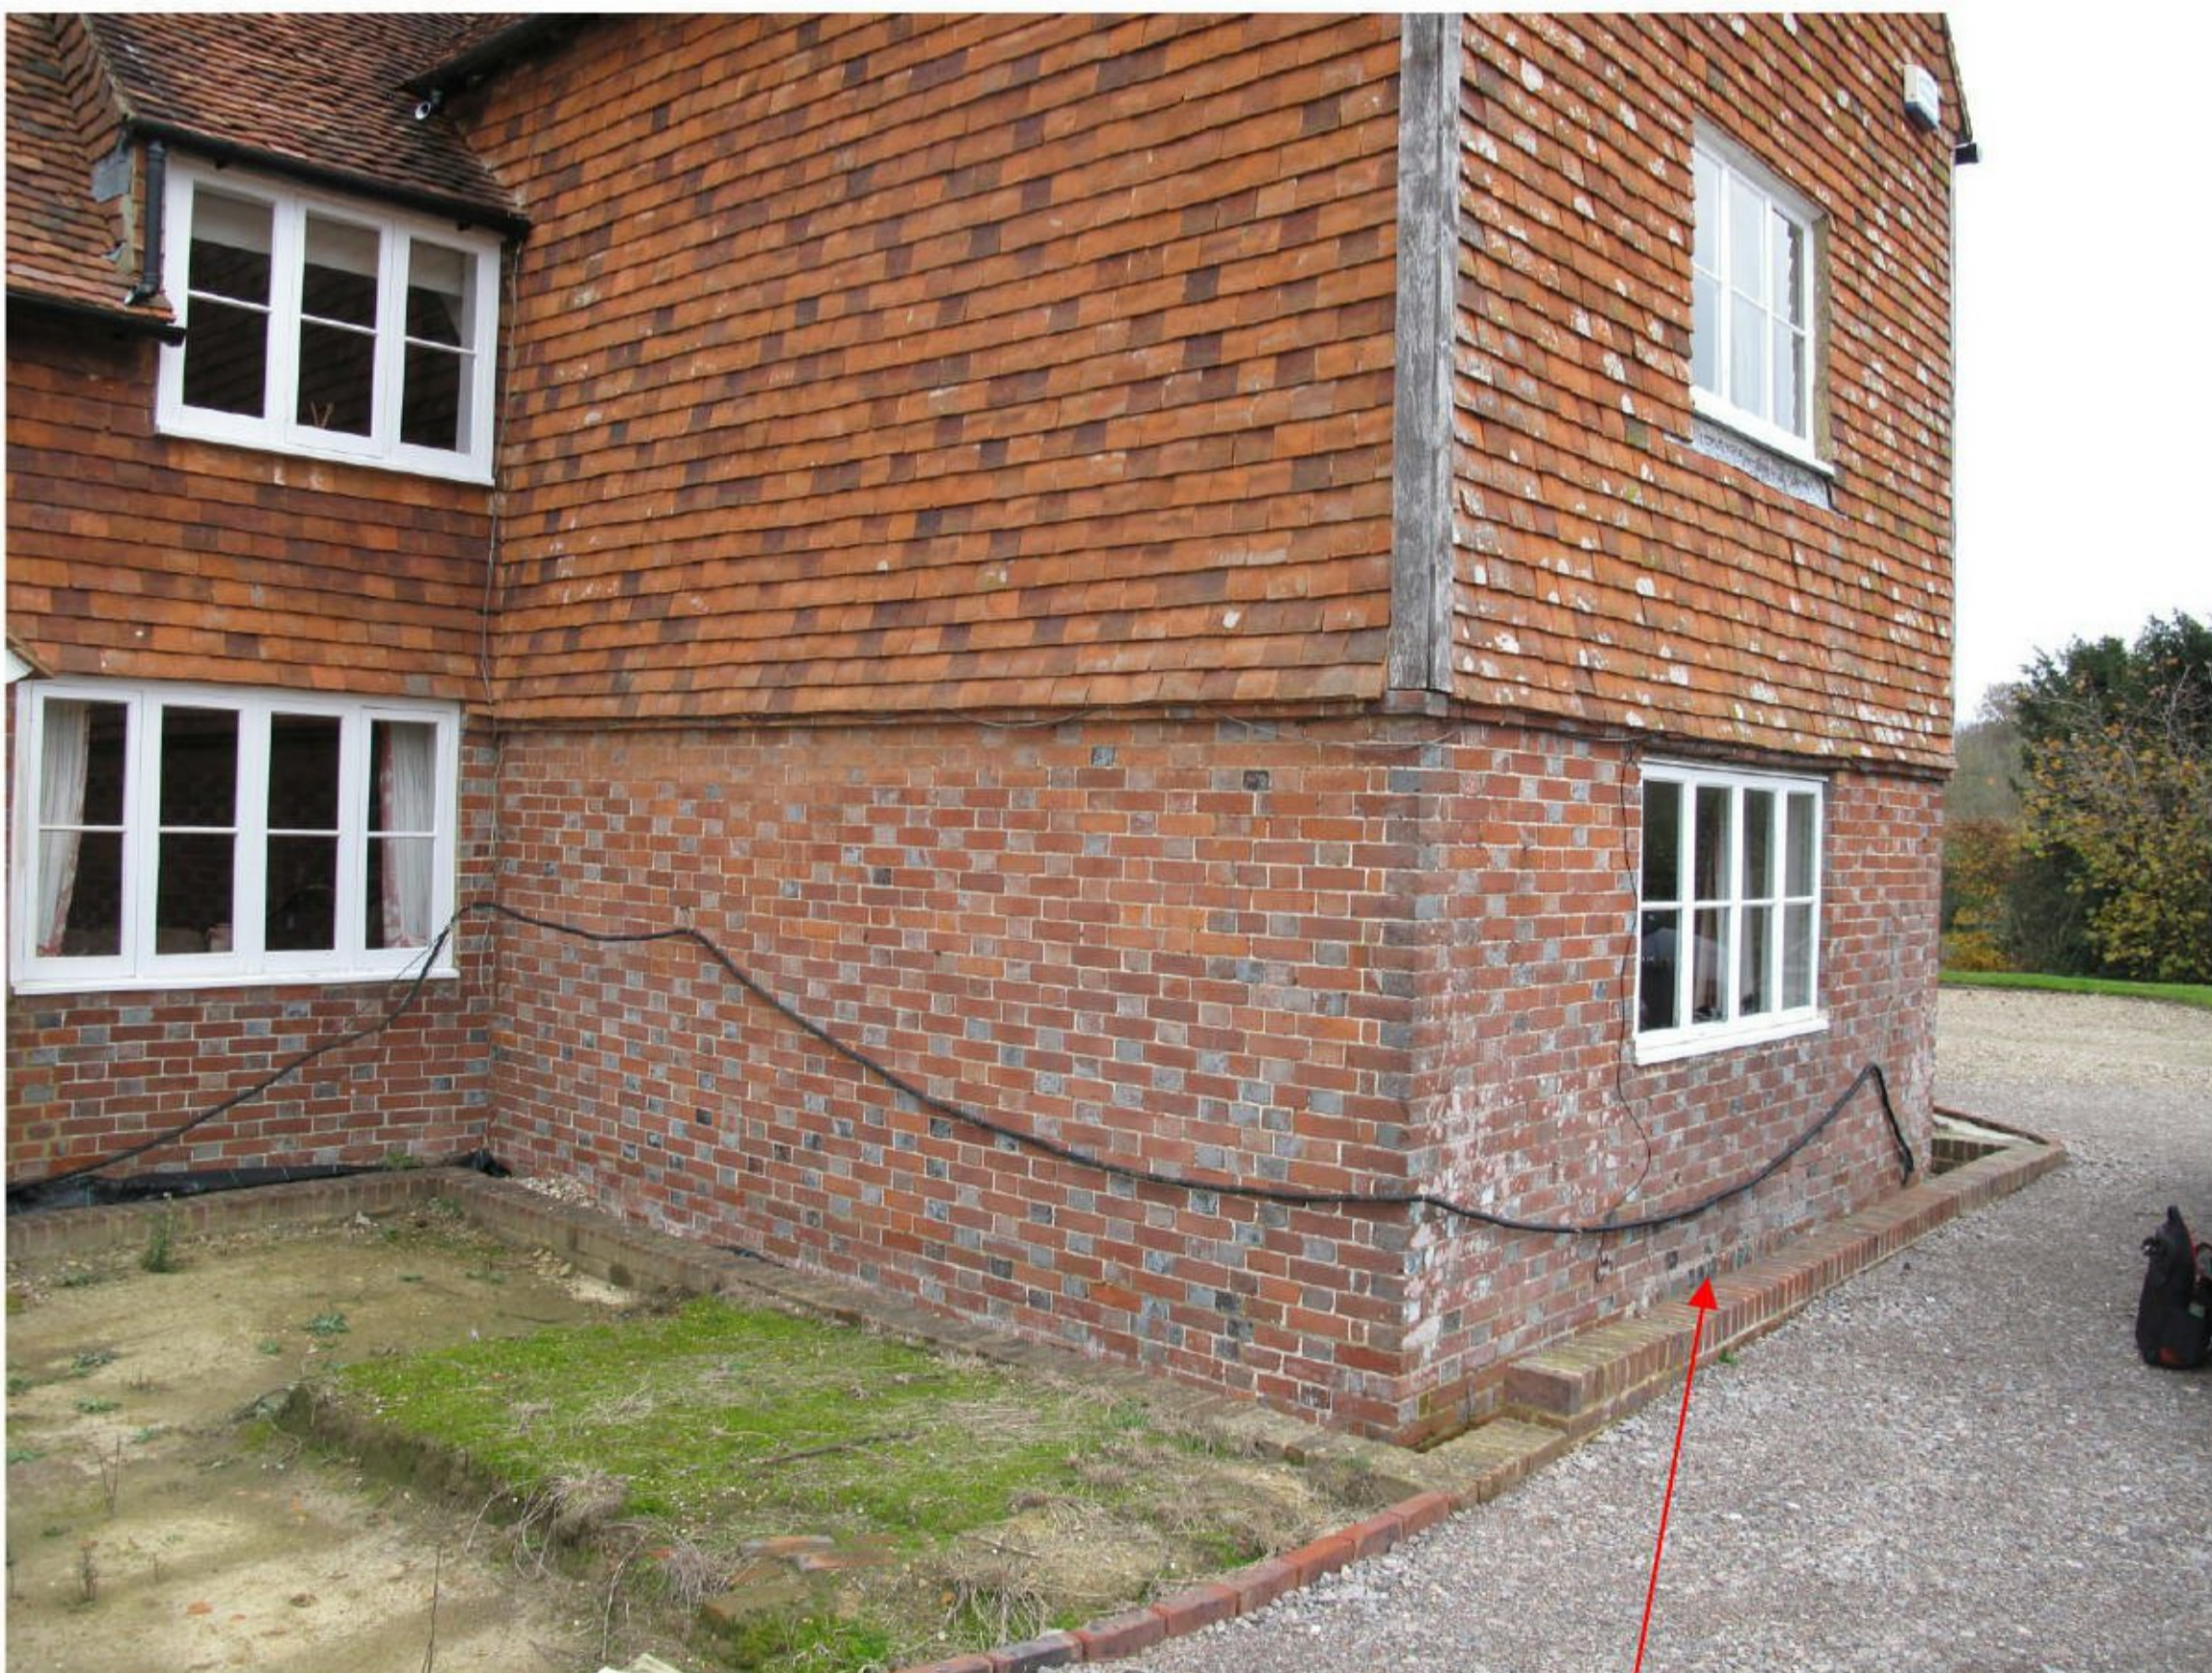
At the end of our visit we also noted a lean to the chimney on the east elevation, photos 12 to 17. Close access is needed to measure the deformations and review the condition of the brickwork in order to prepare proposals for remedial work.

12. Proposed reinstated opening at cellar
