737/03

Lockskimmers Farm

We attach photos taken during a visit on 19 November 2021 to look at the areas of proposed works to the east end of the house, together with marked-up extracts of your proposed plans. These note initial comments on the structural implications of the proposals and the investigations required to progress the structural design.

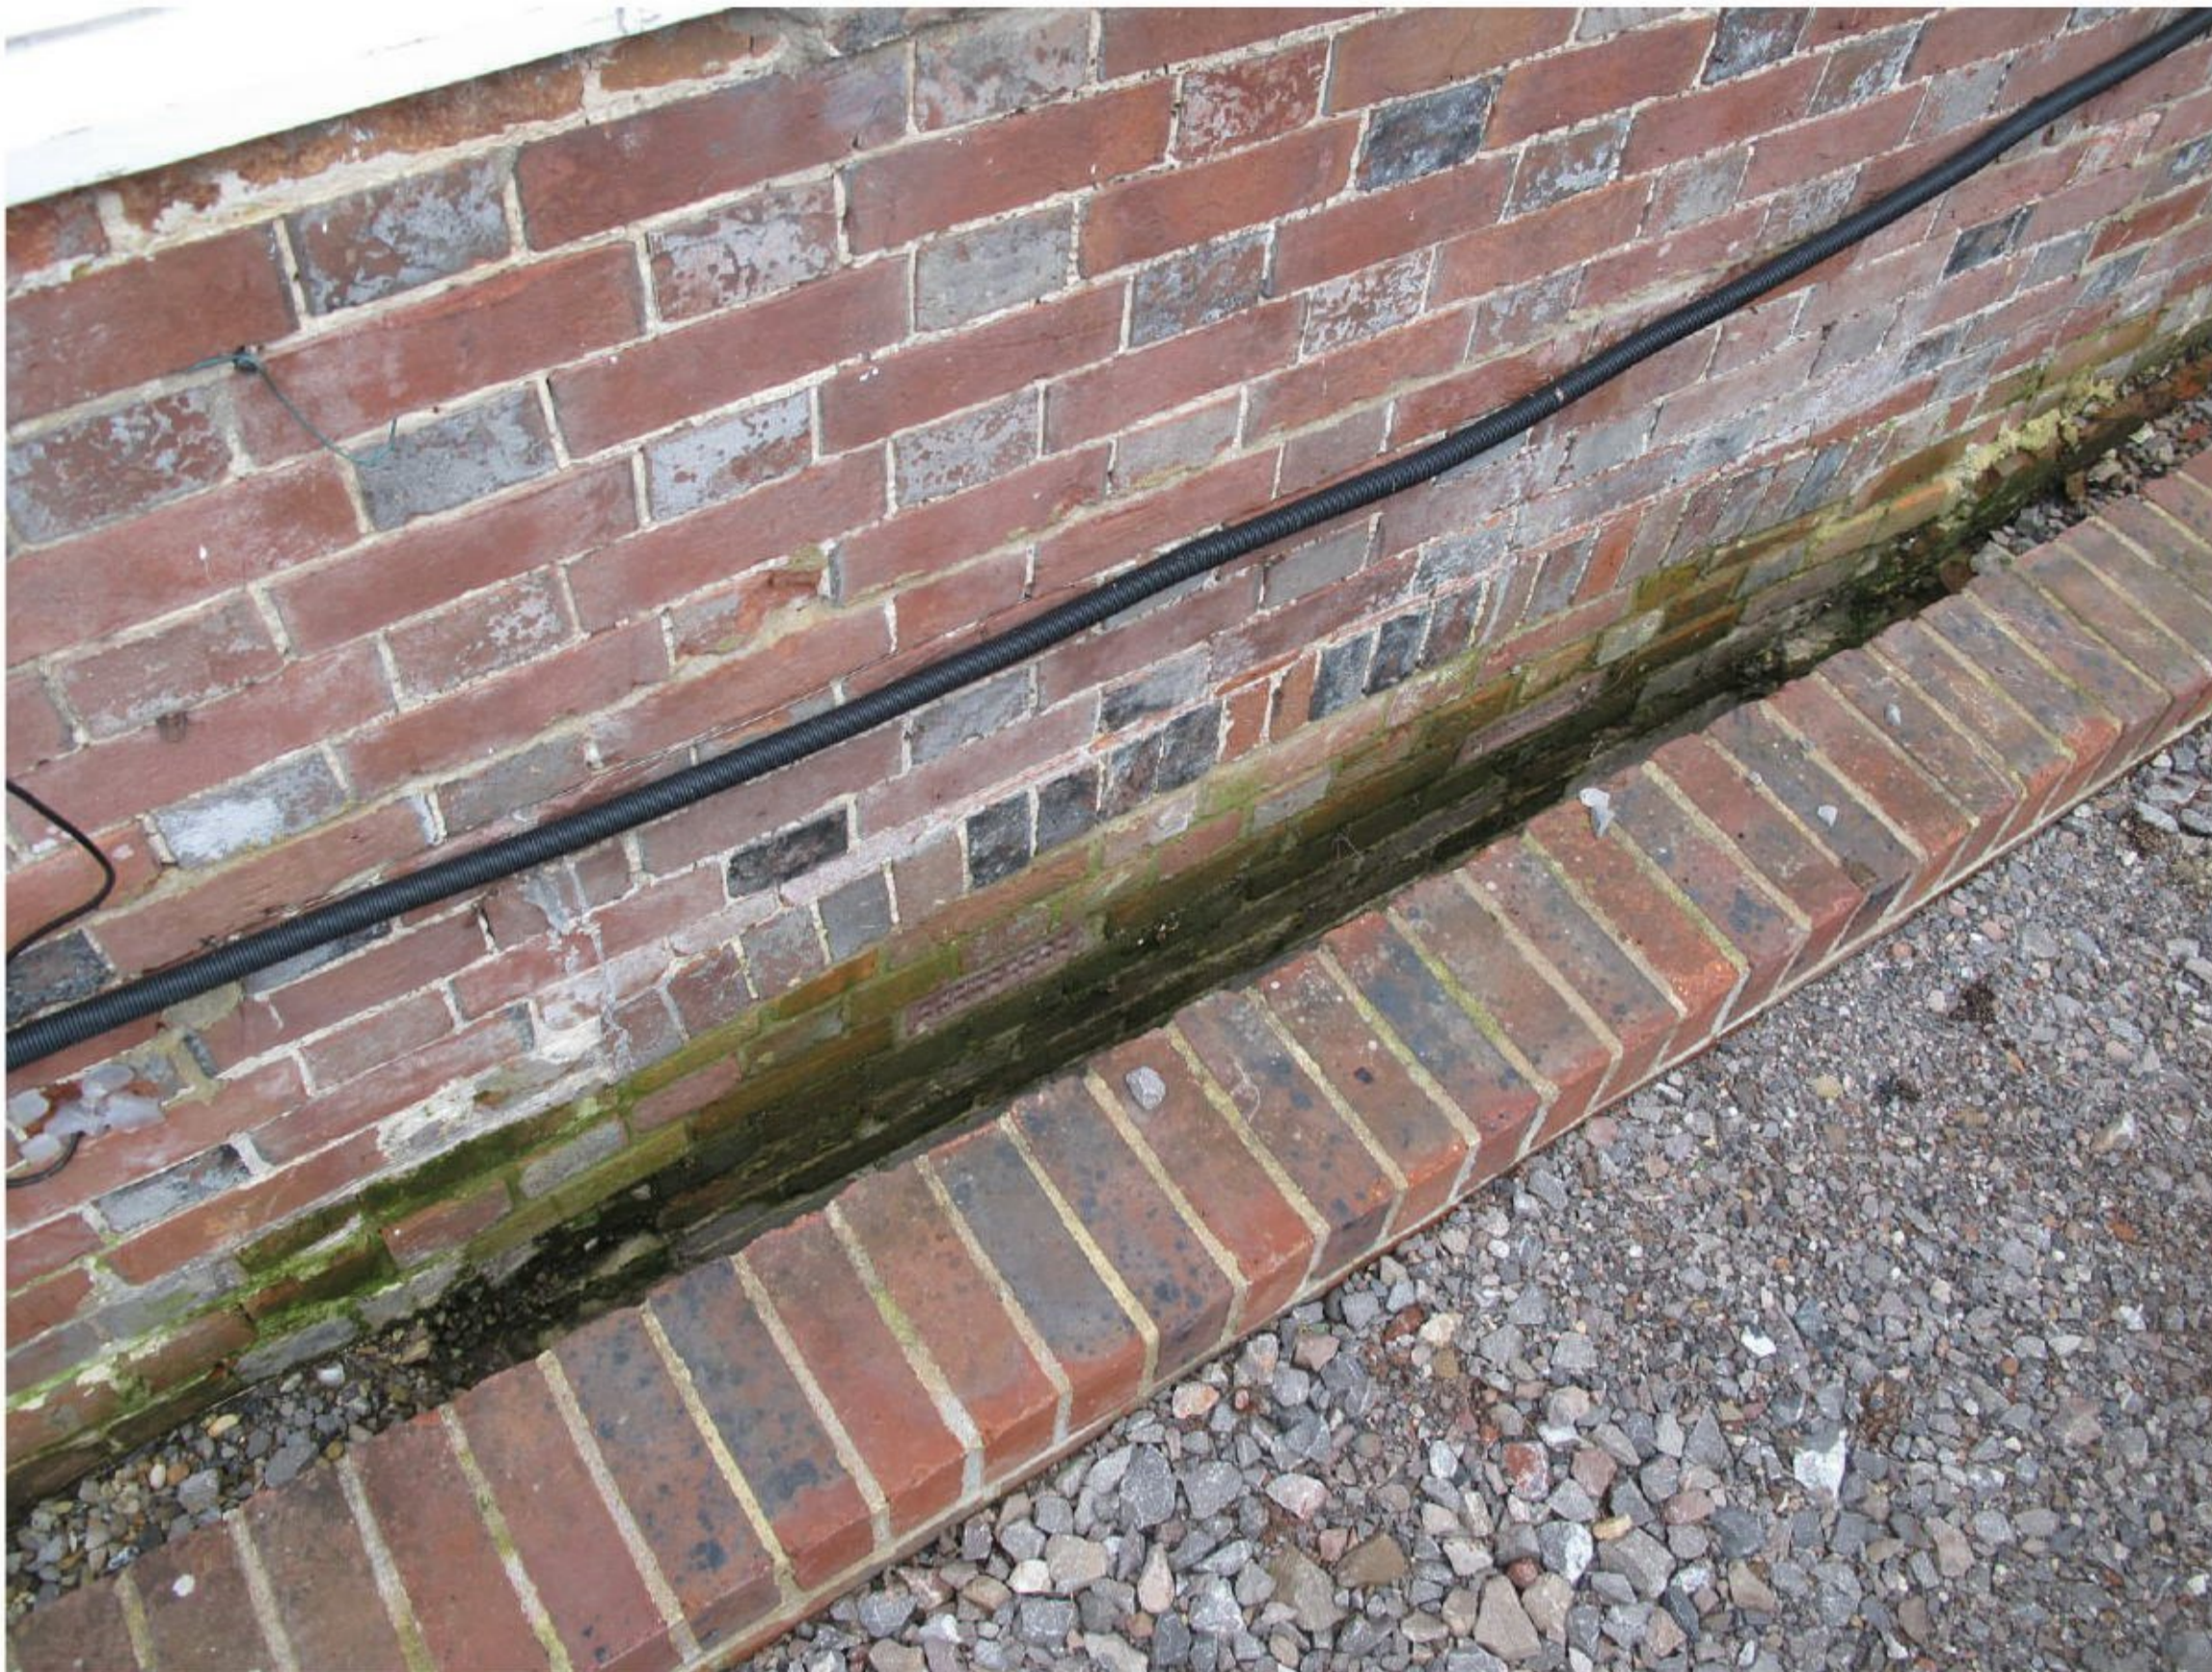
At the end of our visit we also noted a lean to the chimney on the east elevation, photos 12 to 17. Close access is needed to measure the deformations and review the condition of the brickwork in order to prepare proposals for remedial work.

13. Brick arch above reinstated opening to remain with new lintels on inside face

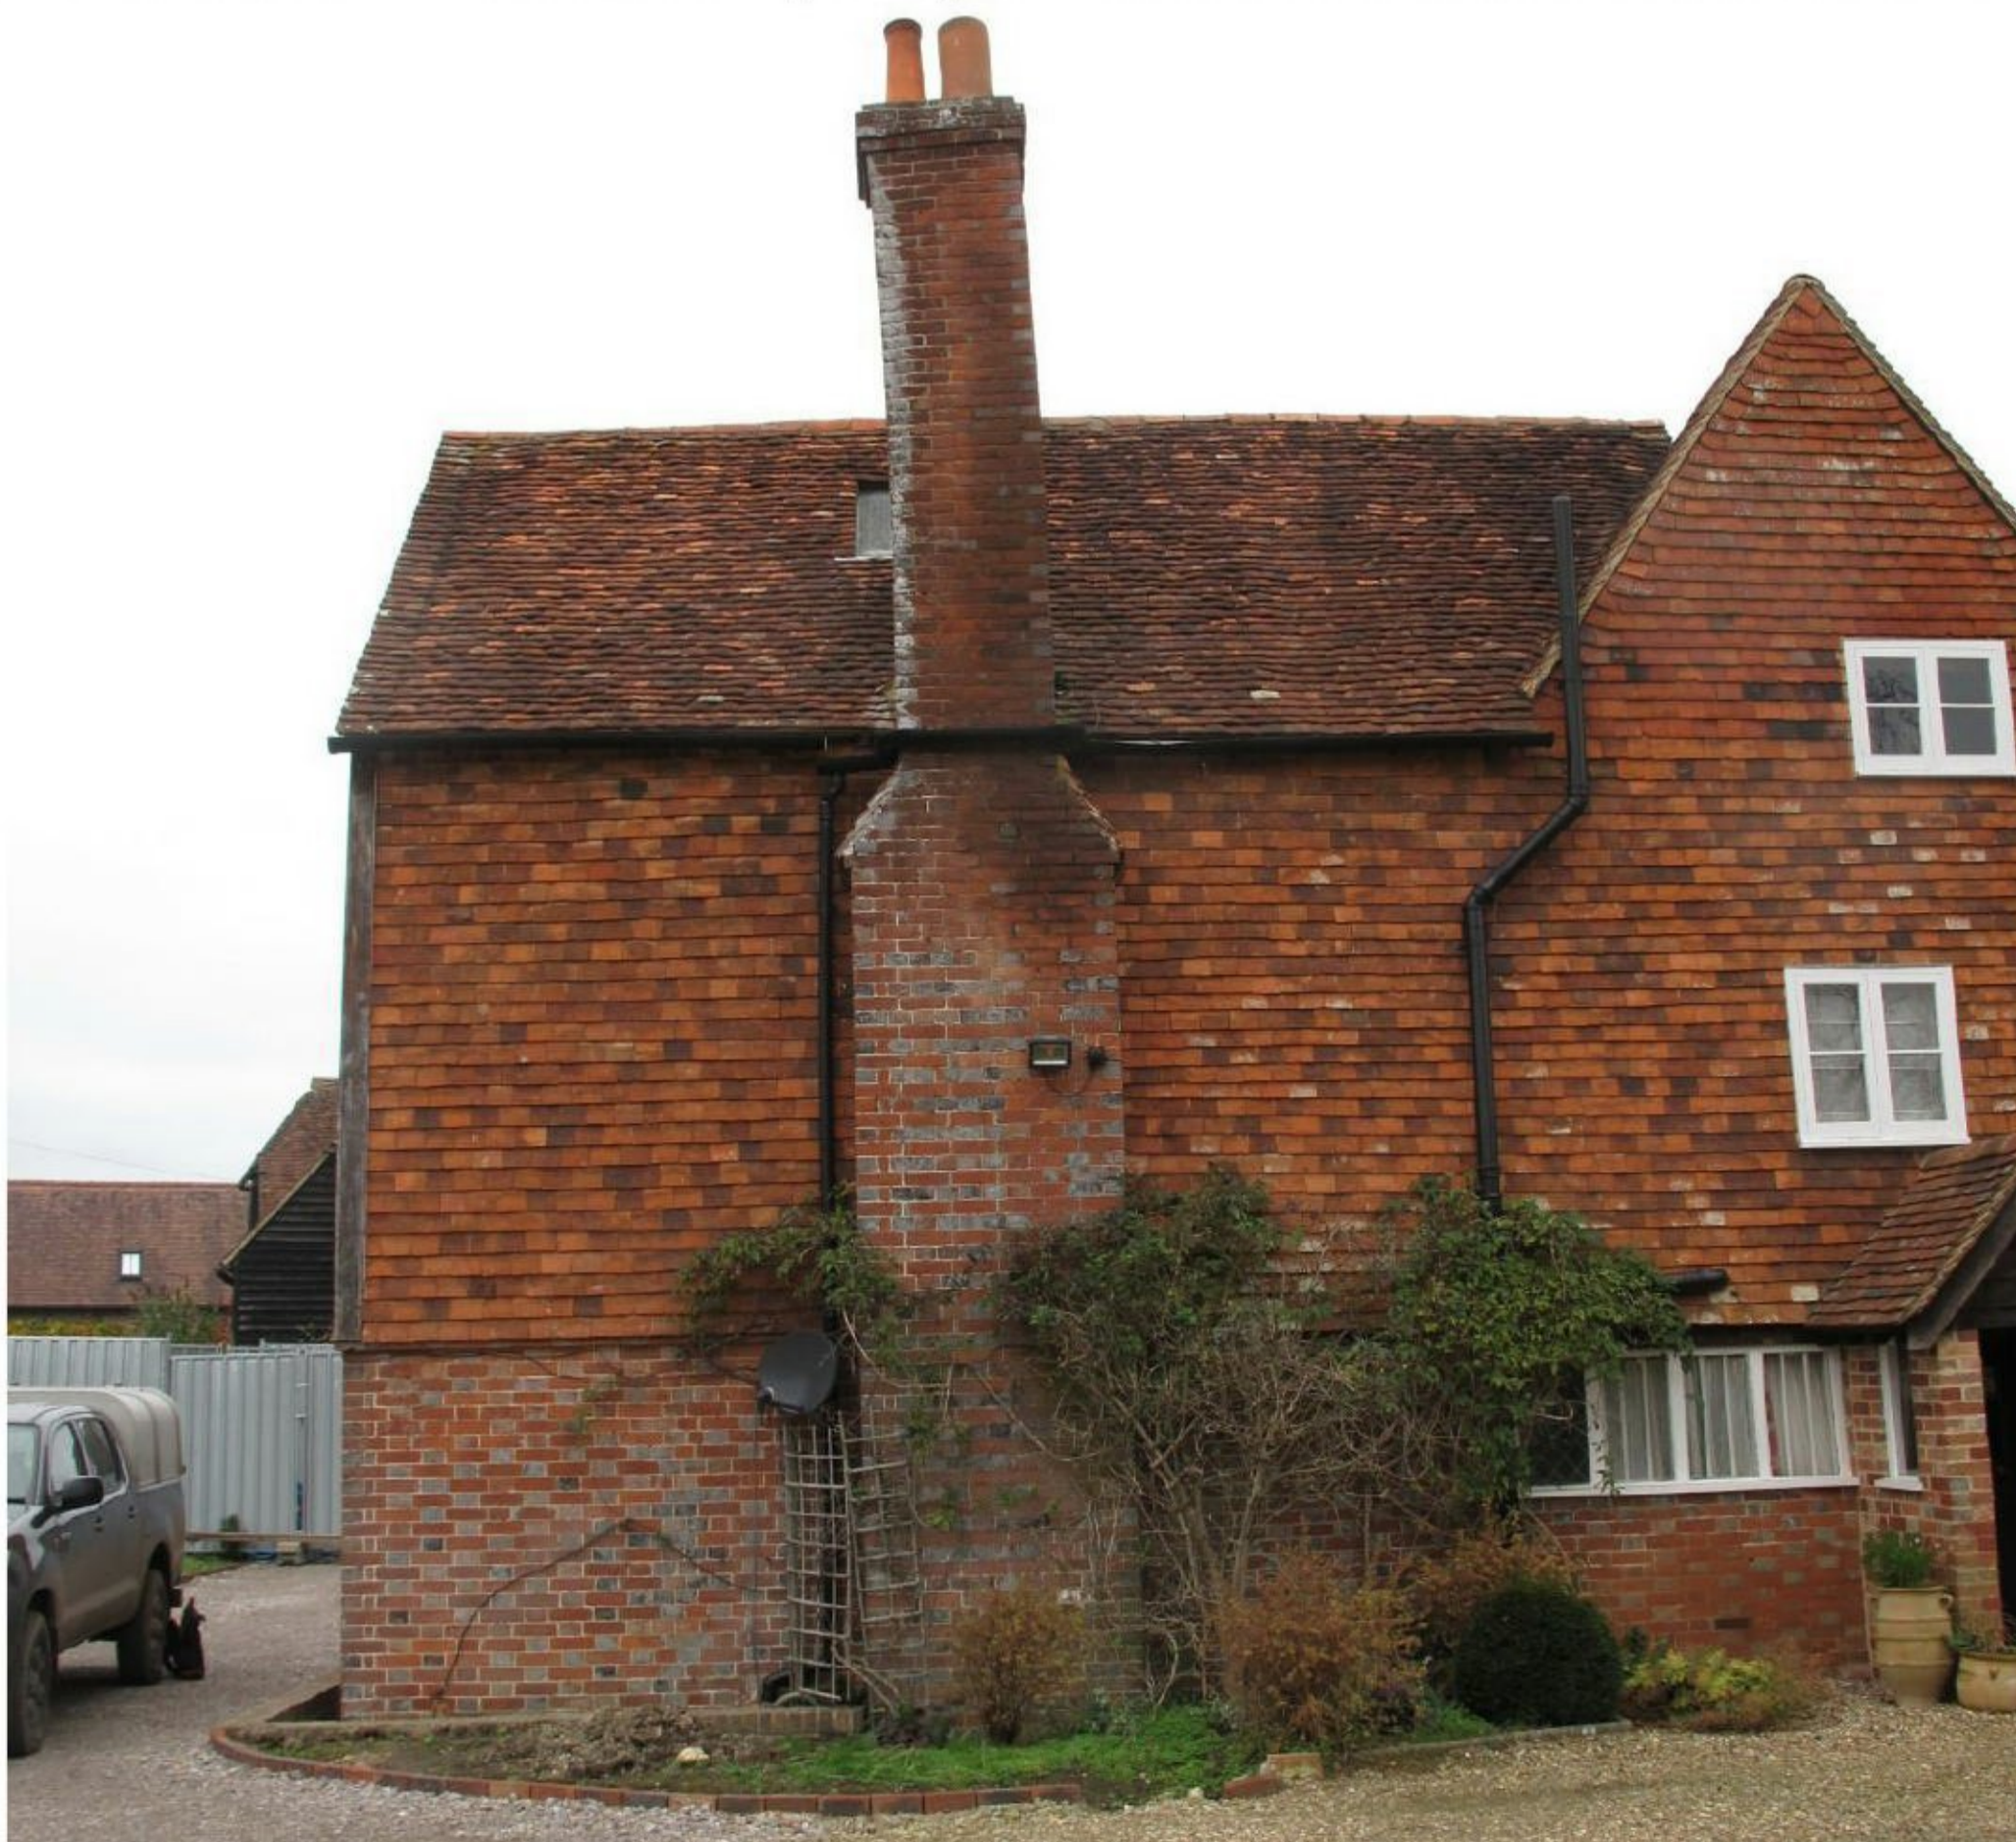
14. Chimney on east elevation leans towards the south

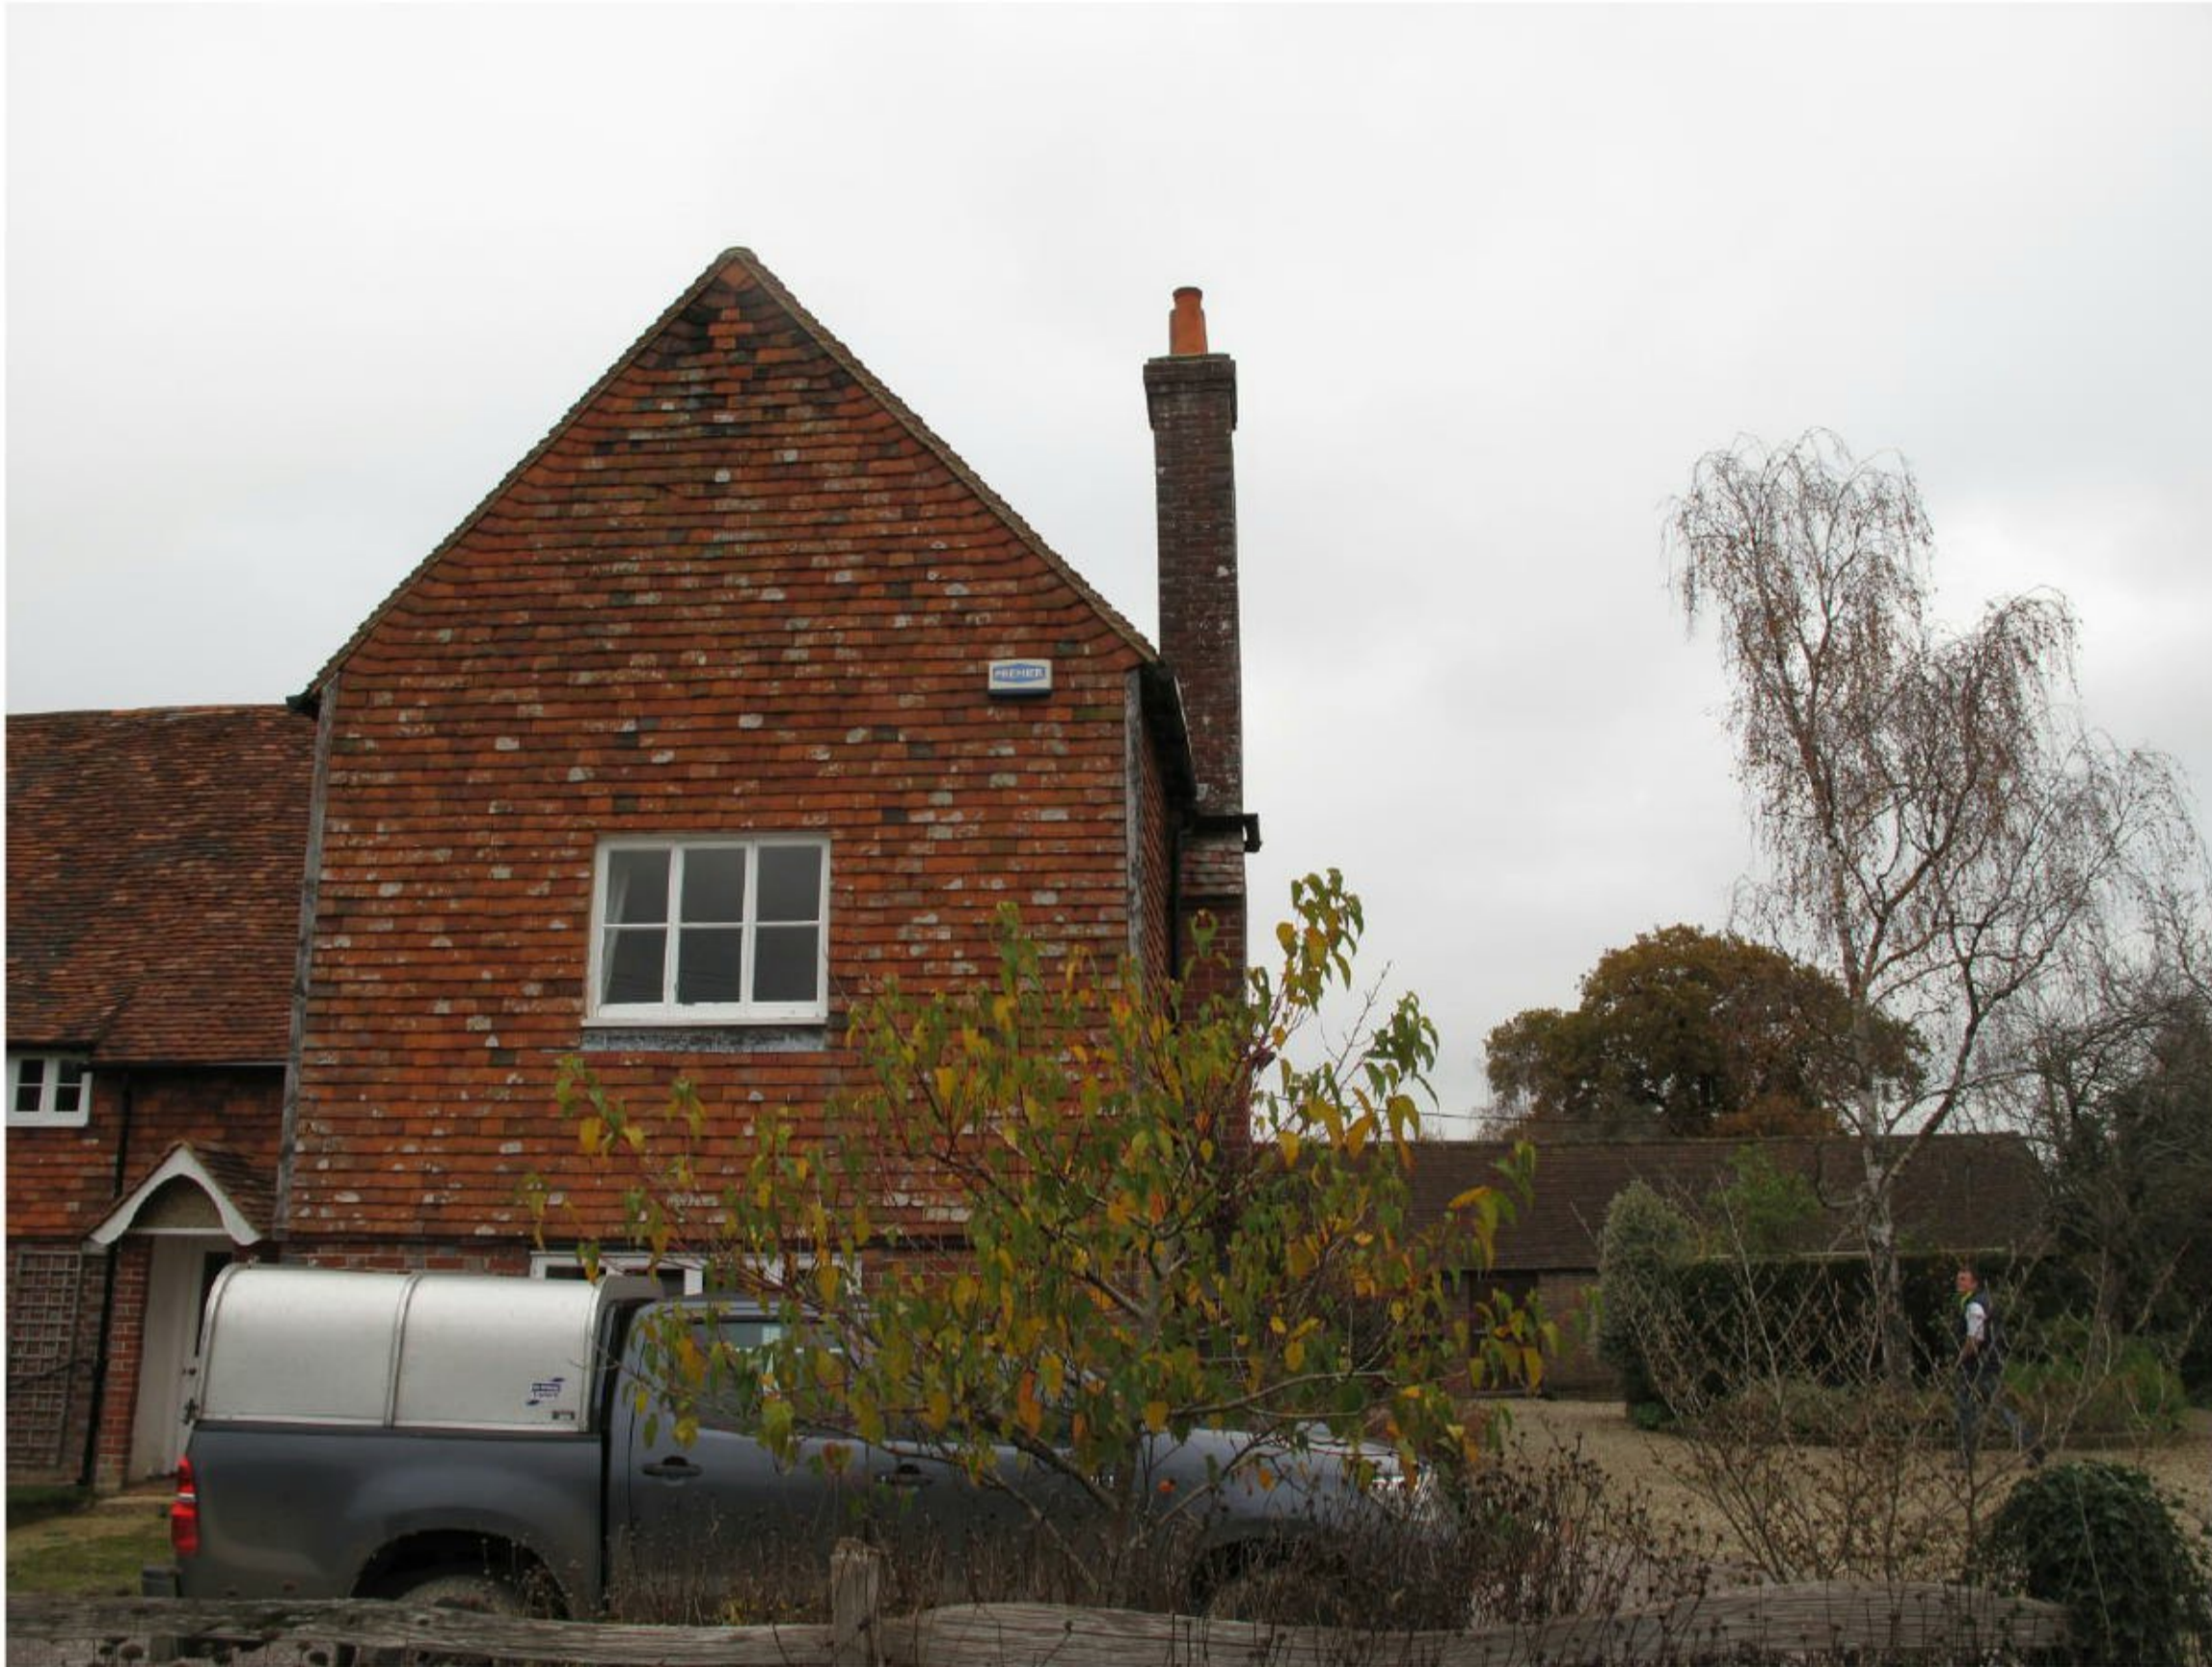
15. Chimney also leans towards the west

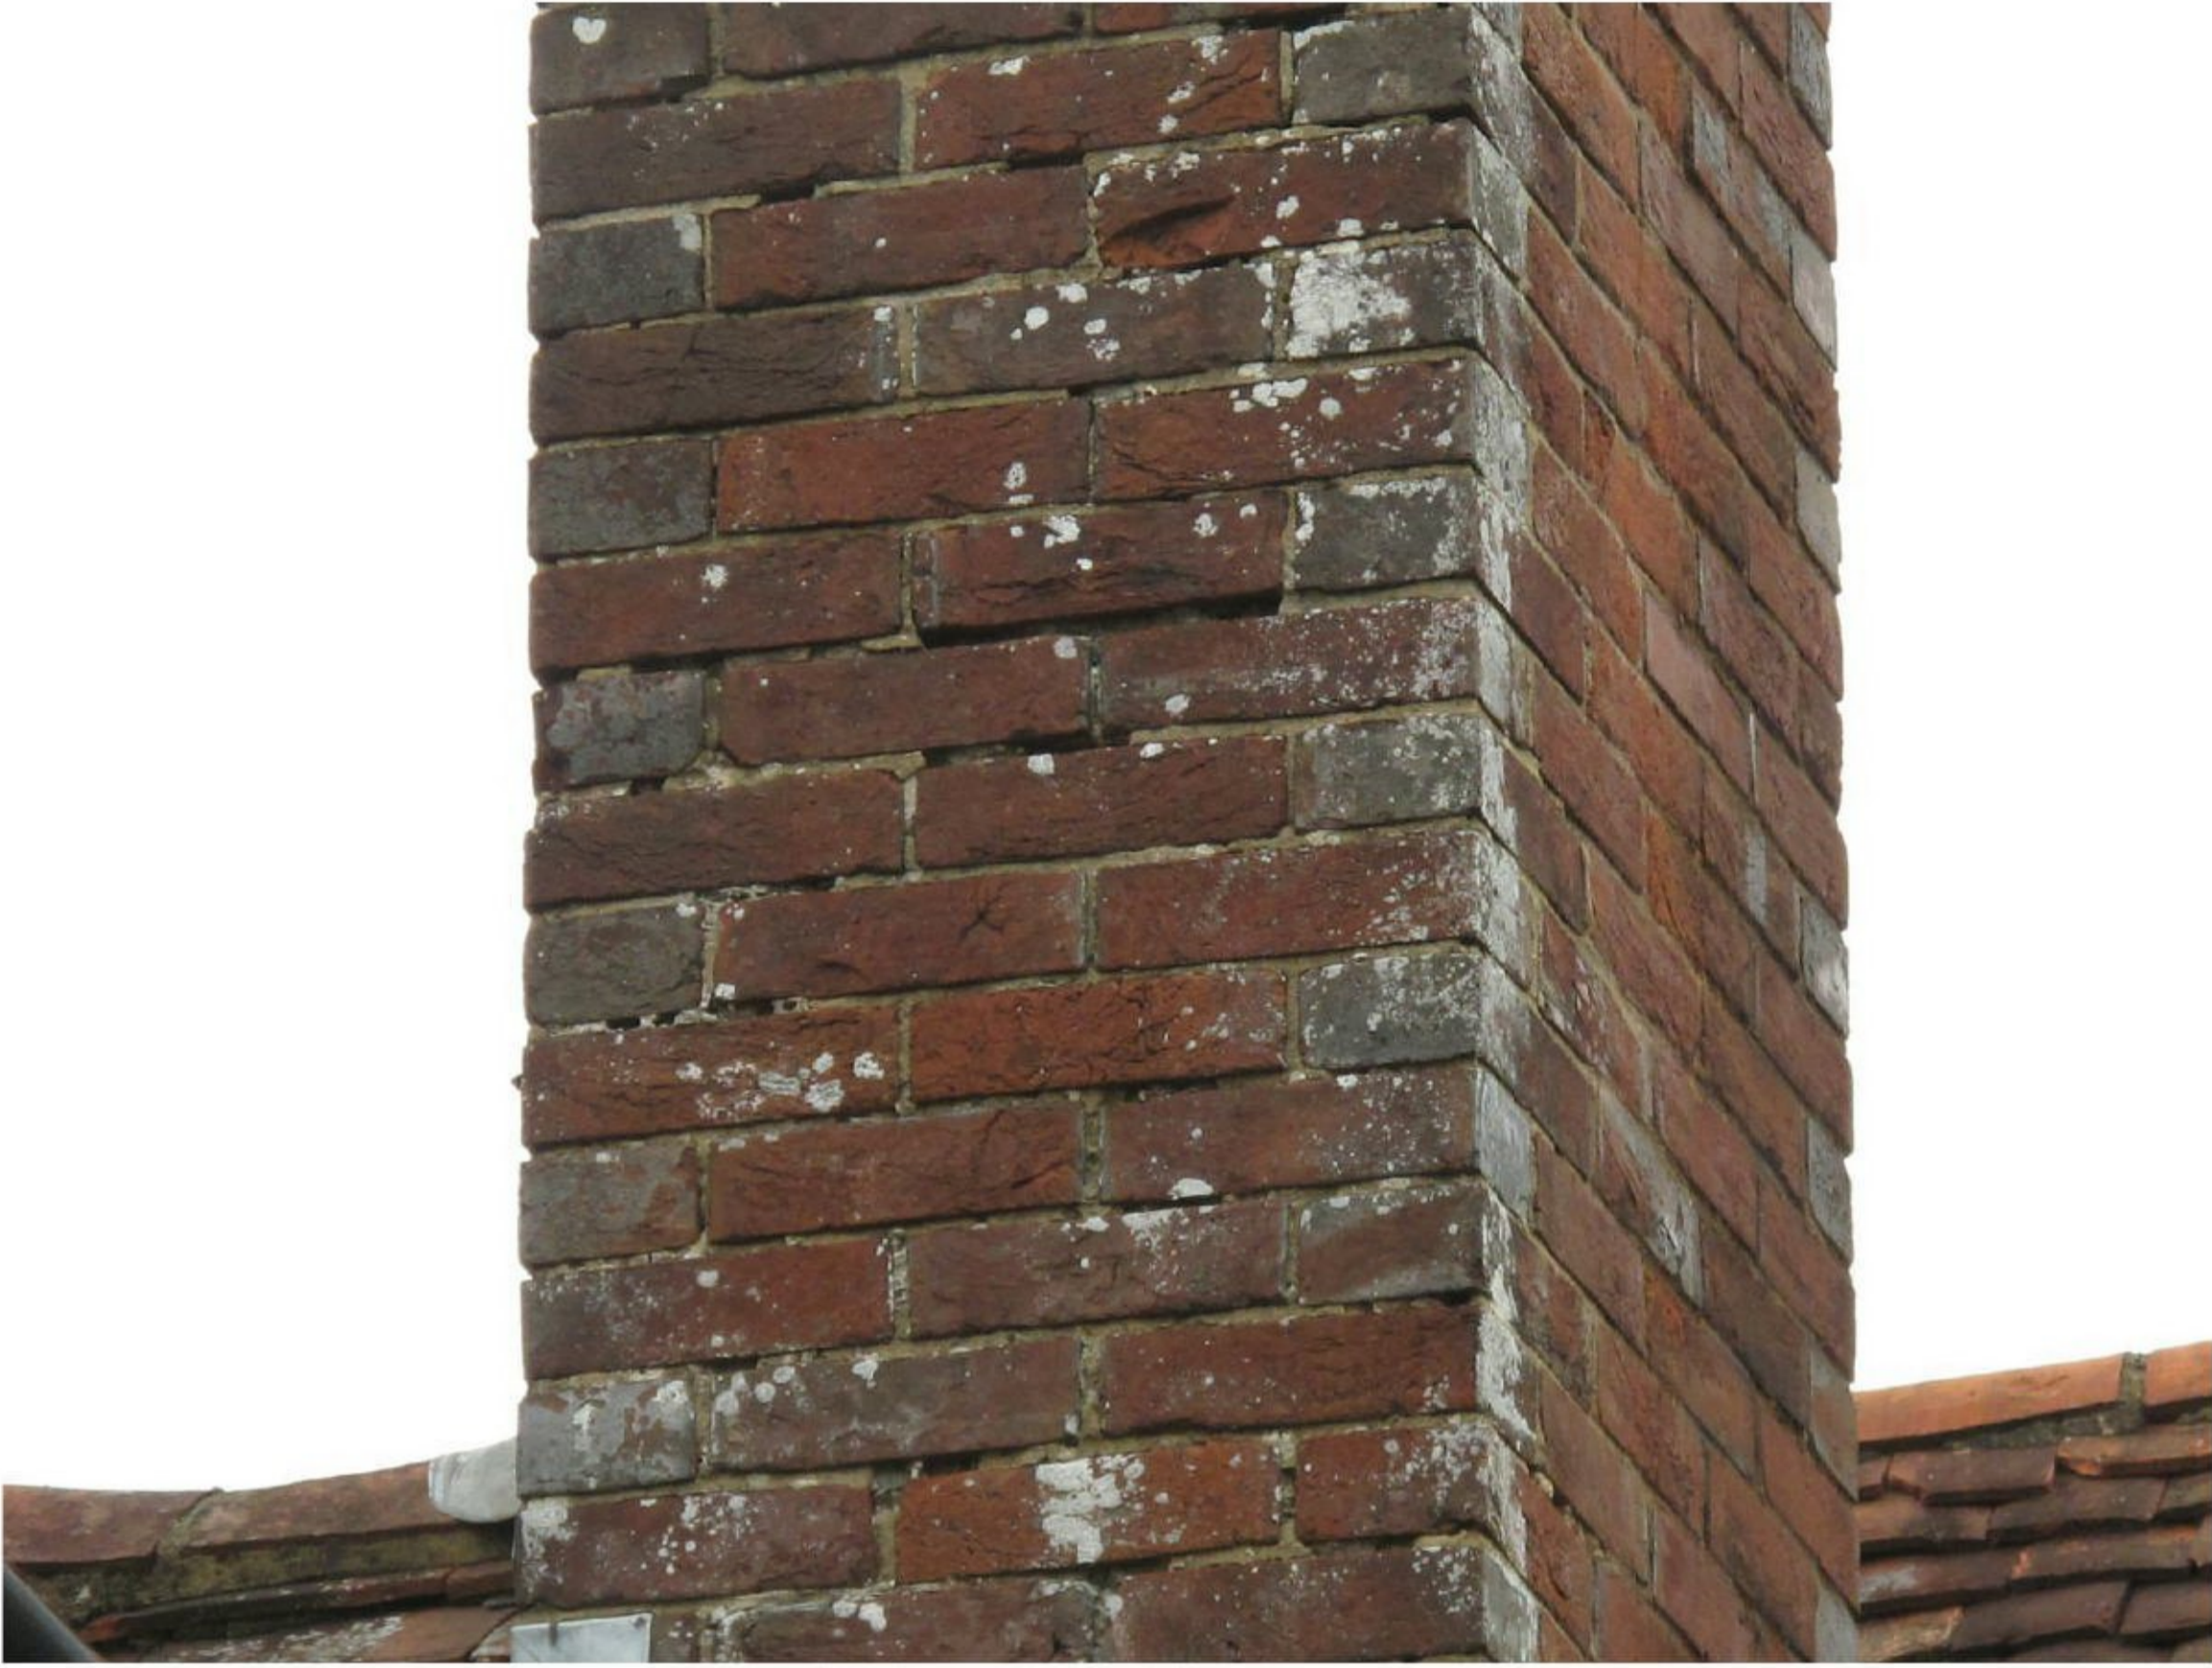
17. Detail of chimney
