**ARBORICULTURAL SURVEY**  
at  
**Bannisters Barn**  
**Markbeece**  
**Edenbridge**  
**Kent**  
**TN8 5NS**

17531/LW

- 1.1.1 This arboricultural report is required by our client as part of an investigation into suspected clay shrinkage subsidence damage at: **Bannisters Barn, Markbeech, Edenbridge, Kent, TN8 5NS.**

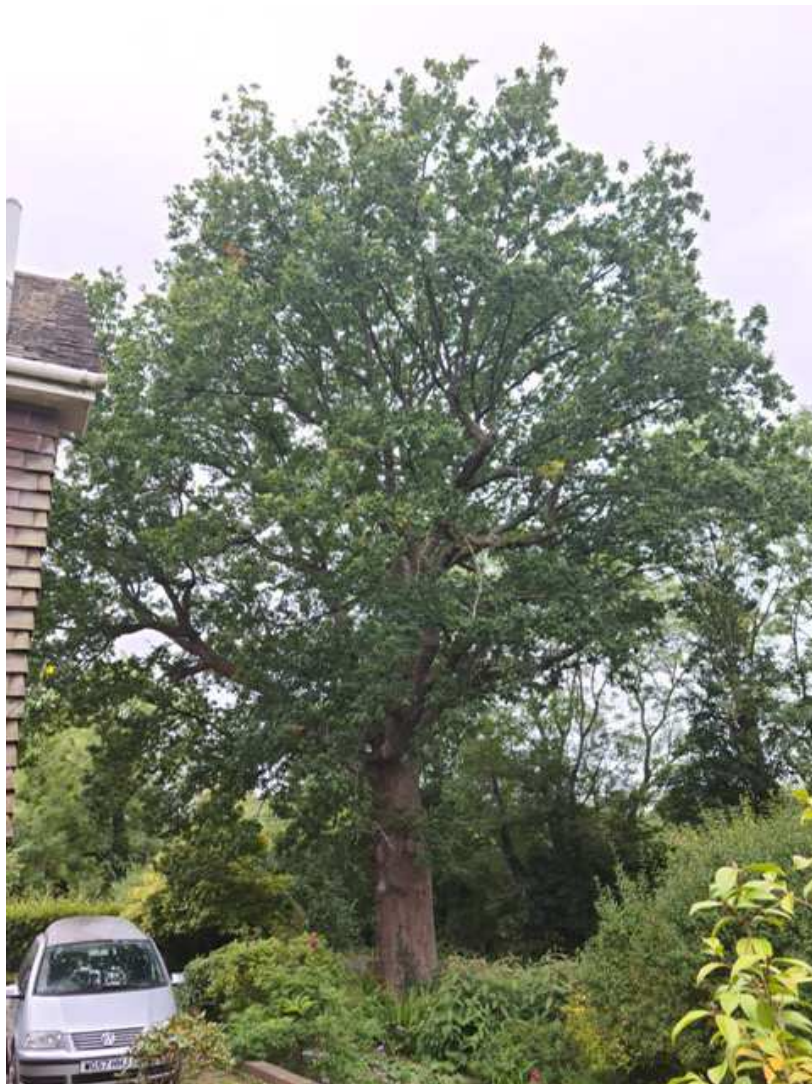
- 3.4.7 The root identification is a family match to the vegetation identified as **T1** and **S3** in this report.

- 6.3 We consider the vegetation identified as **T1** and **C17** to be the primary cause of the damage observed at the subject property. We have therefore recommended that these be removed and that the stump be treated to prevent regrowth.

Image 1: **T1** (Oak) to be removed.
