BS5837:2012 -Trees in relation to design, demolition and construction. Arboricultural matters in relation to land at Dembleby.

Prepared by: East Midlands Tree Surveys Ltd.

Date: 09/11/2021

Tree Constraints Plan
Former Dembleby Plant Centre,
Dembleby

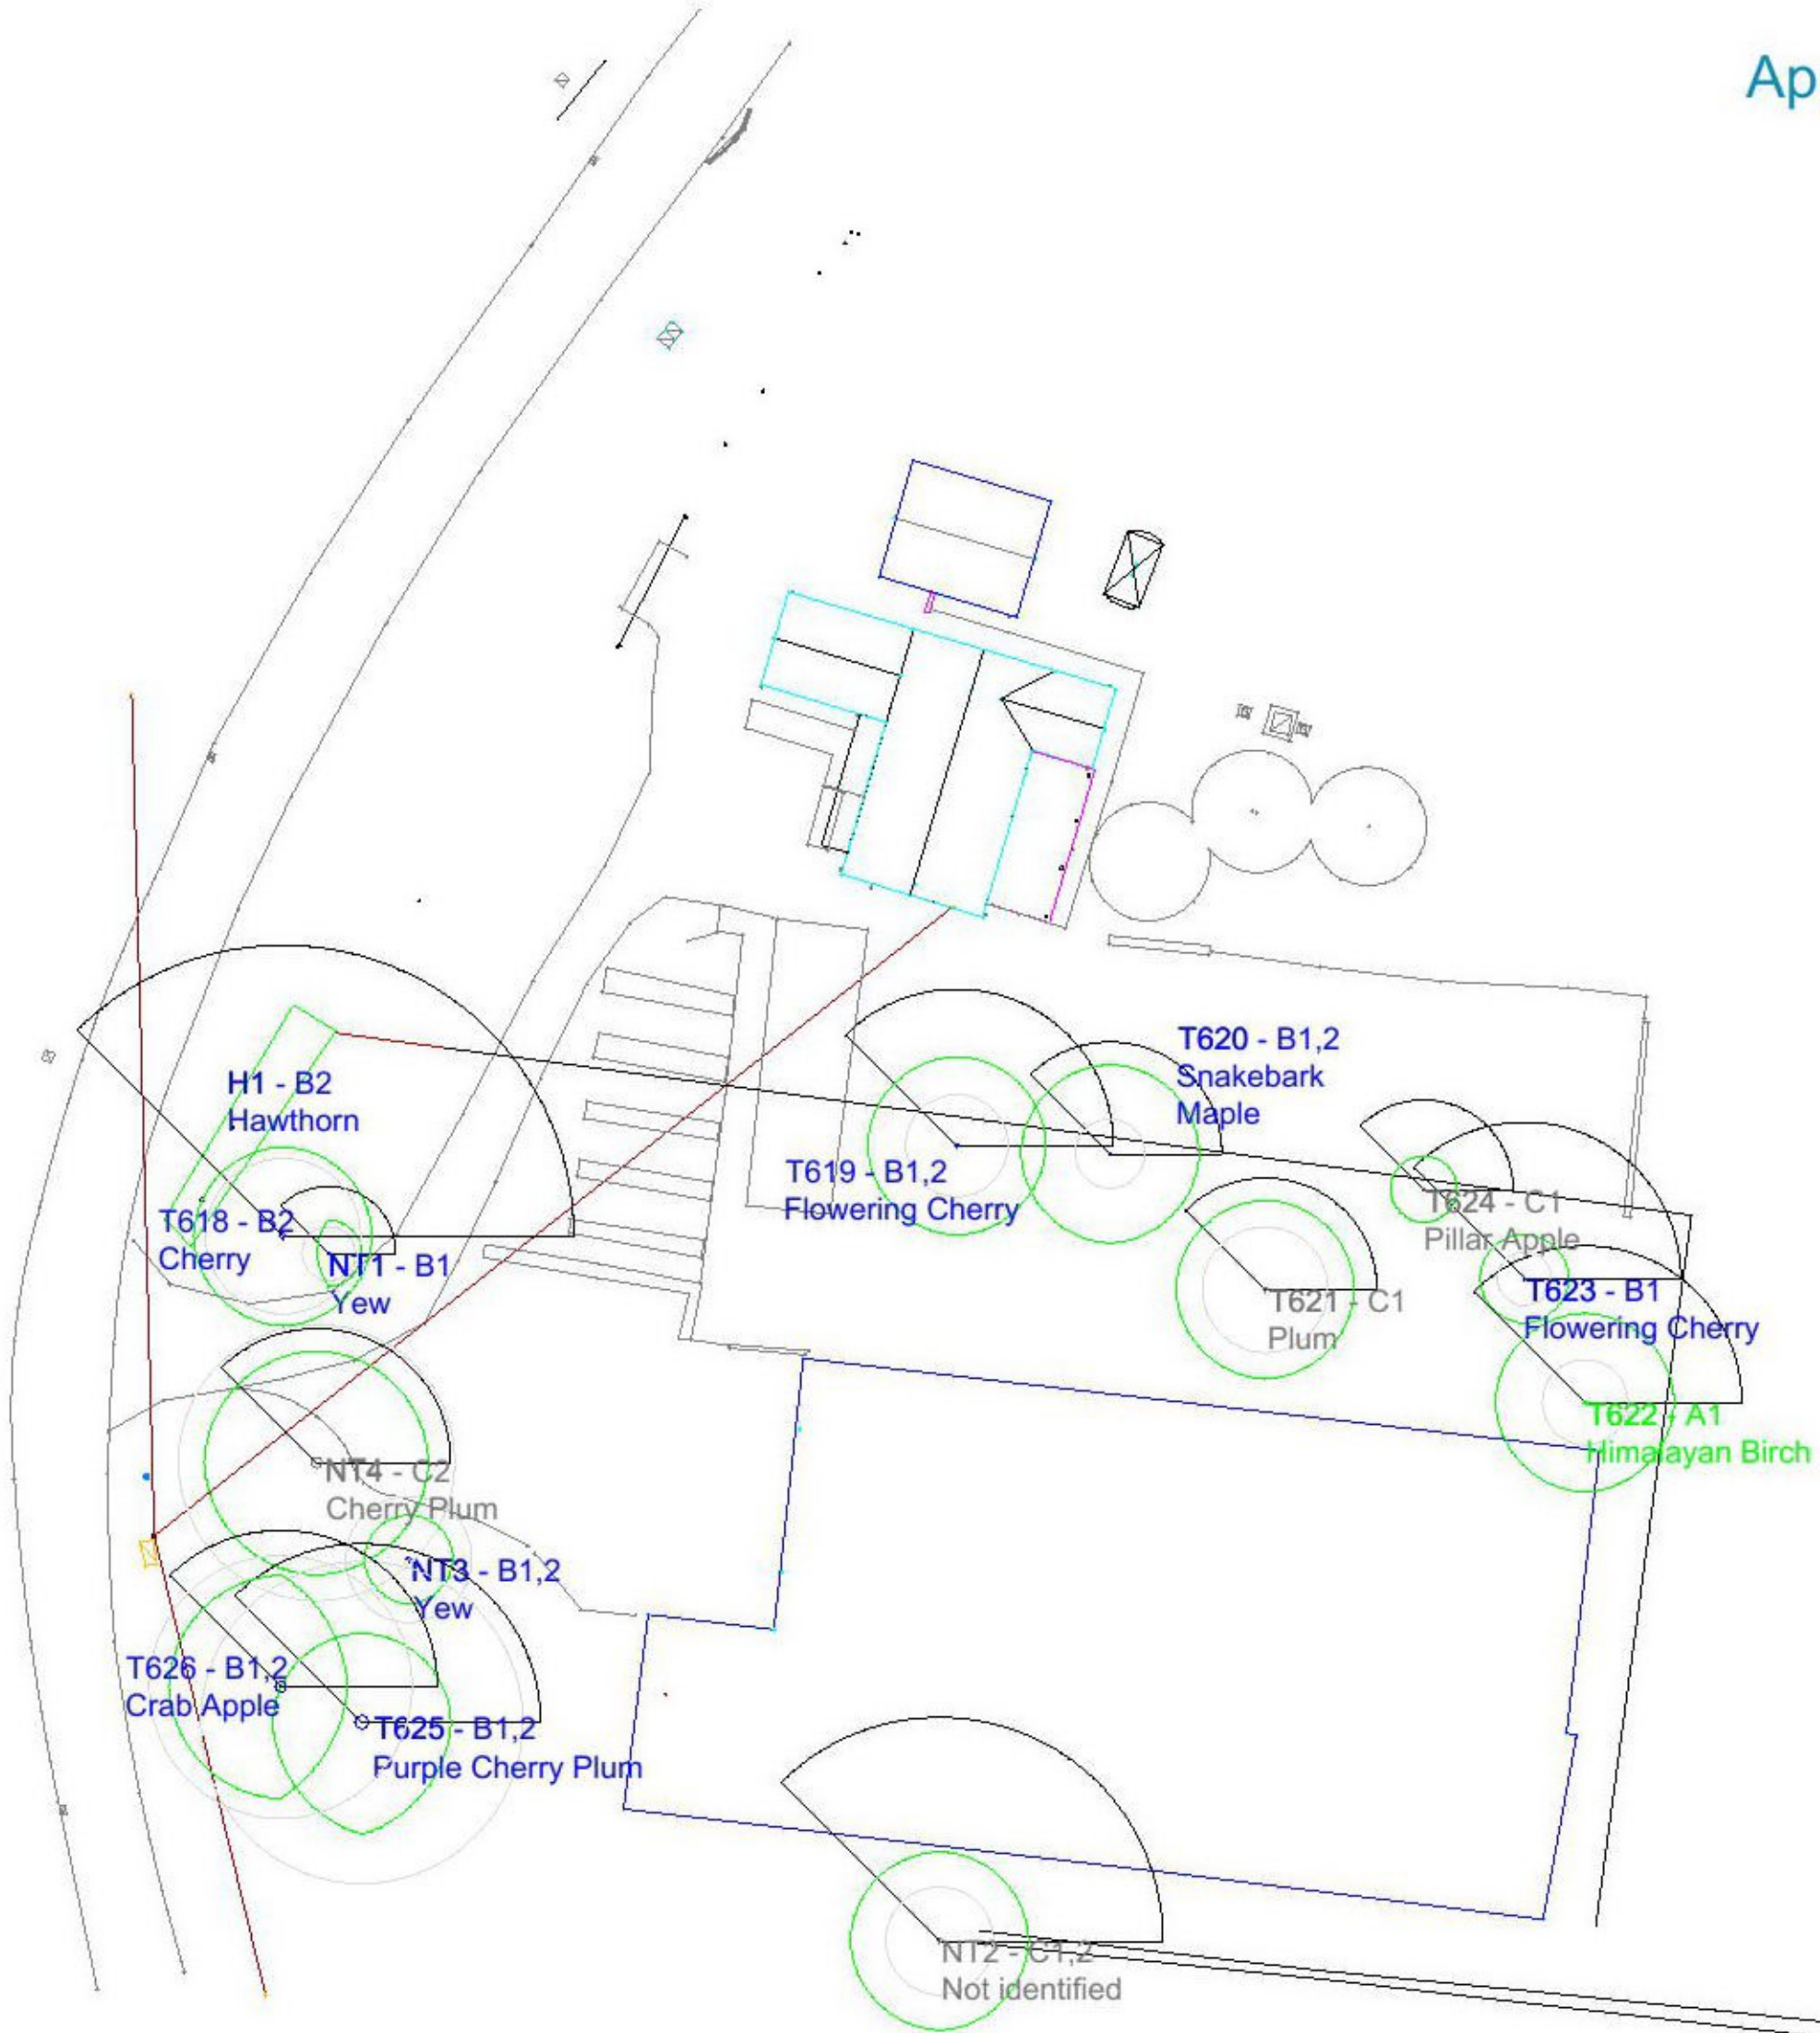
The only caveat to this is NT4 Cherry Plum which has a Gannoderma sp bracket at the base. This tree should be removed and replaced within the context of development but equally from a liability perspective in terms of the main road.

b. **Evaluation of the impact of proposed tree losses:** only NT4 is proposed for removal due to the presence of a known wood decayer; it provides amenity primarily to the adjacent landowners/immediately local area.

Remove NT4.

Laterally prune T618 by 1m over the drive.

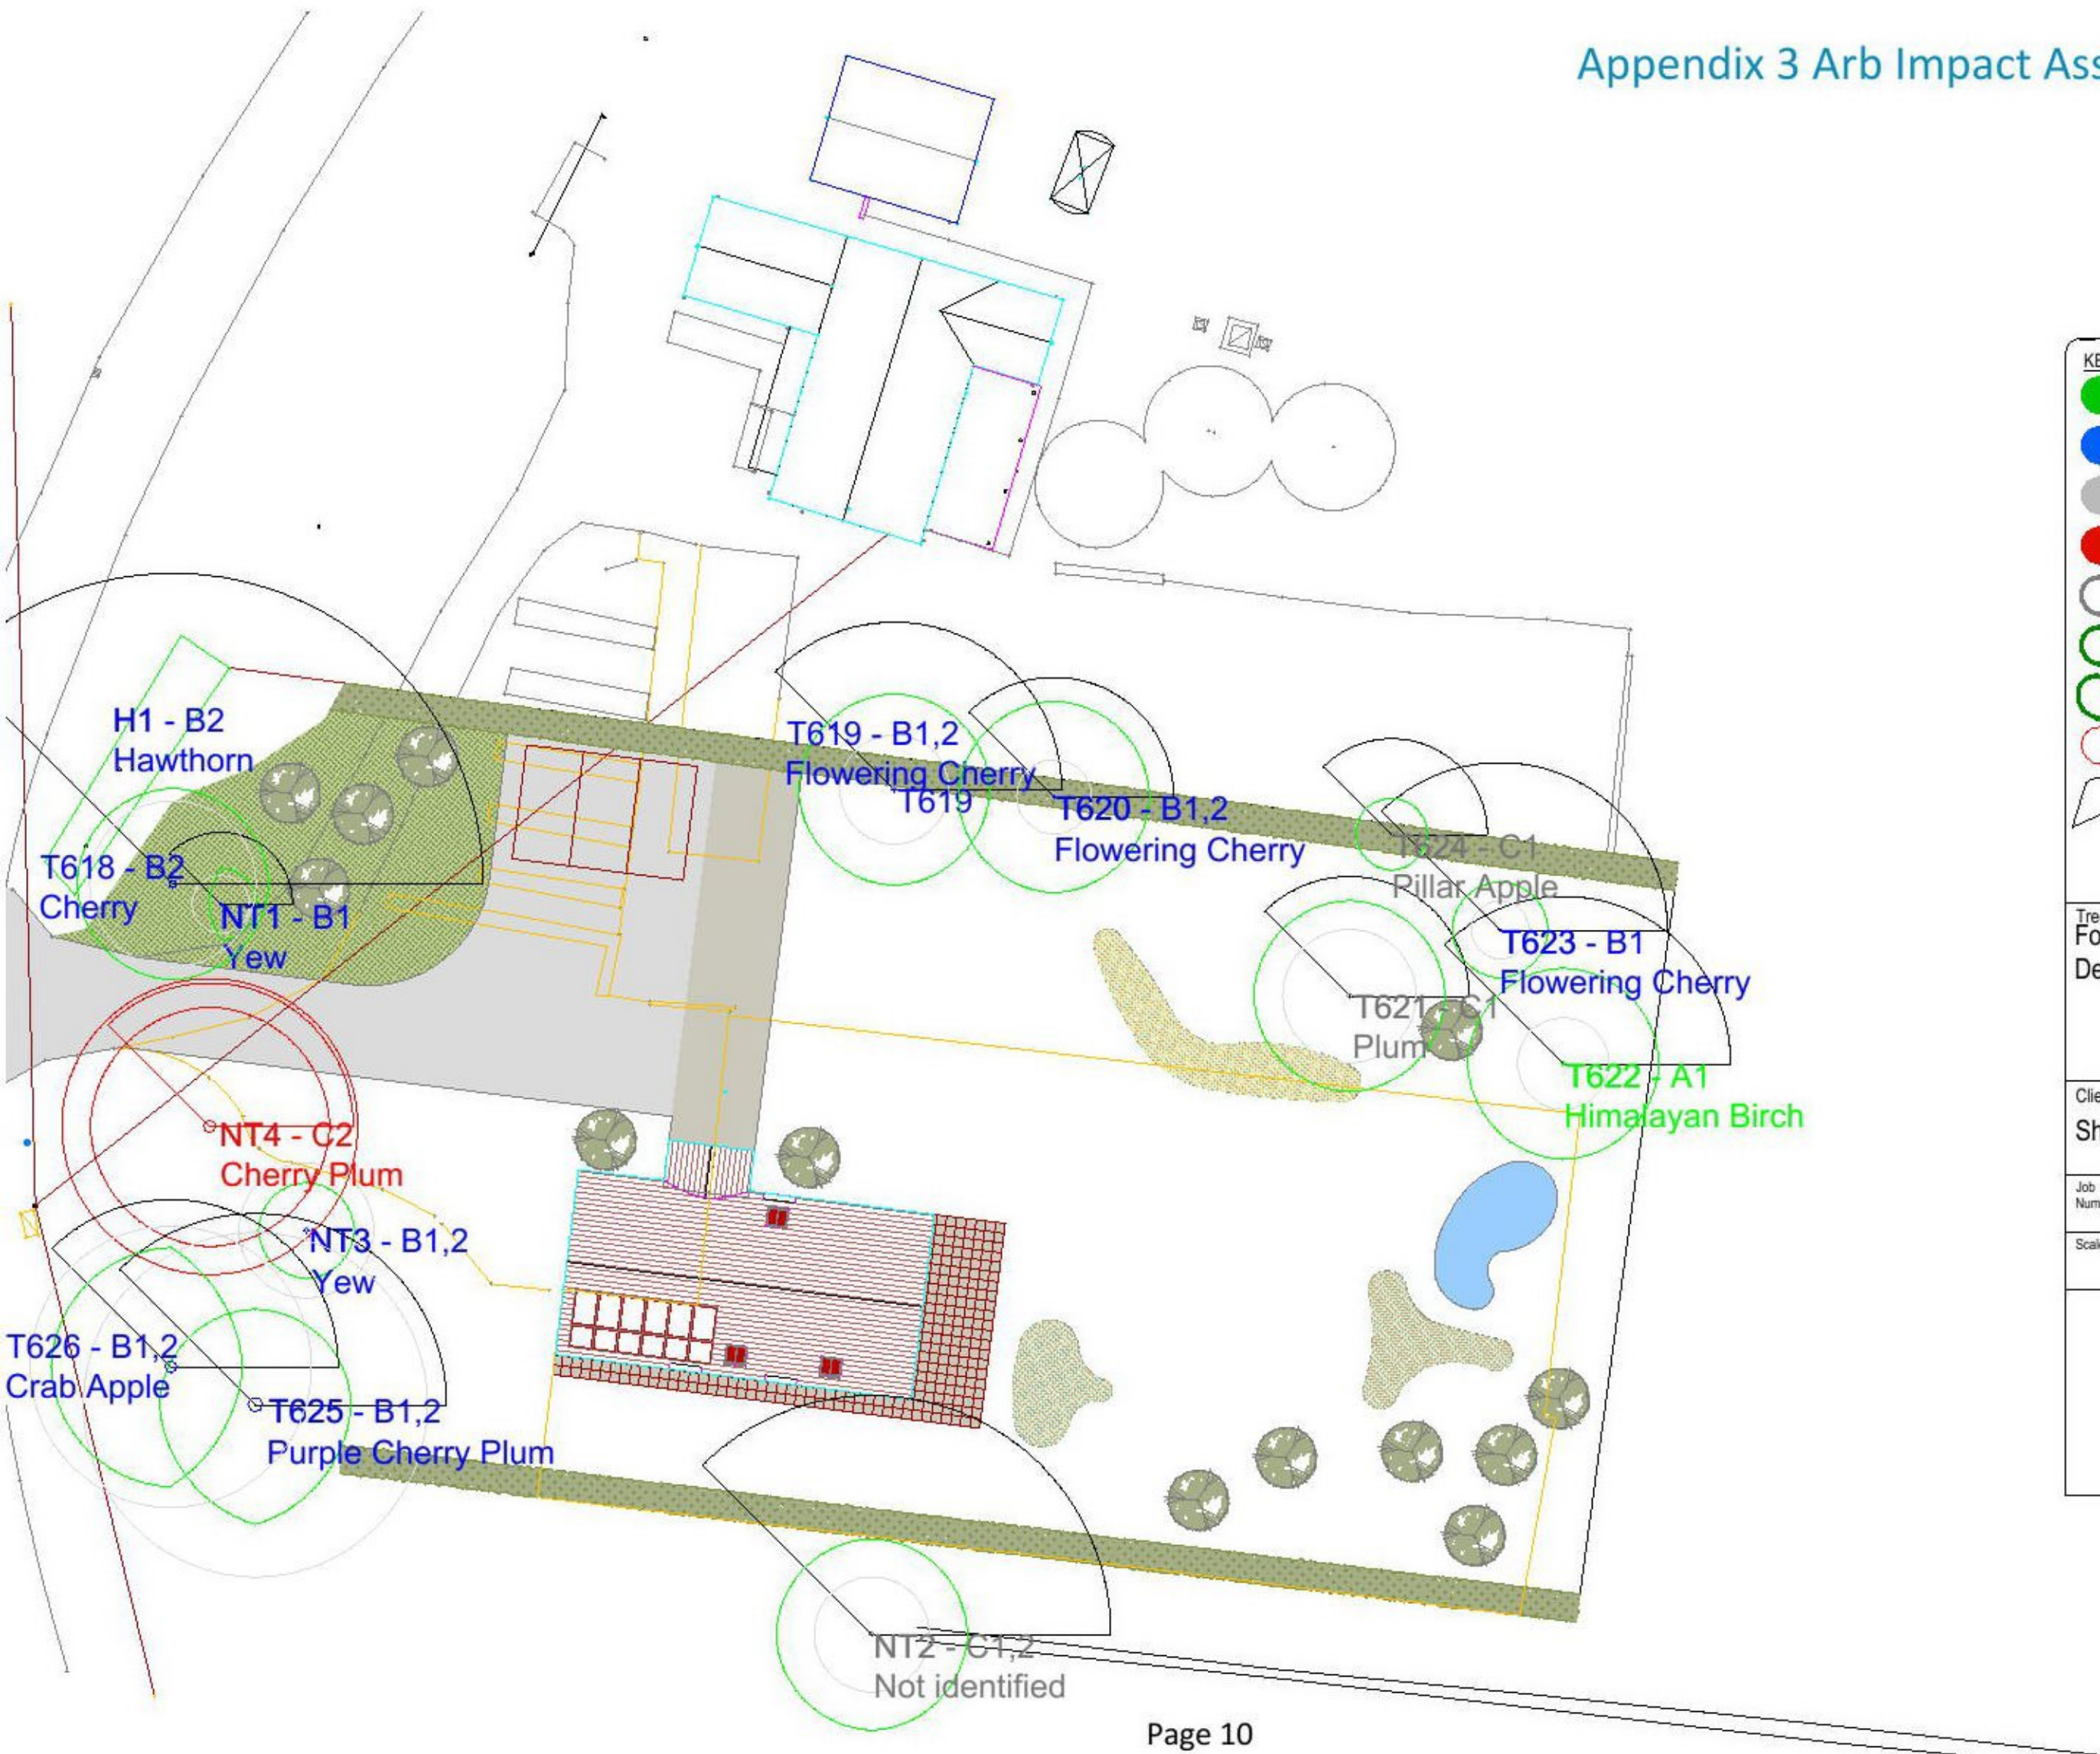
See Appendix 3 for the Impact Assessment plan.

1. Building footprints: are clear of all tree RPA's (Root Protection Area)
2. Access: the existing access will be unchanged.

ii. Tree crown structure – a lateral prune of T618 by 1m will provide necessary clearances for the construction phase.

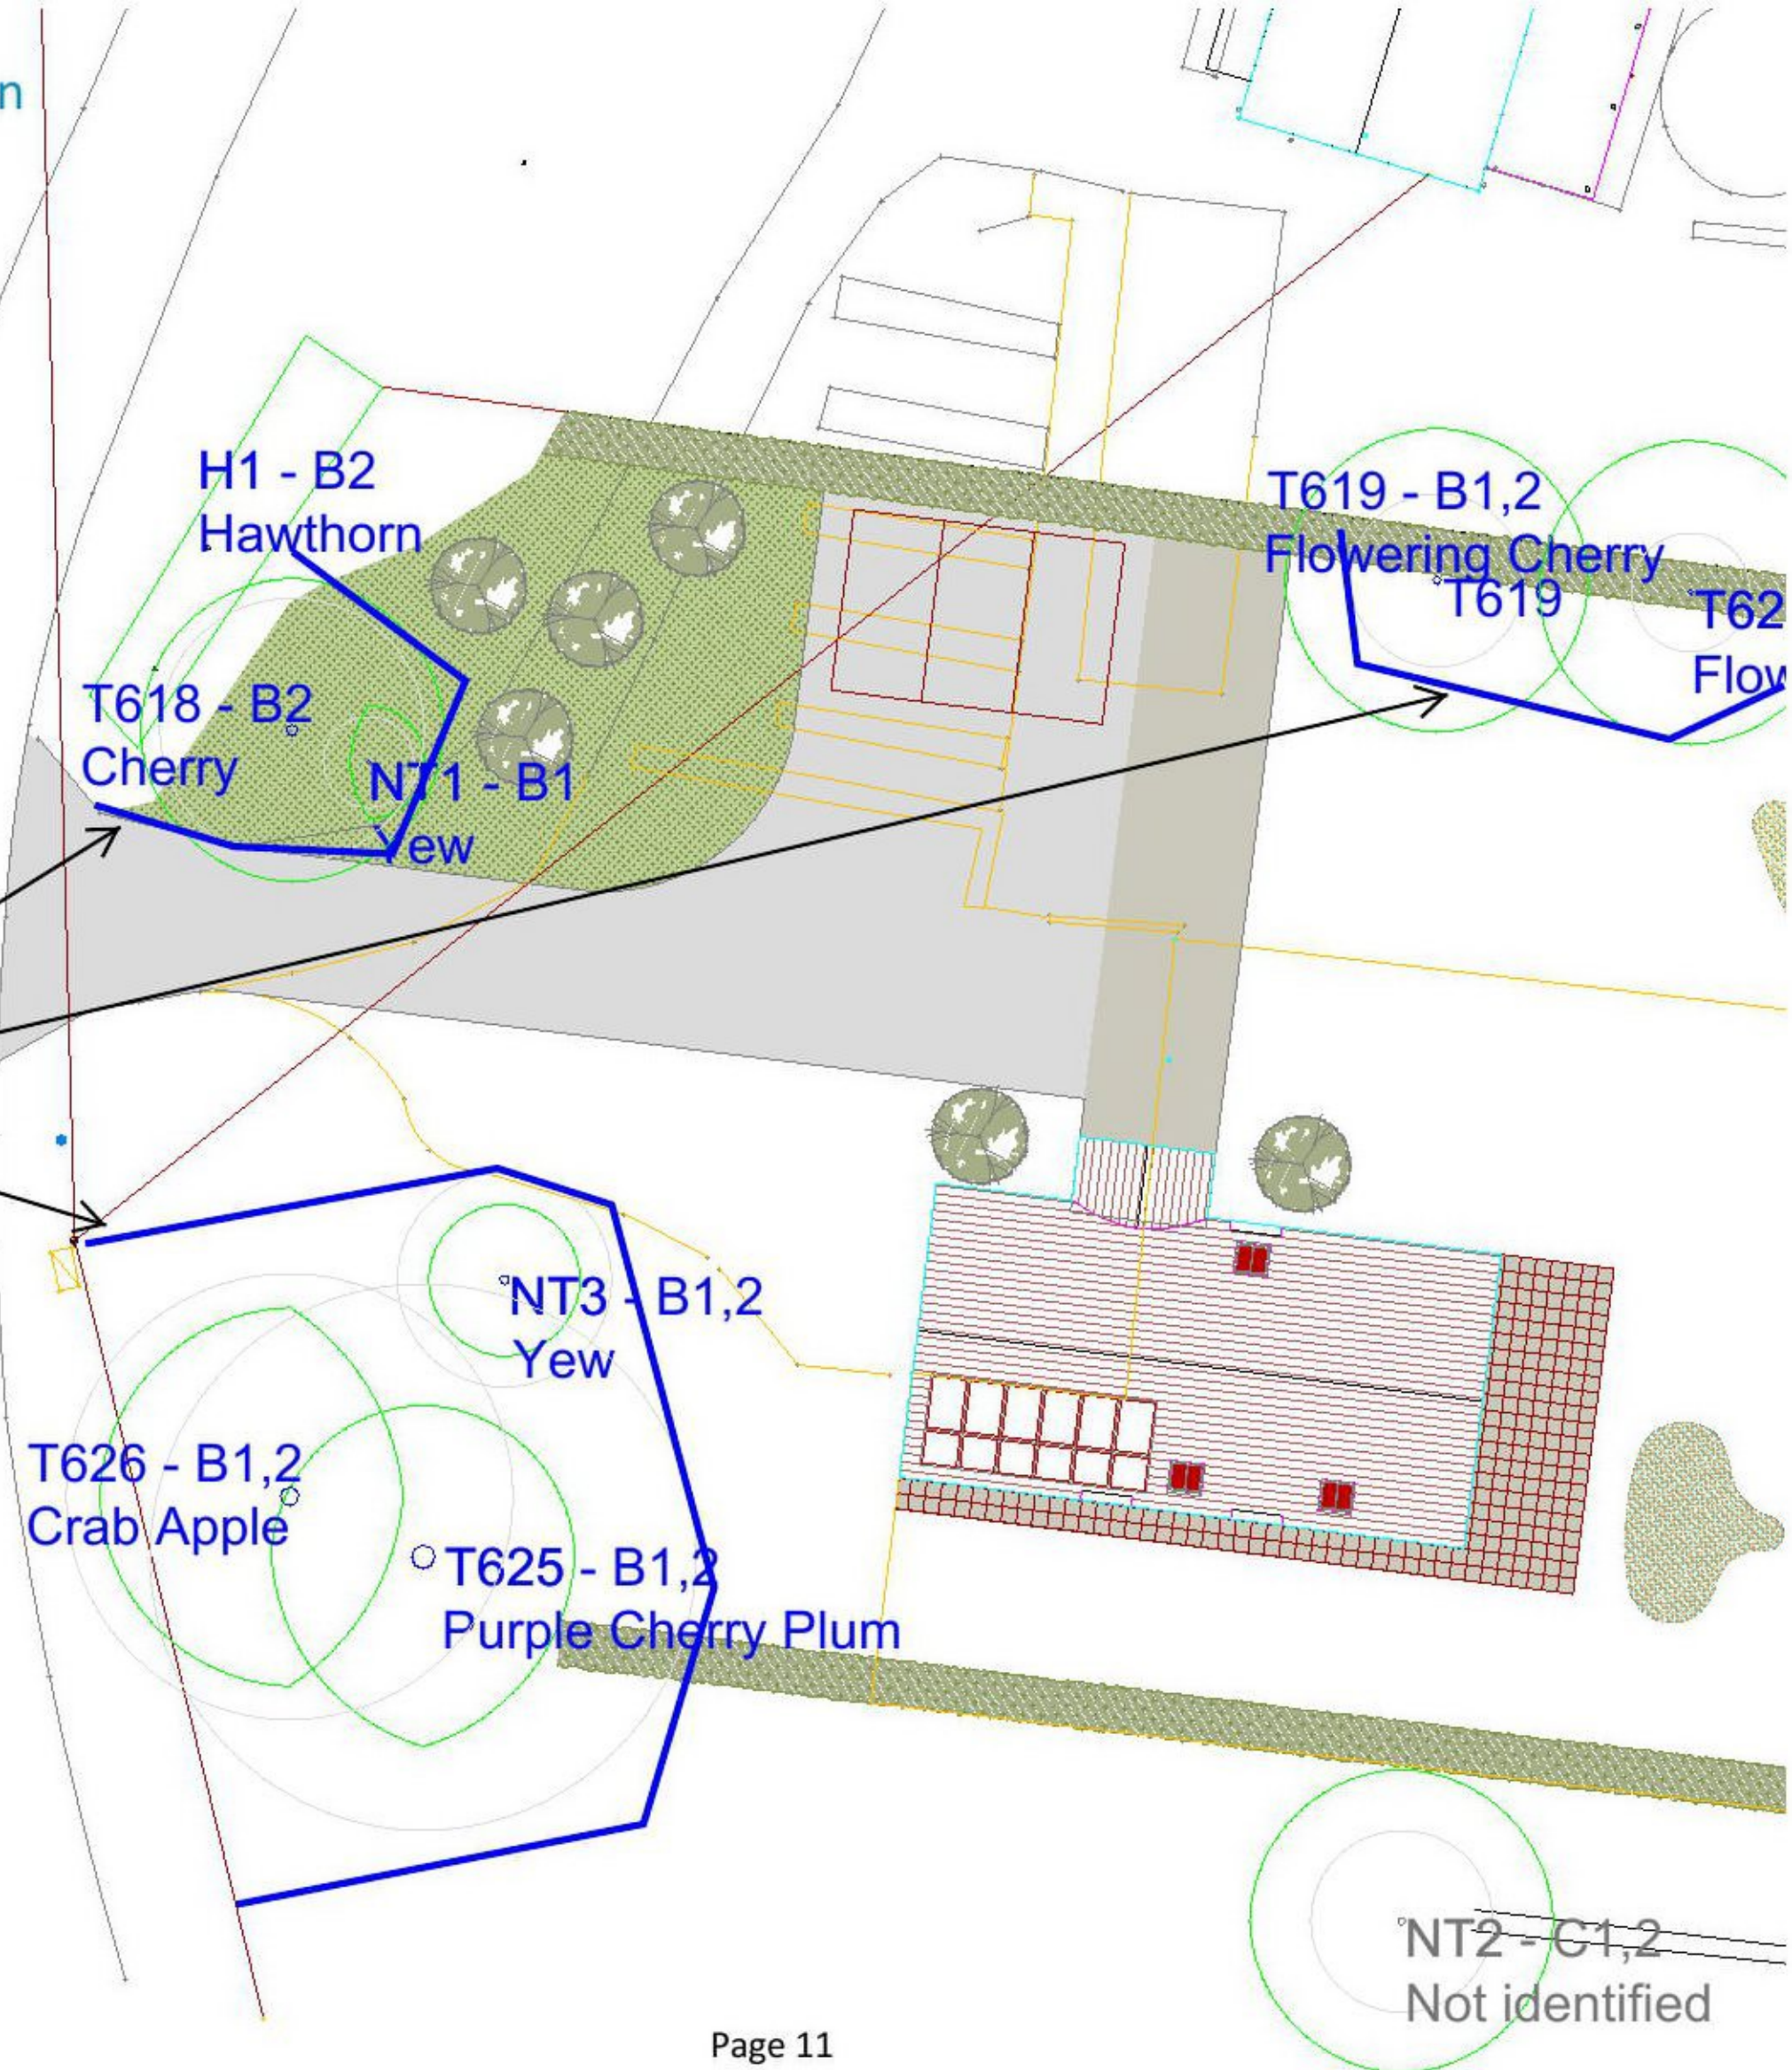
Appendix 4 Tree protection plan

Essentially, the RPAs of T618, T619, T620, T625 & NT3 are to be marked out on the ground to inform the fence runs as per the TPP as per the linear measurements identified in the survey data tables.

The fencing shall remain in place throughout construction and be removed only after completion of each phase.

The default specification as per figure 2 of BS 5837:2012 will be used (see Appendix 5) in order to minimise the risk of damage to roots.
