General Comments:

The shop front appears to date from 1999 when permission was granted by Sevenoaks District Council for the installation of a new shop front.

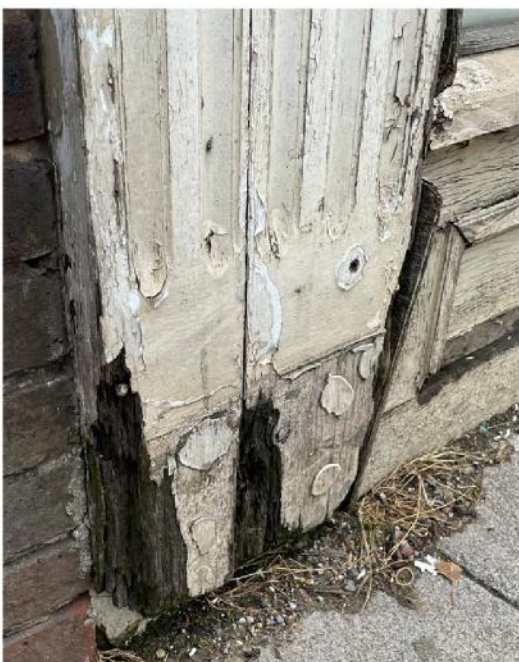
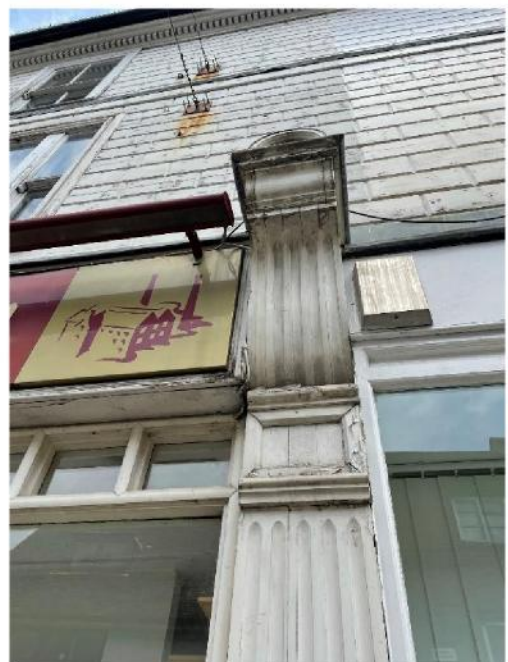
Right & left hand side timber pilasters & scroll type decorative corbels:

Timber decay is visible to varying degrees with failing paint finish and low level damage to pilasters. Main body of the pilaster and corbel appears fairly sound.

Anticipated works – Timber to be repaired where applicable with stabiliser & wood repair compound. Any bad timber that cant be treated/repared will be removed and new sections bonded with resin. Any new mouldings to match profile of existising. Would typically specify products from “Repair Care” Range.

Timber to be rubbed down and prepped for decoration with external grade paint. Colour to match existising.

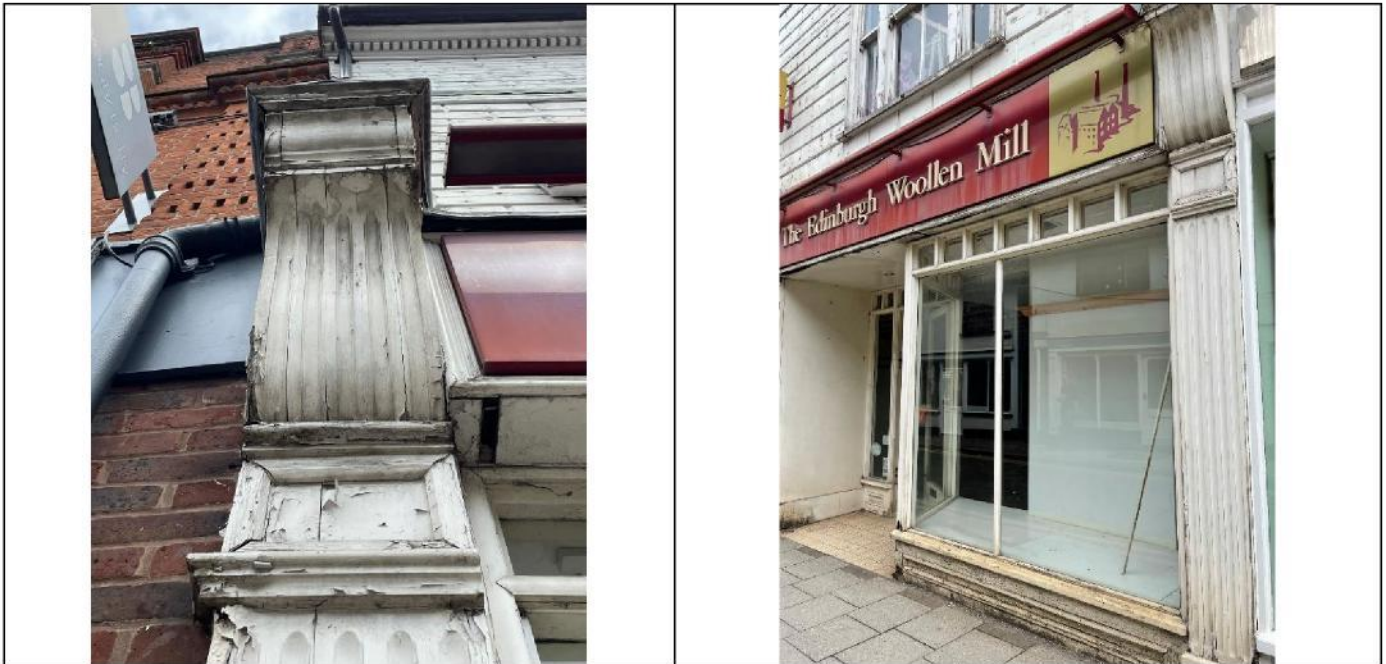
Shop front window mullions, transoms and stallriser/plinth:

Timber decay is visible to varying degrees with failing paint finish. Open joints have formed at timber junctions. To the left side of the left hand door opening significant decay has occurred to the stallriser and this section will require renewal. Mullions and transoms seem generally sound albeit thorough overhaul required

Anticipated works – Timber to be repaired where applicable with stabiliser & wood repair compound. Any bad timber that cant be treated/repared will be removed and new sections bonded with resin. Any new mouldings to match profile of existing. Would typically specify products from “Repair Care” Range.

Timber to be rubbed down and prepped for decoration with external grade paint. Colour to match existing.

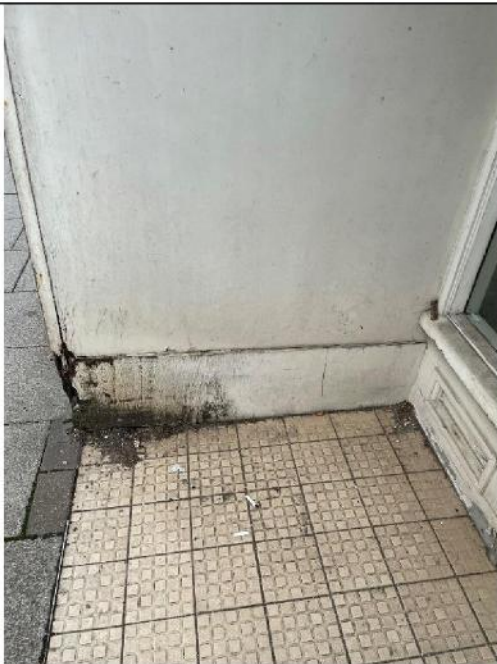
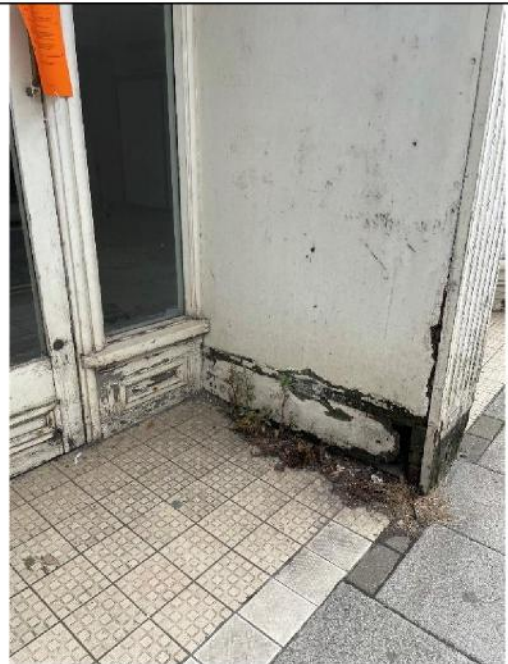
Central doorway divider:

The timber boarding is generally sound apart from low level which is heavily decayed. This appears to be a separate section and straight forward to renew.

Anticipated works – Timber to be repaired where applicable with stabiliser & wood repair compound. Any bad timber that cant be treated/repared will be removed and new sections bonded with resin. Any new mouldings to match profile of exisiting. Would typically specify products from “Repair Care” Range.

Timber to be rubbed down and prepped for decoration with external grade paint. Colour to match exisiting.
