# MORTAR ANALYSIS REPORT

140 West George  
Street, Glasgow

Sample 1

Ashlar bedding/pointing mortar

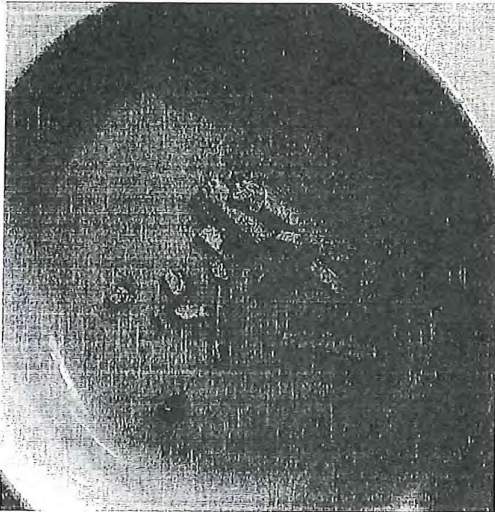
Plate 1. The sample as received. Dish is c160mm diameter.

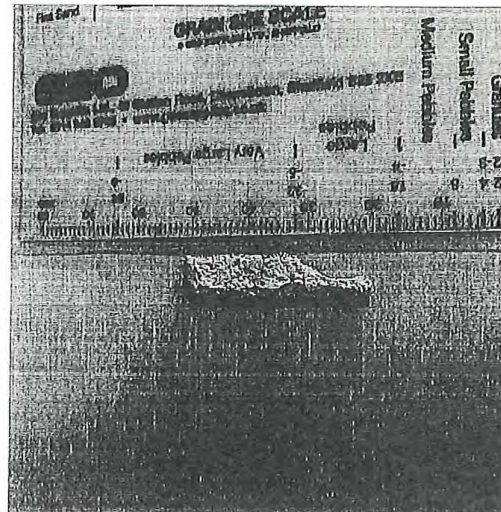
Plate 2. A freshly broken face of the sample. The sample was fragmented upon receipt in the laboratory, common with ashlar joints. Scale is in mm.

PROCEDURE	OBSERVATIONS
PRELIMINARY VISUAL ANALYSIS OF SAMPLE	The sample was received as fully carbonated intact pieces of mortar plus fines. Fines consisted of aggregate grains and silt. The sample is weak, friable and easily disrupted. The total sample weighed 9.42g and the largest intact piece measured = 64.35mm x 9.89mm x 4.28mm
EXAMINATION OF PREPARED SAMPLE BY BINOCULAR MICROSCOPE (X40 MAGNIFICATION)	Once dried the mortar was found to be 10YR 8/1 'white' when assessed against the Munsell Soil Colour Charts. The sample was very disaggregated upon receipt but some aggregate was visible in the small intact pieces. The aggregate appears to consist of fine to medium grained, angular to sub-angular buff/clear/cloudy quartz.
