140 West George Street, Glasgow – 12/05/19

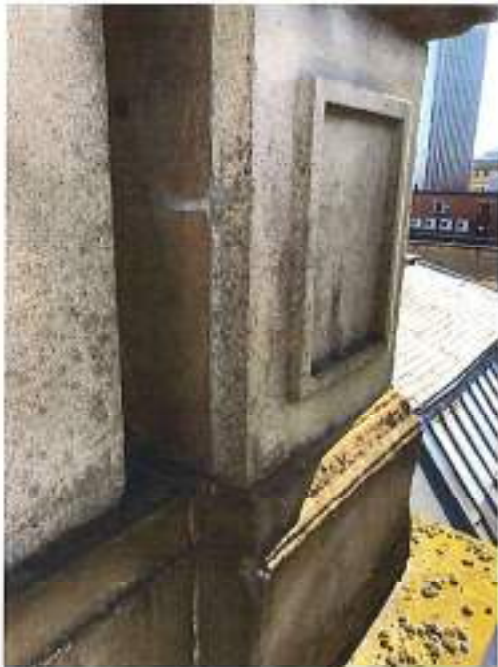
Fig 47: Part replacement with concrete

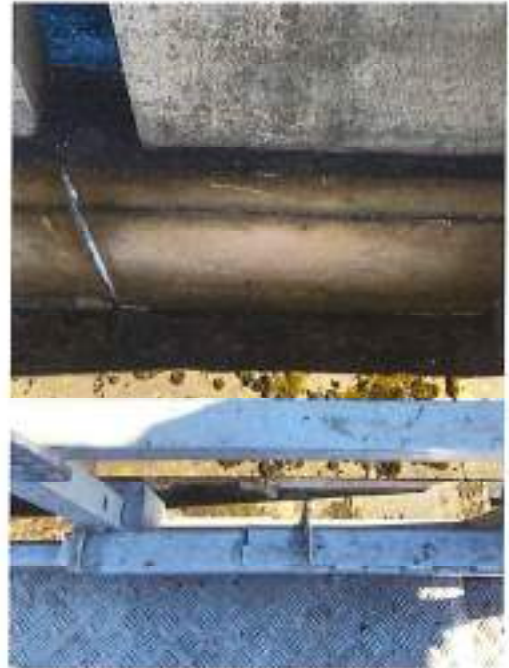
Fig 50: Algae/moss on eaves stringer

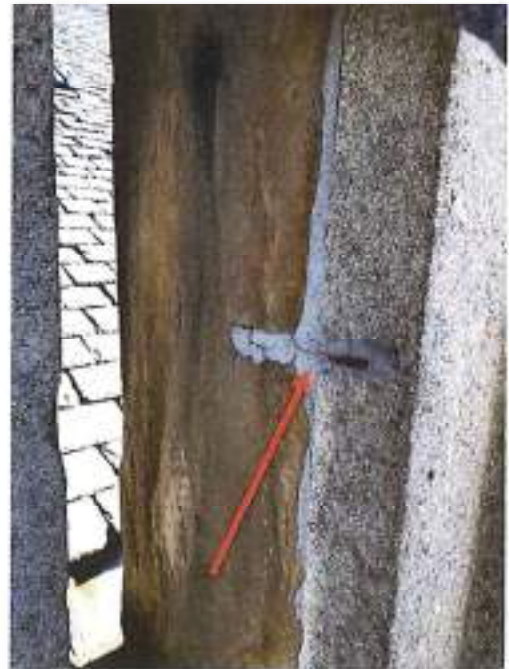
Fig 52: Corroded dowel in part concrete replacement

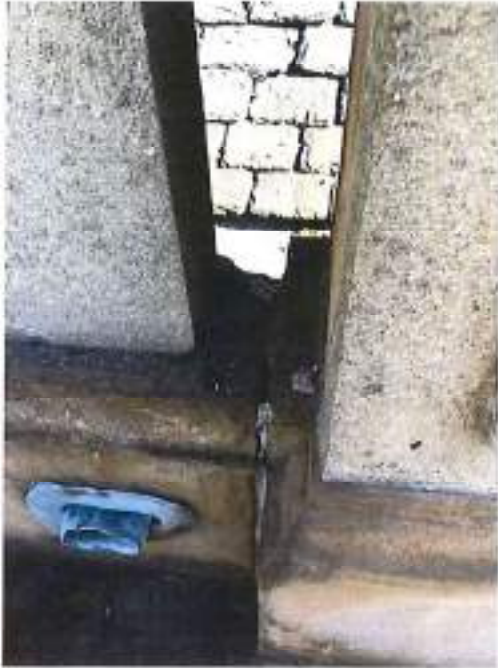
Fig 53: Open joints in parapet plinth course

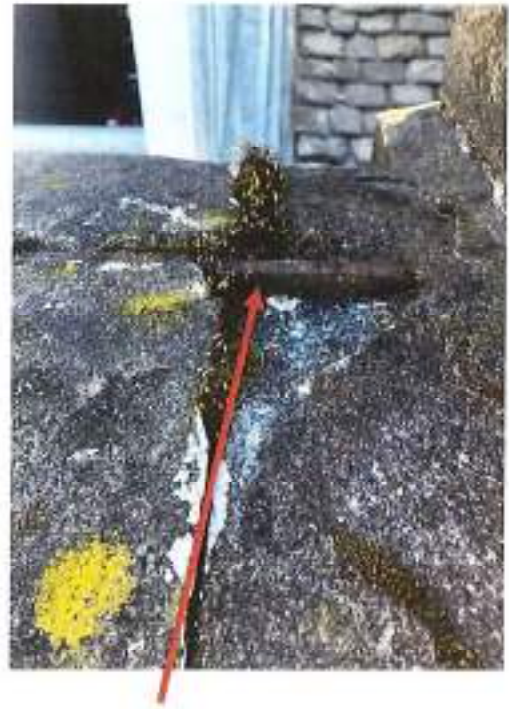
Fig 54: Corroded cramps in parapet copes

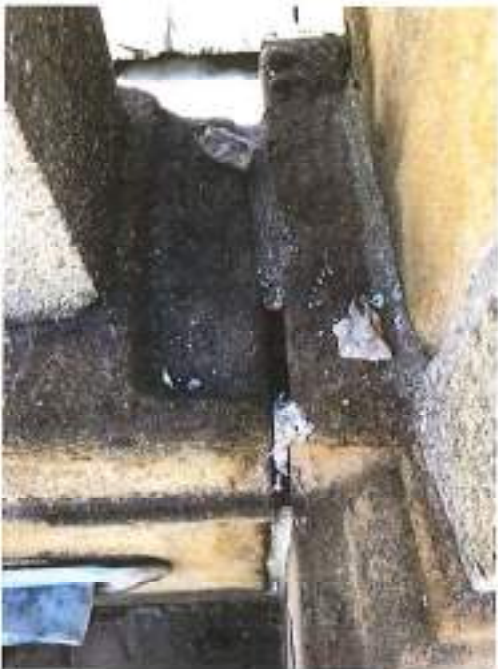
Fig 55: Open joints in parapet plinth course

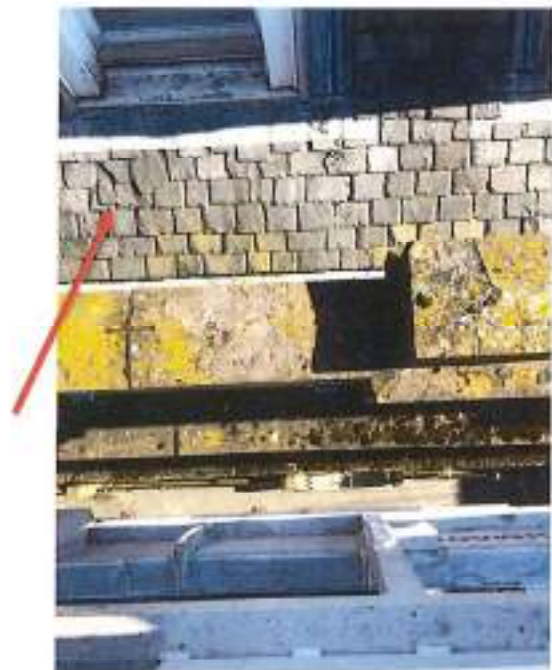
Fig 56: Slipped/moved slates

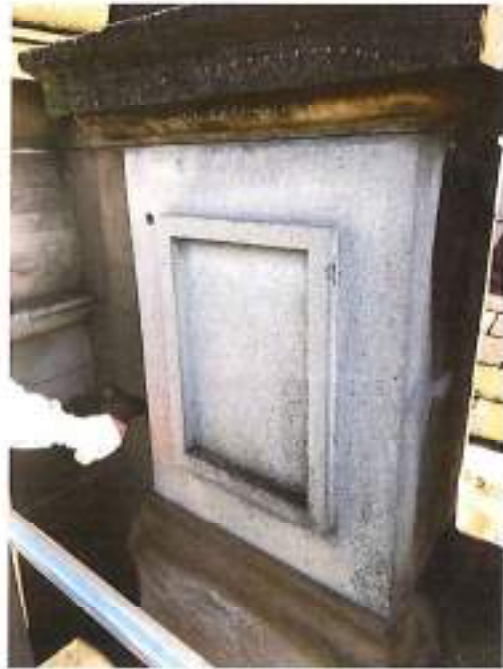
Fig 60: Part replacement with concrete

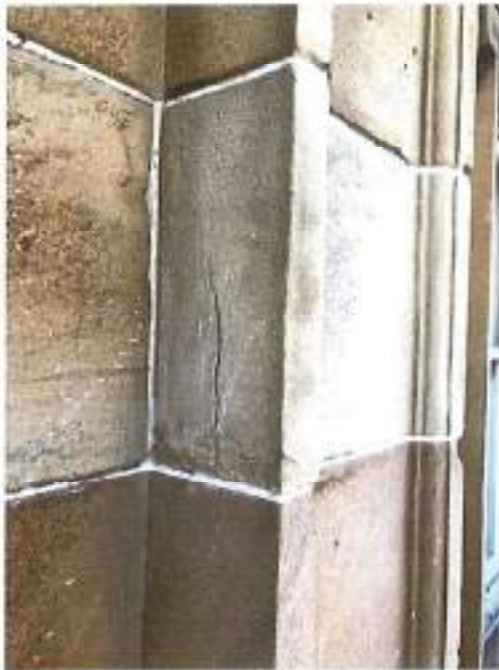
Fig 69: Small fissure

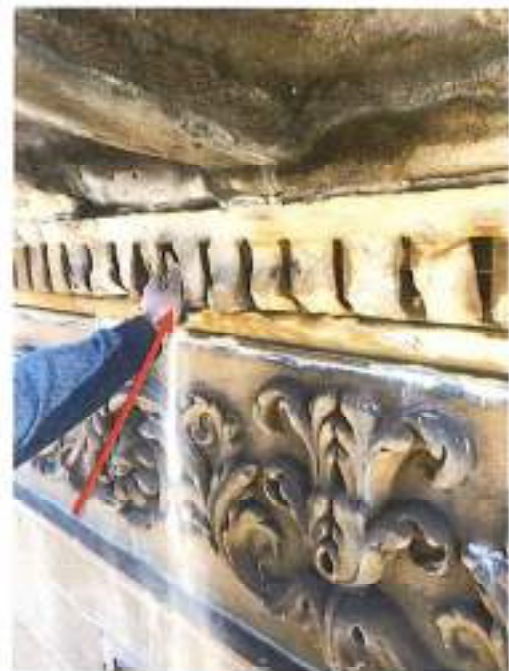
Fig 79: Friable dentil blocks (4th floor projecting cornice)

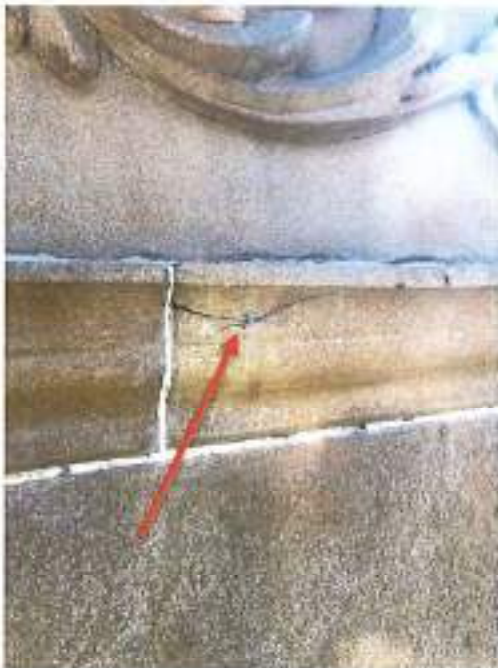
Fig 87: Cracking caused by bird deterrent fixings 3rd floor stringer

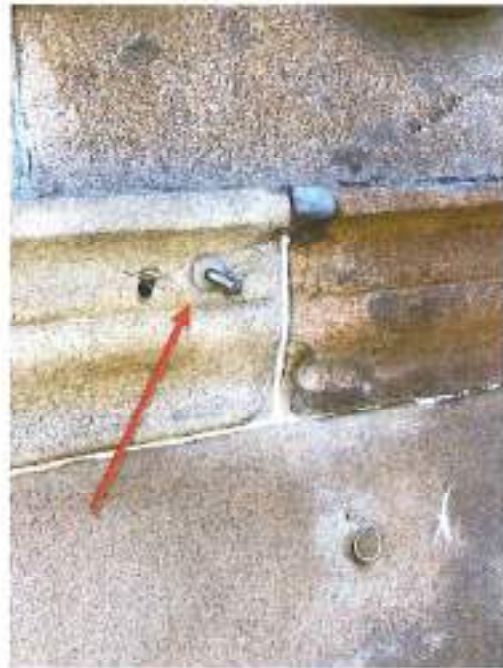
Fig 88: As per Fig 87

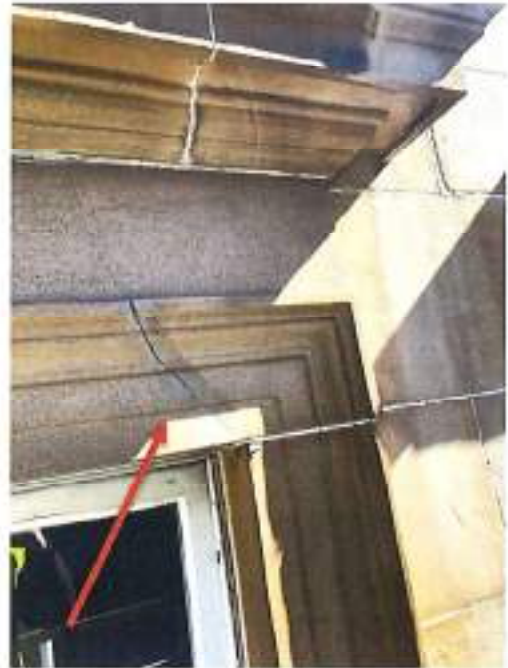
Fig 94: Cracked lintel 2nd floor level

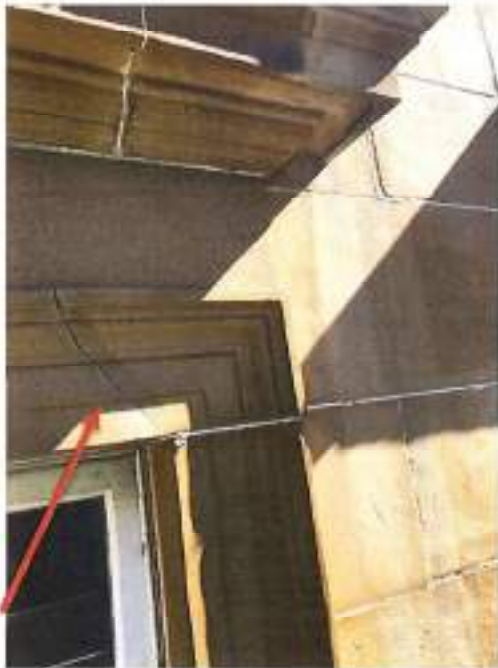
Fig 95: Cracked lintel 2nd floor level

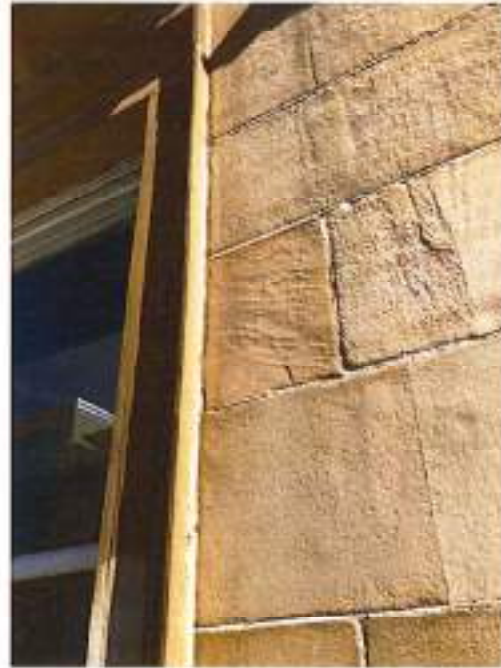
Fig 96: 2nd floor pointing required

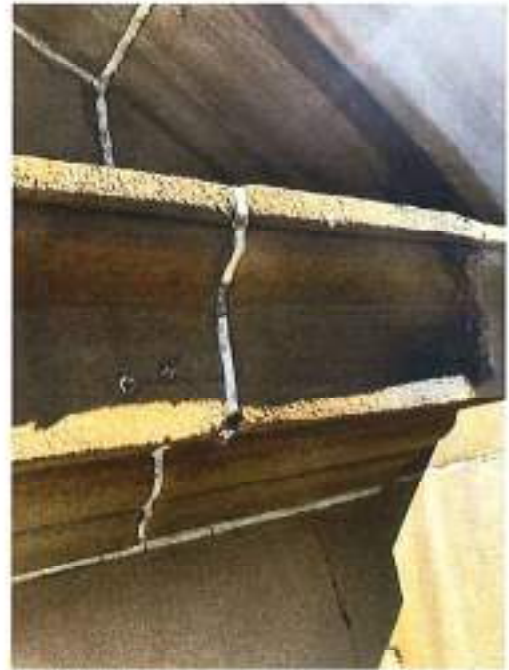
Fig 98: 2nd floor hood pointing required

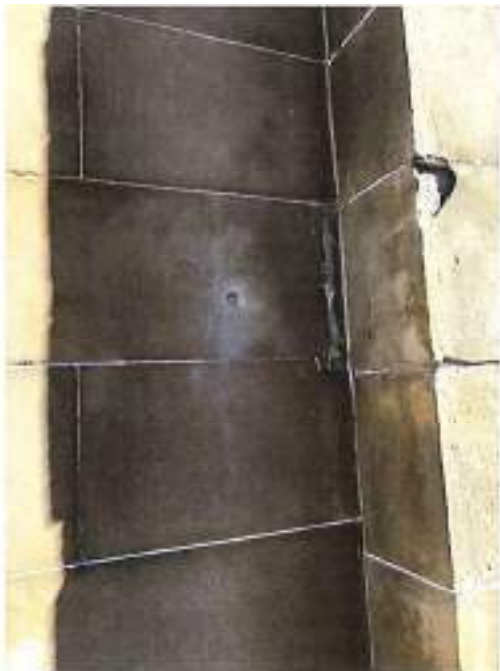
Fig 99: Area of spalling repairs 2nd floor

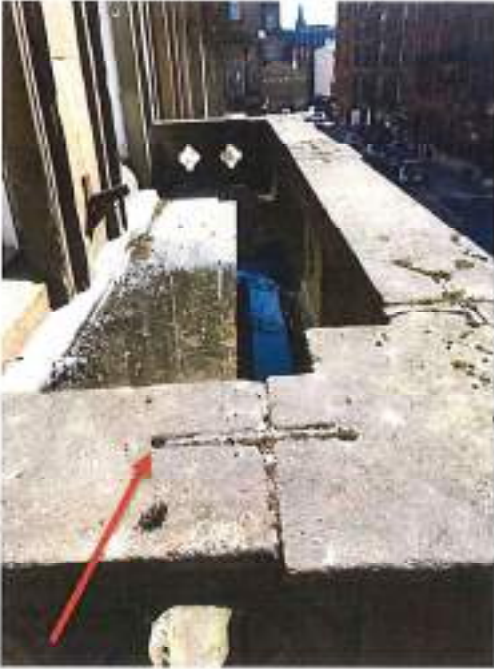
Fig 105: Corroded cramps parapet cope (Portico)

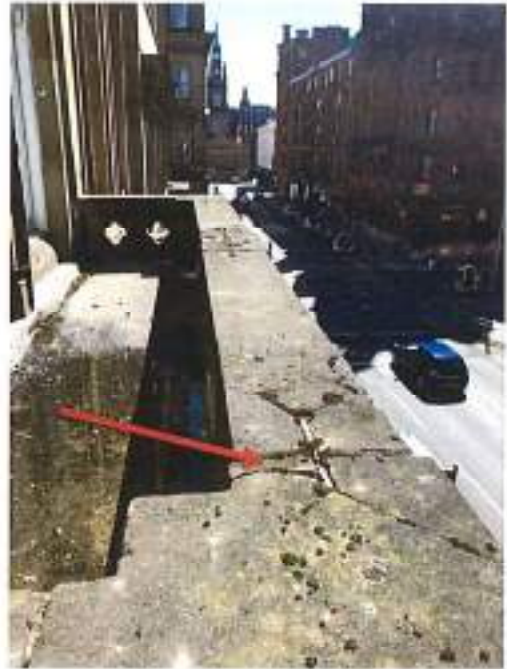
Fig 106: Corroded cramps parapet cope (Portico)

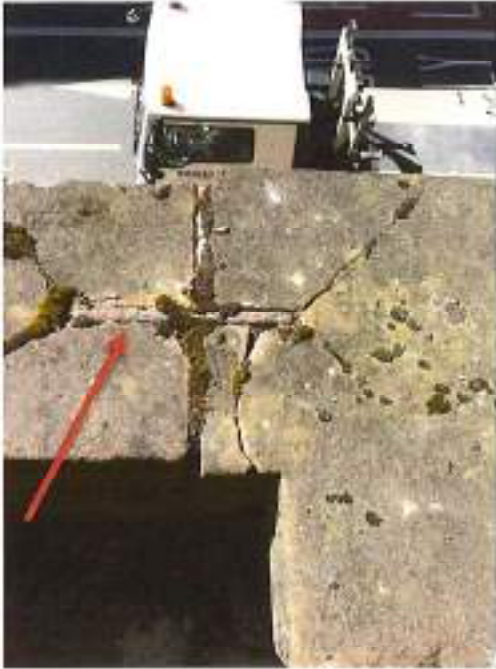
Fig 109: Corroded cramps parapet cope (Portico)

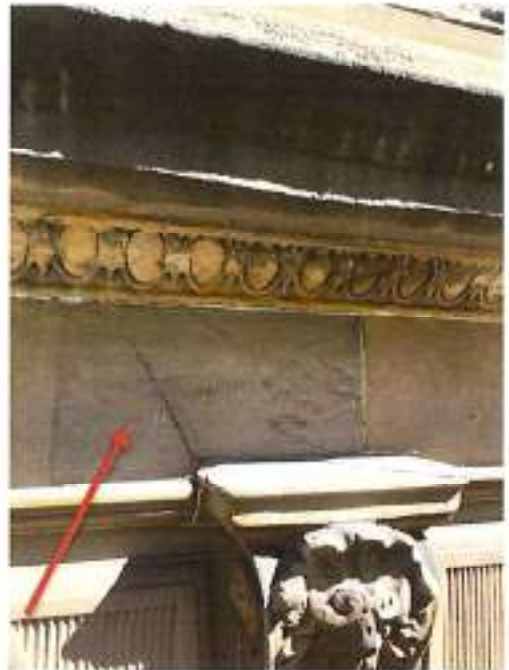
Fig 114: Crack ground floor level

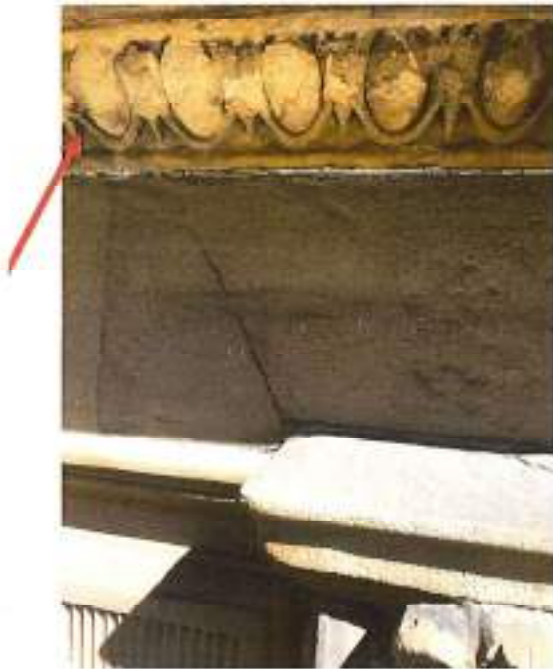
Fig 115: Egg & dart mould GL friable

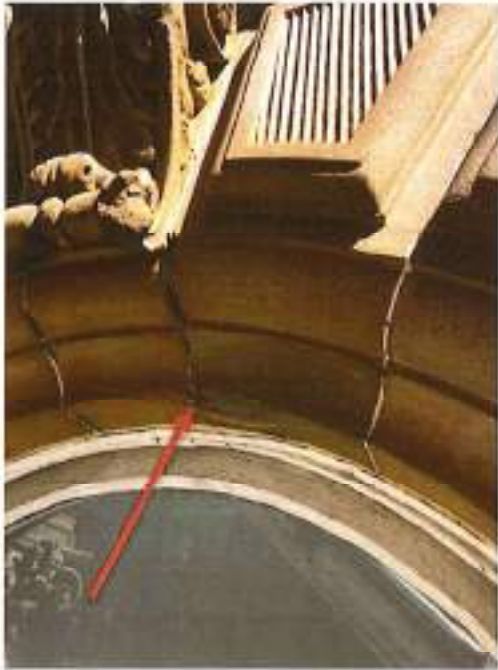
Fig 117: Ground floor window detail. (Spalling)

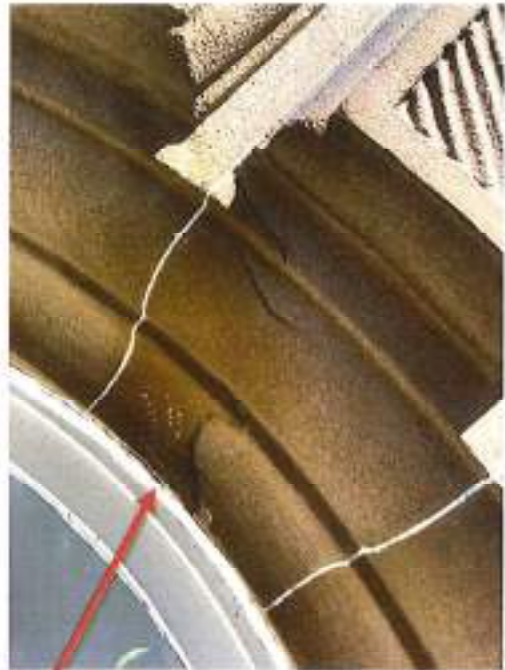
Fig 118: Ground floor window detail. (Spalling)

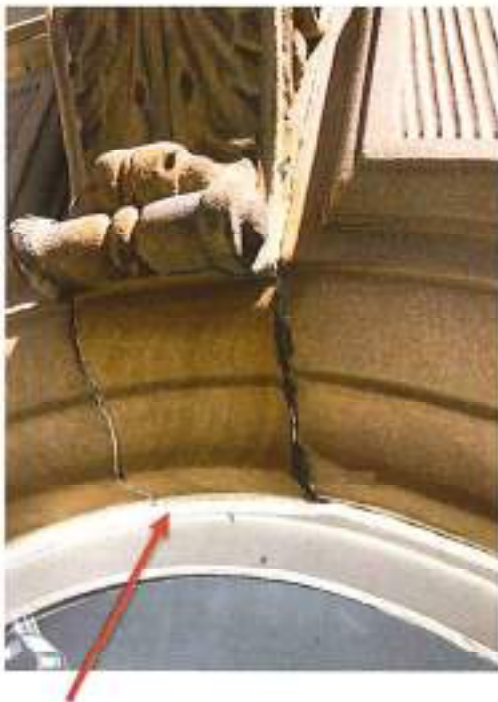
Fig 119: Movement to centre arch detail (Keystone)

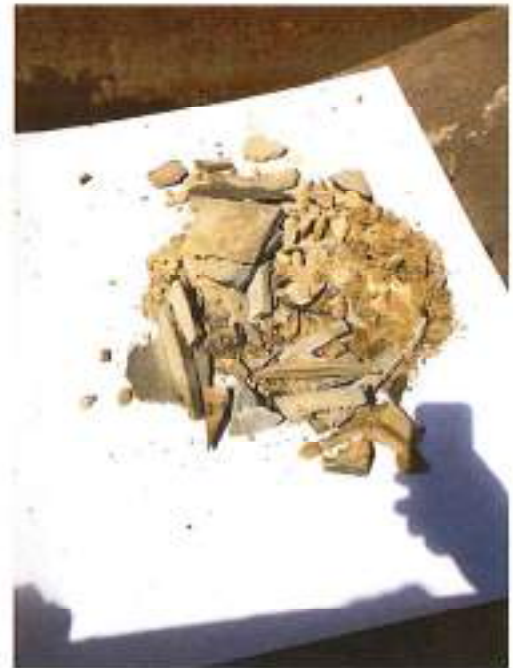
Fig 124: Debris removed during survey 16kg in weight
