Tree Safety Inspection Report

St Mary's Church, Lasham, GU34 5SG

18th September 2021

MDA reference P83

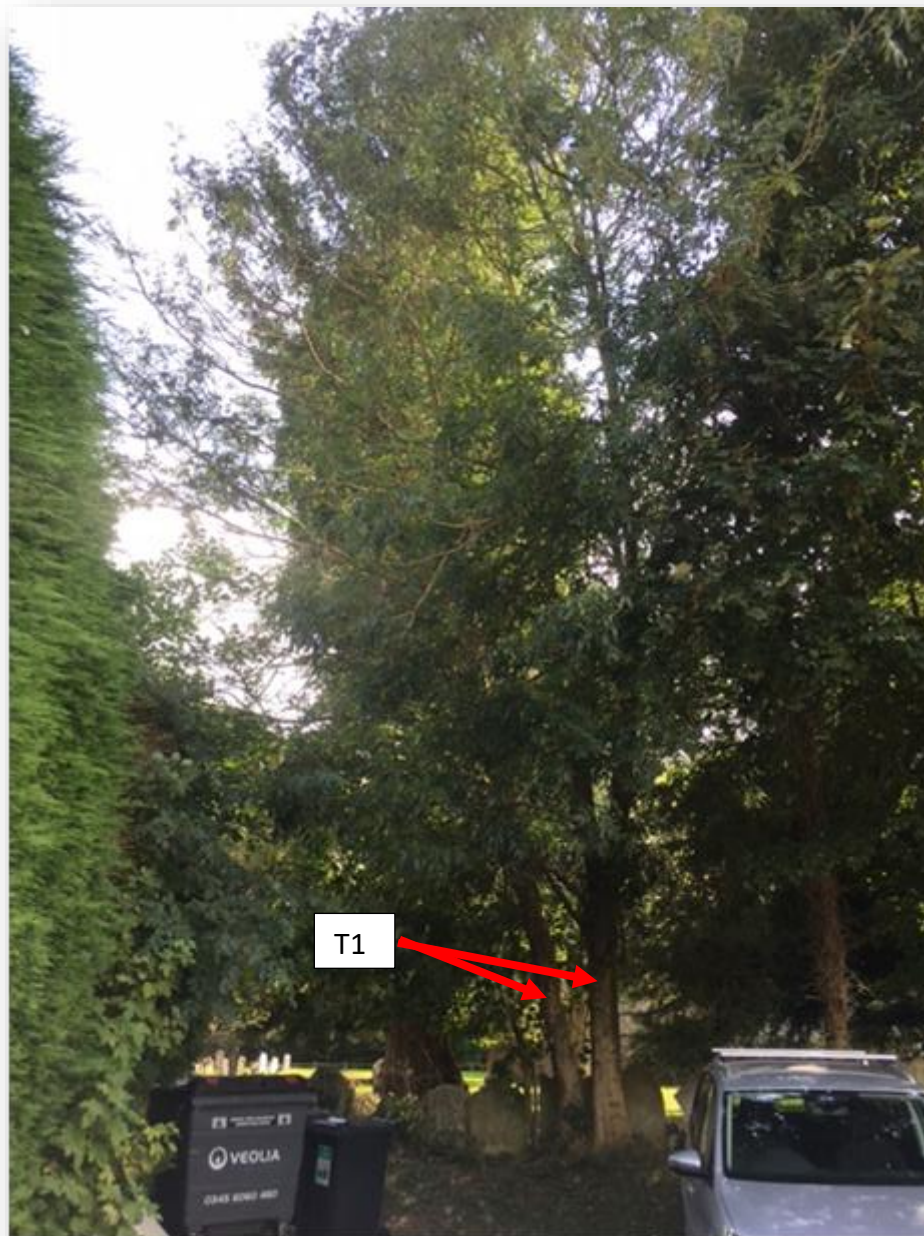
2.5 T1 (Ash) is on the boundary with the Royal Oak pub and is actually two separate trees, but they are effectively a single tree as they grow so close together. Both are infected with ash dieback and are within falling distance of the car park and adjacent property (Figure 1). It is recommended that they are both felled within 12 months.

Figure 1. T1 two Ash stems to be felled.

Tree No.	Common Name	Height (m)	Stem Dia. (mm)	Crown Radius (m)	Maturity	Condition	Comments	Tree Works	Priority
T1	Ash	18.6	320 & 250	14	Semi Mature	Poor	Co-dominant stemmed ash. Eastern stem showing medium infection of Ash Dieback Disease (<i>Hymenoscyphus fraxineus</i>). Western showing low/early signs of infection. Target includes pub car park and adjacent private dwelling. Weak union between stems. Large tear out wound on western stem at 4m.	Fell both stems	3
T2	Lawson Cypress	19.5	880	10	Mature	Fair	Deadwood at 7m on northern side; Minor deadwood approx. 5% of crown; Knock test sounding solid at base.	Remove deadwood and Reinspect within 24 months	4
T3	Beech	17.8	480	10	Semi Mature	Normal	Recent changing of levels observed around the base of the tree, and indications of soil compaction noted. Continue to monitor condition for signs of stress and prevent further changing of levels	Reinspect within 24 months	4

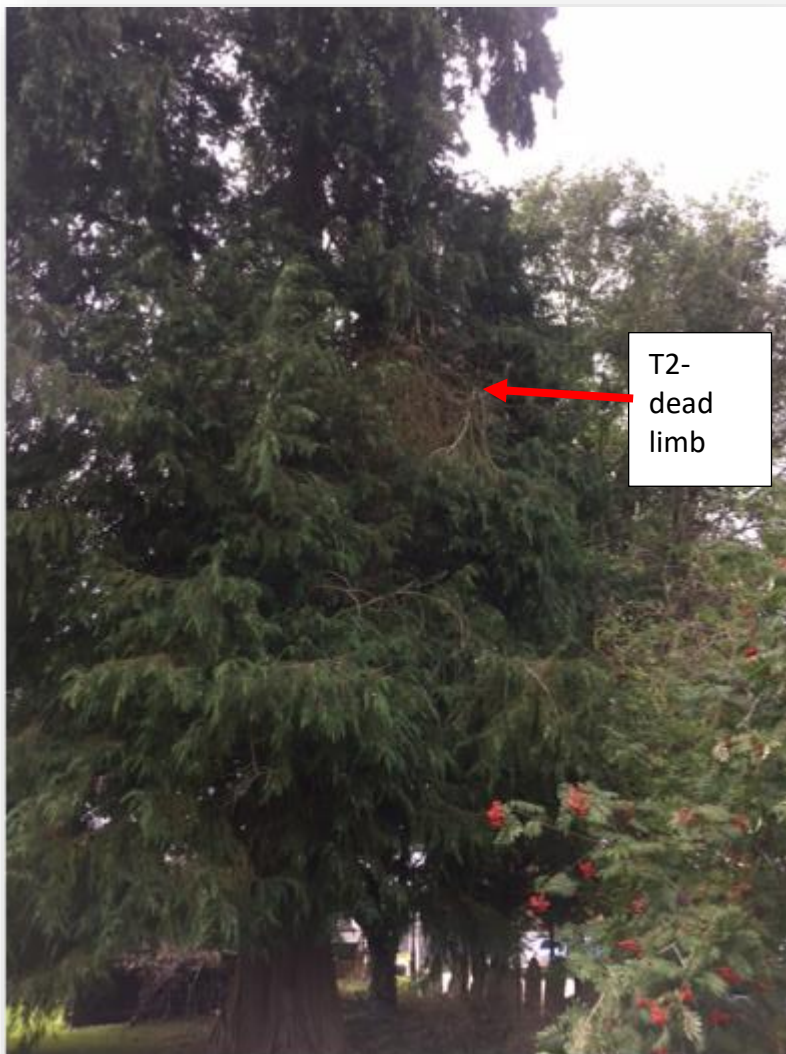
2.6 T2 (Lawson cypress) is in overall fair condition, though a dead limb on the northern side of the canopy should be pruned out (Figure 2): to remove potential hazard, aid further investigation and assist ongoing monitoring of condition. Follow up inspection should be undertaken within 24 months.

Figure 2. T2 Lawson Cypress – remove dead limb.

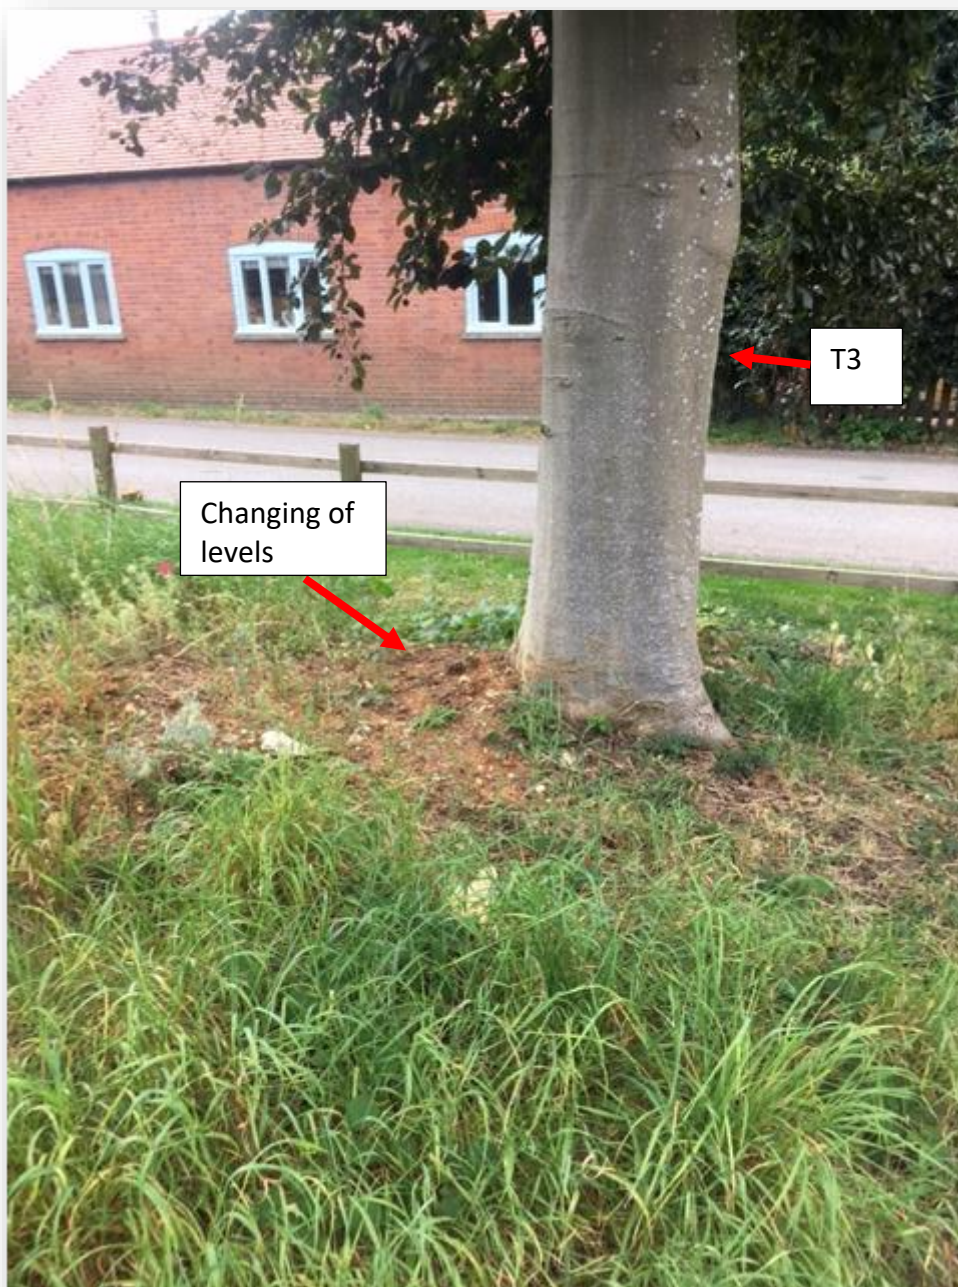
2.7 T3 (Beech) is in normal condition but I observed evidence of recent changes of soil around the base of the trunk, and that this was compacted (Figure 3). No further levels changes should take place (either adding or removing soil) as the roots of Beech are very sensitive to changes in their rooting environment. The condition of the tree should be monitored for signs of stress which may be a consequence of changing of levels or soil compaction. Remedial works may be required in future to address this, but no further action is required at this time.

Figure 3. T3 (Beech) - note disturbed soil around base. Monitor condition of tree.

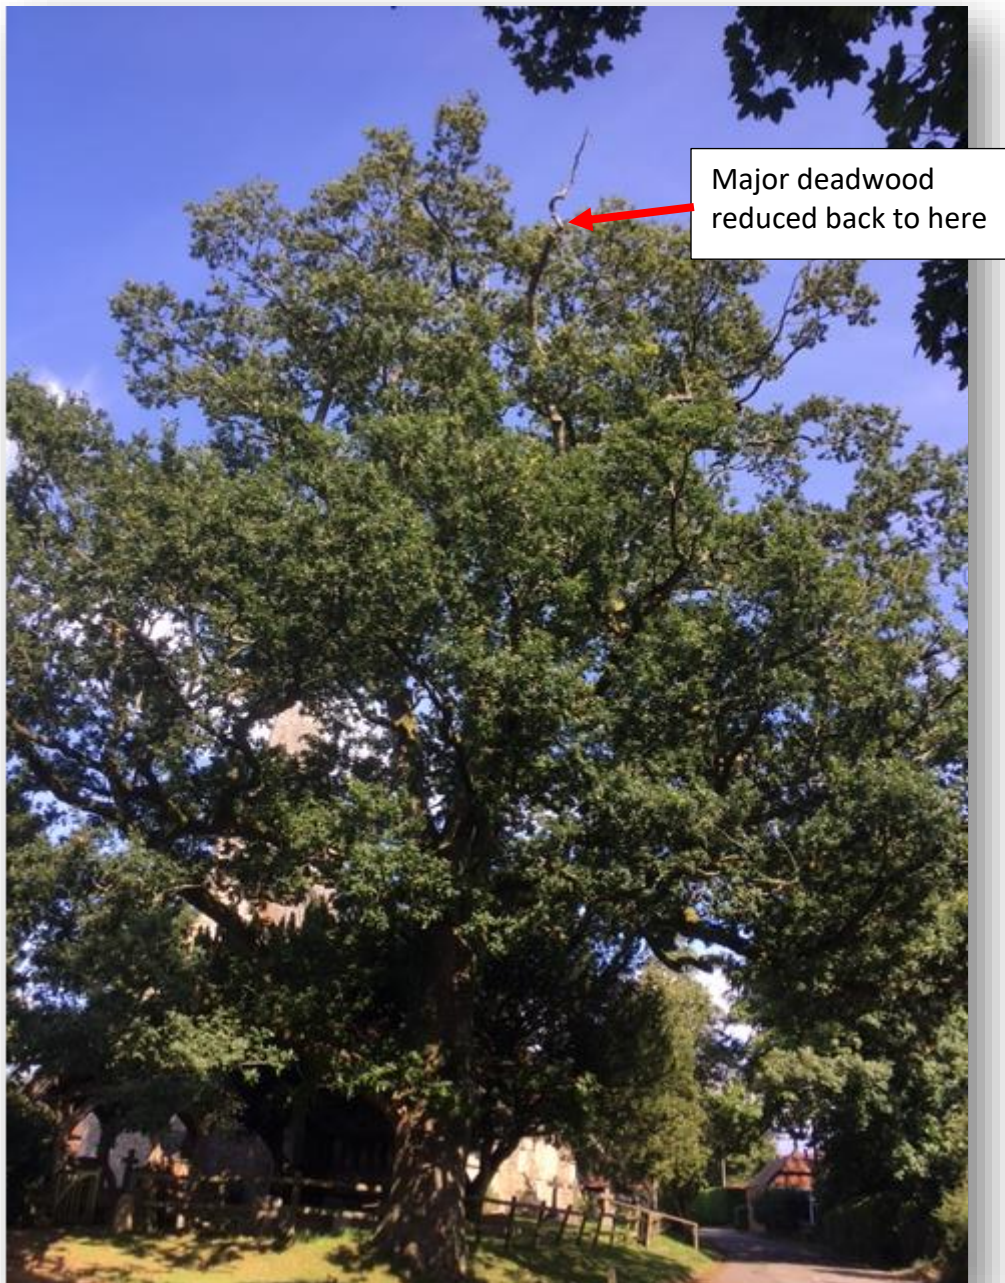
- 2.8 T4 (Oak) a fine veteran tree which is highly significant in the location for amenity, sense of place and biodiversity. It has evidence of former pruning wounds and there is significant dead wood in the canopy. Major dead wood (branches > 50mm diameter) or damaged branches should be removed where they present a hazard to users of the road and path into the church (e.g. Figures 4 – 6).

Figure 4. T4 (Oak) – major dead wood to be removed.

T4	Oak	26.3	1270	23	Veteran	Fair	Knock Test solid around base; Major deadwood at approx. 20m over junction; multiple former pruning wounds on southern side of canopy- not occluding well but do not present hazard at present. Mechanical damage to limb at 5m over junction from repeated vehicle strikes, and minor deadwood on same limb; Major deadwood on northern side at approx. 5m over path to lychgate	Remove/reduce major deadwood and remove limb over junction	3

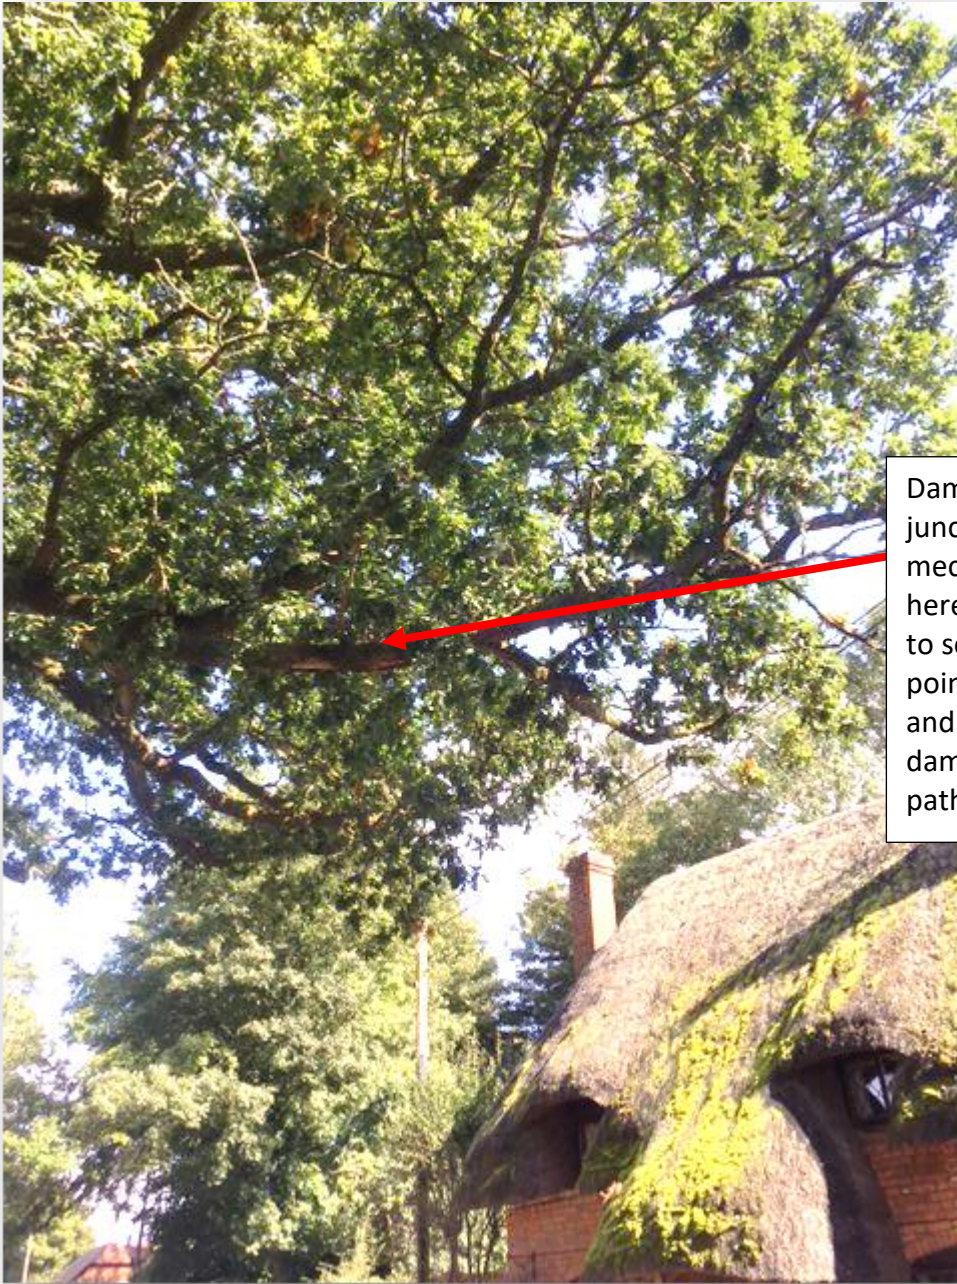
Figure 5. T4 – Damaged branch over junction with Church Lane to be removed.

Damaged limb over junction (note mechanical damage here): reduce limb back to secondary branching point to remove hazard and prevent further damage allowing pathogen attack

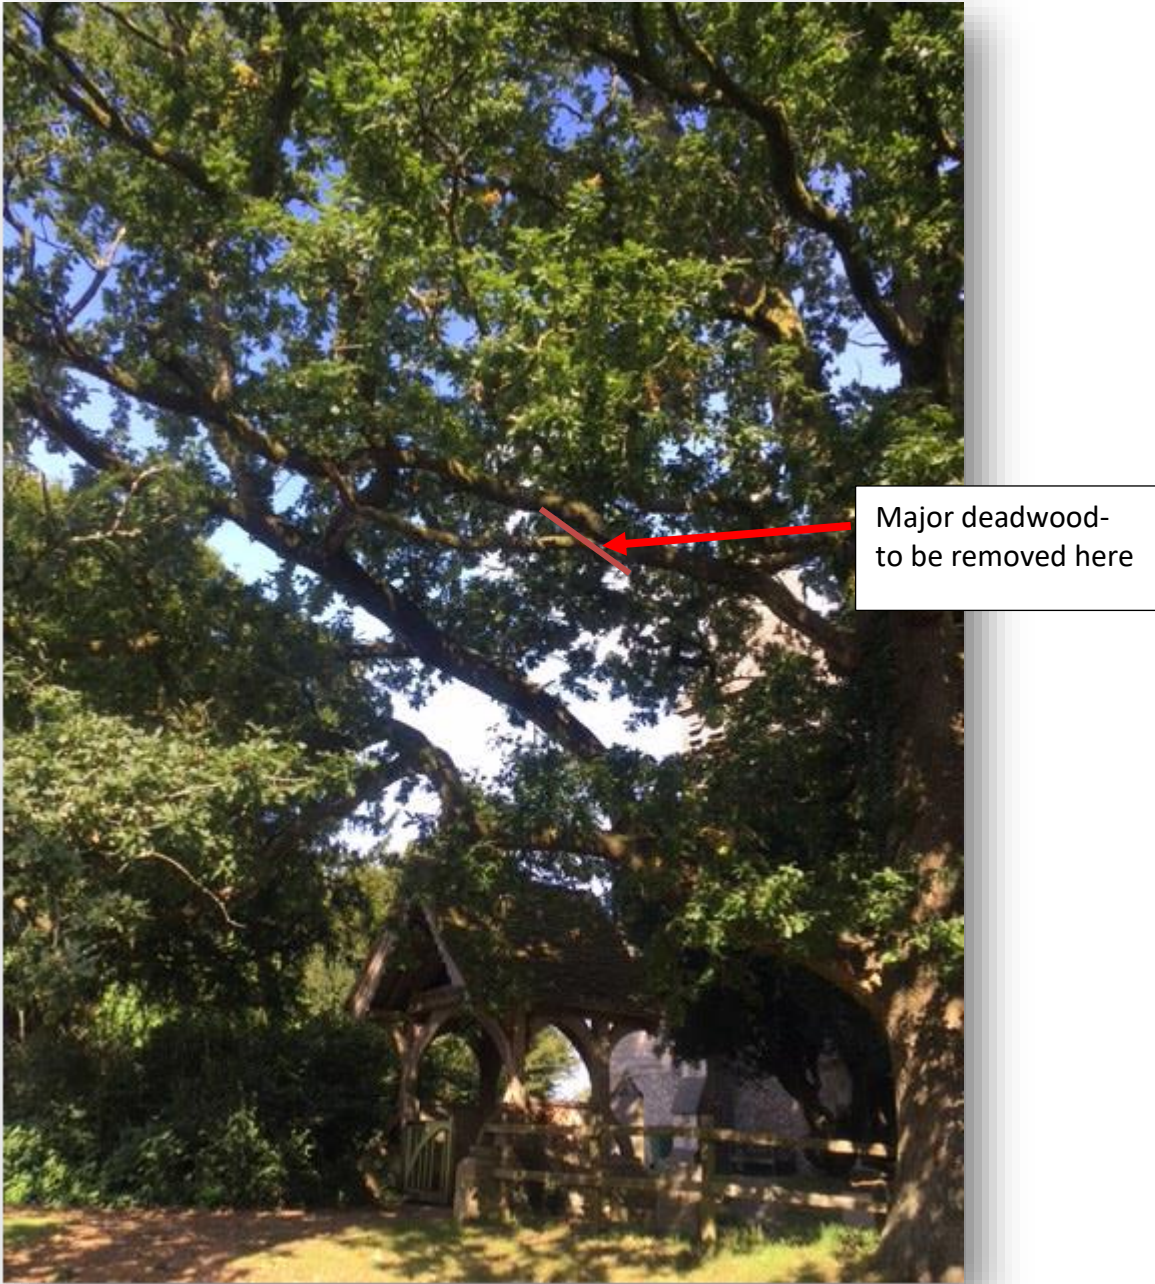
Figure 6. T4 - Major deadwood over path to Lychgate to be removed.
