HOLLYCOMBE HOUSE

LIPHOOK

Paint samples were taken from the six main south facing rooms which were designed by Nash and built in 1802.

The object of the investigation was to find out in general terms how these rooms were decorated when first built and how they have been painted in later years. Only approximately twenty samples were taken from each room, so this cannot be seen as a full survey.

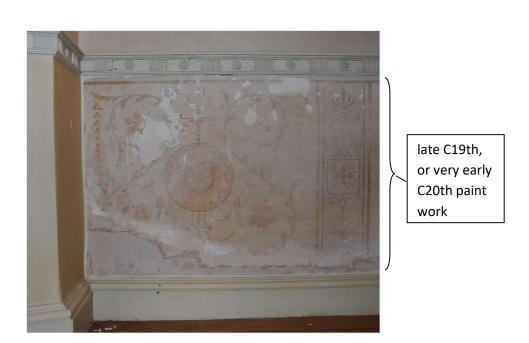
North wall, left of fireplace

The walls at dado level were painted as seen today on the north wall, where later layers have been removed.

The main pigment was lead white [Sample A1, p.17]. Lead white is rarely used after the 1940s. The pink areas were painted using vermilion, a pigment rarely used after the 1920s. The use of these pigments and the fact that certain areas such as skirtings went on to be twice repainted using lead paints, points to this decoration dating to around the turn of the century.

That ornate decoration on the dado appears to have been done to match the decoration seen today on the ceiling.

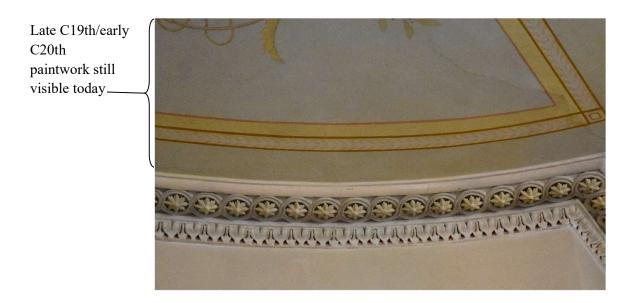
The ceiling decoration is on paper, but it is certainly a painting, and not a print. The same lead-based oil paints and pigments as were used for the dado were found in the samples taken from the ceiling [Sample A29, p.17].

Samples taken from the cornice decoration show that the same set of pigments were also used for this feature. Some details, such as the dark red background to the flowers on that cornice has not been overpainted since, and so the original vermilion is still visible.

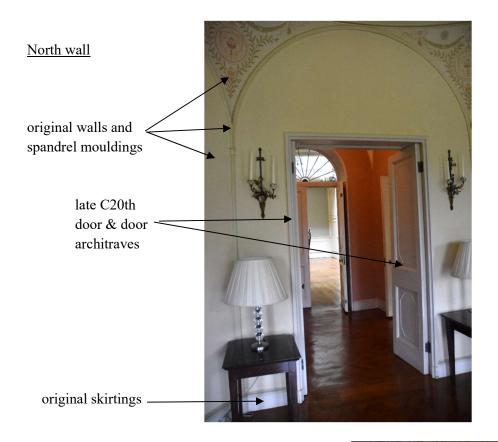
North/west wall

late C20th replastering above cupboard in the niche

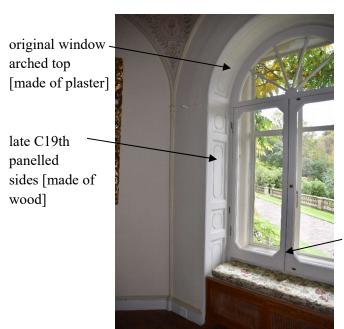
South wall

late C20th window

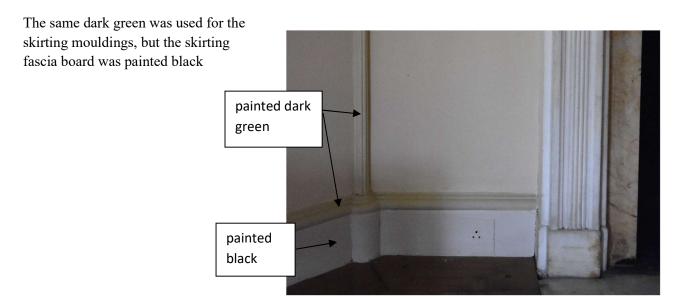
A very dark green was used for the wall mouldings [Sample B1, p.19]

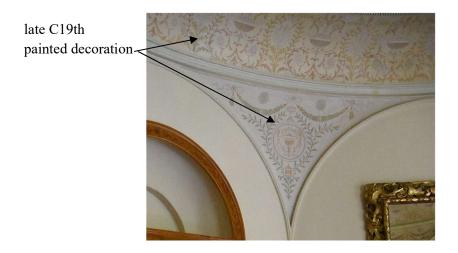
The floral decoration seen today on the ceiling was painted using oil paints based on lead white [Sample B7, p.20].

The paints that were used look very similar to the paints used for the floral decoration seen today on the Drawing Room ceiling, and the two rooms may have been painted at the same time.

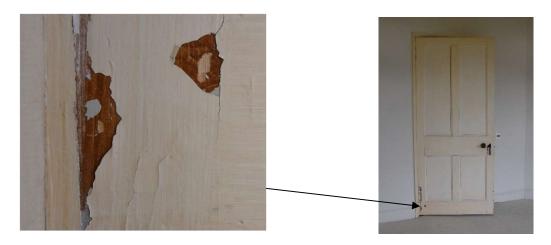
The entrance door was grained to imitate oak. Where paint layers have flaked off, we can see a small patch of this graining today

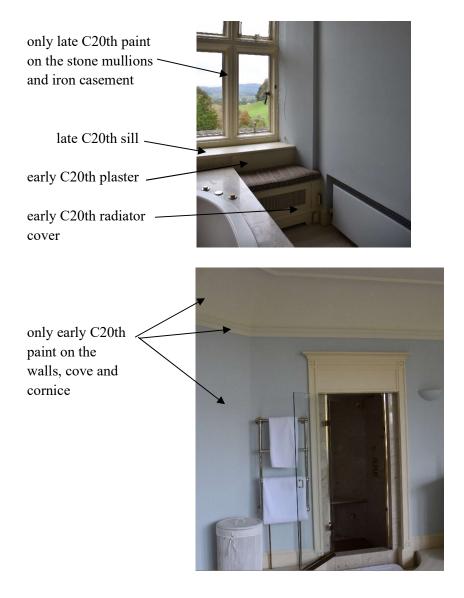
Work appears to have been done to all the walls, including the application of a thin gypsum skim coat in some areas. The cornice, the cove and the ceiling still have original plaster [Sample F5, p.23], but all early paint layers have been stripped off.

Following that early twentieth-century refurbishment, the room was painted plain white. The paint used was still based on lead white, but it was the last lead-based paint, and so likely to have been applied in the years before the Second World War.

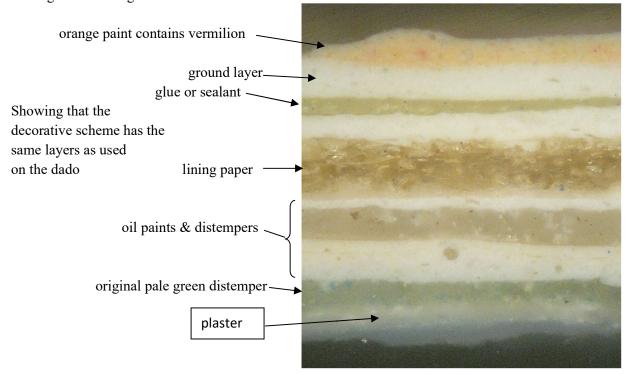
SAMPLE A29a

Ceiling – from orange detail

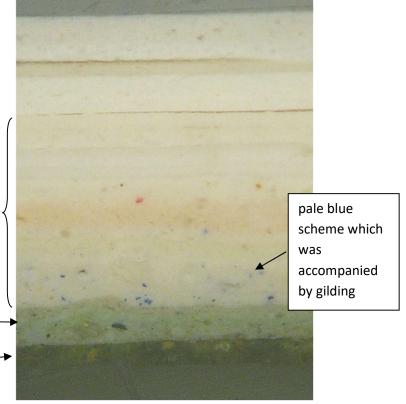
SAMPLE B7

Study - painting in spandrel – orange detail

showing the layers of the decorative paint work over the same distinctive pale blue as seen in B5 above

pale blue with particles of ultramarine

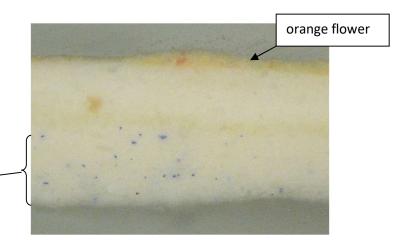
SAMPLE B12

Study – arched top of SW window

The early layers contain pale greens which may be a clue to how the walls of this room were painted

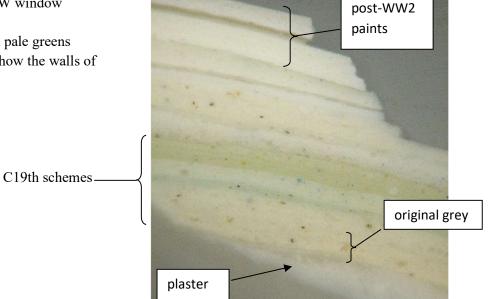
SAMPLE B14 Study - Wall to

Study - Wall to left of fireplace

The sequence starts with a later C19th pale blue containing particles of French ultramarine [invented 1828]

The early C19th layers may have been distempers which were later cleaned off

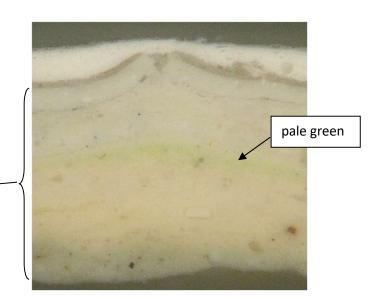
Fragment (ii)

Lower layers & wood

Showing the greys used in the early years – the earliest very pale, later ones darker

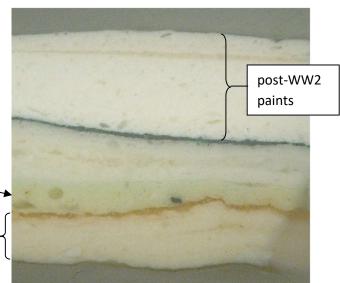
SAMPLE E10

We can date this to the late nineteenth century because the clear oil size used for the gold leaf is typical of that period [Sample E10, p.23], and the gold scheme was followed by just three more lots of lead paint.

Bead around niche

Under a late C19th pale green [see previous page] is a gilding scheme

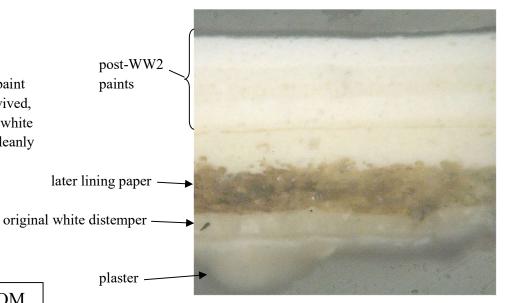
SAMPLE E20

Ceiling

not many later paint layers have survived, but the original white distemper sits cleanly on the plaster

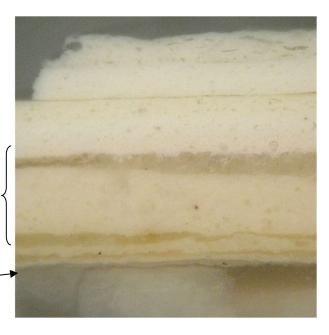
SAMPLE F5

Cornice

Very little early paint survived in this room. The samples shows show white paints which predate WW2
