Arboricultural survey to British
Standard B.S. 5837: 2012 'Trees in
relation to design, demolition and
construction - Recommendations'
at
375 Malden Road
Worcester Park
KT4 7NT

Client: Mr Shahid Ahmad

05/10/2020

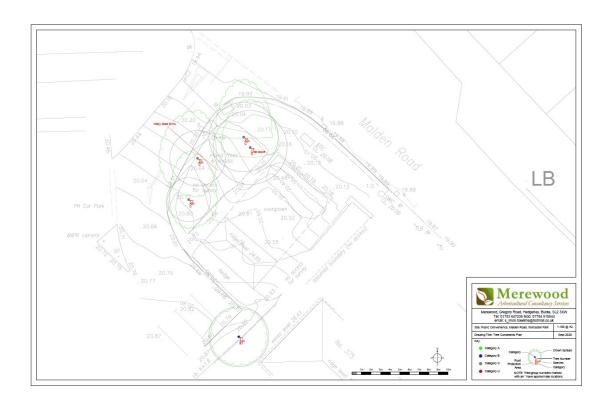
# Appendix 3 Tree Constraints Plan

- 4.3 A longer established crab apple (T5) is growing at the front of the plot, overhanging the pavement of the Malden Road. This is a fully mature ornamental tree that has a limited useful life ahead of it.
- 4.4 To the south of the site, in the restaurant car park is a specifically planted ash tree (T1) that is beginning to establish itself.
- 4.5 The tree survey has shown that of the 5 trees surveyed, 0 are category 'A' 1 is category 'B'; 4 are category 'C' and 0 are category 'U'.

- 5.2 A number of these self-set trees are dying anyway and present a liability prone to dropping into the road as they decay.
- 5.3 The more established crab apple (T5) would have formed part of the original landscaping of the facility. However, the tree is becoming over mature and with a pronounced lean over the public footpath and the fact that the tree is becoming smothered by ivy the time has come to review the future of this tree.

- 5.4 There are otherwise no other considerations with regards to the trees at this site. There are no trees of such importance as to prevent a development of this plot or to influence its' design. However, there should be realistic scope for new tree planting incorporated into any proposed layout.
