LYNWOOD AVENUE/
LYNWOOD ROAD,
EPSOM

TREE REPORT

MR STEERE

Written By:	M. Jones
Checked By:	H. Pinn
Date:	15/10/2021
Ref:	PRI23502tr
Revision:	n/a

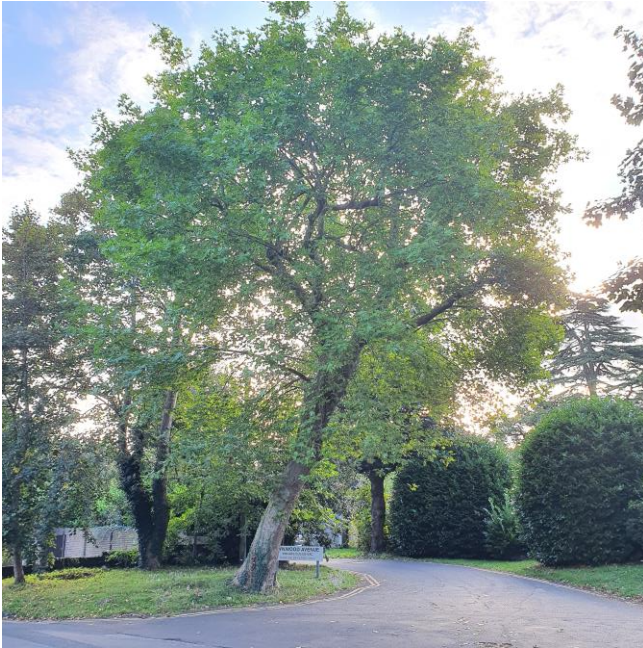
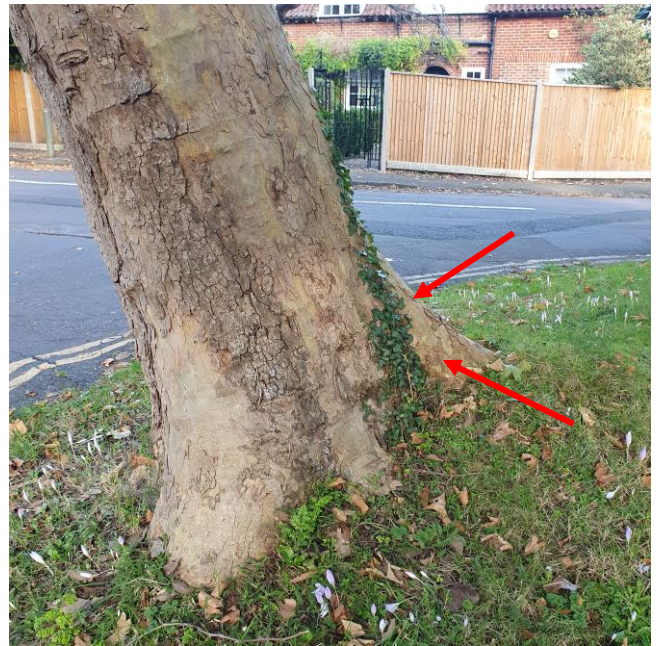
- 4.1. The primary driver for ACD being instructed to complete this survey was the perceived, gradual increase in the angle at which the trees' trunk leans.
- 4.2. On inspection, it was noted that a large proportion of the notional circular Root Protection Area (RPA), determined by a formula based on the diameter of the trunk, was covered in non-porous, tarmac hard surfacing which makes up the wearing courses of both Lynwood Avenue and Lynwood Road, and this surfacing extends to within 1m of the base of the tree; direct damage to roots in these areas may have occurred historically.
- 4.3. The morphology of the root-trunk transition zone shows some evidence of reactive growth and swelling, presumably to stabilise the tree's heavily leaning trunk, which is weighted towards the west.

Photographs 1 and 2: showing the tree's current location and growing environment (below left) and a detailed photo of the root-stem transition zone, with some reactive growth (below right).

- 4.5. As reactive growth on broad-leafed trees is typically found on the tension side of a lean, as opposed to a coniferous specimen where reaction growth is typically found on the compression side, it could reasonably be expected that there would be more abundant reactive growth than shown at Photograph 2 above if the angle of lean had remained constant.

- 4.6. The Client alleges that the angle of trunk lean has increased continually over the past few years. Our assessment of the condition and morphology of the tree is inconclusive. However, on balance, the morphological features of the tree's lower stem and root system suggest that a sudden increase may have occurred, but that the tree is actively seeking to react to any potential change. It is acknowledged that the tree is located within a sub-optimal growing environment, which may have some bearing on future management requirements.

1. **Within 6 months:** Reduce canopy with a long-term objective to reduce the tree to 6m in height.
 - First reduction in height to be to c. 10m and lateral branches to c. 3m. A period of physiological recovery of two years should be allowed before further works are completed.
 - **Then, within 3 years:** reduce canopy to final height of 6m and lateral spread of 1m.
 - **Thereafter:** maintain extents by undertaking biennial removal of new growth.

This approach will progressively reduce the trees overall stature, and therefore the forces acting upon it, including gravity and torsional forces created by the wind, to such an extent that in the event of total failure at its base, only the road will be affected.

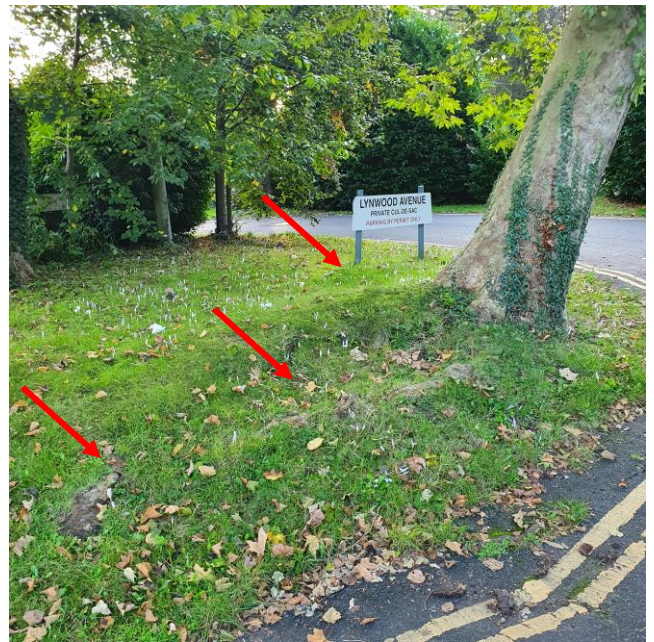
Photograph 3: showing significant surface roots

4.4. Moreover, the shallow surface roots on the north-east aspect now protrude through the mown grass area and are visible to approximately 3.5m from the trunk, where there is evidence of damage on their upper sides, consistent with being struck by a lawnmower or similar, before they then drop below the grass again. The formation of this rooting habit is likely due to a combination of factors: firstly, the heavily leaning trunk requires reactive

growth to compensate for forces acting on the canopy, and the underlying soil geology, which is likely to be predominantly chalk, which may pose a physical barrier to deep root growth. Soil information is referenced via the Geology of Britain interactive map by The British Geological Survey, available at [this link](#).

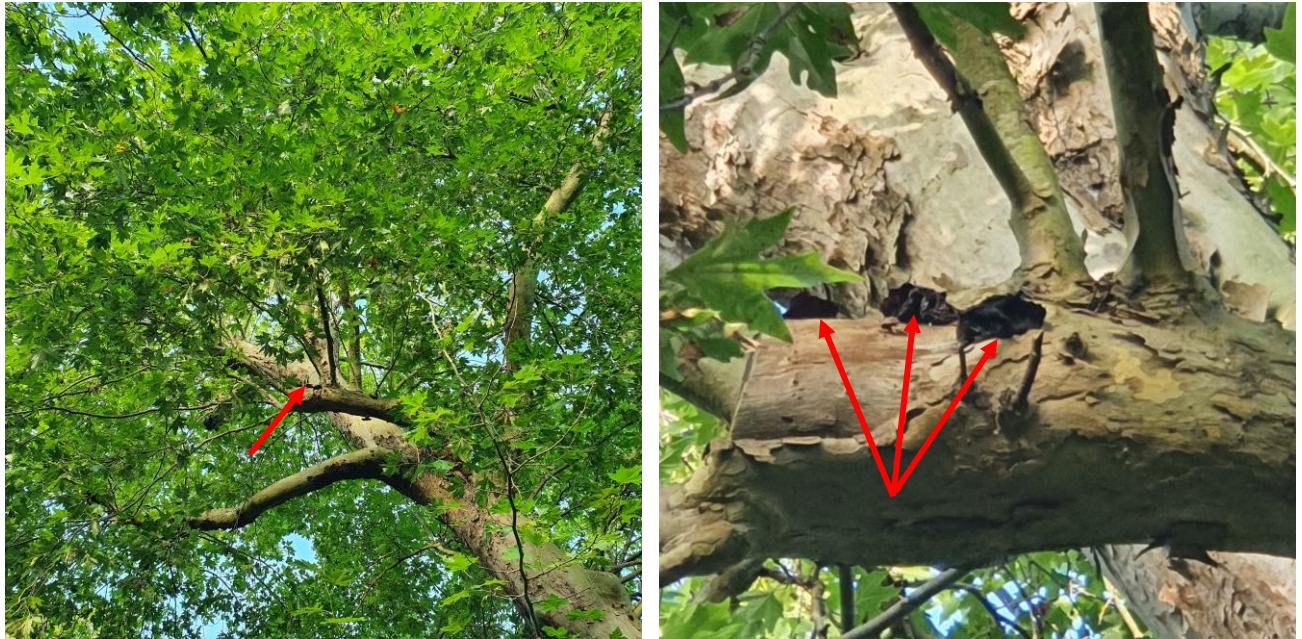
- 4.7. As a secondary observation, we noted the presence of *Auricularia auricula-judae* (Wood Ear) fungus near a historic pruning wound on a low branch in the western portion of the canopy. The fungus is largely considered saprotrophic but can act as a weak parasite and is indicative of dysfunction when located near pruning wounds and may be an indicator of the more problematic Massaria Disease (*Splanchnonema platini*), on London Plane trees.

- 4.8. Massaria Disease is a discrete fungal infection that causes strip cankers to form on the upper surfaces and along the length of infected branches. Due to its inconspicuous nature, it is often not visible from ground level and can lead to the sudden failure of infected branches if not identified.

Photographs 4 and 5: showing the location and detail of the fruiting bodies of *A. auricula-judae* fungus

Defect	Likelihood of failure	Likelihood of impact	Combined likelihood	Consequences of failure	Risk rating
Leaning trunk	Possible	Medium	Unlikely	Severe	Low
<i>A. auricula-judae</i> fungus	Possible	Medium	Unlikely	Significant	Low

This option is likely to be the most cost-effective way of managing the risks posed by the tree.
3. **Within 6 months:** Undertake an aerial inspection of the tree to determine whether Massaria Disease is present, and to what extent.
