Project Name 14479 EURO GARAGES BLACKPOOL	Project Number 14479	Project Date 08/12/2021
---	--------------------------------	-----------------------------------

PLR: MH01AX	Upstream Node: MH01A
Inspection Direction: Upstream	Downstream Node: MH01
Inspected Length: 2.42 m	Dia/Height: 150 mm
Total Length: 2.42 m	Material: Vitrified clay

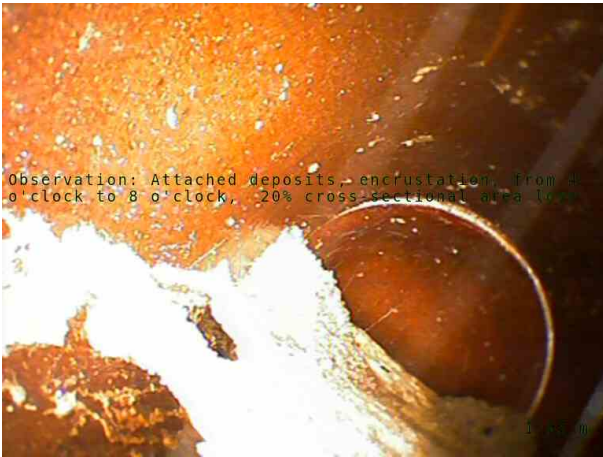
Observation: Attached deposits, encrustation, from 4 o'clock to 8 o'clock, 20% cross-sectional area loss

MH01AX_0001.jpg, 00:00:27, 1.95 m
Attached deposits, encrustation, from 4 o'clock to 8 o'clock,
20% cross-sectional area loss

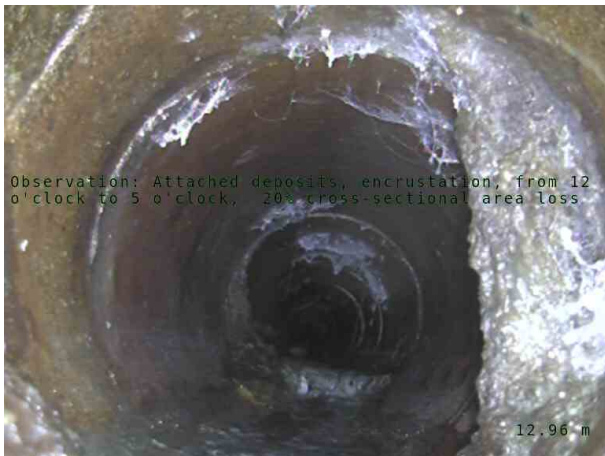
Observation: Attached deposits, encrustation, from 12 o'clock to 5 o'clock, 20% cross-sectional area loss.

MH01CX_0001.jpg, 00:02:08, 12.96 m
 Attached deposits, encrustation, from 12 o'clock to 5 o'clock, 20% cross-sectional area loss

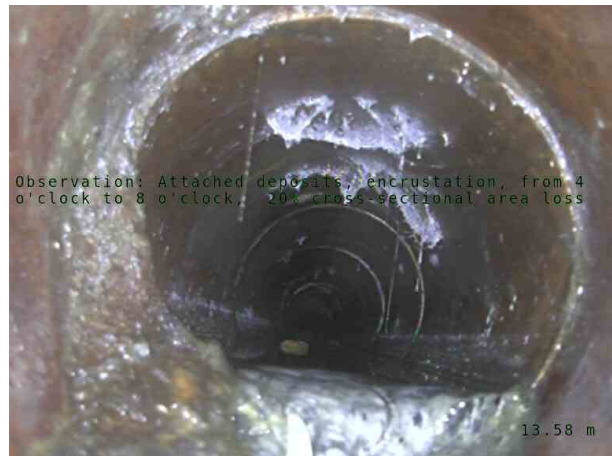
Observation: Attached deposits, encrustation, from 4 o'clock to 8 o'clock, 20% cross-sectional area loss.

MH01CX_0002.jpg, 00:02:17, 13.58 m
 Attached deposits, encrustation, from 4 o'clock to 8 o'clock, 20% cross-sectional area loss

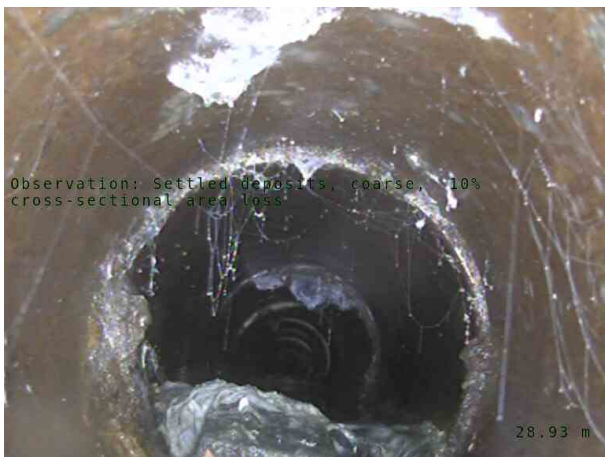
Observation: Settled deposits, coarse, 10% cross-sectional area loss.

MH01CX_0003.jpg, 00:03:42, 28.93 m
 Settled deposits, coarse, 10% cross-sectional area loss

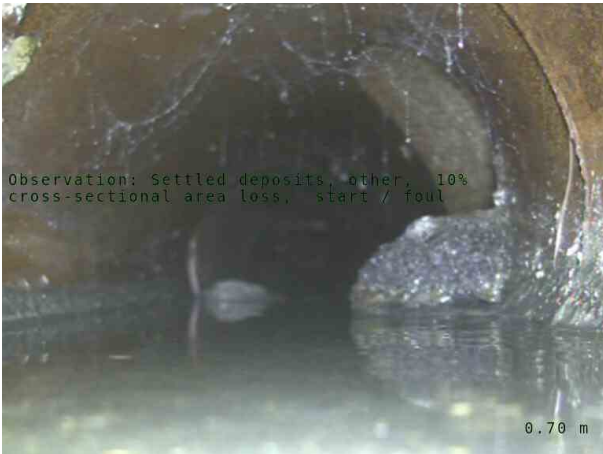
MH01X_0001.jpg, 00:00:13, 0.70 m
 Settled deposits, other, 10% cross-sectional area loss, start, foul

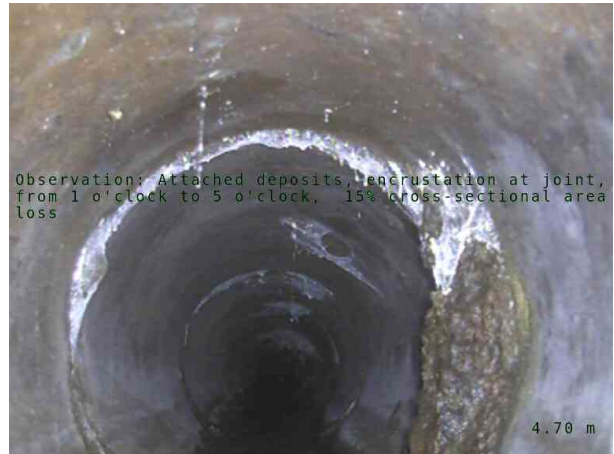
MH01X_0002.jpg, 00:01:09, 4.70 m
 Attached deposits, encrustation at joint, from 1 o'clock to 5 o'clock, 15% cross-sectional area loss

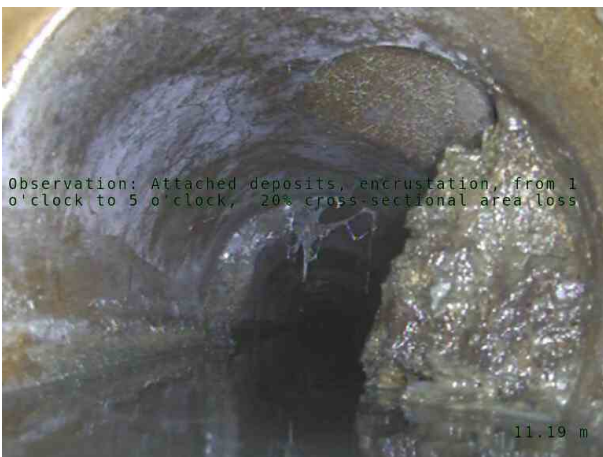
MH01X_0003.jpg, 00:01:45, 11.19 m
 Attached deposits, encrustation, from 1 o'clock to 5 o'clock, 20% cross-sectional area loss

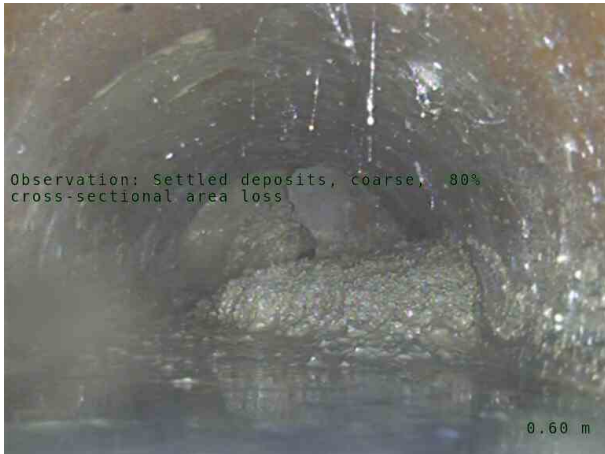
MH01BX_0001.jpg, 00:00:12, 0.60 m
 Settled deposits, coarse, 80% cross-sectional area loss

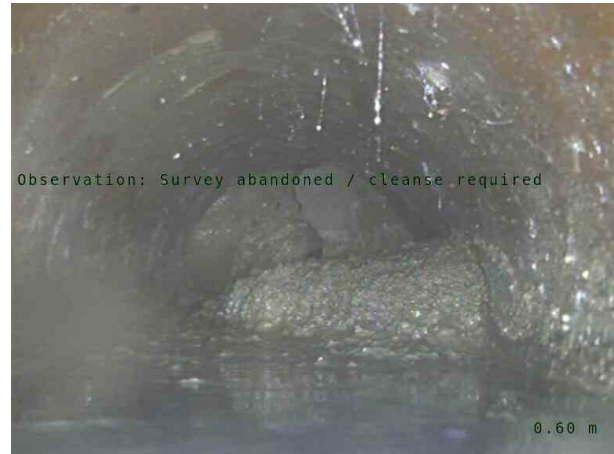
MH01BX_0002.jpg, 00:00:17, 0.60 m
 Survey abandoned, cleanse required
