Project Name: 14479 EURO GARAGES BLACKPOOL
Project Description: CCTV Drainage Inspection Report
Project Number: 14479
Project Date: 08/12/2021

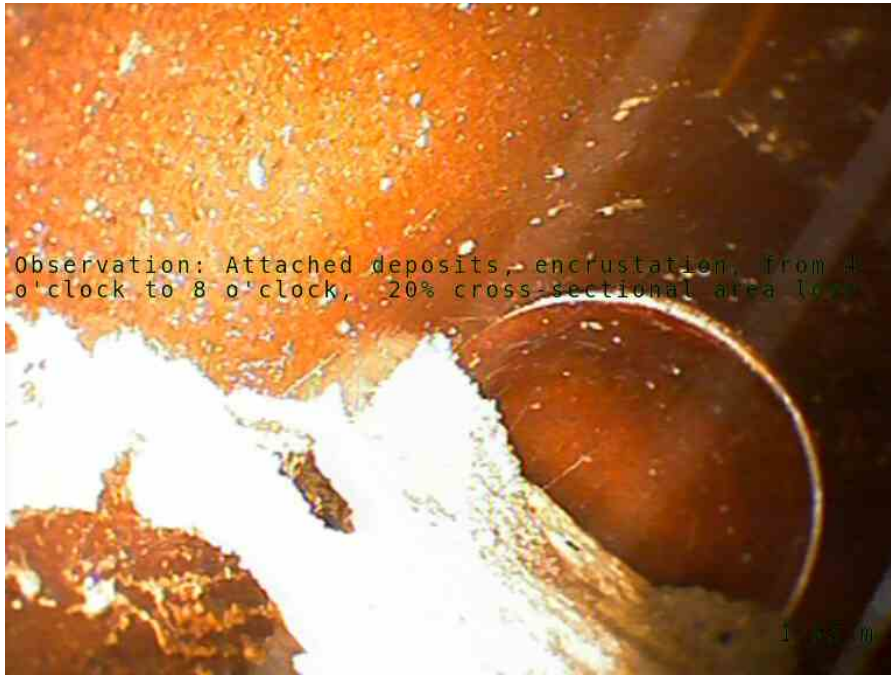
1, 00:00:27, 1.95 m

Observation: Attached deposits, encrustation, from 4 o'clock to 8 o'clock, 20% cross-sectional area loss

Attached deposits, encrustation, from 4 o'clock to 8 o'clock, 20% cross-sectional area loss

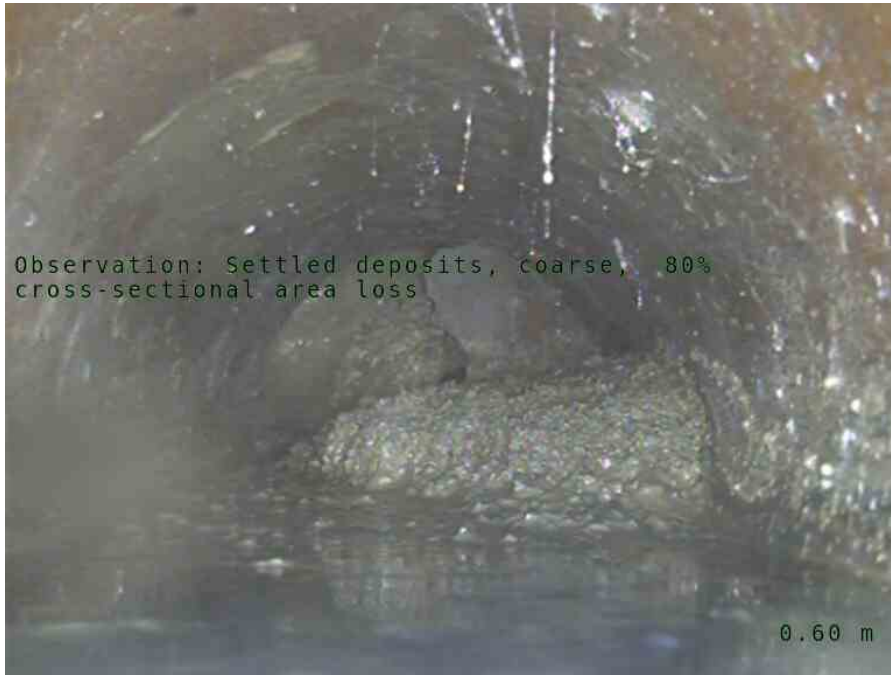
1, 00:00:12, 0.60 m
Settled deposits, coarse, 80% cross-sectional area loss

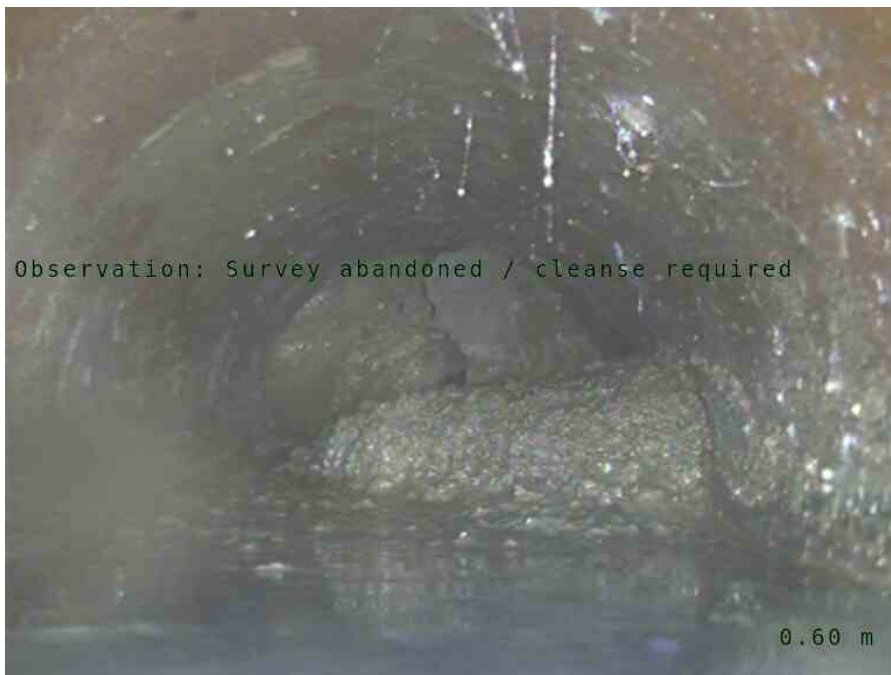
2, 00:00:17, 0.60 m
Survey abandoned, cleanse required

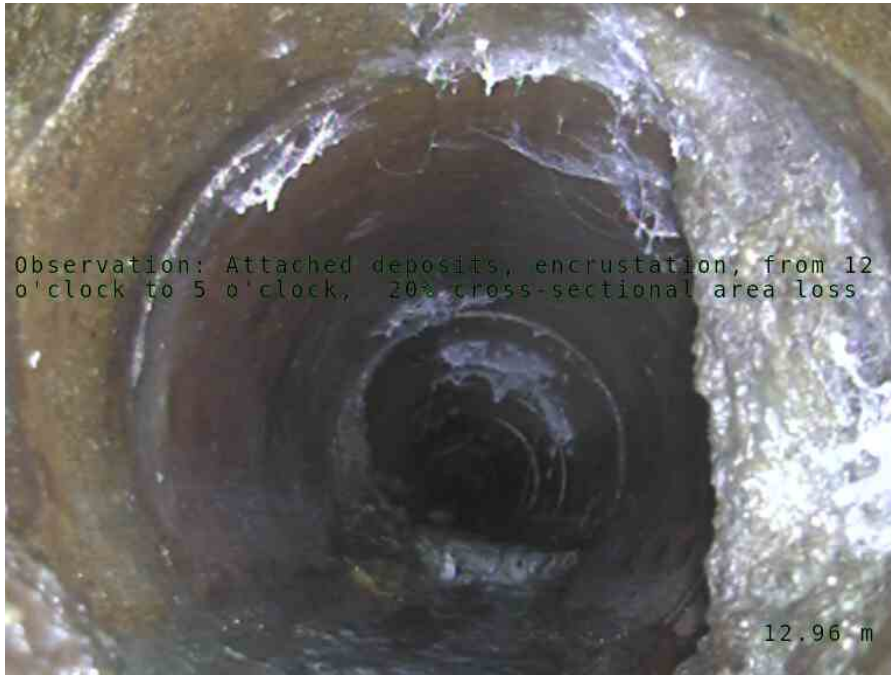
1, 00:02:08, 12.96 m

Observation: Attached deposits, encrustation, from 12 o'clock to 5 o'clock, 20% cross-sectional area loss

Attached deposits, encrustation, from 12 o'clock to 5 o'clock, 20% cross-sectional area loss

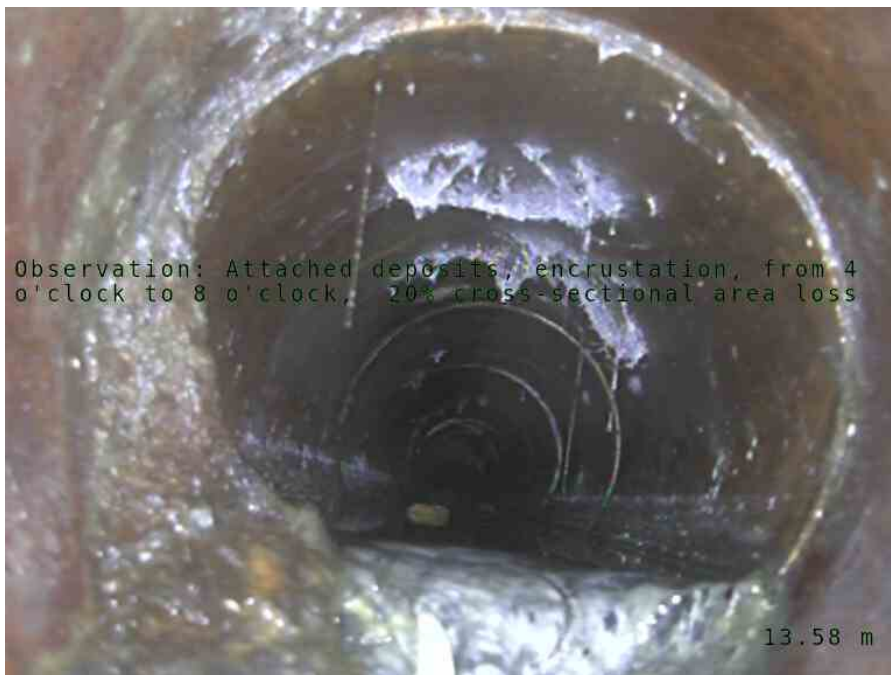
2, 00:02:17, 13.58 m

Observation: Attached deposits, encrustation, from 4 o'clock to 8 o'clock, 20% cross-sectional area loss

Attached deposits, encrustation, from 4 o'clock to 8 o'clock, 20% cross-sectional area loss

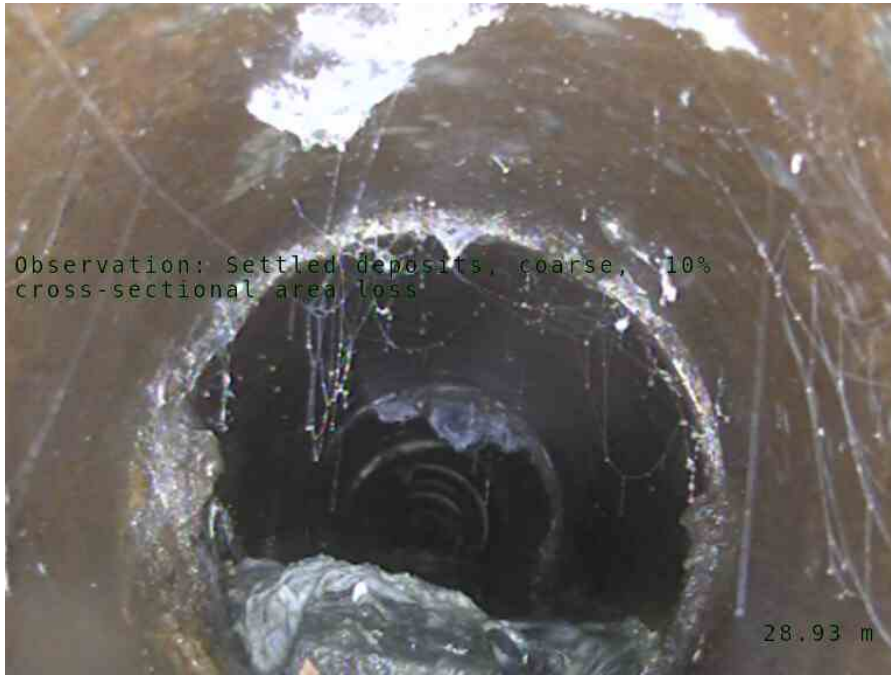
3, 00:03:42, 28.93 m

Observation: Settled deposits, coarse, 10% cross-sectional area loss

Settled deposits, coarse, 10% cross-sectional area loss

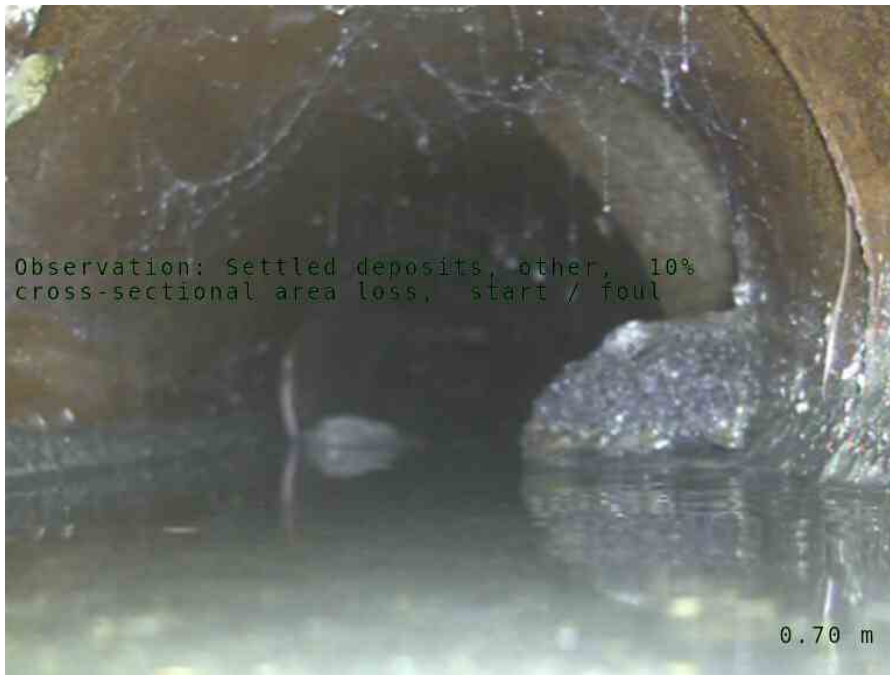
1, 00:00:13, 0.70 m
 Settled deposits, other, 10% cross-sectional area loss, start, foul

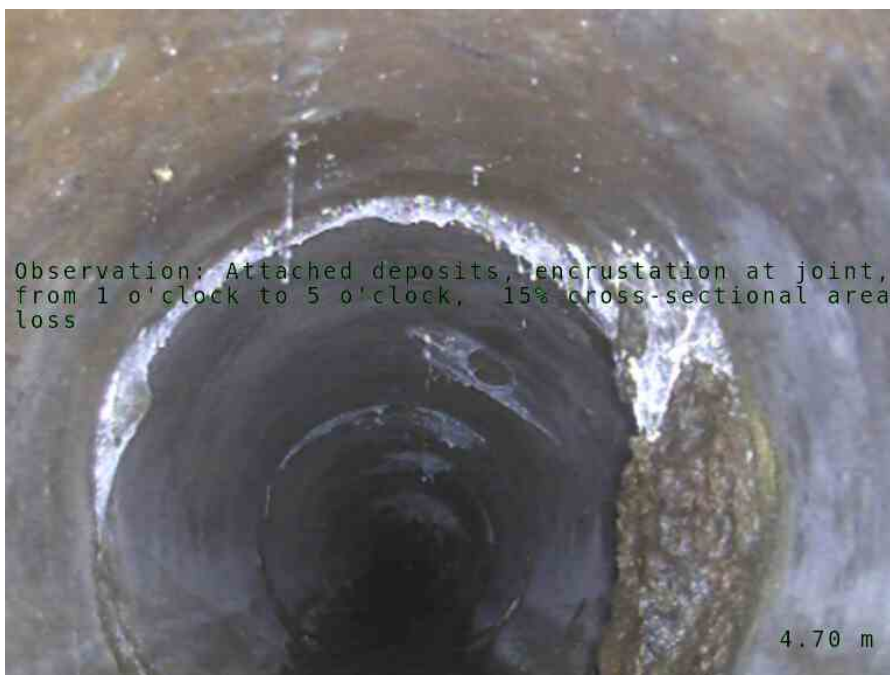
2, 00:01:09, 4.70 m
 Attached deposits, encrustation at joint, from 1 o'clock to 5 o'clock, 15% cross-sectional area loss

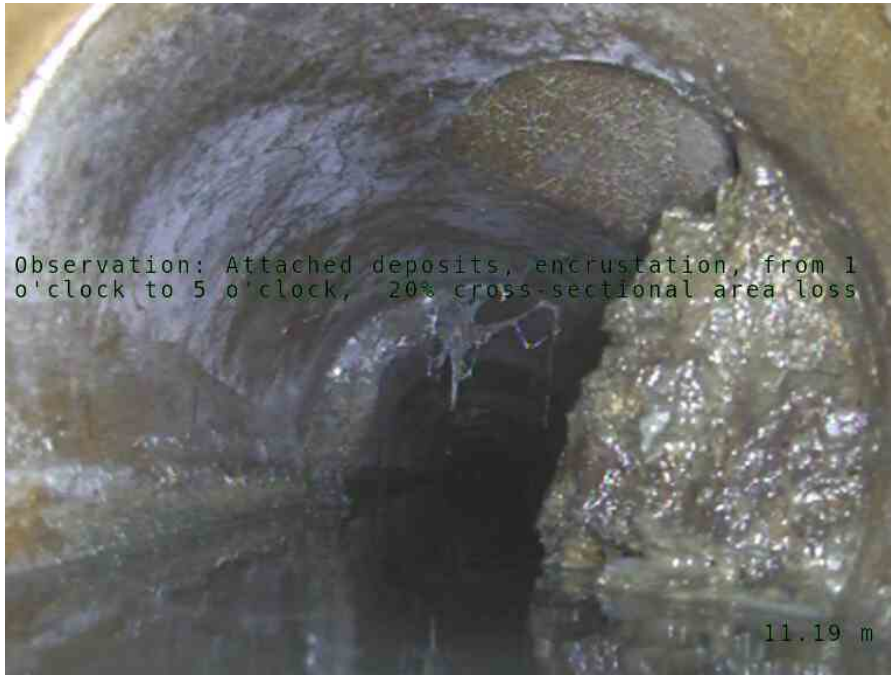
3, 00:01:45, 11.19 m

Observation: Attached deposits, encrustation, from 1 o'clock to 5 o'clock, 20% cross-sectional area loss

Attached deposits, encrustation, from 1 o'clock to 5 o'clock, 20% cross-sectional area loss
