APPENDIX A

Site photographs

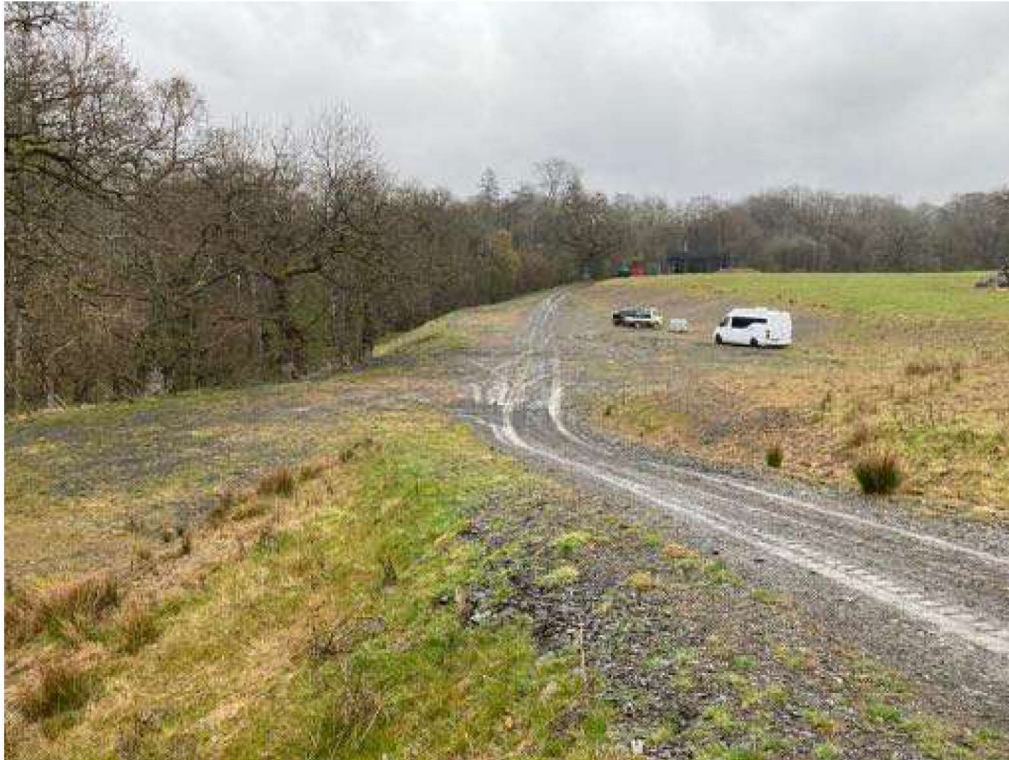
Photograph 1

Description: Site A: proposed motocross reception and parking area

Location: View from current access road – looking to the east

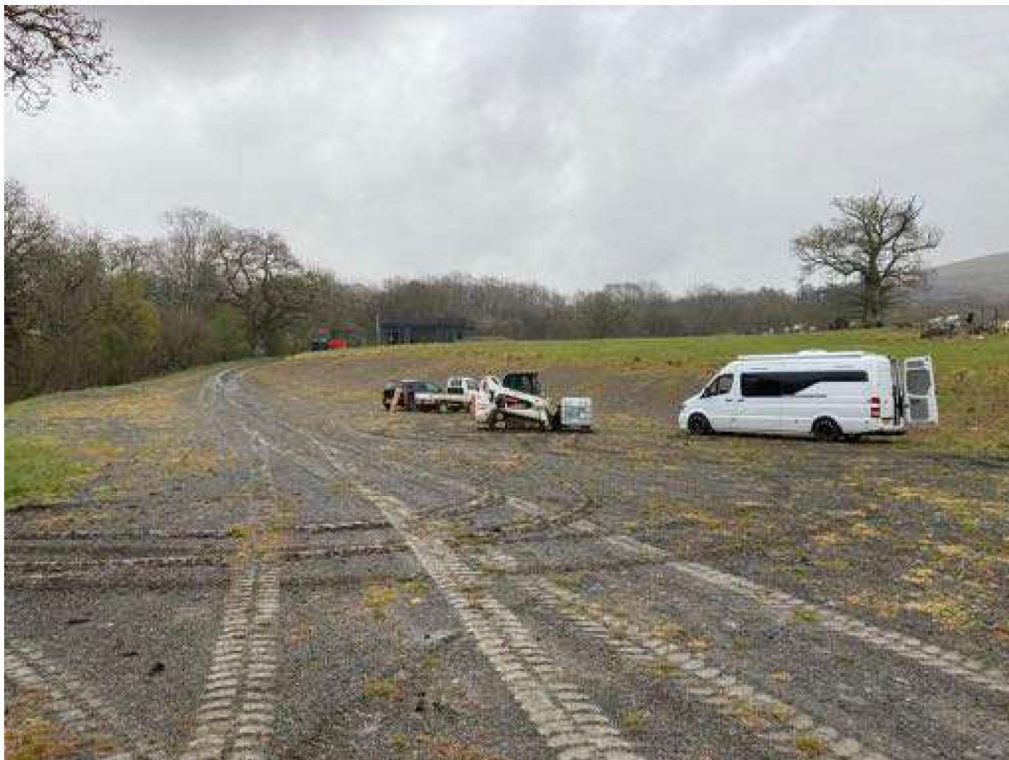
Photograph 2

Description: Site A: proposed motocross reception and parking area

Location: View from central site area – looking to the east

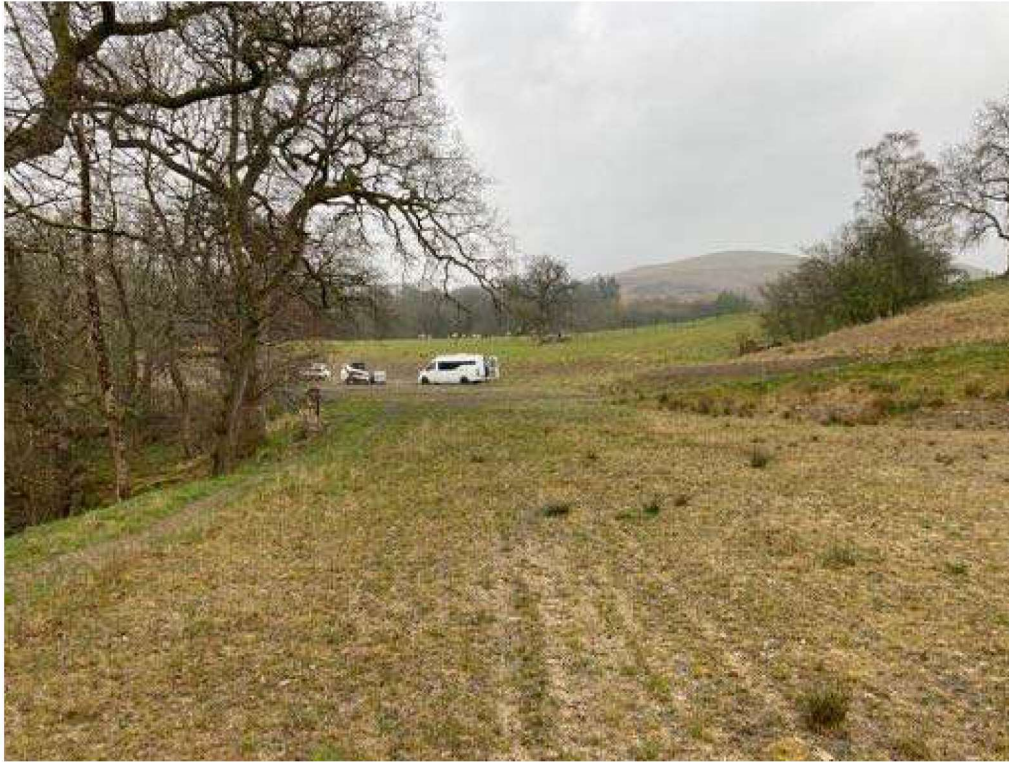
Photograph 3

Description: Site A: proposed motocross reception and parking area

Location: View from western part of the site – looking to the east

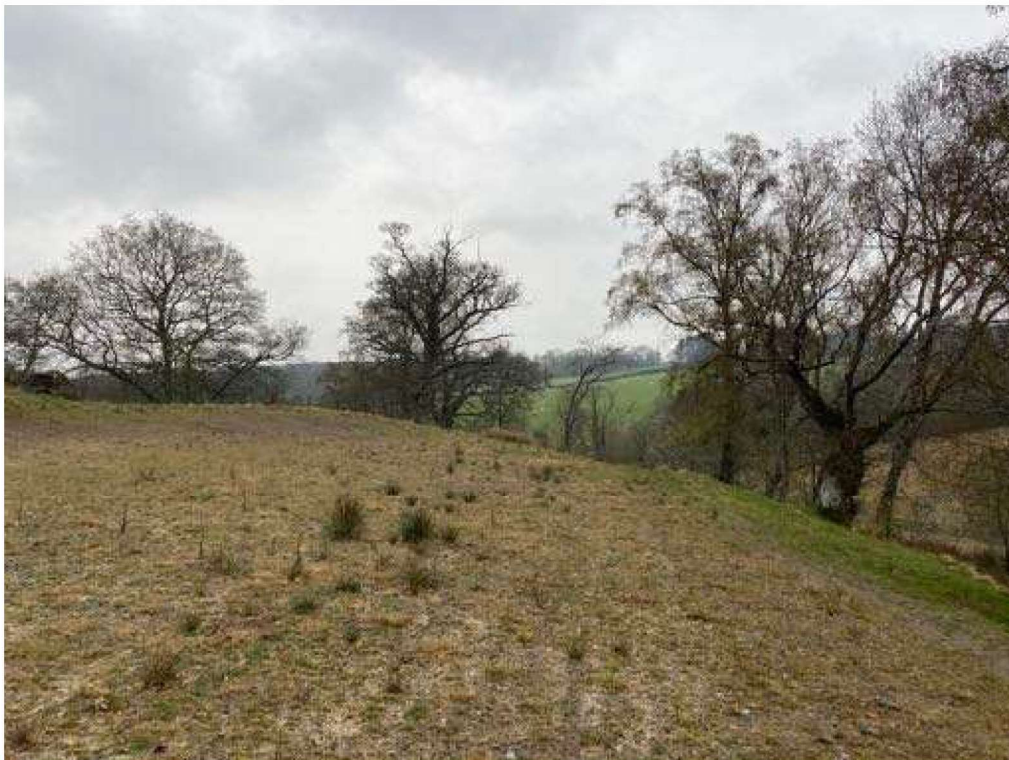
Photograph 4

Description: Site A: proposed motocross reception and parking area

Location: View from western part of the site – looking to the west

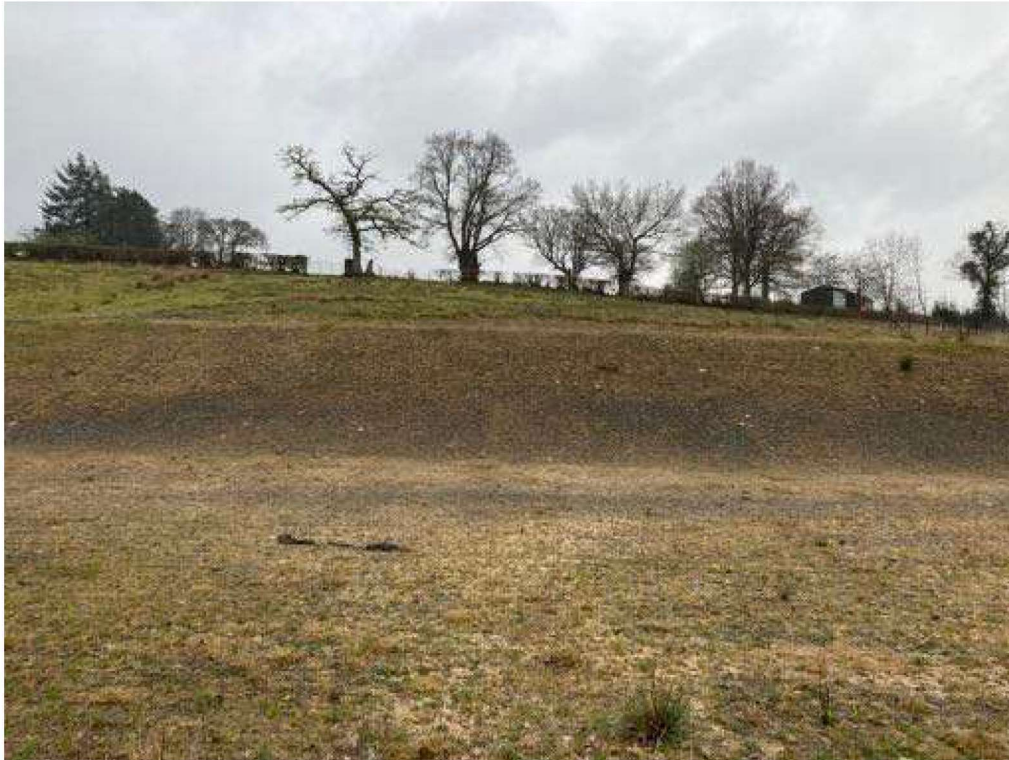
Photograph 5

Description: Site A: artificial bank resulting from previous groundworks

Location: View from central-western part of the site – looking to the south

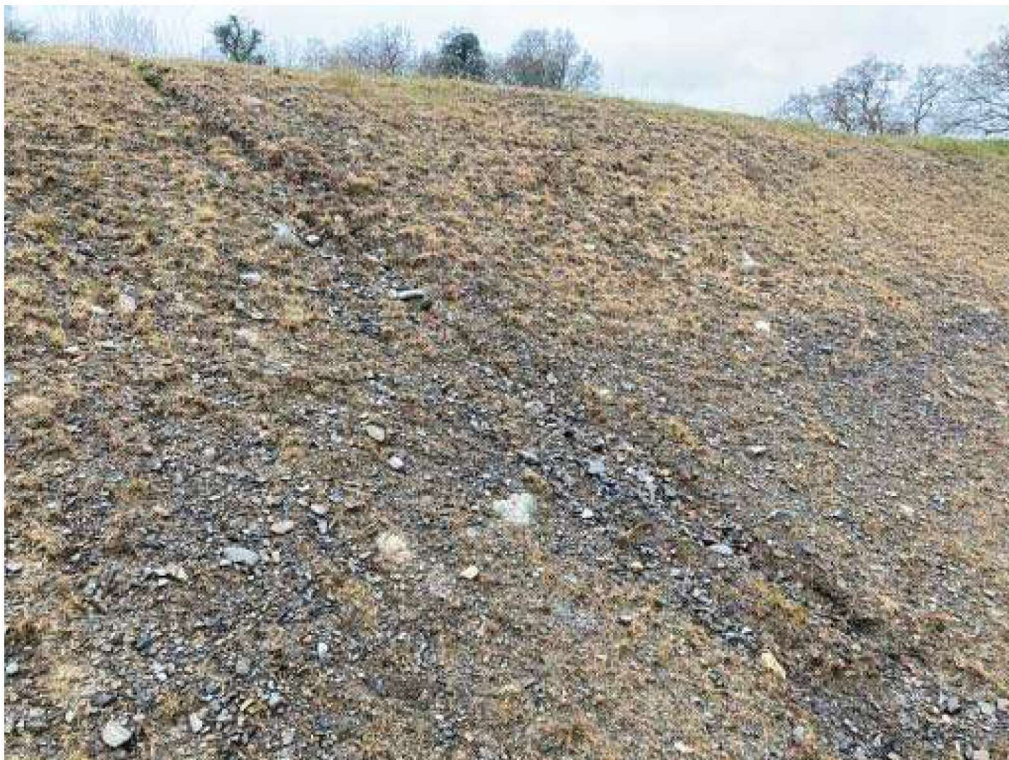
Photograph 6

Description: Site A: drainage rills within the artificial bank

Location: South-western part of Site A

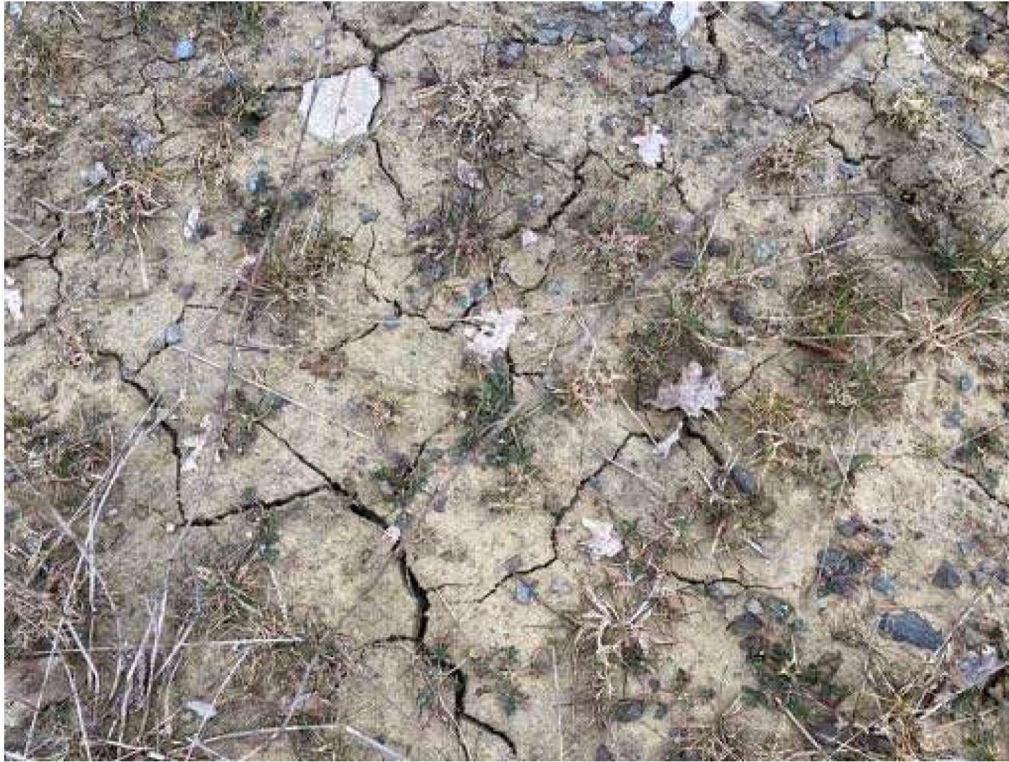
Photograph 7

Description: Site A: surface cracks within clayey soils

Location: South-western part of Site A

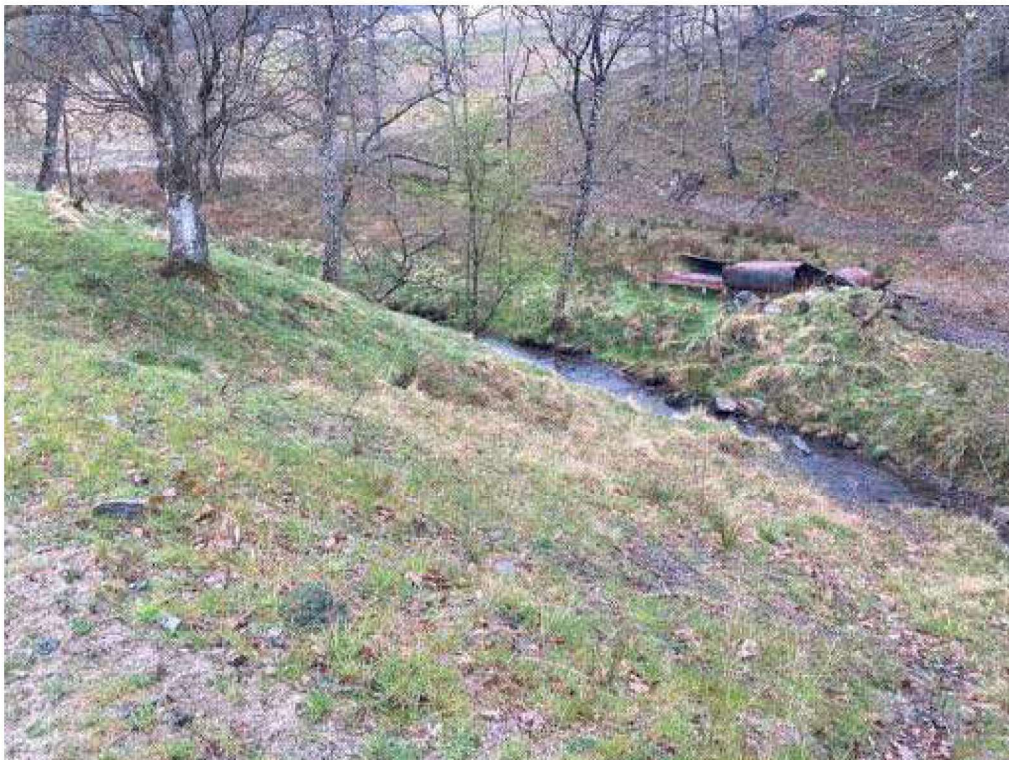
Photograph 8

Description: Site A: sloping ground leading down to Dulas Brook

Location: Northern boundary of Site A – looking to the north-west

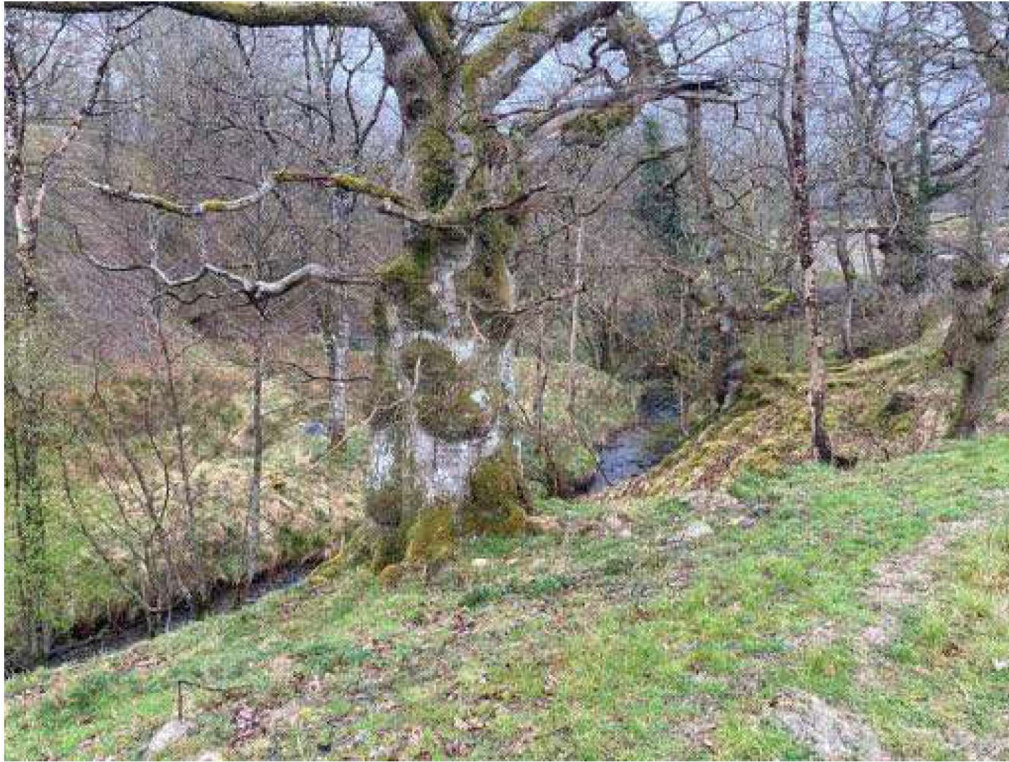
Photograph 9

Description: Site A: Dulas Brook river corridor

Location: Northern boundary of Site A – looking to the east

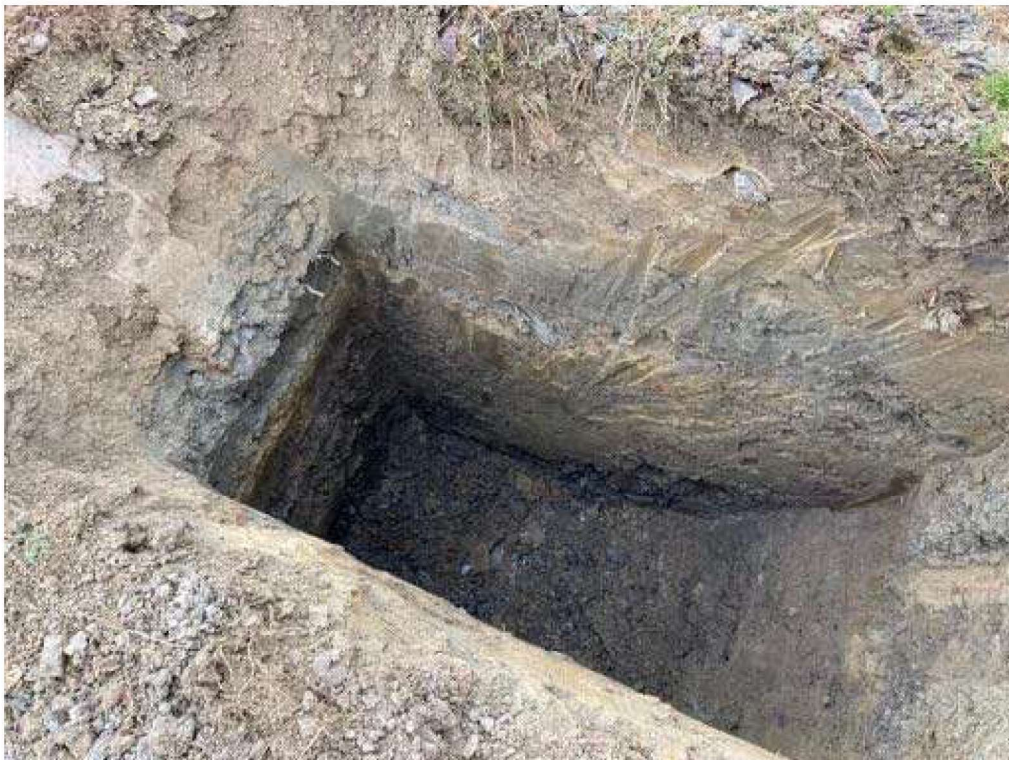
Photograph 10

Description: Trial pit TP01

Location: North western part of Site A

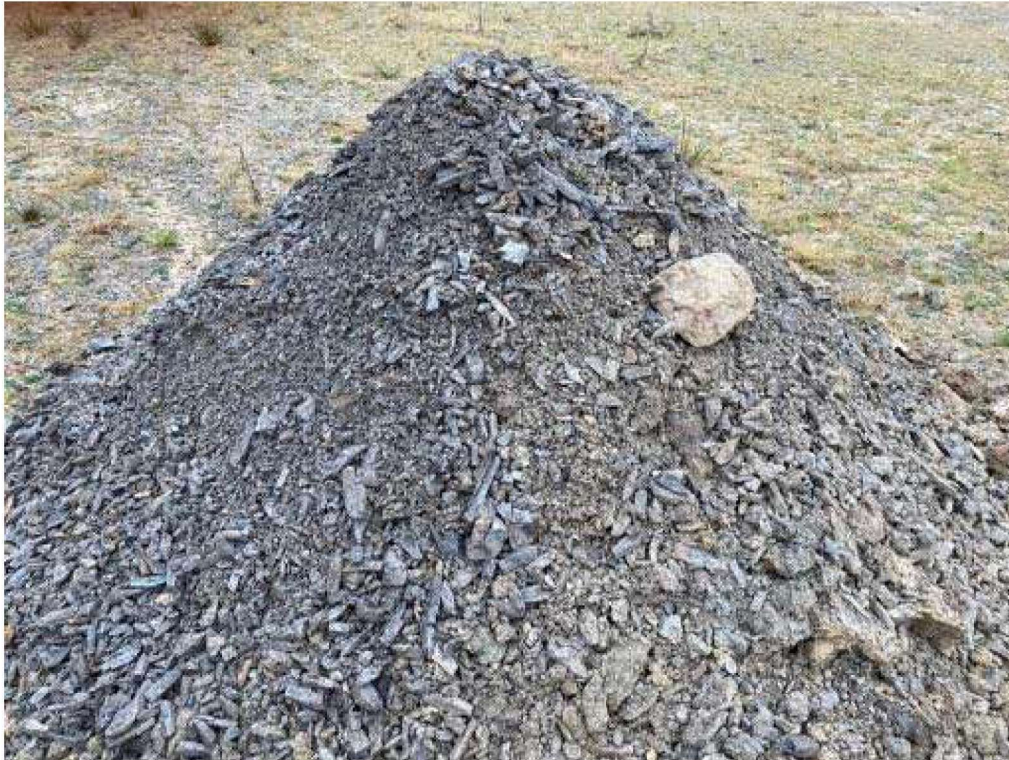
Photograph 11 **Description:** Spoil removed from trial pit TP01
 Date: 28/04/2021
 Location: North western part of Site A

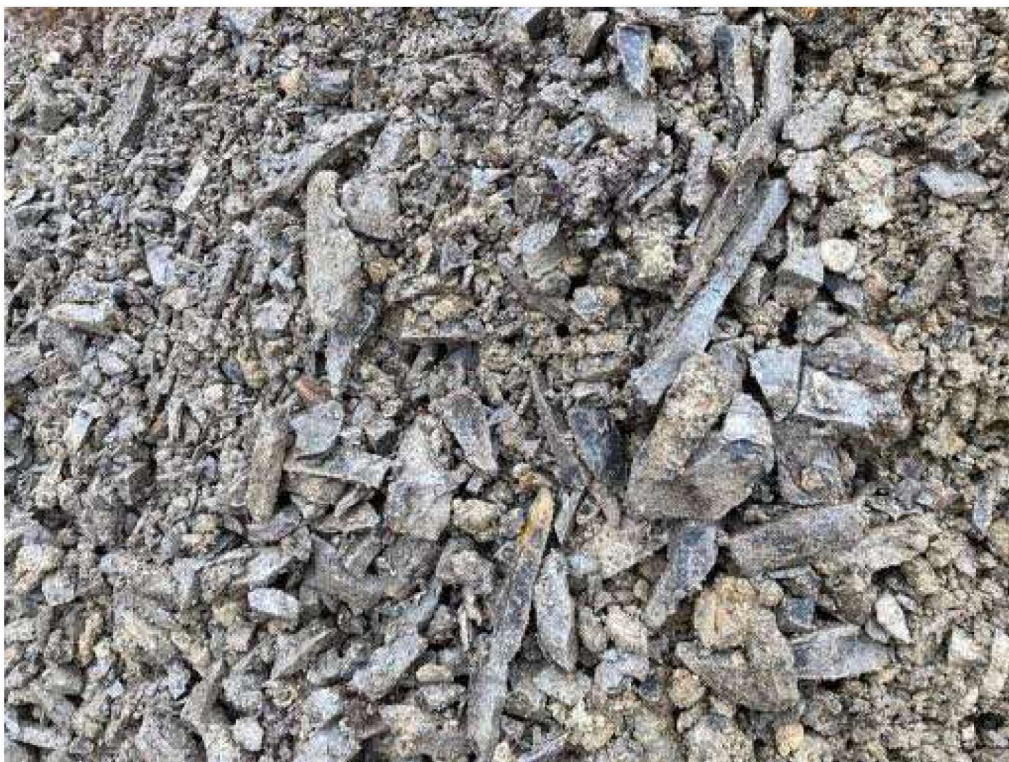
Photograph 12 **Description:** Spoil removed from trial pit TP01
 Date: 28/04/2021
 Location: North western part of Site A

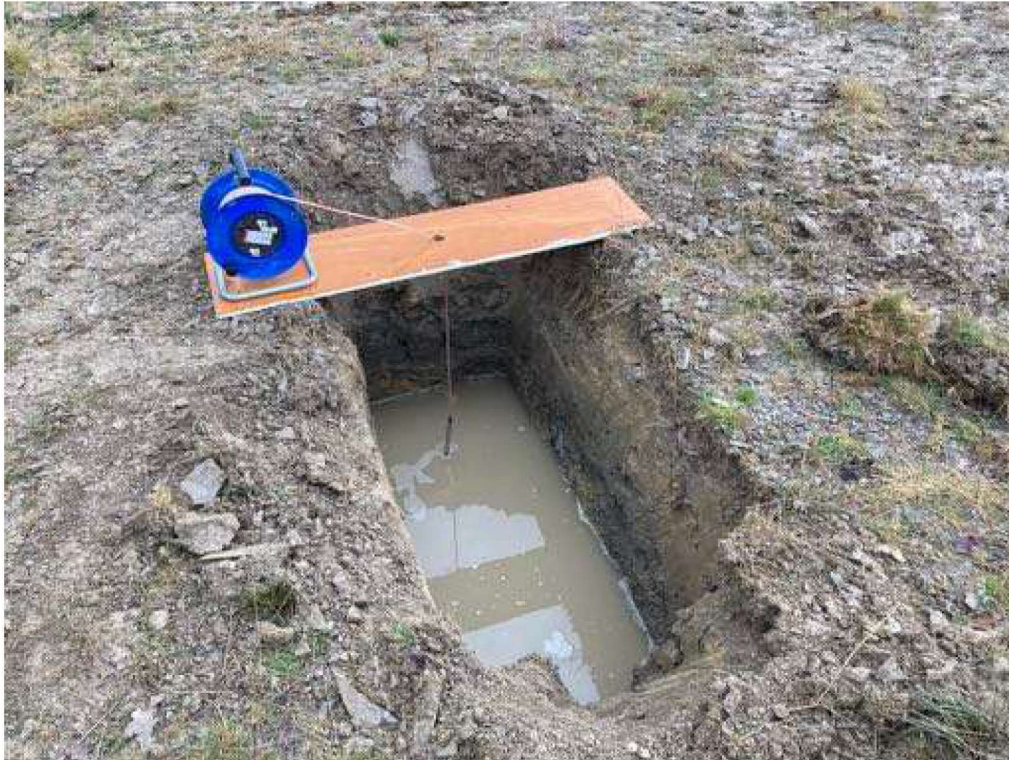
Photograph 13 **Description:** Water level monitoring at trial pit TP01 (start of test)
Date: 28/04/2021
Location: North western part of Site A

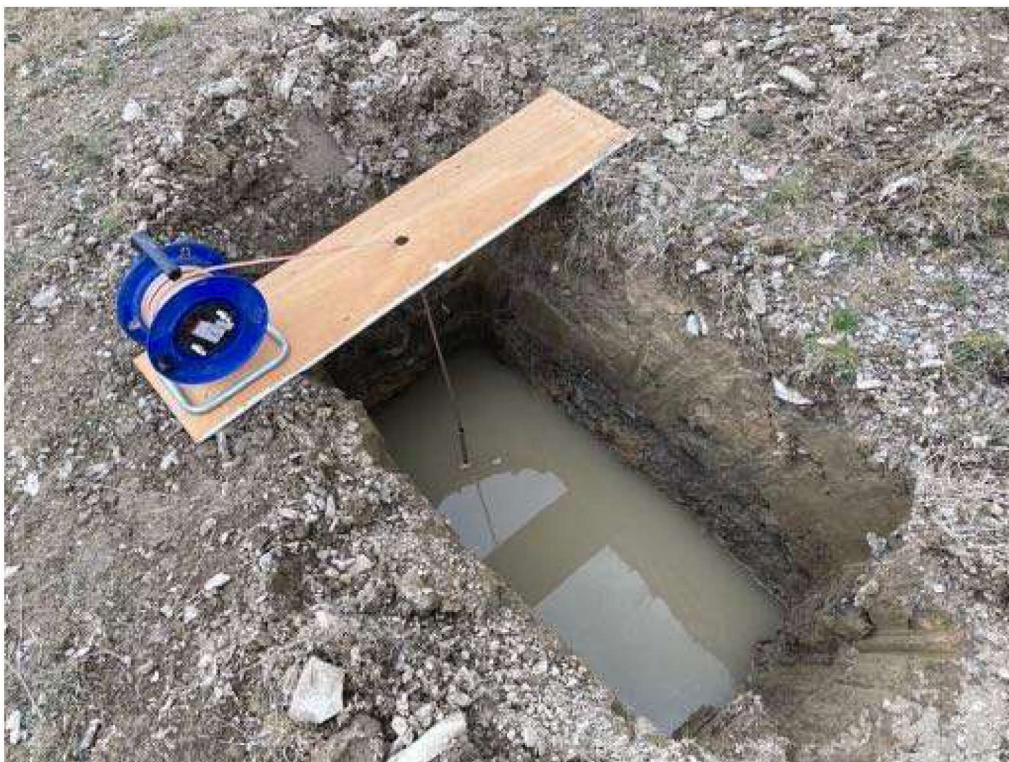
Photograph 14 **Description:** Water level monitoring at trial pit TP01 (end of test)
Date: 28/04/2021
Location: North western part of Site A

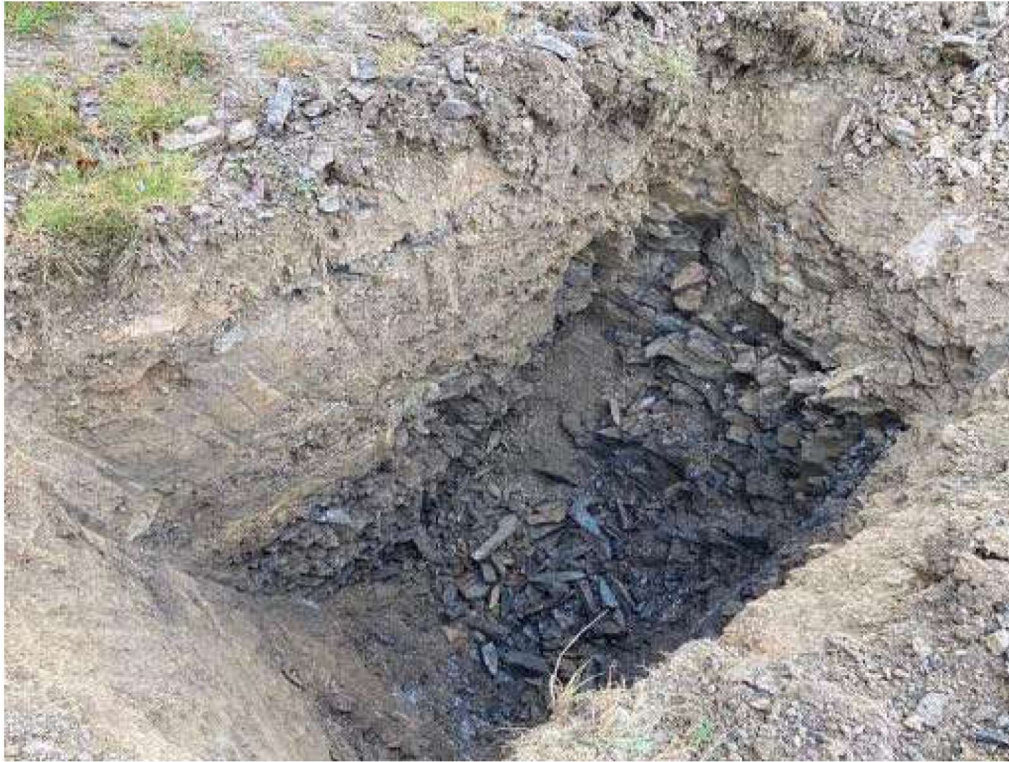
Photograph 15

Description: Trial pit TP02

Location: North western part of Site A

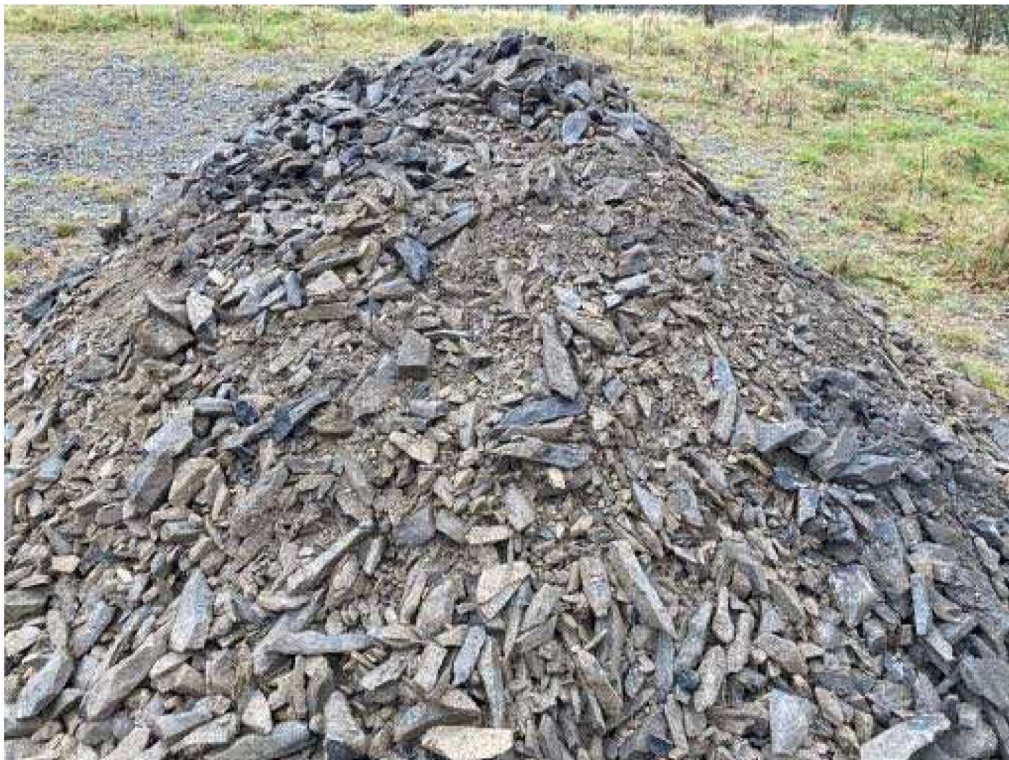
Photograph 16

Description: Spoil removed from trial pit TP02

Location: North western part of Site A

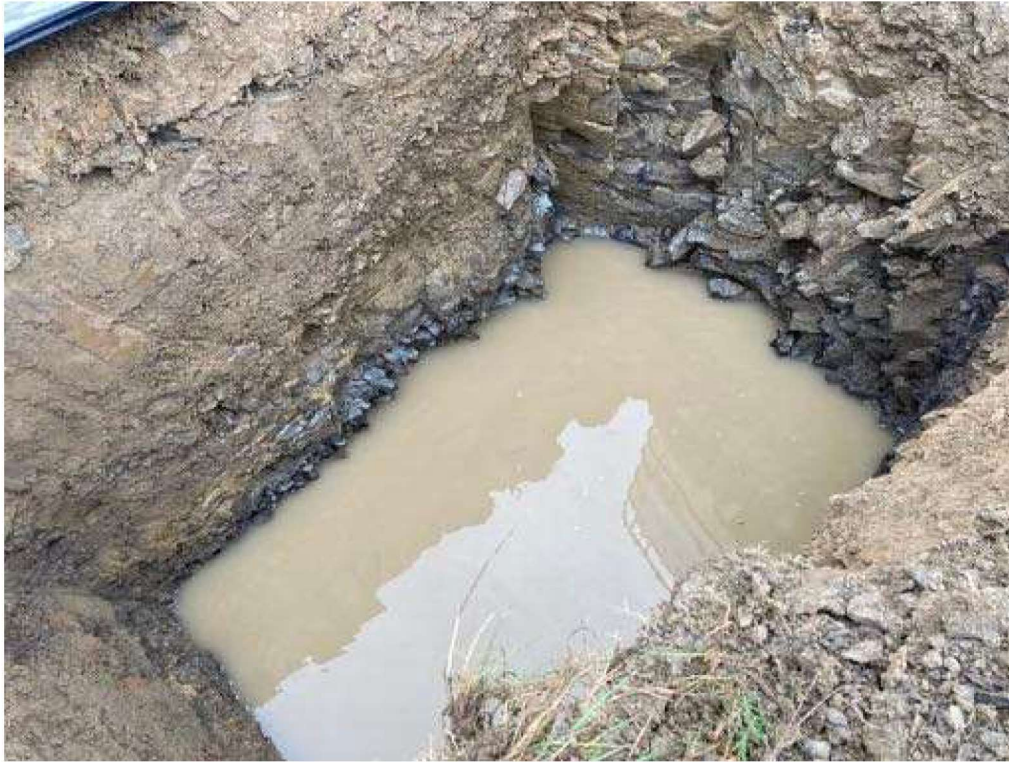
Photograph 17 **Description:** Inundation of trial pit TP02 (start of test)
 Date: 28/04/2021
 Location: North western part of Site A

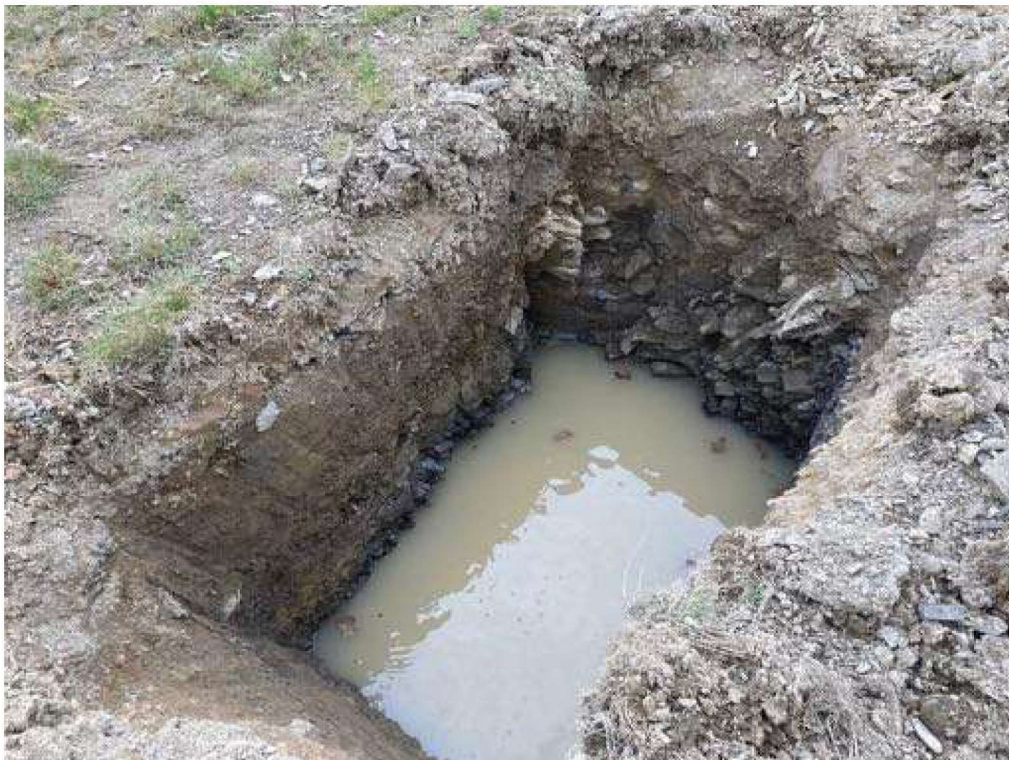
Photograph 18 **Description:** Trial pit TP02 (end of test)
 Date: 28/04/2021
 Location: North western part of Site A

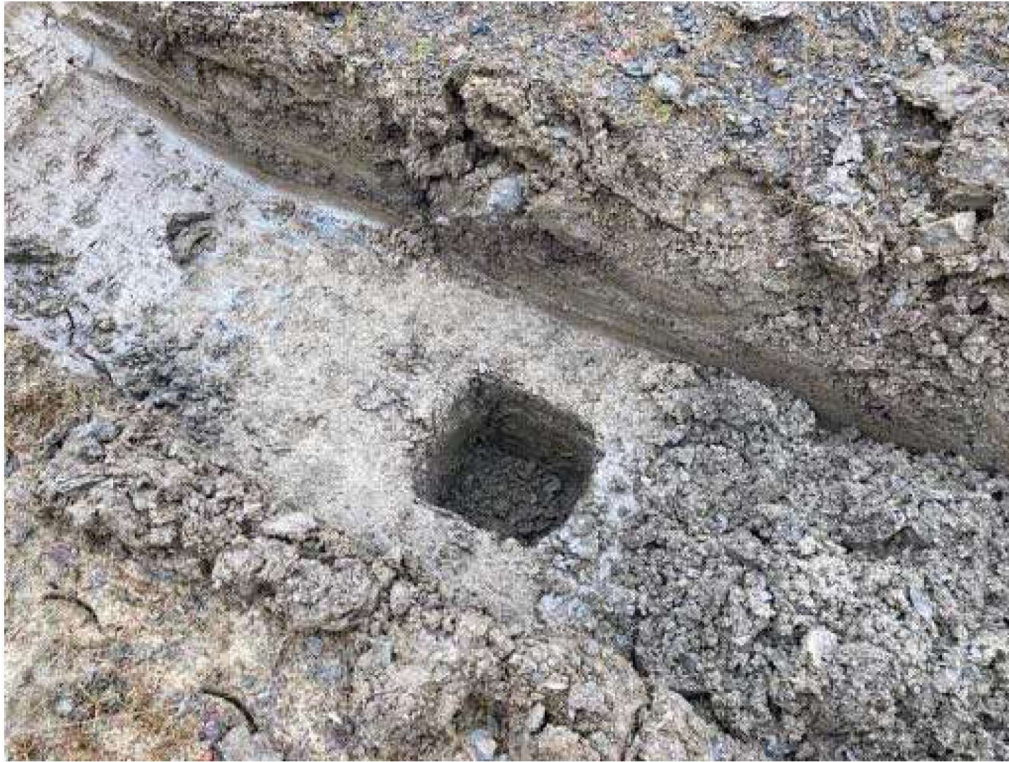
Photograph 19

Description: Hand pit HP01

Location: Lower terraced area in the central-western part of Site A

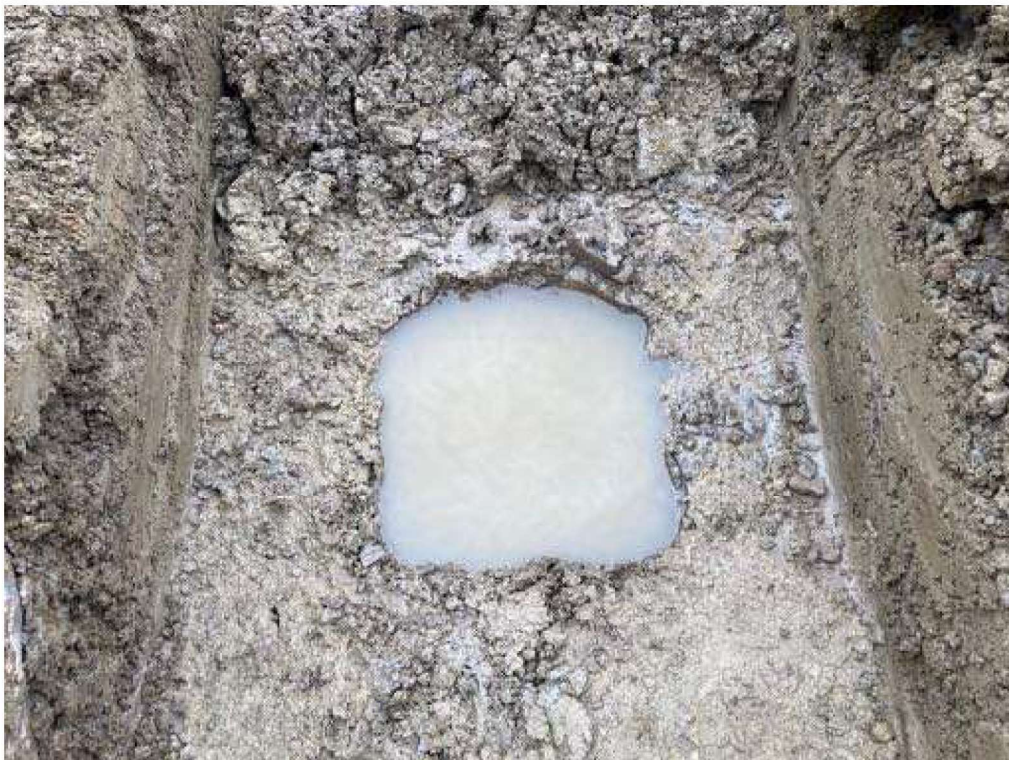
Photograph 20

Description: Hand pit HP01 (start of test)

Location: Lower terraced area in the central-western part of Site A

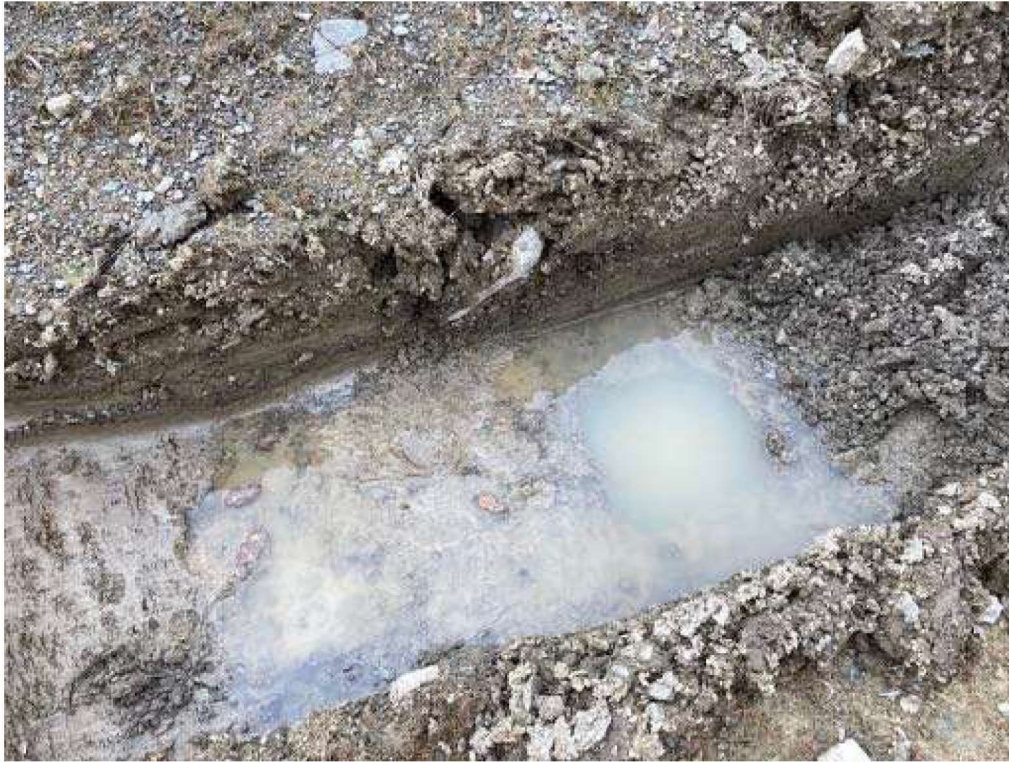
Photograph 21

Description: Hand pit HP01 – increase in water levels at end of test

Location: Lower terraced area in the central-western part of Site A

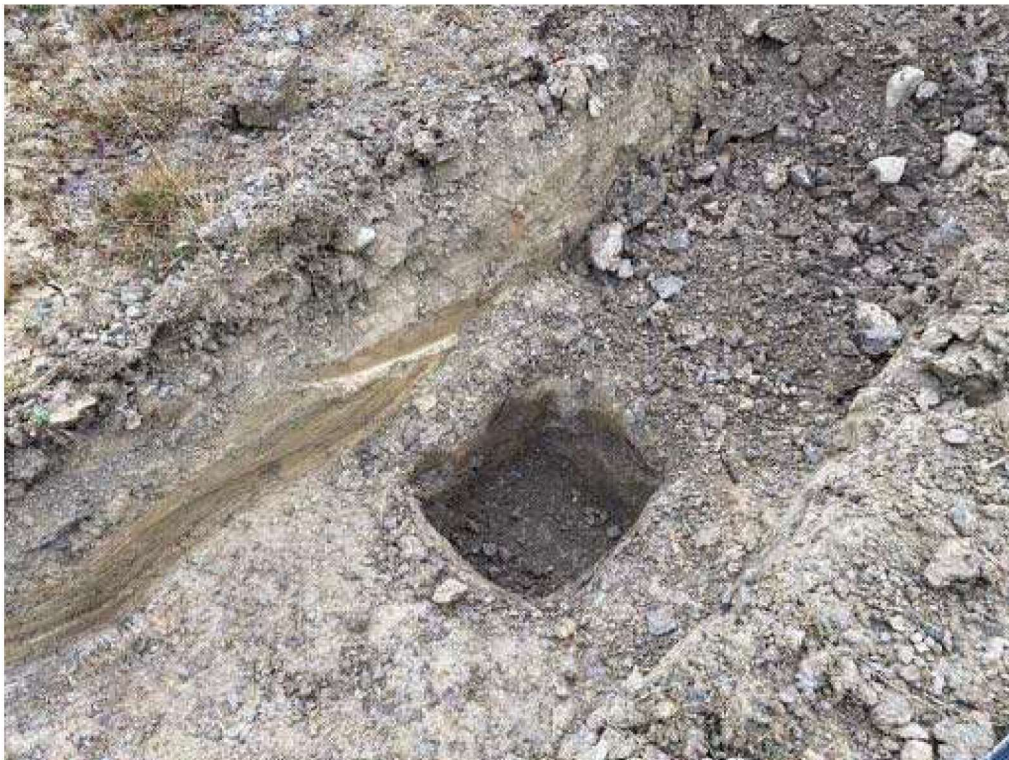
Photograph 22

Description: Hand pit HP02

Location: Upper terraced area in the central-western part of Site A

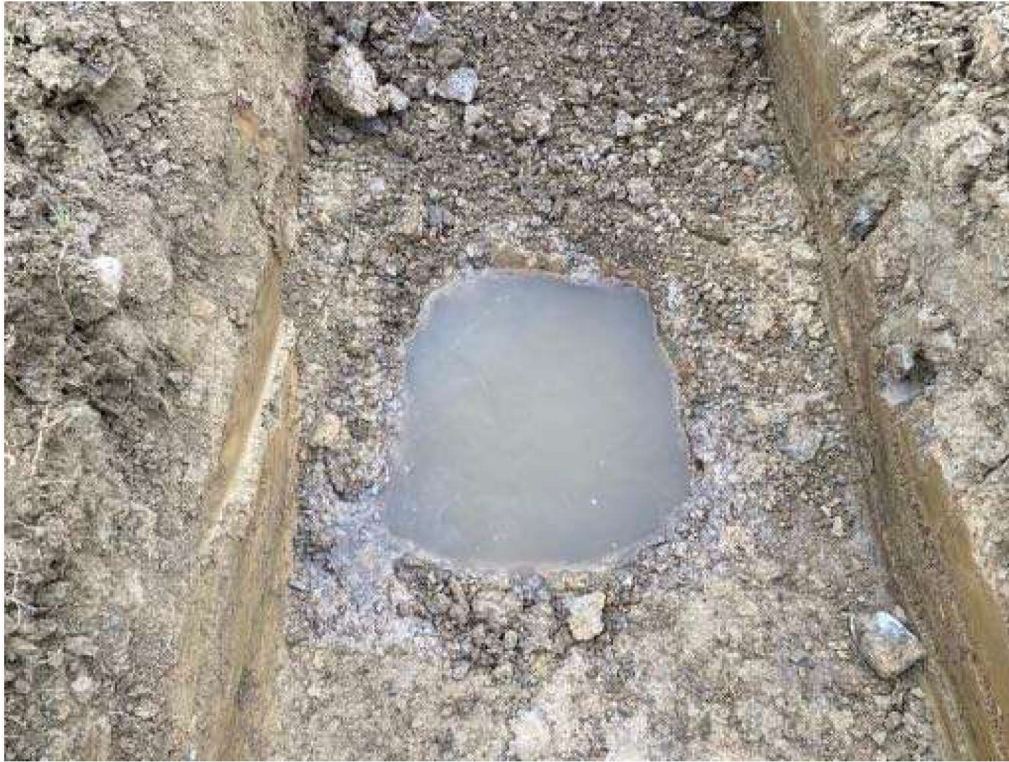
Photograph 23

Description: Hand pit HP02 (start of test)

Location: Upper terraced area in the central-western part of Site A

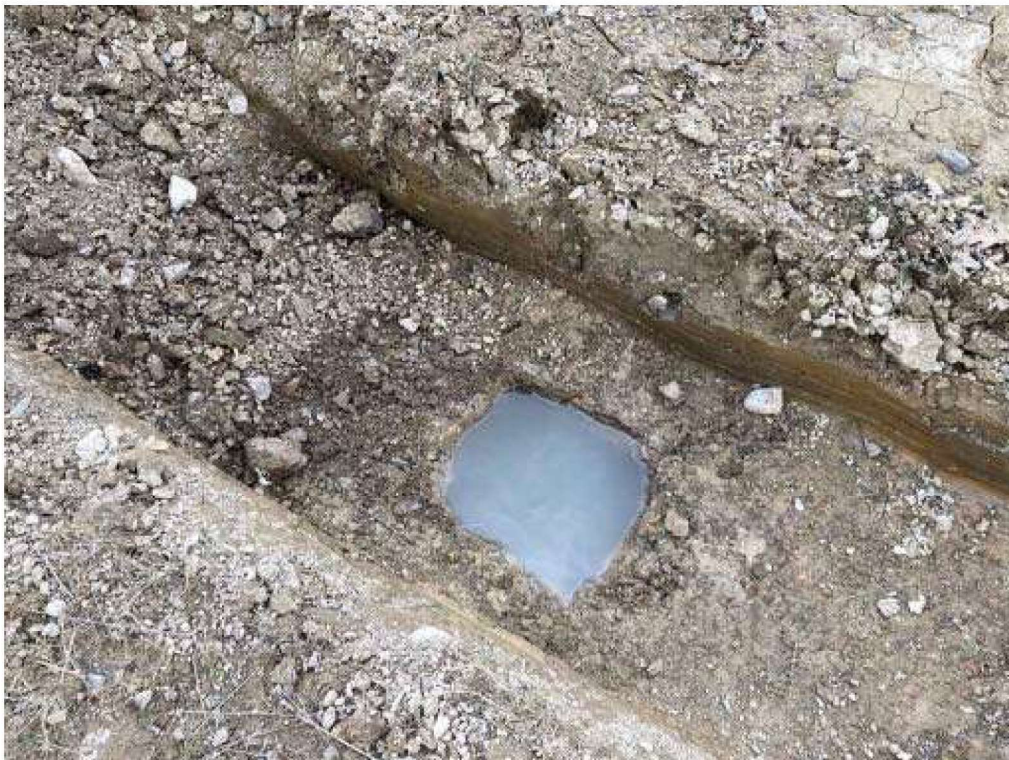
Photograph 24

Description: Hand pit HP02 (end of test)

Location: Upper terraced area in the central-western part of Site A

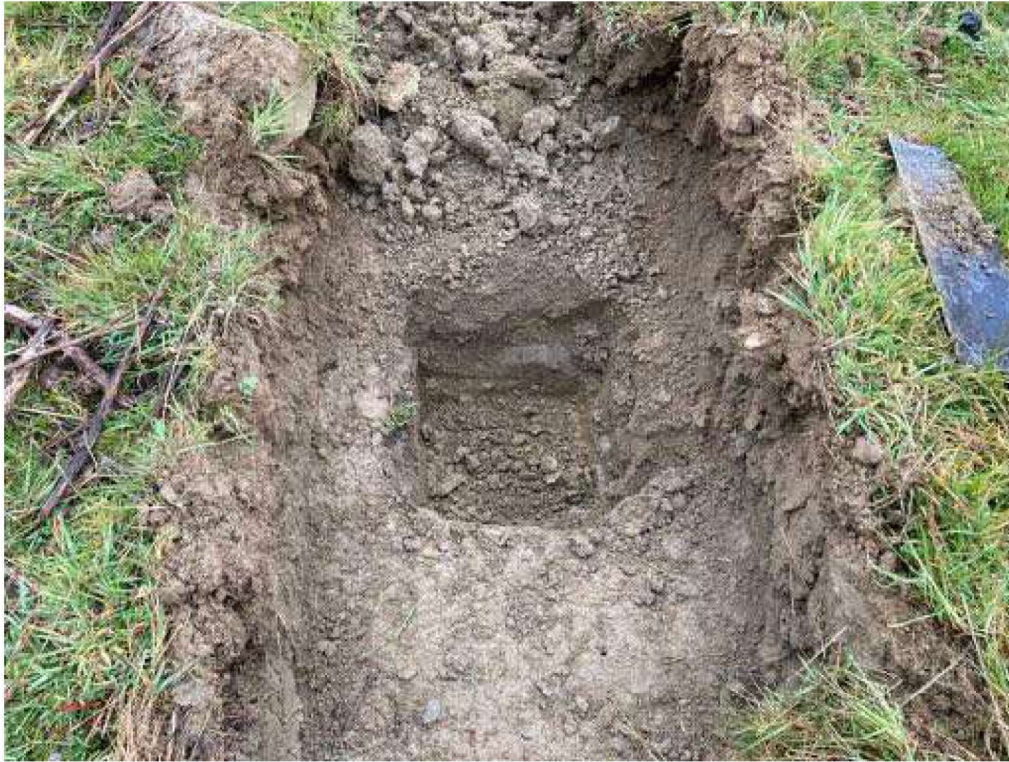
Photograph 25

Description: Hand pit HP03

Location: Sloping land to the south of the current access

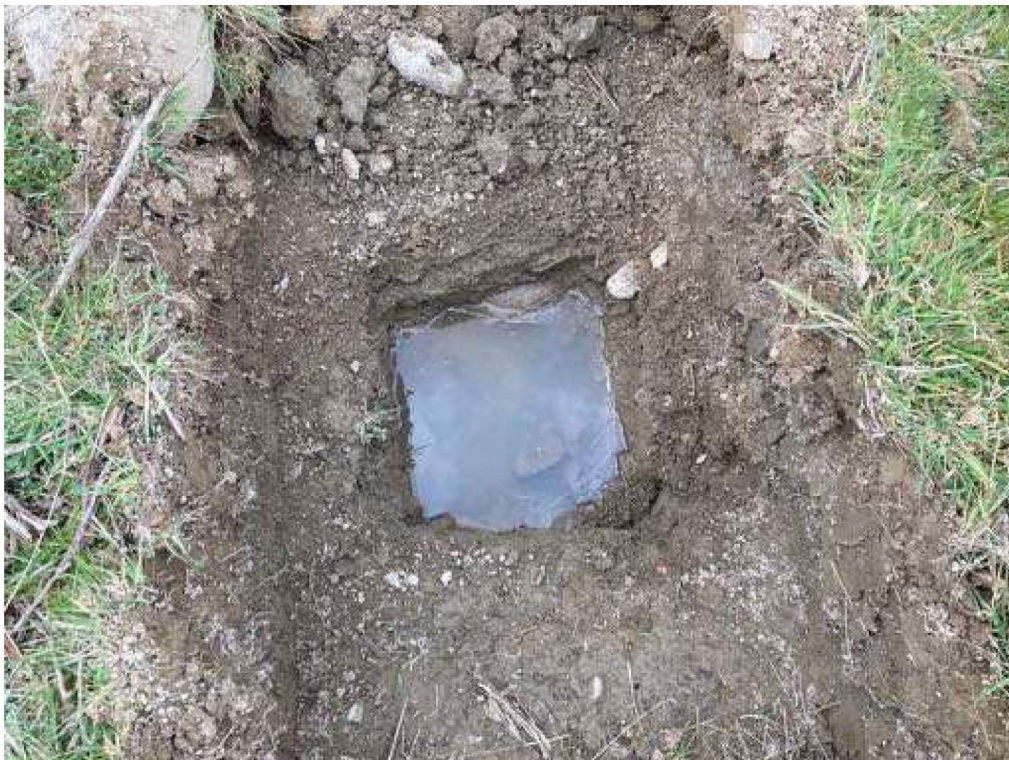
Photograph 26

Description: Hand pit HP03 (end of test)

Location: Sloping land to the south of the current access

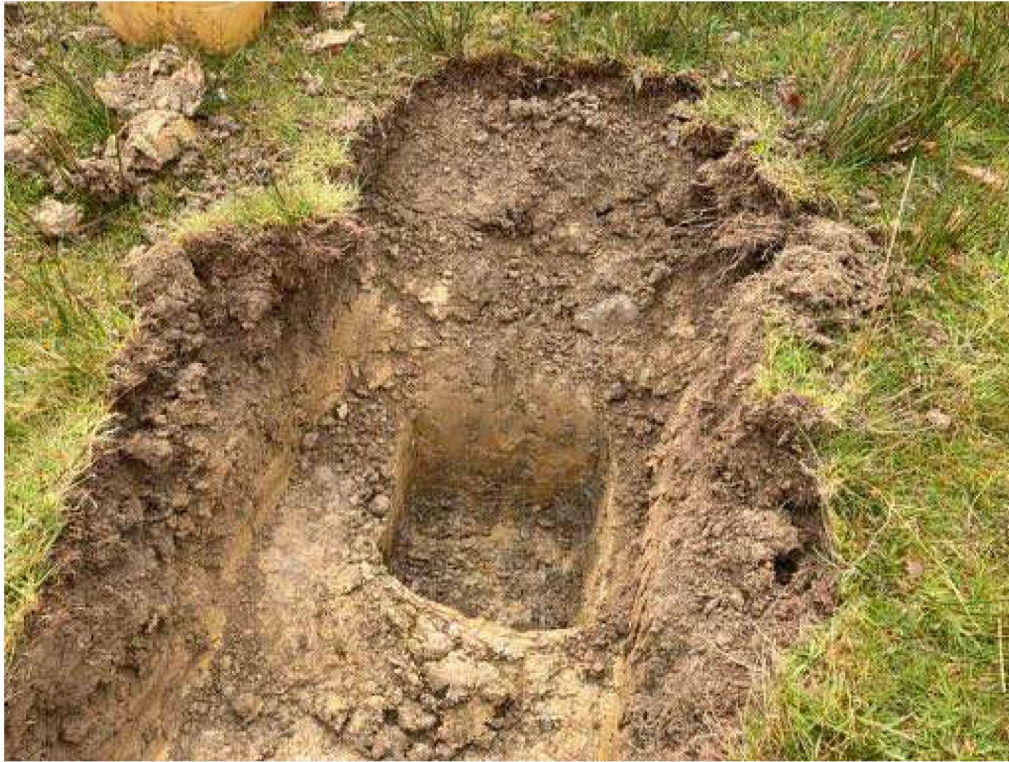
Photograph 27

Description: Hand pit HP04

Location: Sloping land to the south of the current access

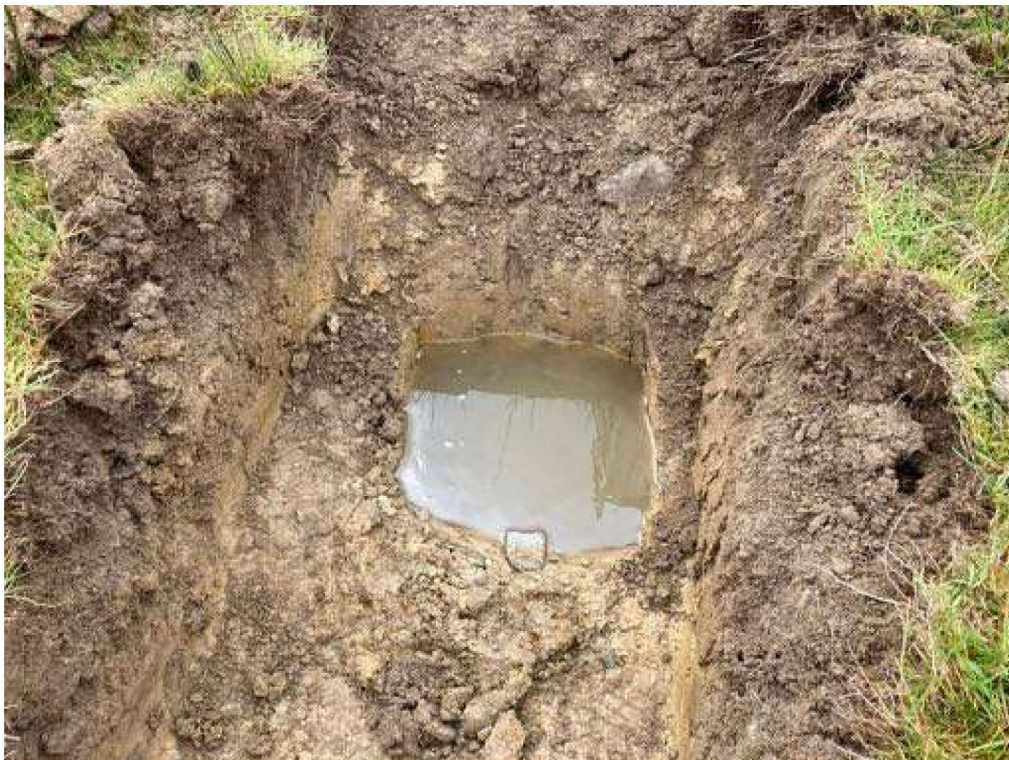
Photograph 28

Description: Hand pit HP04 (start of test)

Location: Sloping land to the south of the current access
